Inspection Photos

API: 099-06215

Operator: BERRY* WALTER V DBA BERRY
ENERGY INC

Inspection Date: 12/1/2021

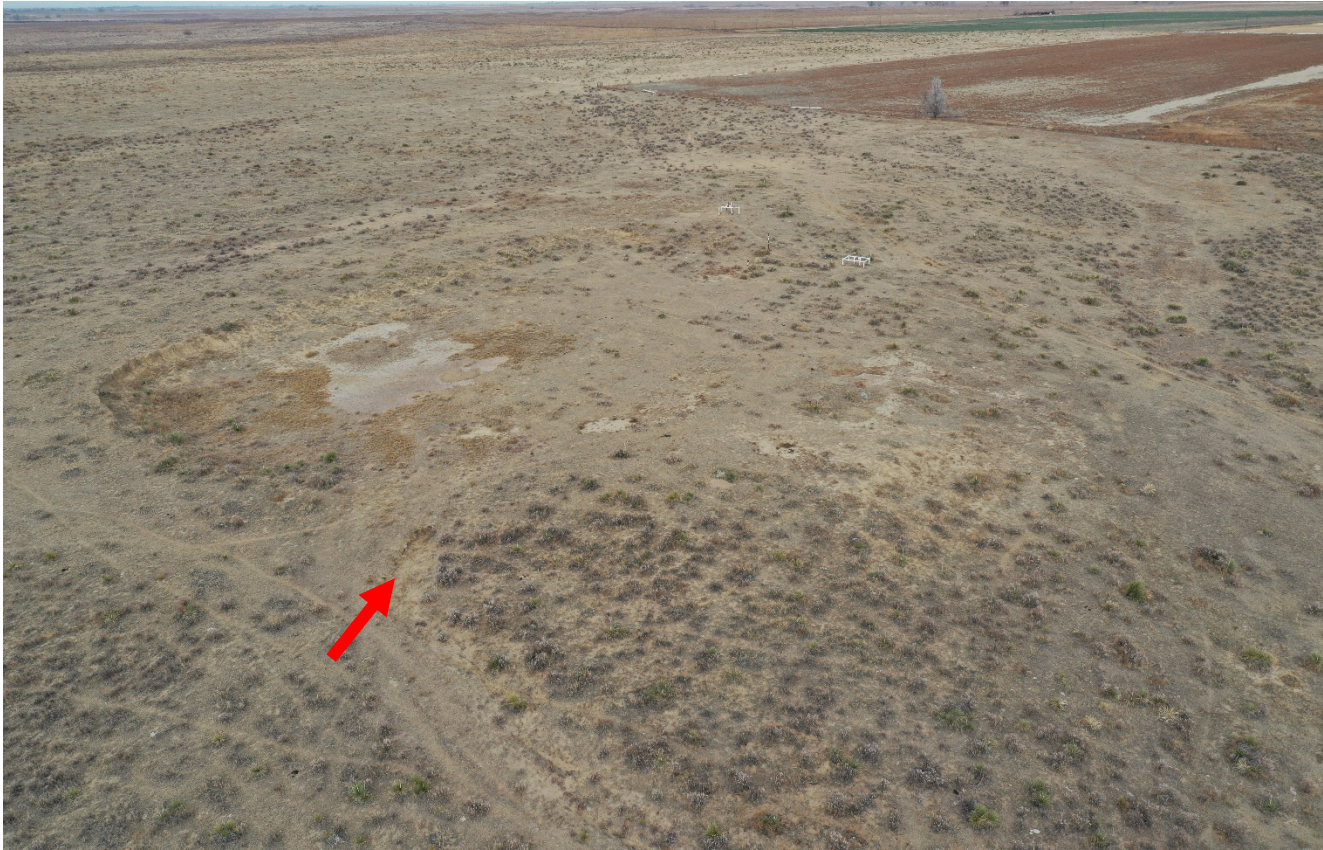
Photo 1. Drone aerial photo facing northwest toward the abandoned well location. The location has not been recontoured and reclaimed. There is erosion occurring along the access road near the location shown at red arrow.

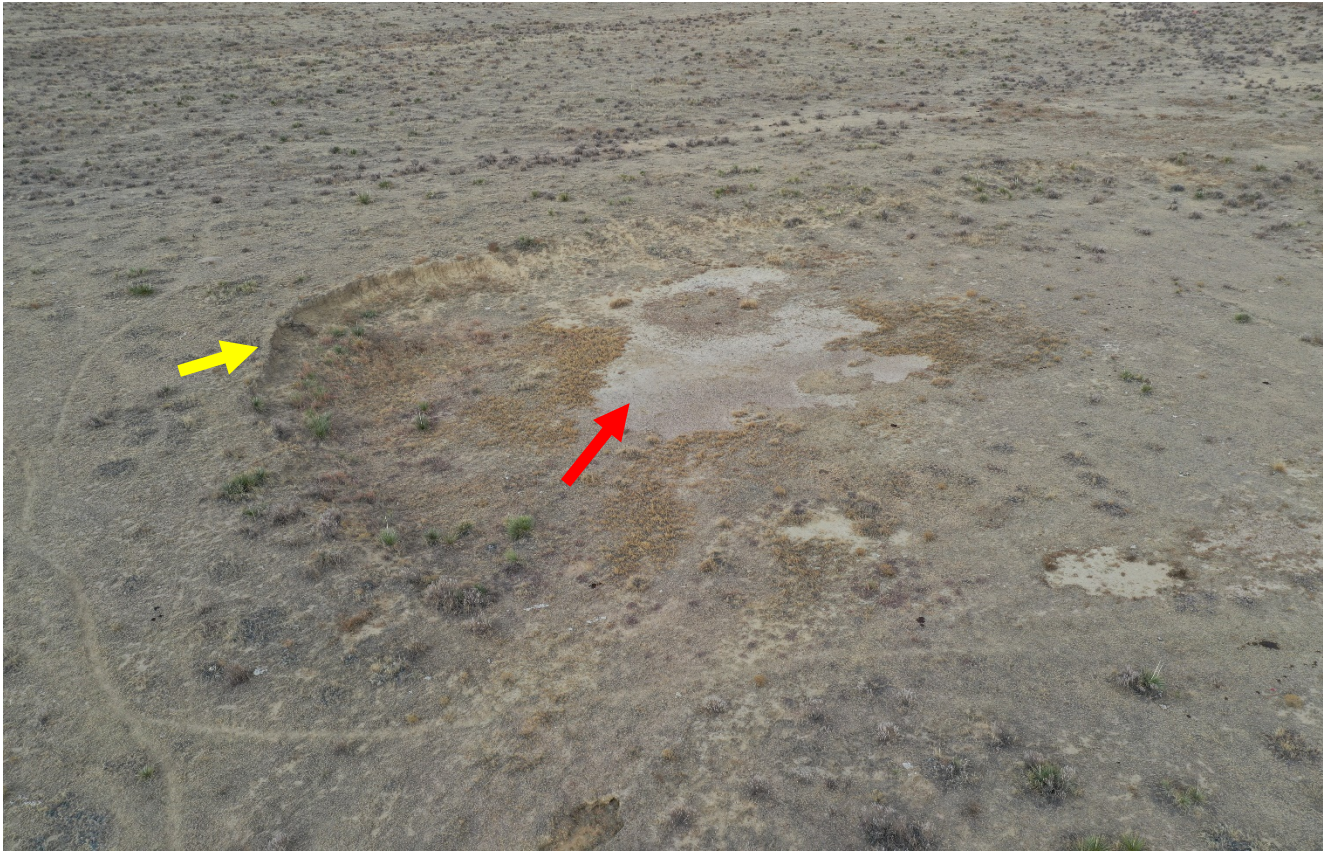
Photo 2. There is an area 150' x 100' with no vegetation shown at red arrow. Additionally the cut slope of the location is shown along the yellow arrow.

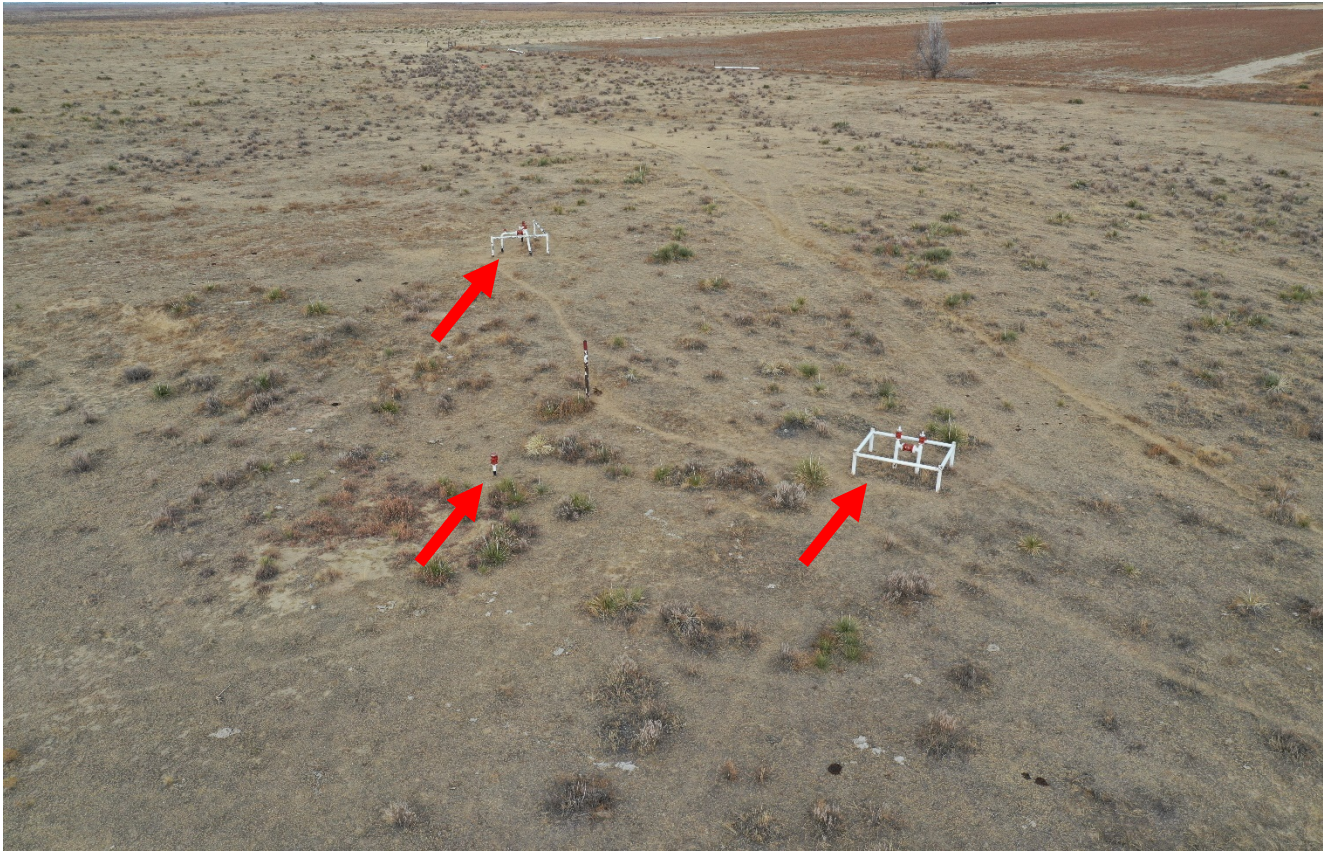
Photo 3. There are abandoned pipe risers that remain at the north side of the location.
