Inspection Photos
Operator: Simcoe
API: 067-09677
Date: 12/7/2021

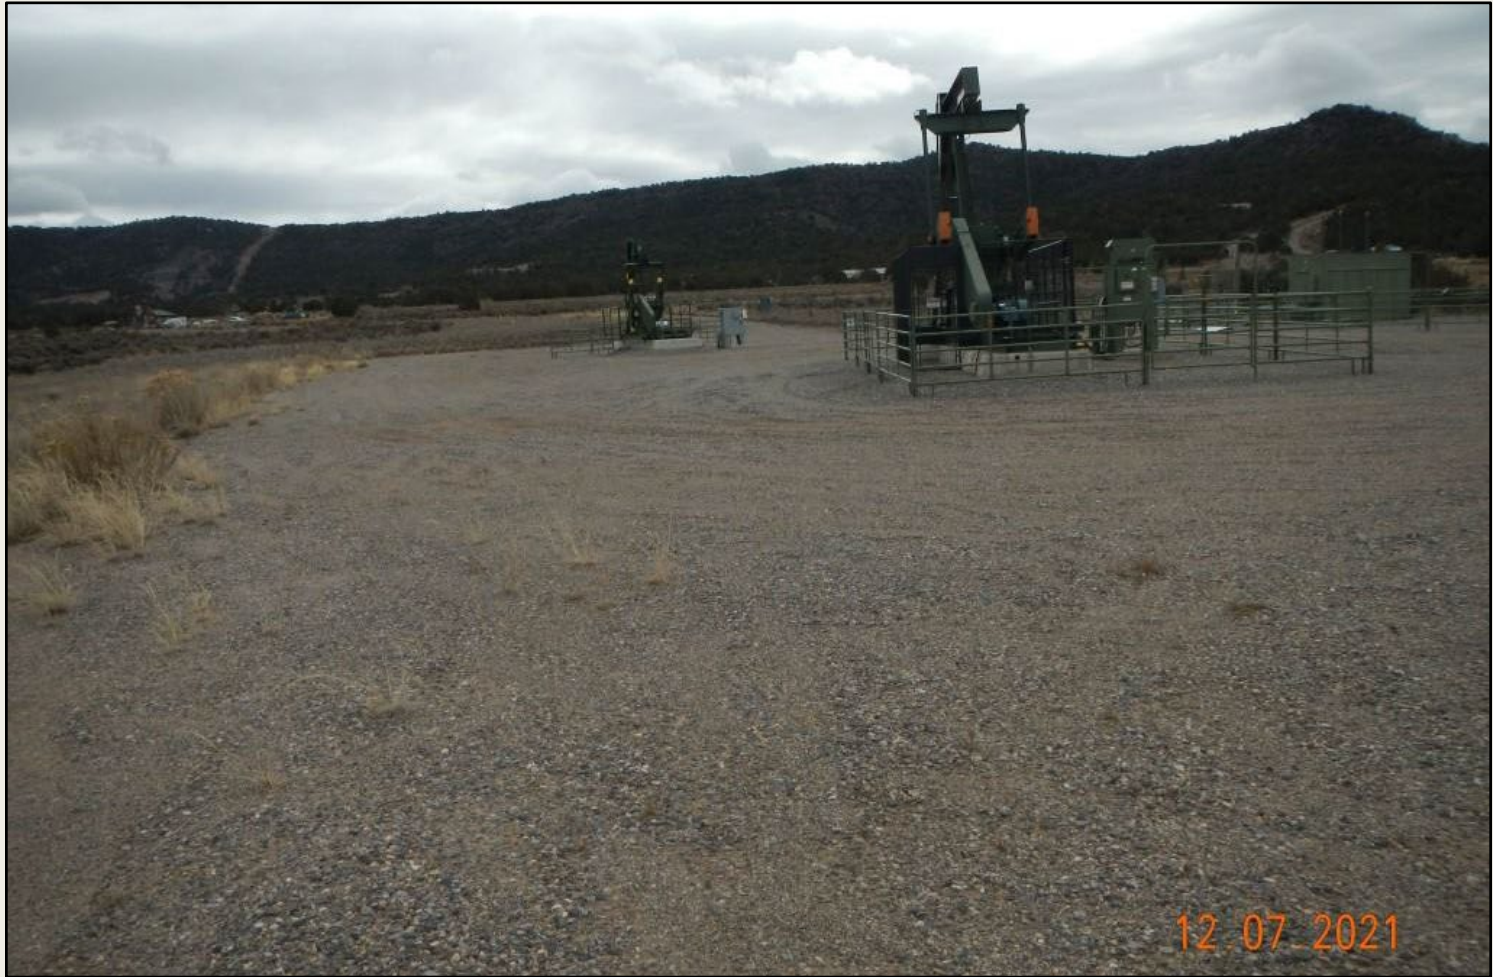
Photo 1. View of the project area from the southeastern corner facing center.

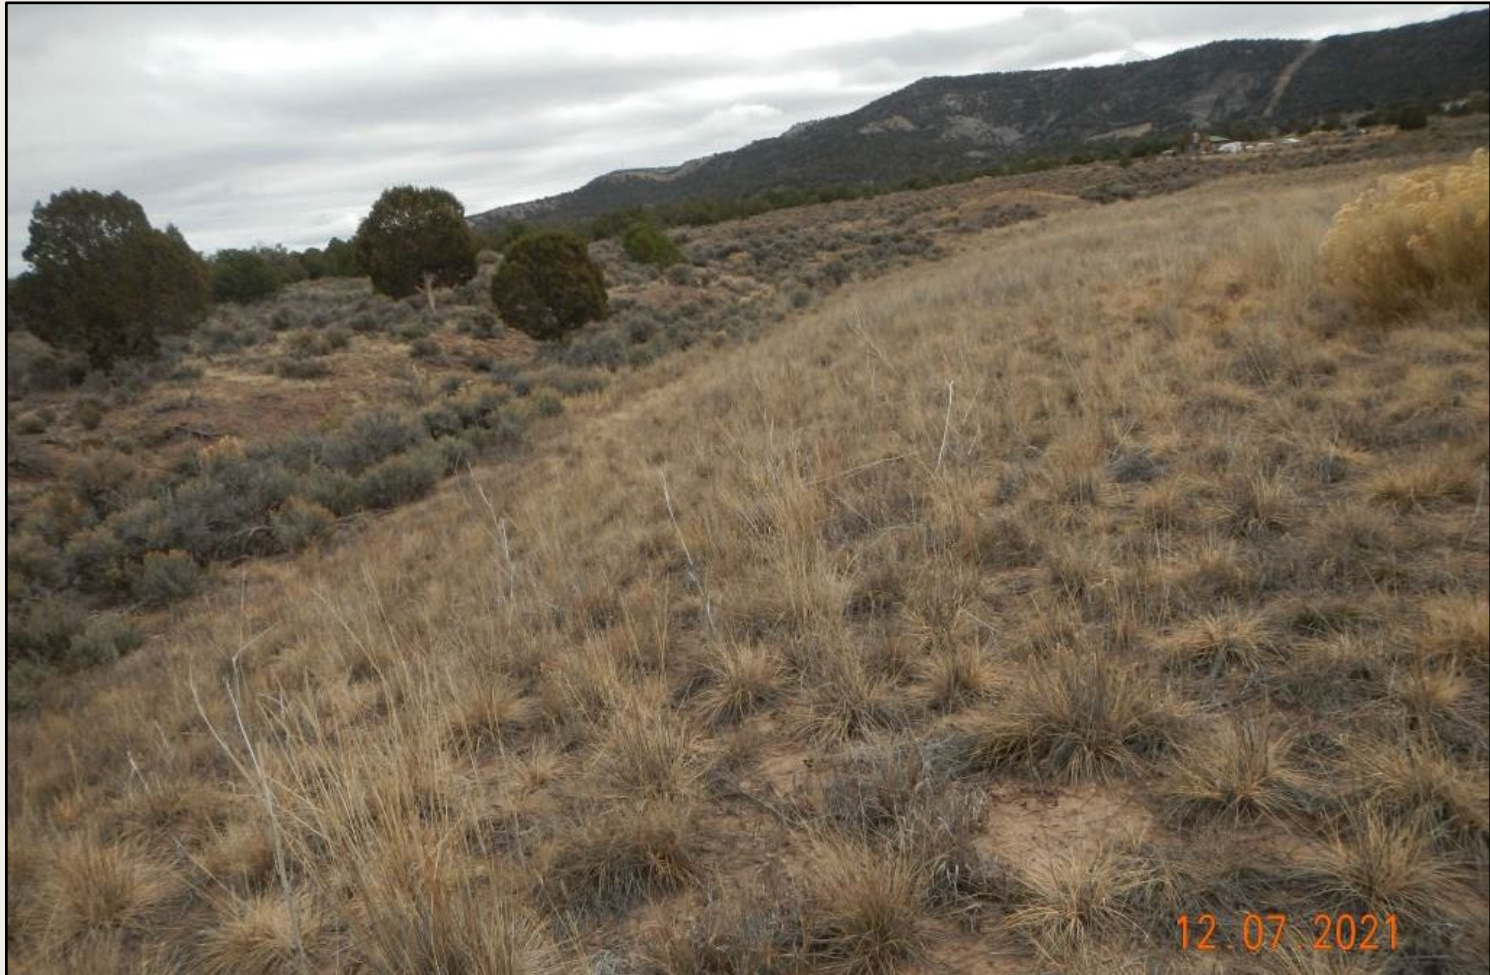
Photo 2. View of eastern project area from the southeastern corner facing northward. Revegetation is progressing here with crested wheatgrass, intermediate wheatgrass, sand dropseed, rubber rabbitbrush, and western wheatgrass.

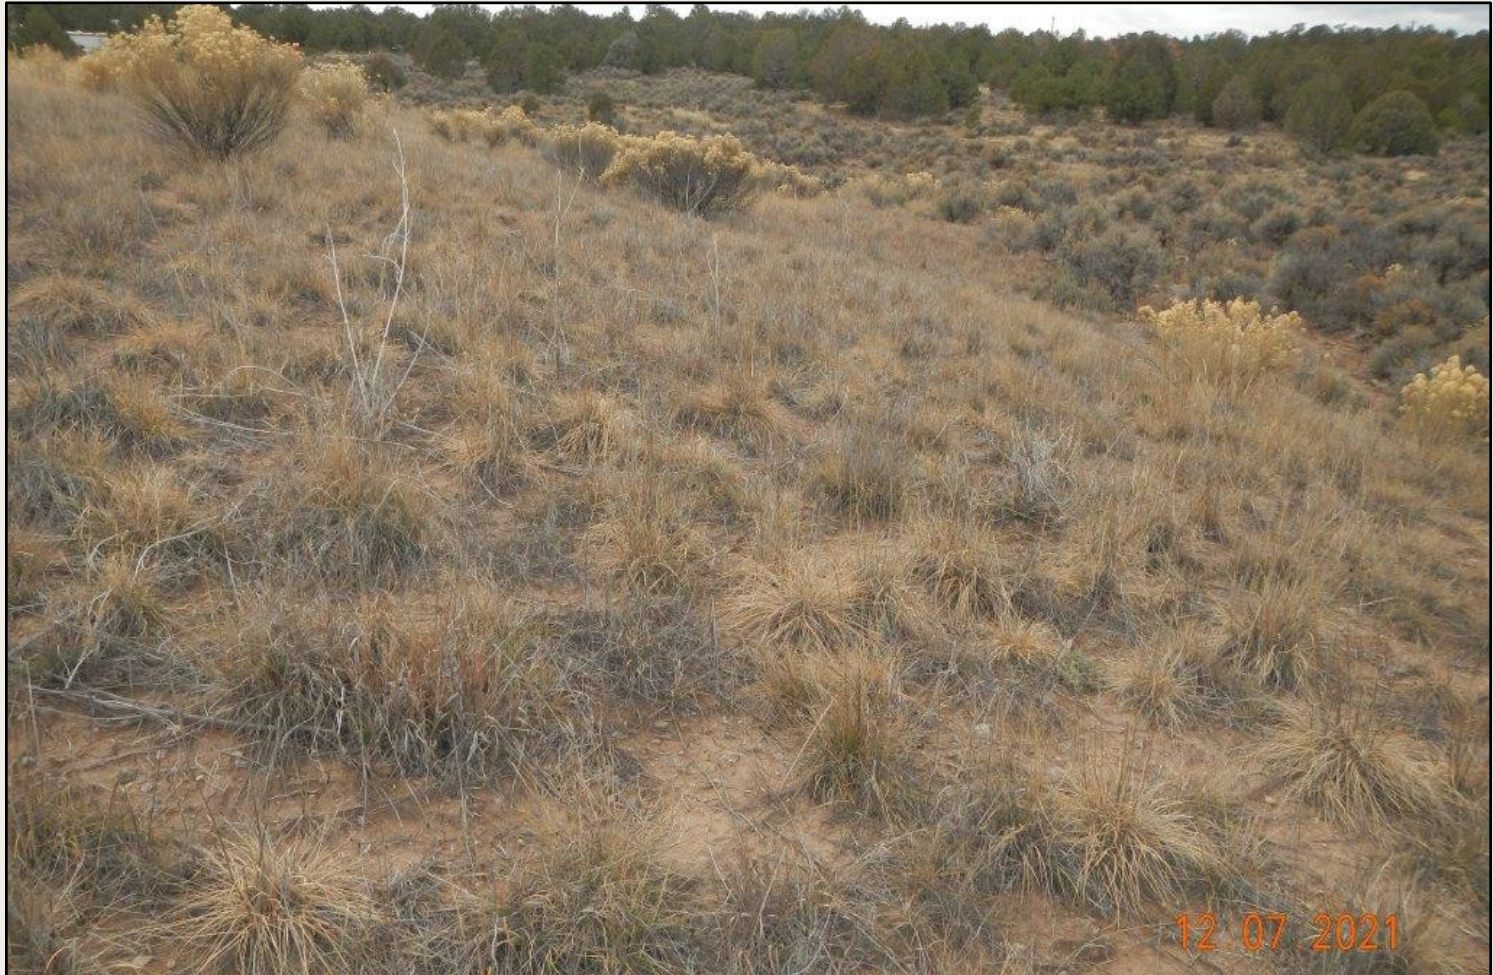
Photo 3. View of the northern project area from the northeastern corner facing westward.

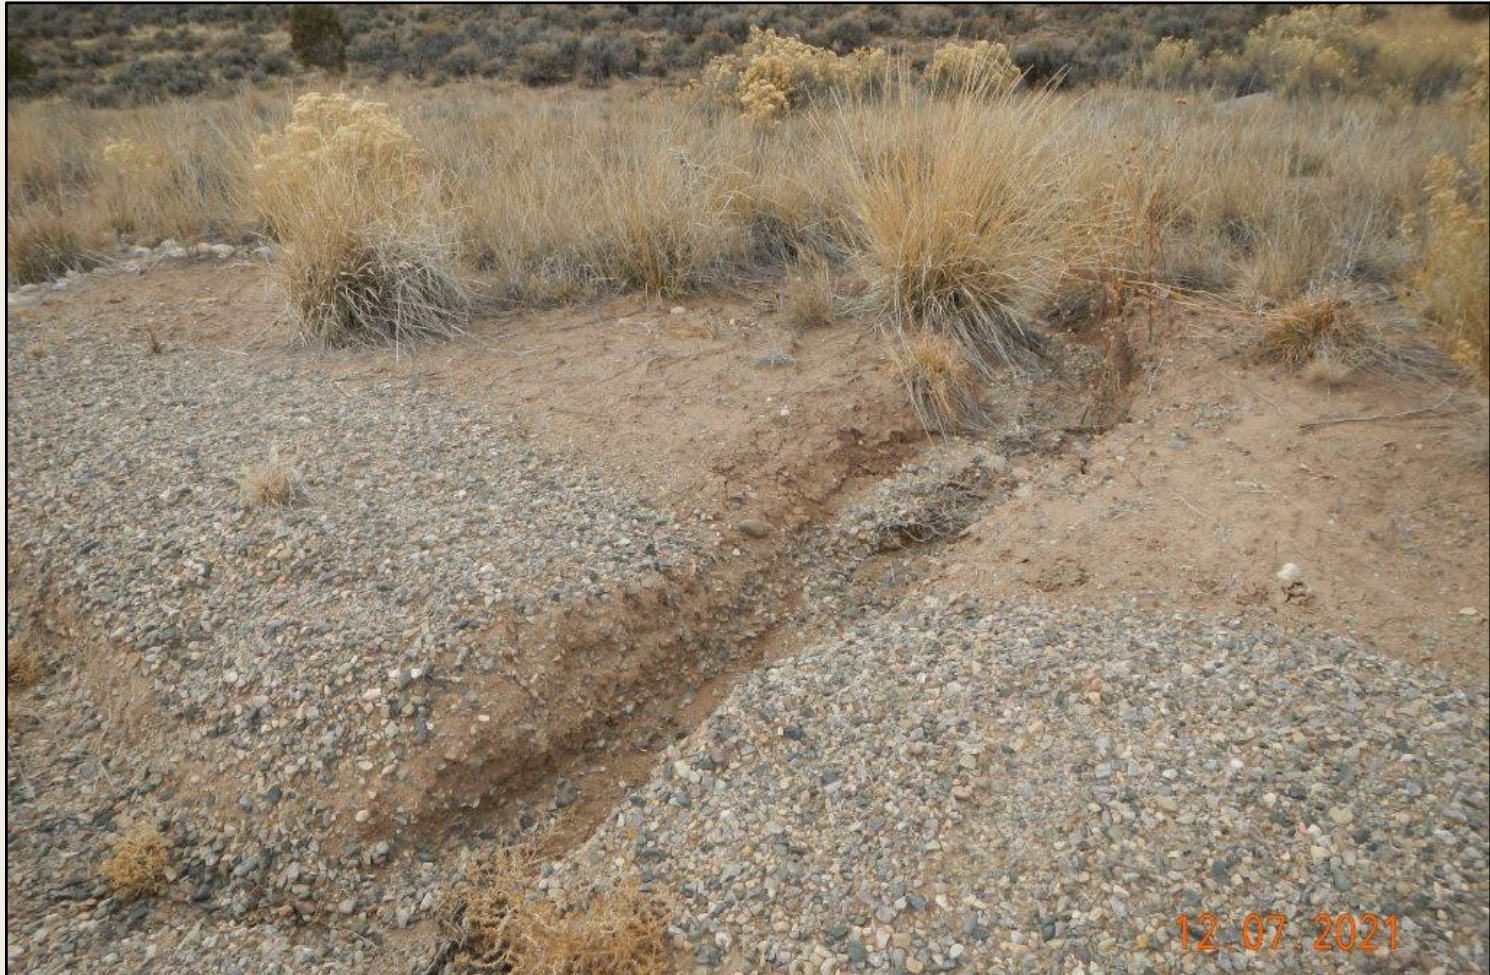
Photo 4. View of an erosional channel approximately 1ft wide and deep, within the northern project area, needing stabilization.

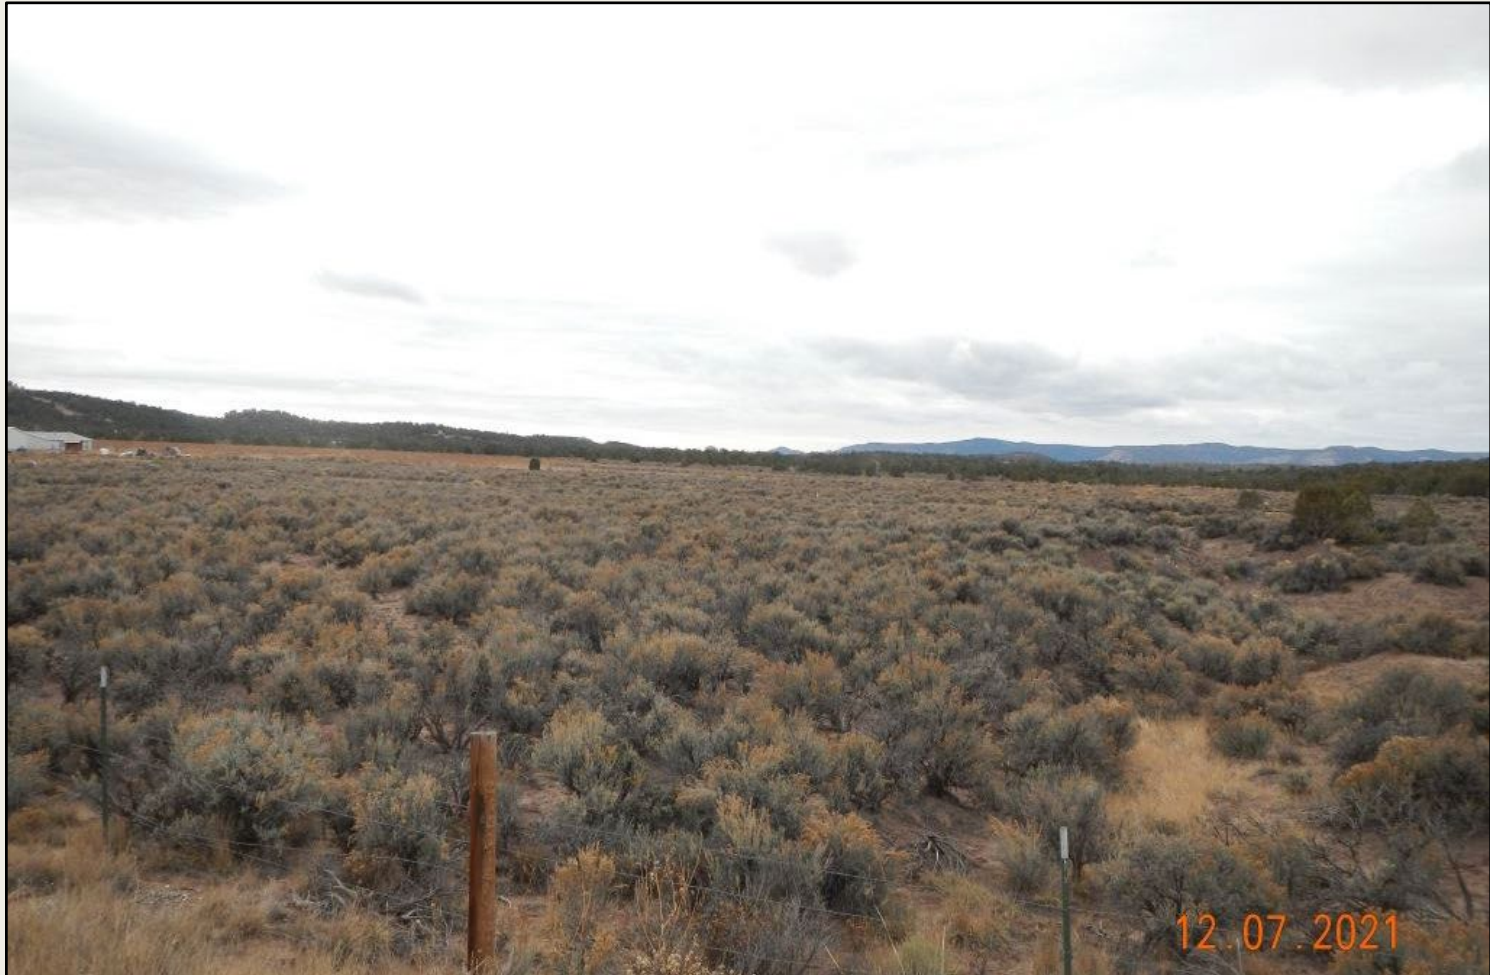
Photo 5. View of reference area comprised of sagebrush shrubland with Indian ricegrass, James galleta, snakeweed, and prickly pear.
