Inspection Photos

Operator: TEP ROCKY MOUNTAIN LLC #96850

Location ID: 323866

Garfield County, CO

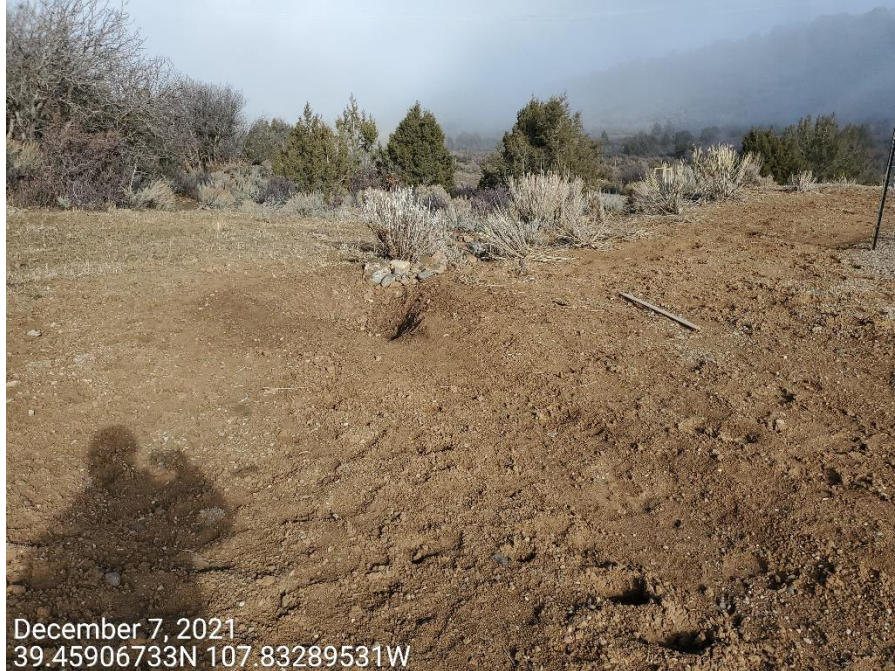
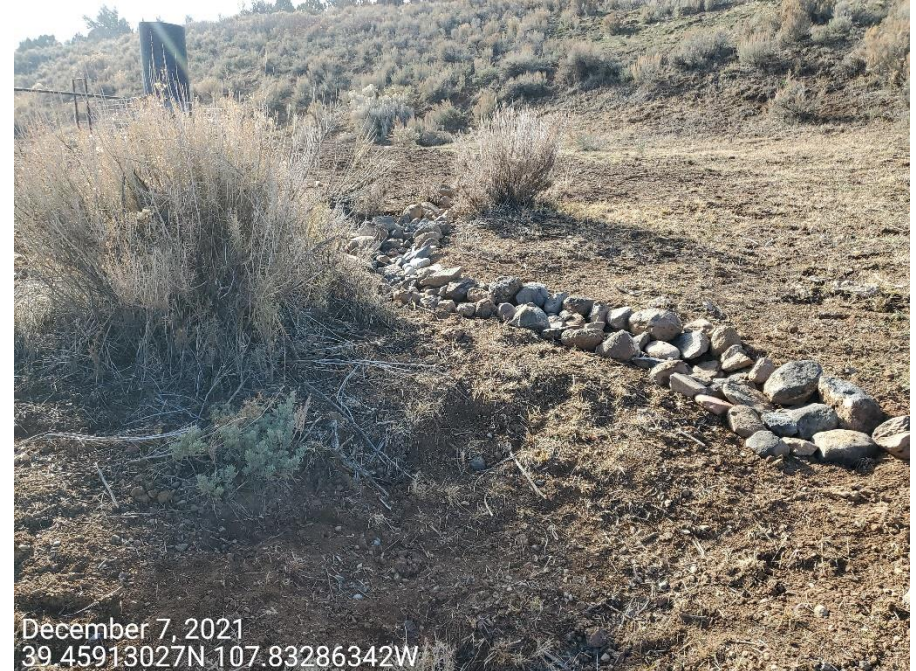
Photo 1: Photo shows Operator has constructed a shallow sediment trap at the end of the ditch; outlet missing geotextile lining beneath the rip-rap material per good engineering practices.

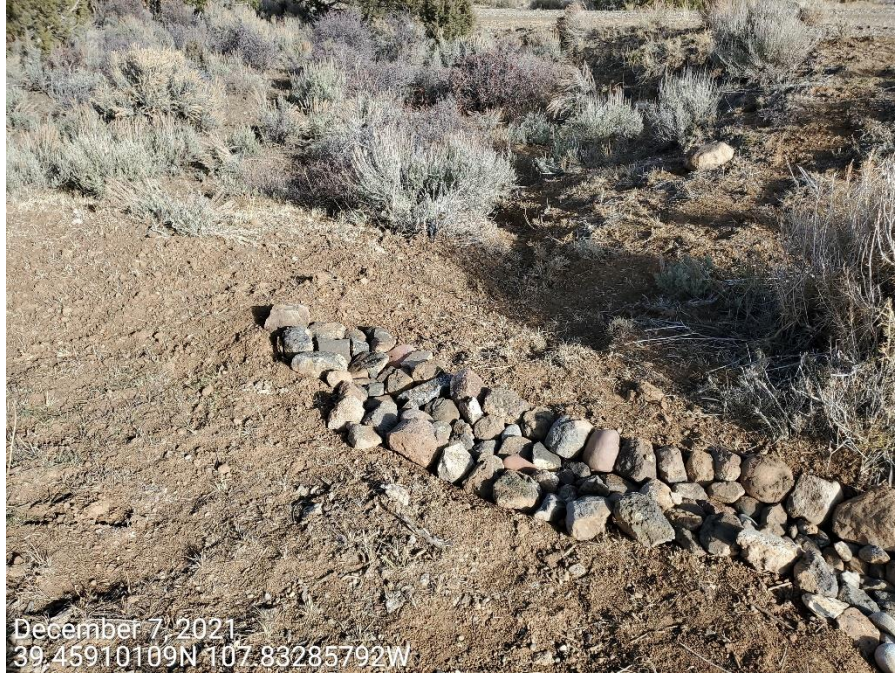
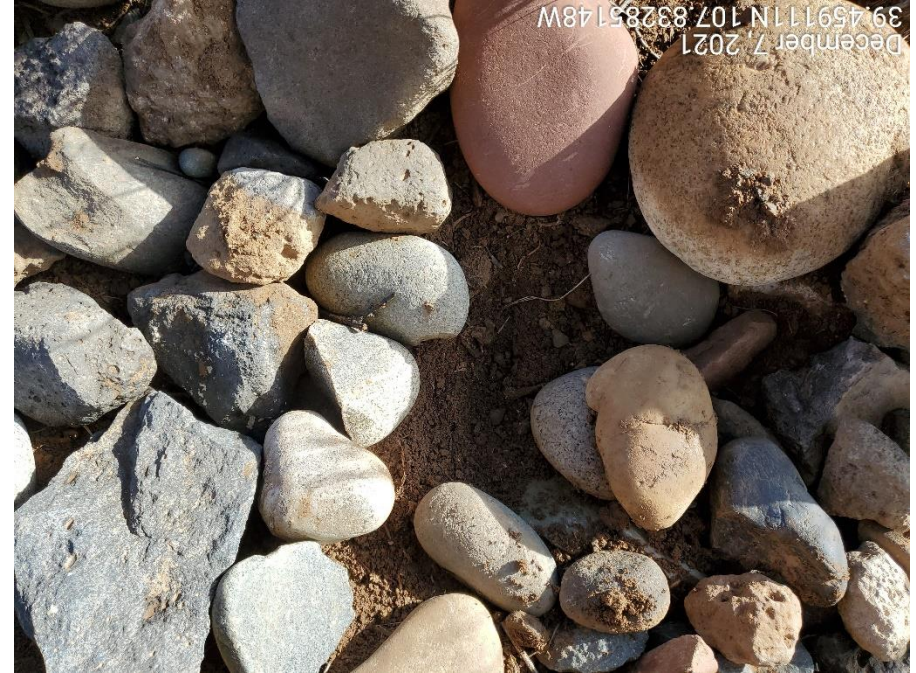
Photo 2: Photo shows Operator has constructed a shallow sediment trap at the end of the ditch; outlet missing geotextile lining beneath the rip-rap material per good engineering practices.

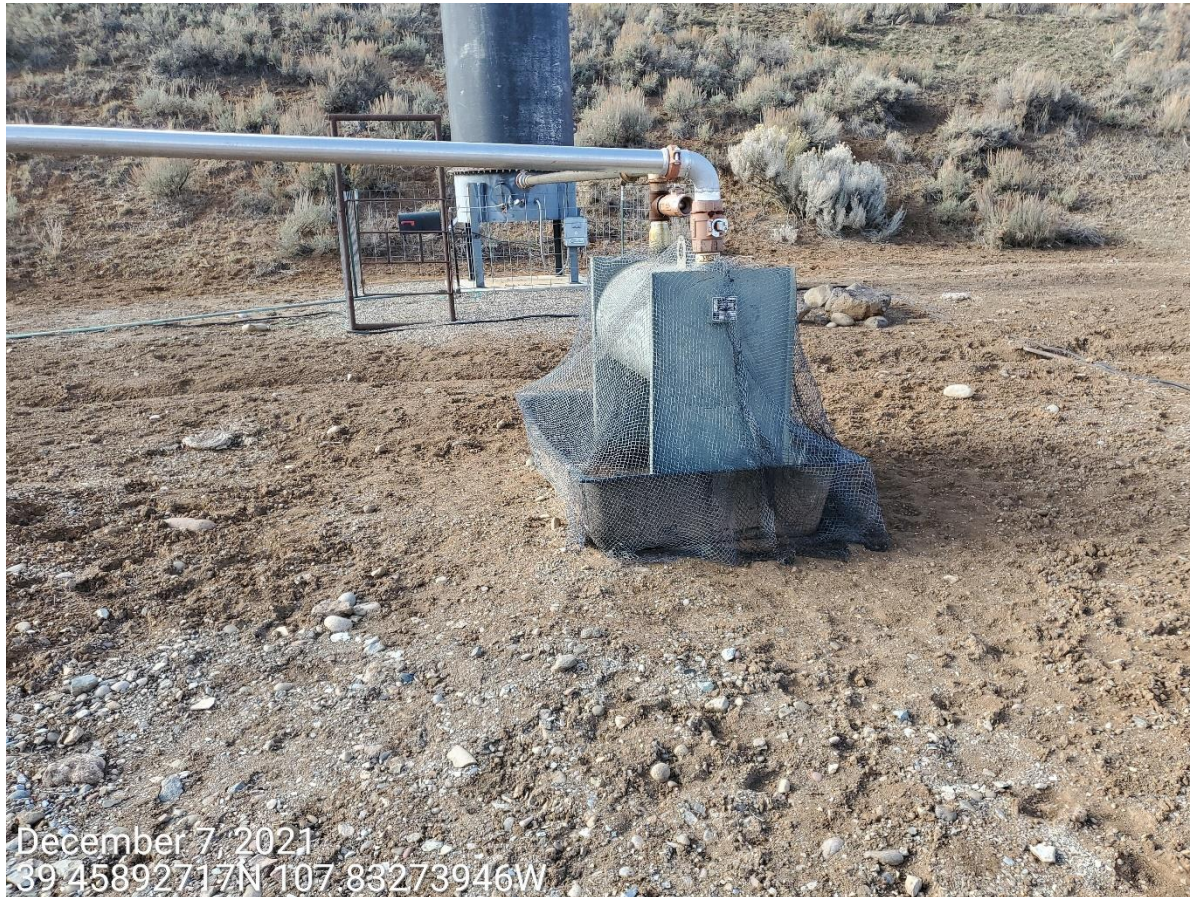
Photo 3: Photo shows controls measures (netting) has been implemented at the containment BMP to prevent wildlife .
