TANK BATTERY DECOMMISSIONING FORM

SITE NAME: Bryant 9&34-30A O SA Facility							DATE: 9/14/2021	REM. PROJECT #:	WEATHER: Sunny 64 degrees		
SITE DIRECTIONS: CR 16.5 & CR 3.25, W. 0.1, SW. 0.1, INTO							CLIENT: Oxy				
LEGALS AND LAT/LONG: 40.106044, -105.039492							TASMAN PERSONNEL: Sierra Kirylo				
SOIL TYPES: Poorly Graded Sand - SP							SURFACE GRADIENT: Southwest				
SOIL SAMPLING							FACILITY INFRASTRUCTURE				
Date/Time	Soil Sample ID	PID (ppm)	Visual	Olfactory	Photo?	Grab or Lab Sample?	EQUIPMENT		Quantity		
							Above Ground Storage Tank (AST)		7		
9/14/2021 14:24	AST-B01@3"	0.0	No Staining	No Odor	Yes	N/A	Buried or Partially Buried Vessel				
9/14/2021 14:25	AST-B02@3"	0.1	No Staining	No Odor	Yes	Lab	Separator				
9/14/2021 11:10	AST-B03@3"	0.6	Oxidization	No Odor	Yes	Lab	Emission Control Device (ECD)				
9/14/2021 11:11	AST-B04@3"	0.5	No Staining	No Odor	Yes	N/A	Dump Line				
9/14/2021 14:15	AST-B05@3"	0.0	No Staining	No Odor	Yes	N/A	Wellhead

Bryant 9834-30A O SA Facility

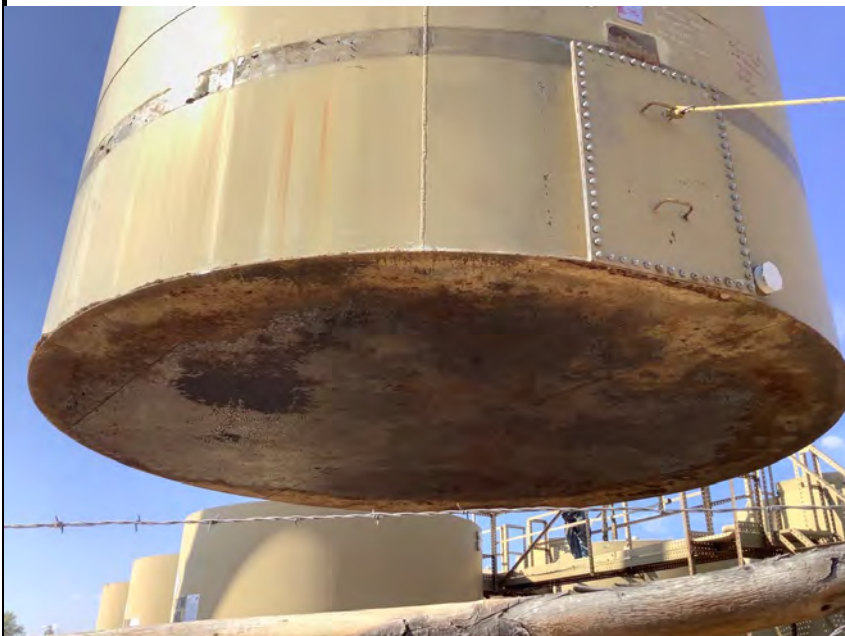
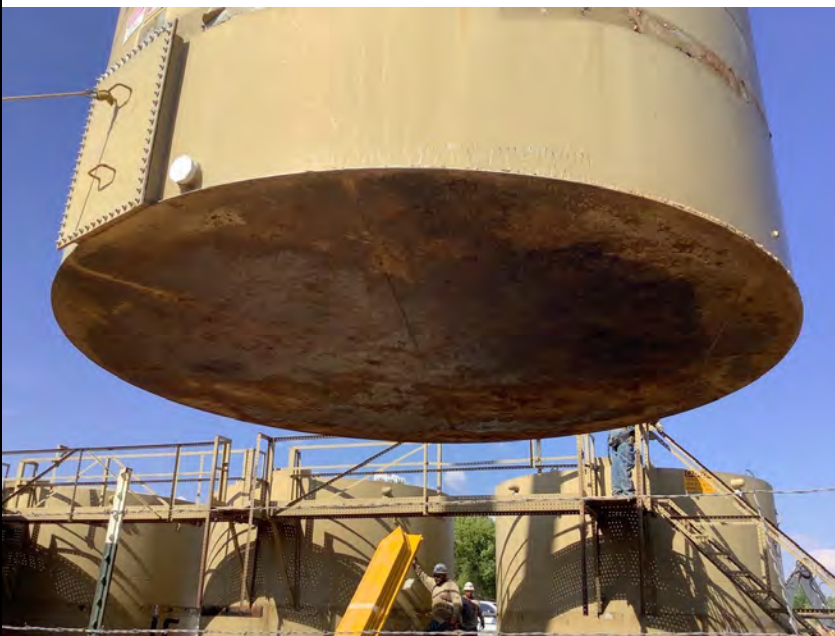
Equipment ID:		Equipment Type: Above Ground Storage Tank			
Material: Steel	Volume: 315 BBL	Contents: Crude Oil			
Notes/Conditions: Tank #1 (refer to field sketch)					
Equipment ID:		Equipment Type: Above Ground Storage Tank			
Material: Steel	Volume: 315 BBL	Contents: Crude Oil			
Notes/Conditions: Tank #2 (refer to field sketch)

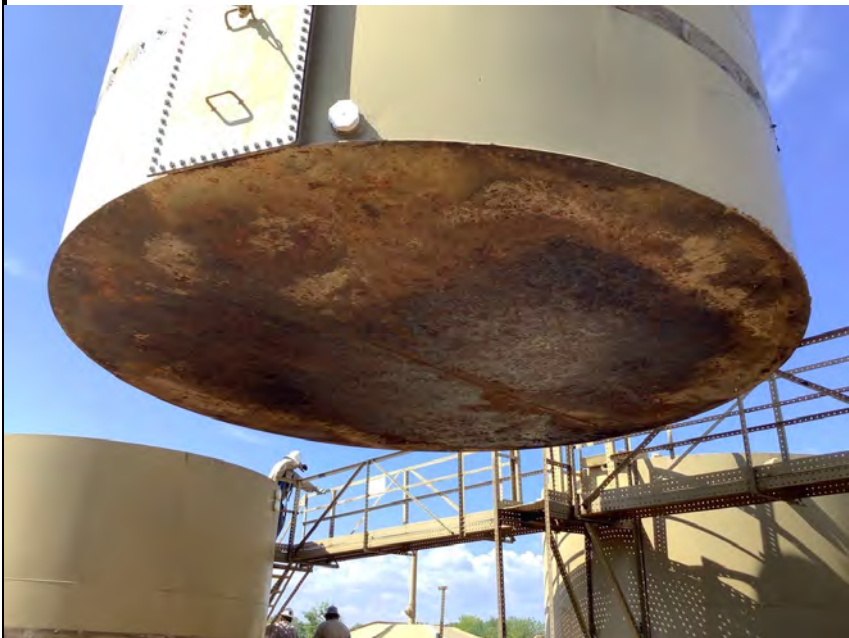
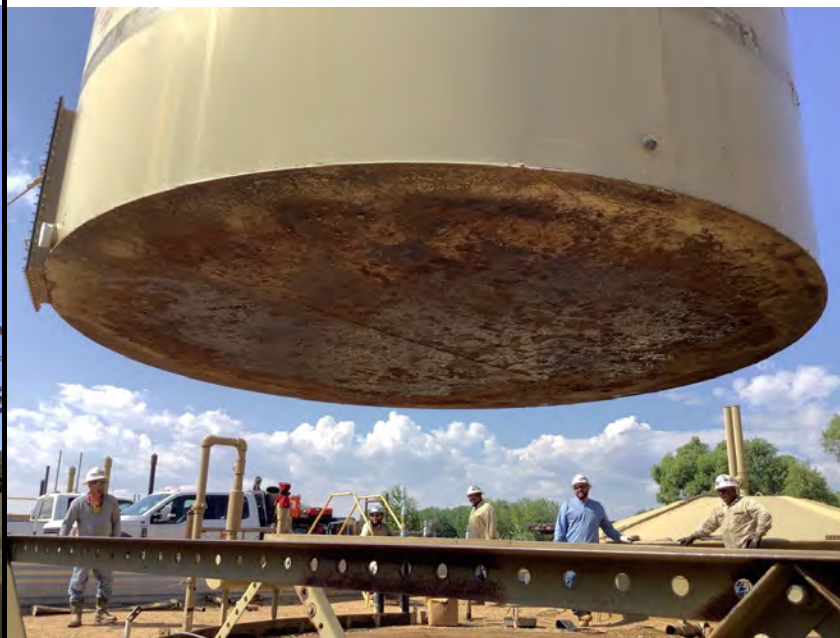
Equipment ID:	Equipment ID:
Equipment Type: Above Ground Storage Tank	Equipment Type: Above Ground Storage Tank
Material: Steel	Material: Steel
Volume: 315 BBL	Volume: 315 BBL
Contents: Crude Oil	Contents: Crude Oil
Notes/Conditions: Tank #3 (refer to field sketch)	Notes/Conditions: Tank #4 (refer to field sketch)

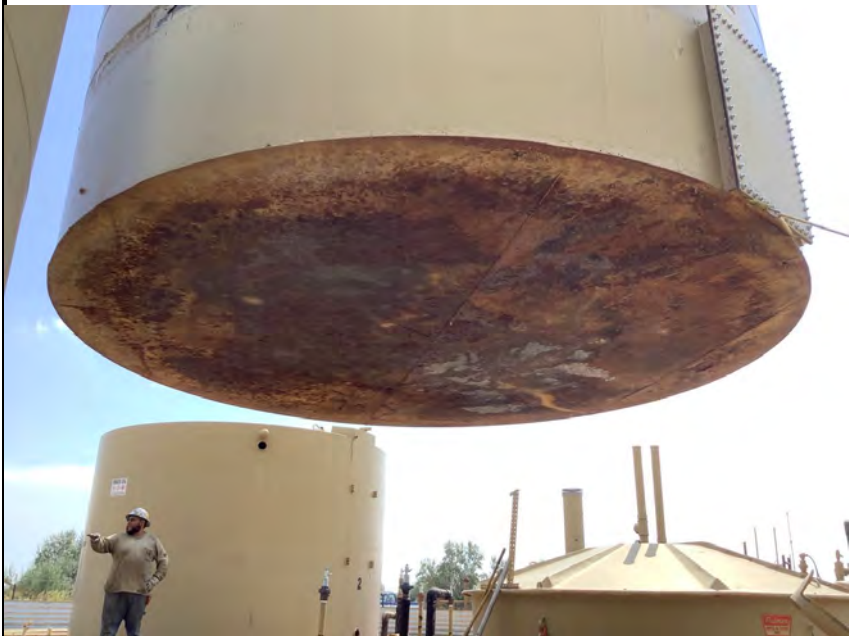
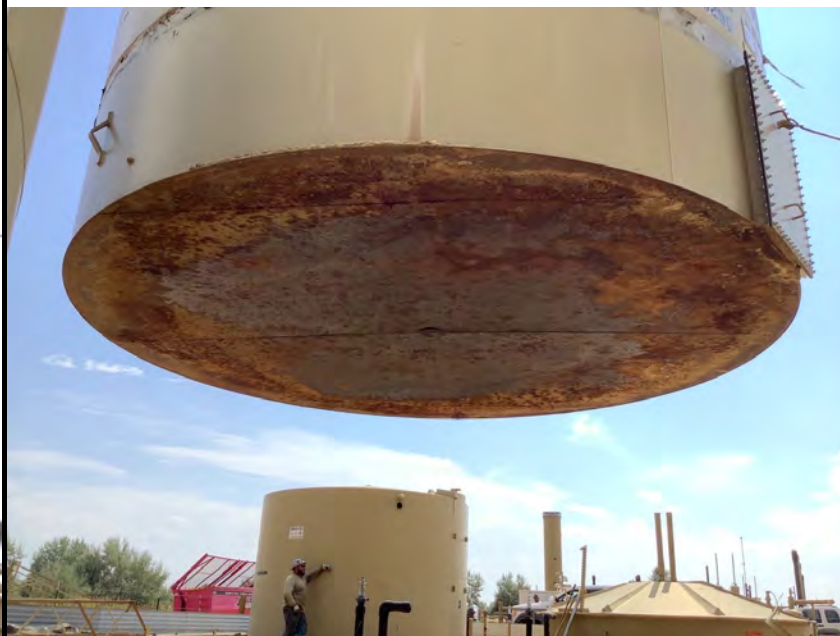
Equipment ID:	Equipment Type: Above Ground Storage Tank		Equipment ID:	Equipment Type: Above Ground Storage Tank	
Material: Steel	Volume: 315 BBL	Contents: Crude Oil	Material: Steel	Volume: 315 BBL	Contents: Crude Oil
Notes/Conditions: Tank #5 (refer to field sketch)			Notes/Conditions: Tank #6 (refer to field sketch)

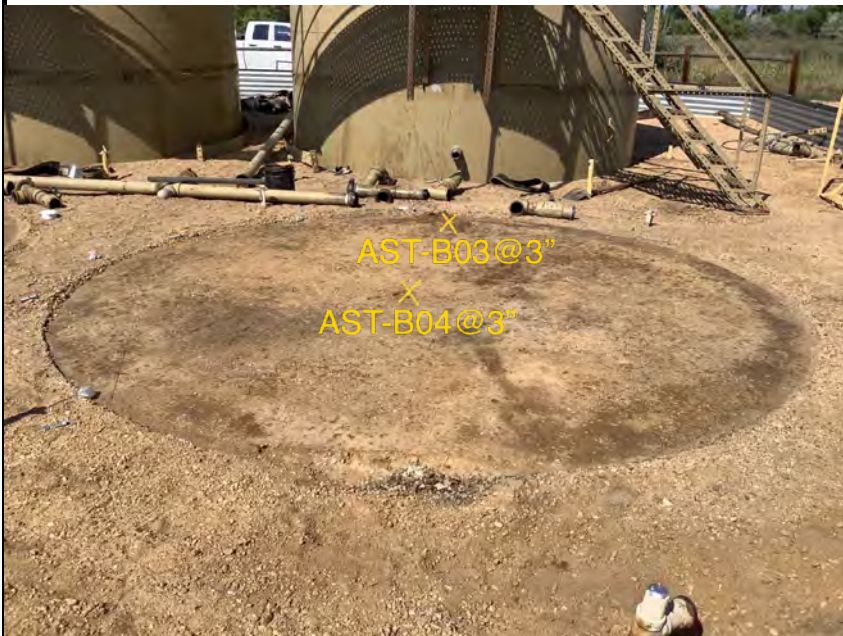
<p>AST-B03@3" X AST-B04@3" X</p>

<p>AST-B05@3" X AST-B06@3" X</p>						
Equipment ID:		Equipment Type:		Equipment ID:		Equipment Type:			
Material:		Volume:		Material:		Volume:		Contents:	
Notes/Conditions: AST-B03@3" and AST-B04@3" facing west					Notes/Conditions: AST-B05@3" and AST-B06@3" facing west

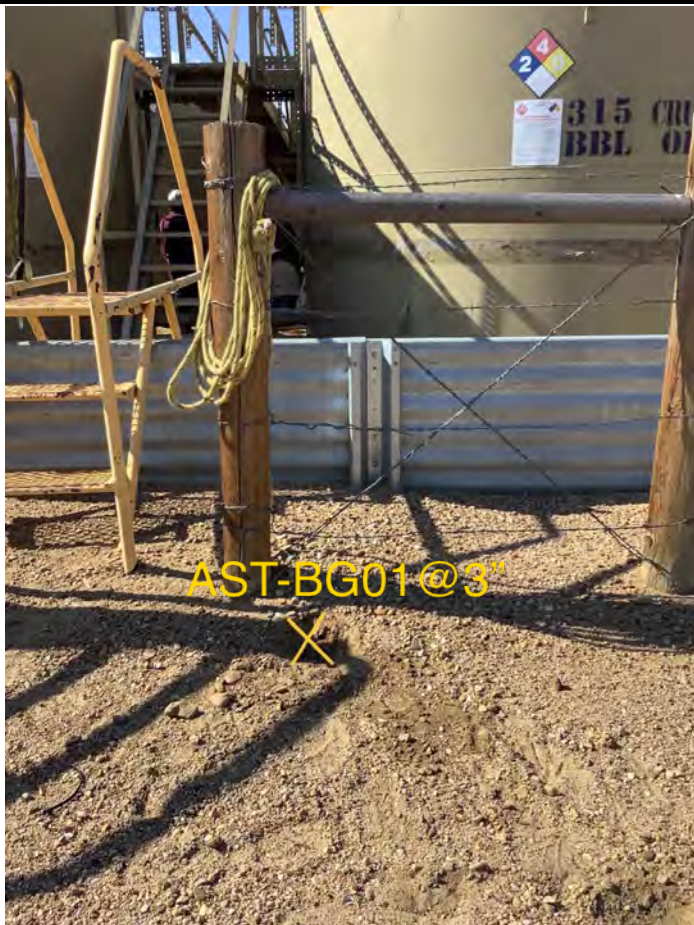
AST-BG01@3"

Equipment ID:		Equipment Type:		Equipment ID:		Equipment Type:	
Material:	Volume:	Contents:		Material:	Volume:	Contents:	
Notes/Conditions: AST-BG01 @3" to the north of tank berm				Notes/Conditions: AST-BG02 @3" to the south of tank berm

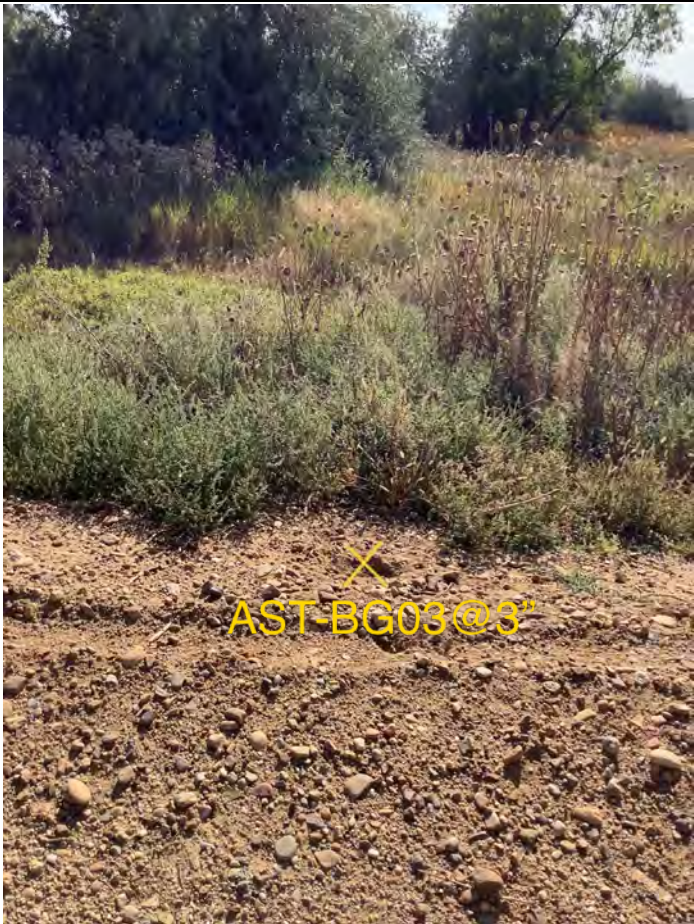
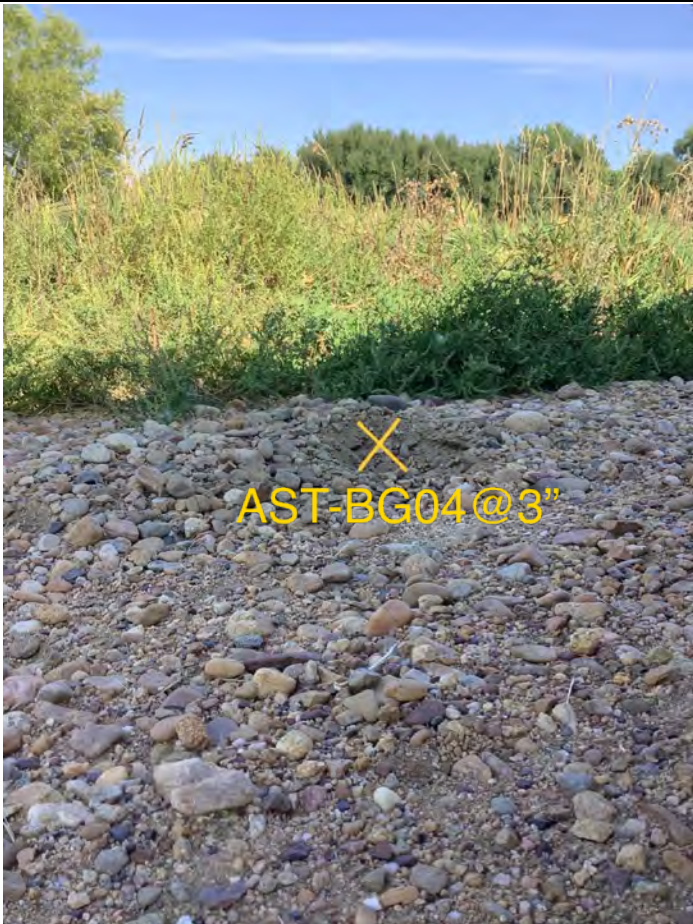
Equipment ID:		Equipment Type:		Equipment ID:		Equipment Type:	
Material:		Volume:		Material:		Volume:	
Contents:				Contents:			
Notes/Conditions: AST-BG03@3" to the east of tank berm				Notes/Conditions: AST-BG04@3" to the west of tank berm
