Inspection Photos  
Operator: Simcoe  
API: 067-07960  
Date: 12/17/2021

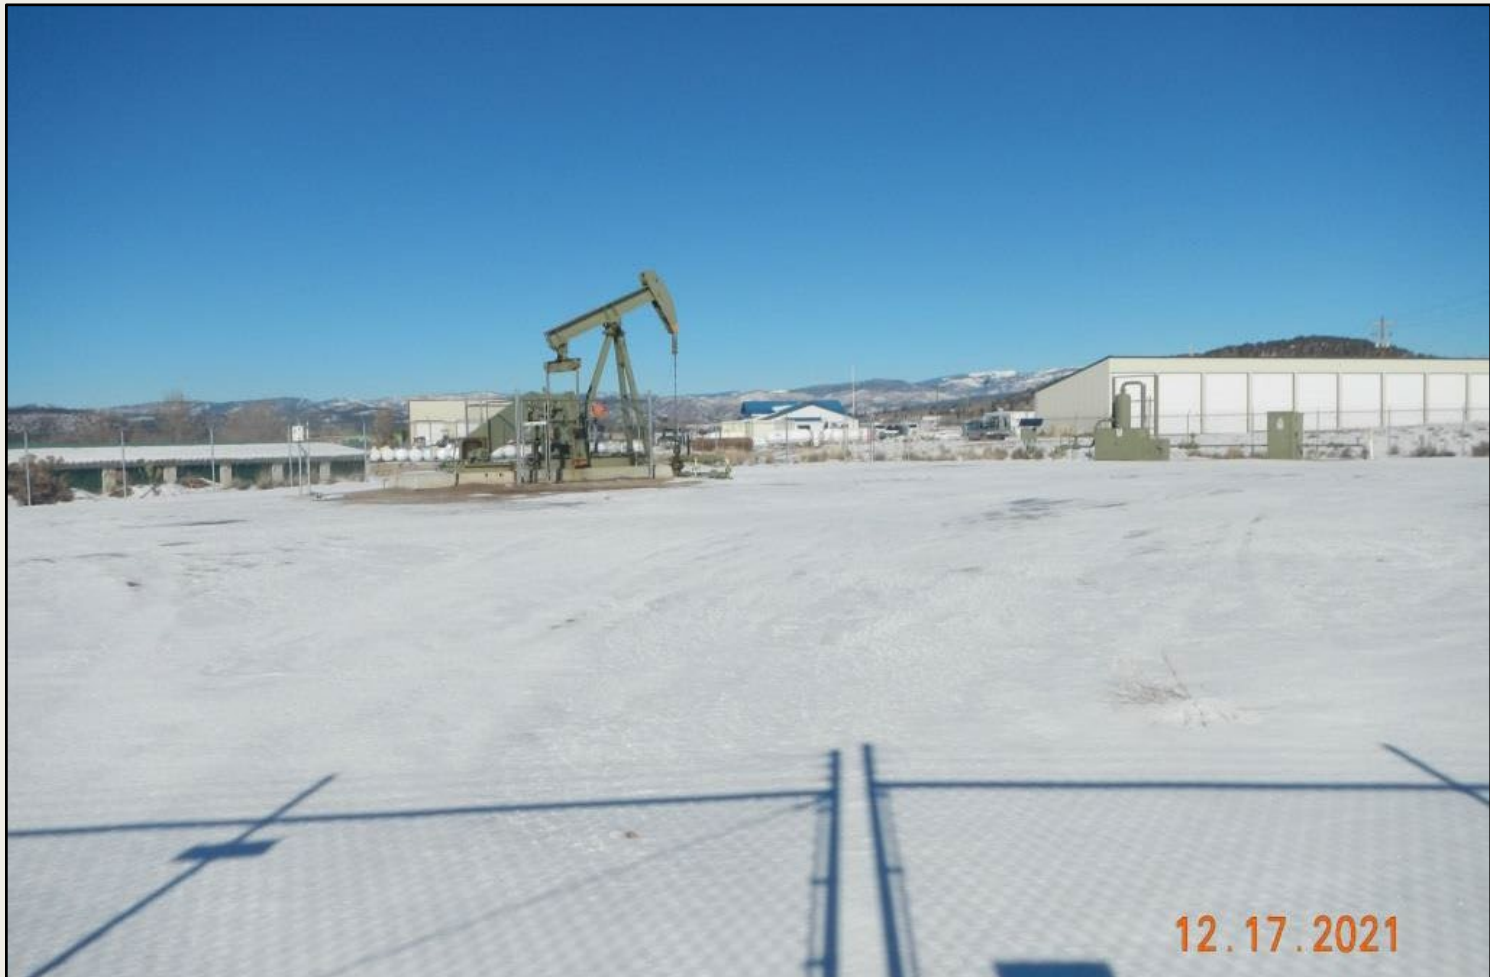
Photo 1. View of the project area from the well pad entrance facing center.

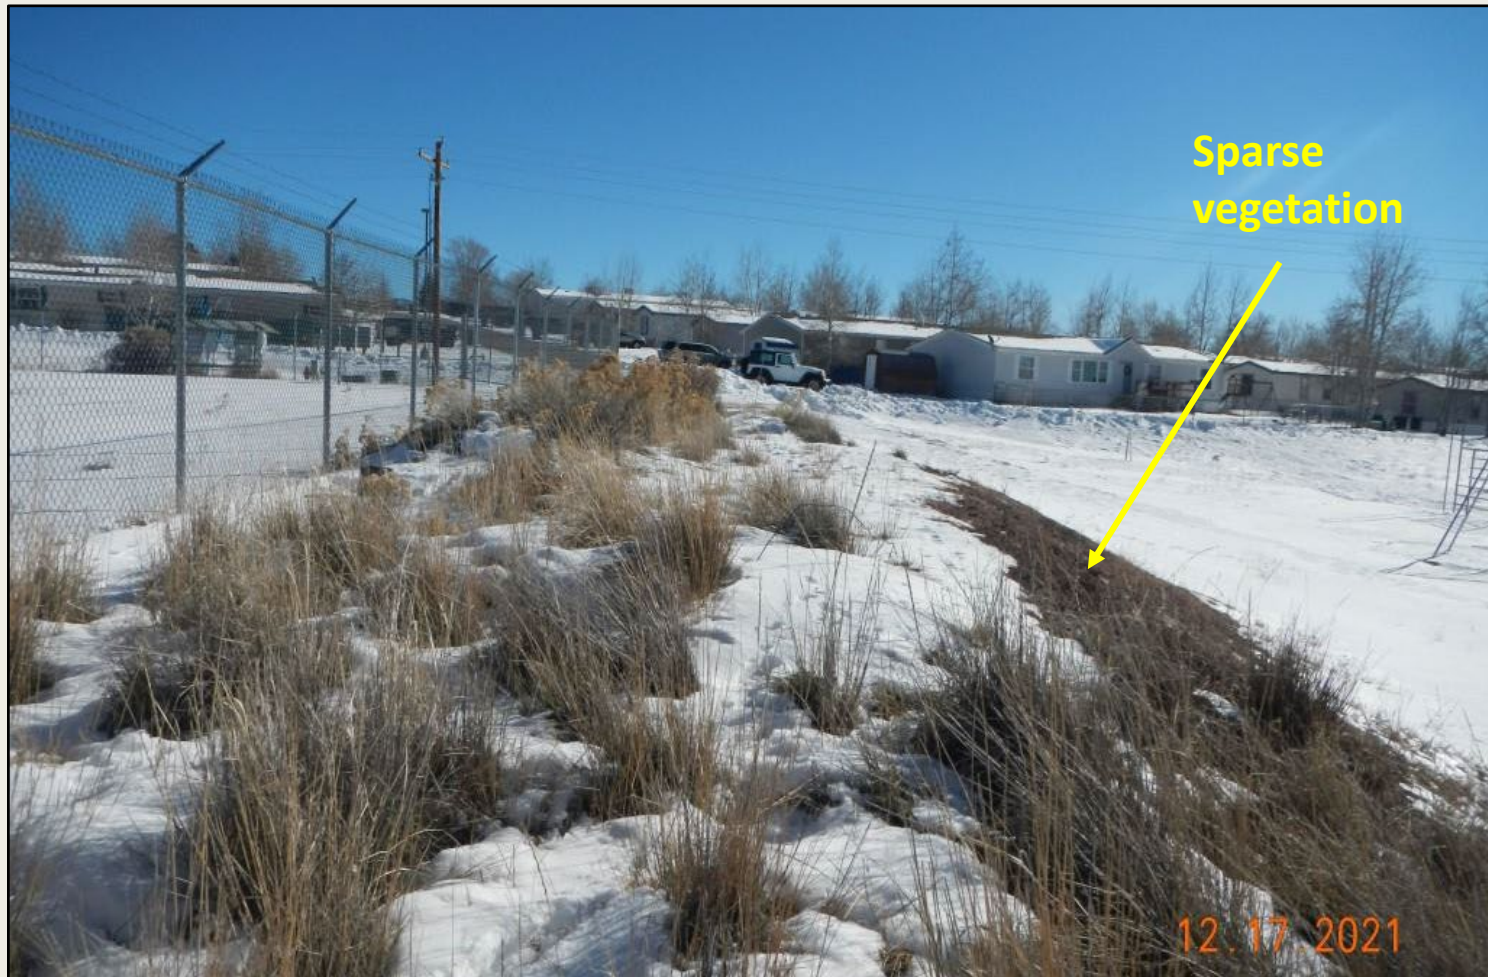
Photo 2. View of the southern project area from the southwestern corner facing eastward. Revegetation is progressing with crested wheatgrass, intermediate wheatgrass, and smooth brome. Sparse vegetation on the southern fill slope needs to be assessed during the 2022 growing season and determine whether spot seeding is needed.

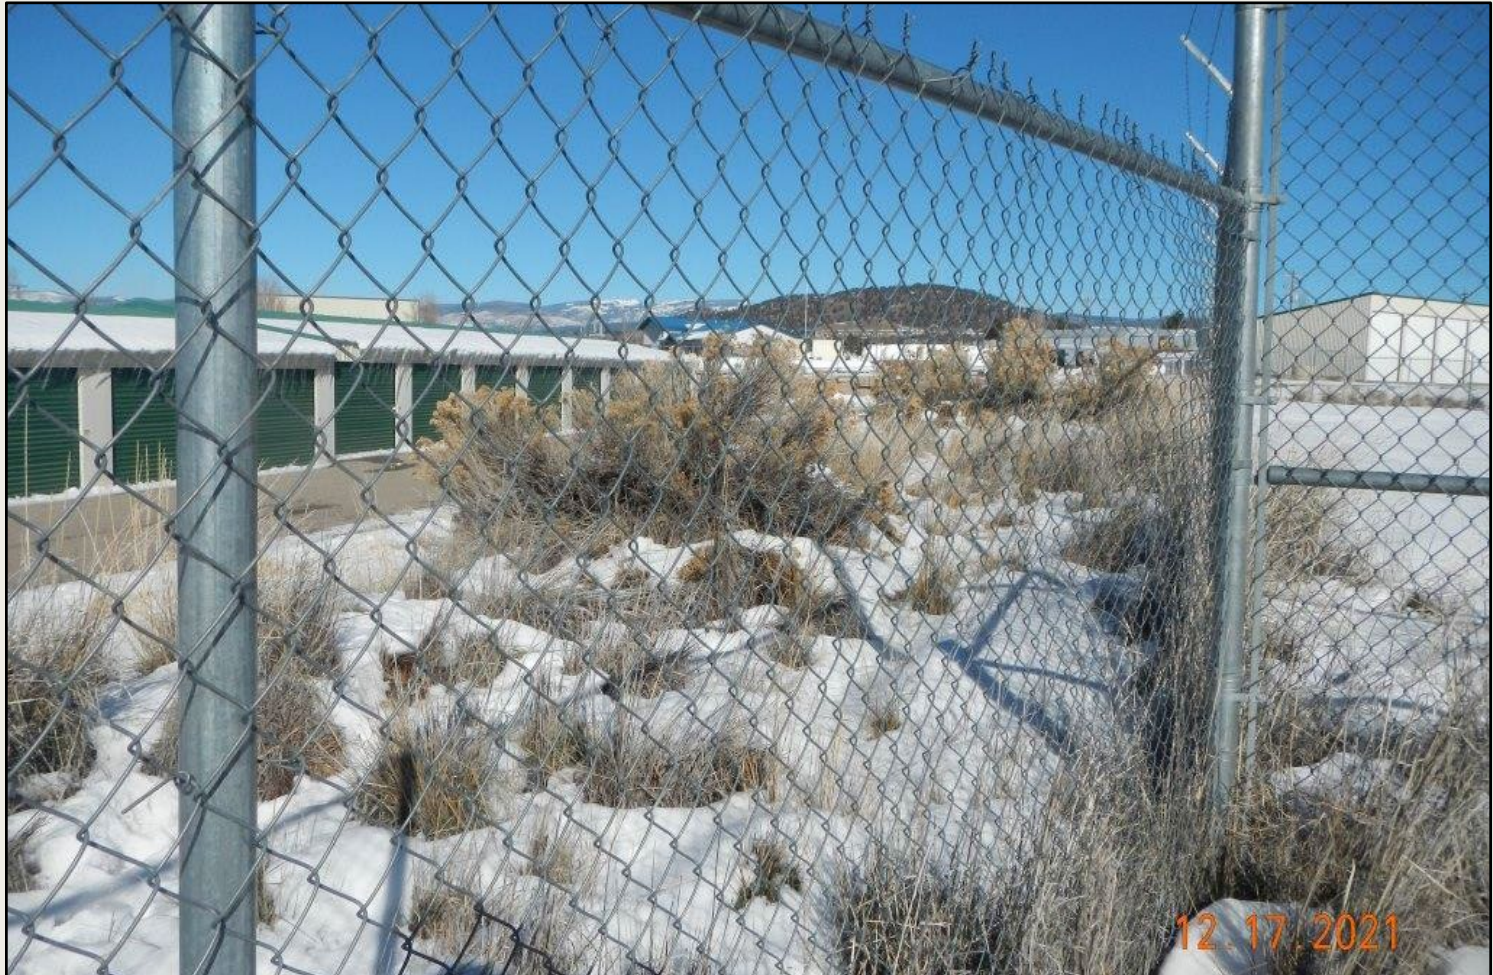
Photo 3. View of the western project area from the southwestern corner facing northward.

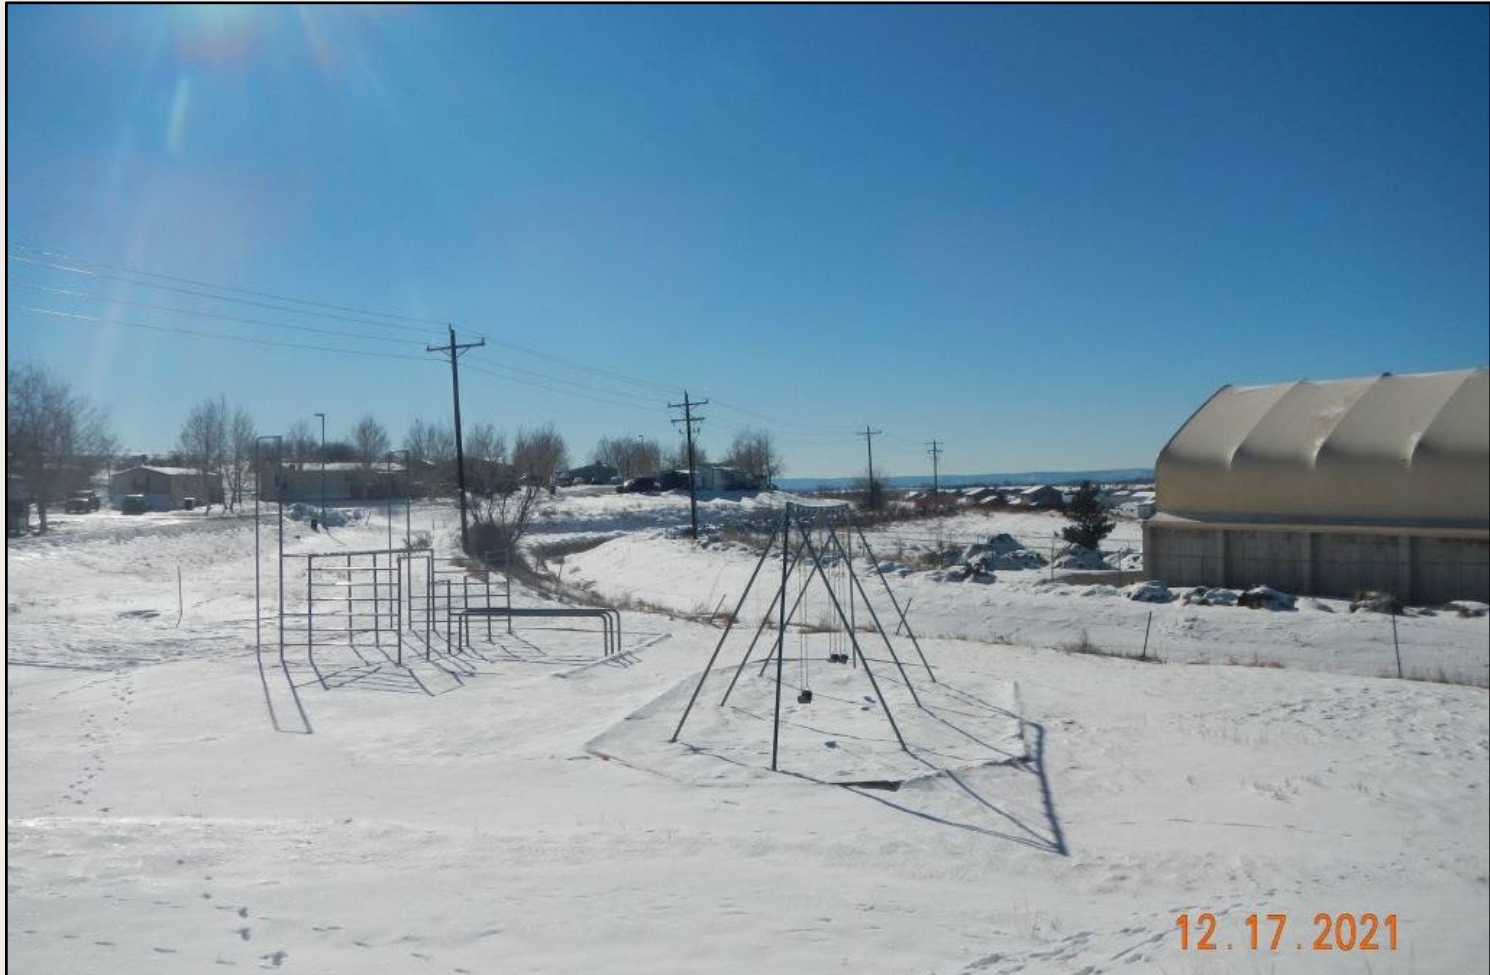
Photo 4. View of reference area comprised of developed neighborhood infrastructure. Park space is present south of project area.
