Inspection Photos

API: 071-06657

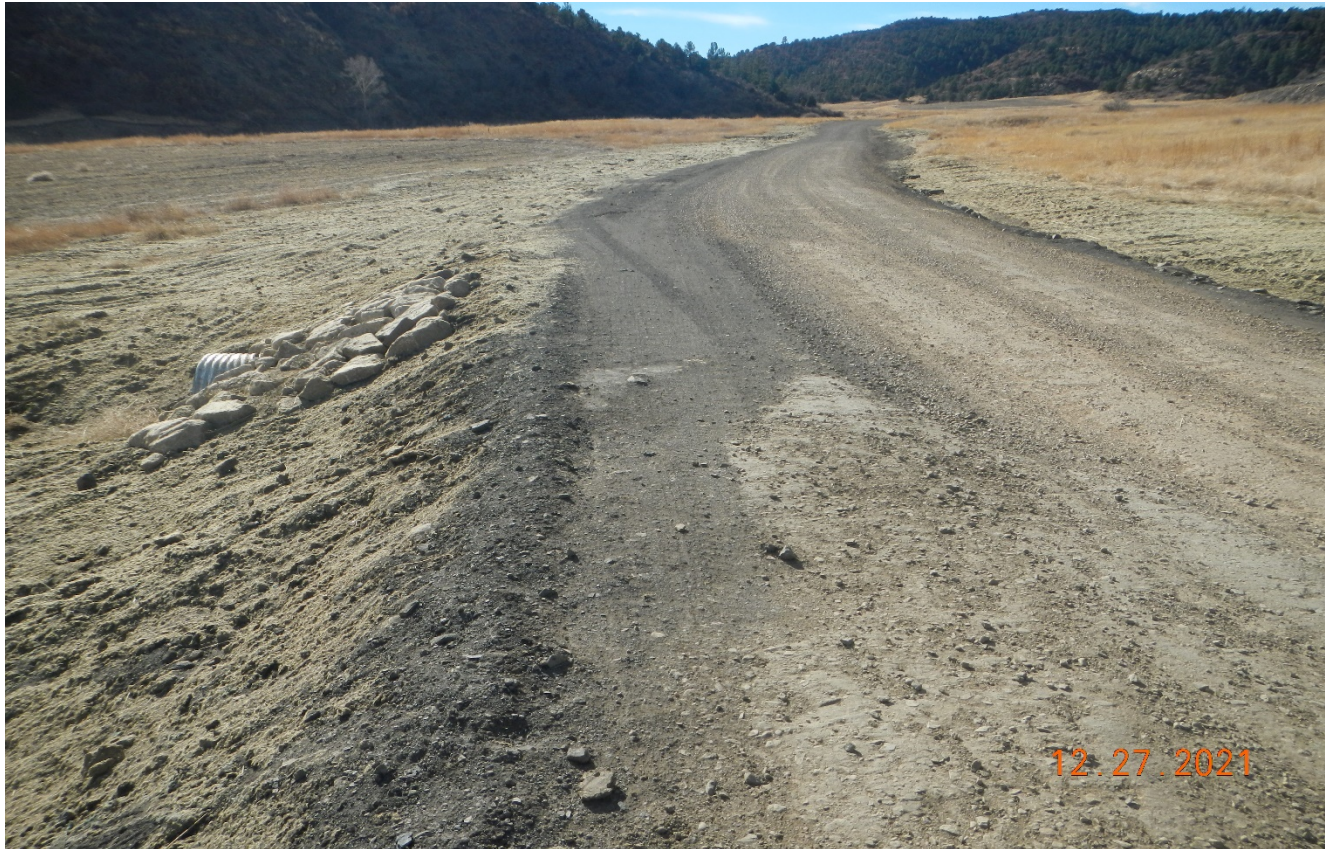
Photo 3. The area of erosion further along the road has been repaired and a culvert has been installed.

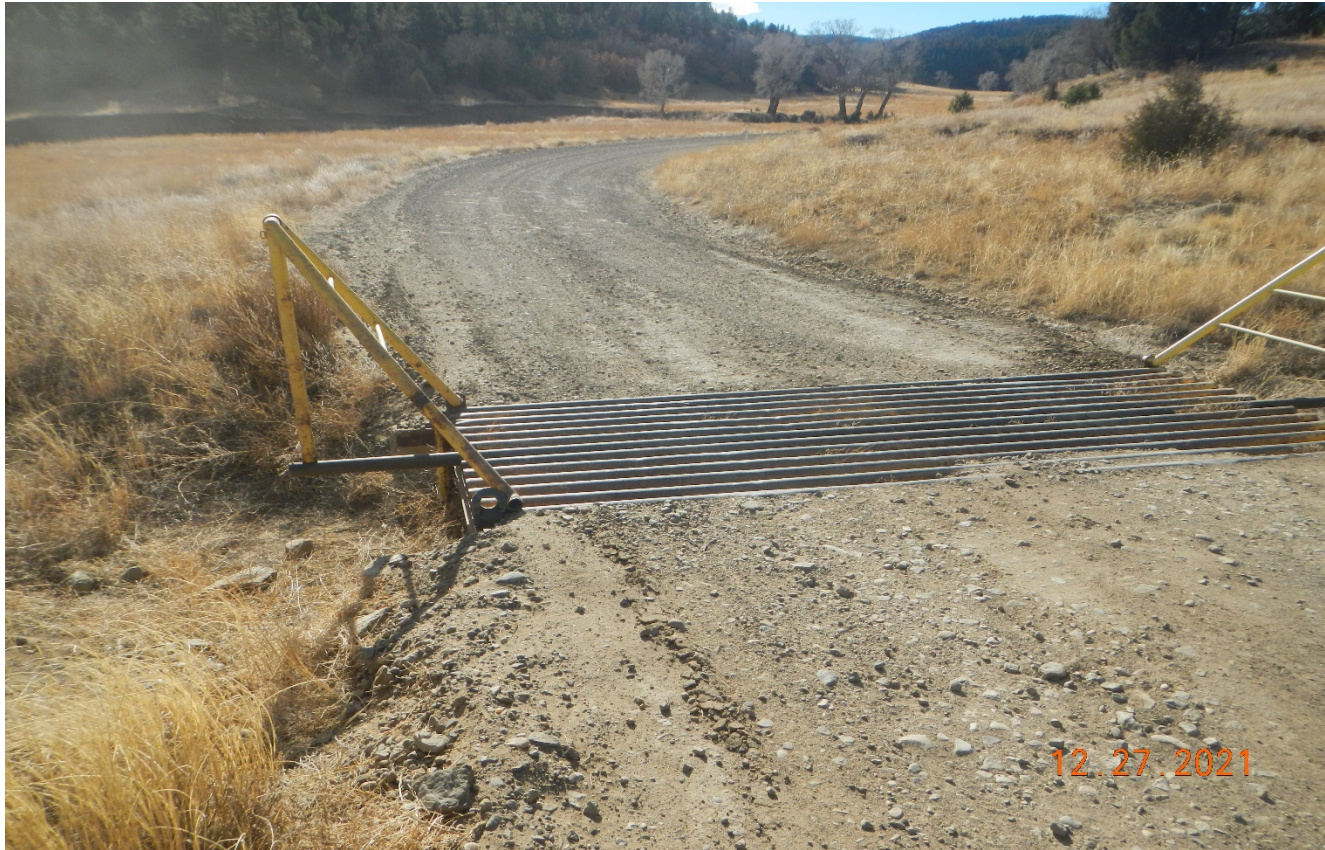
Photo 5. The cattle guard along the road has been repaired.
