# Interim Reclamation and Stormwater Inspection

Operator: KERR MCGEE OIL & GAS ONSHORE LP #47120

Location ID: 331598

Inspection Photos  
Location Name: GUEST /3N-12HZ  
Location ID: 331598

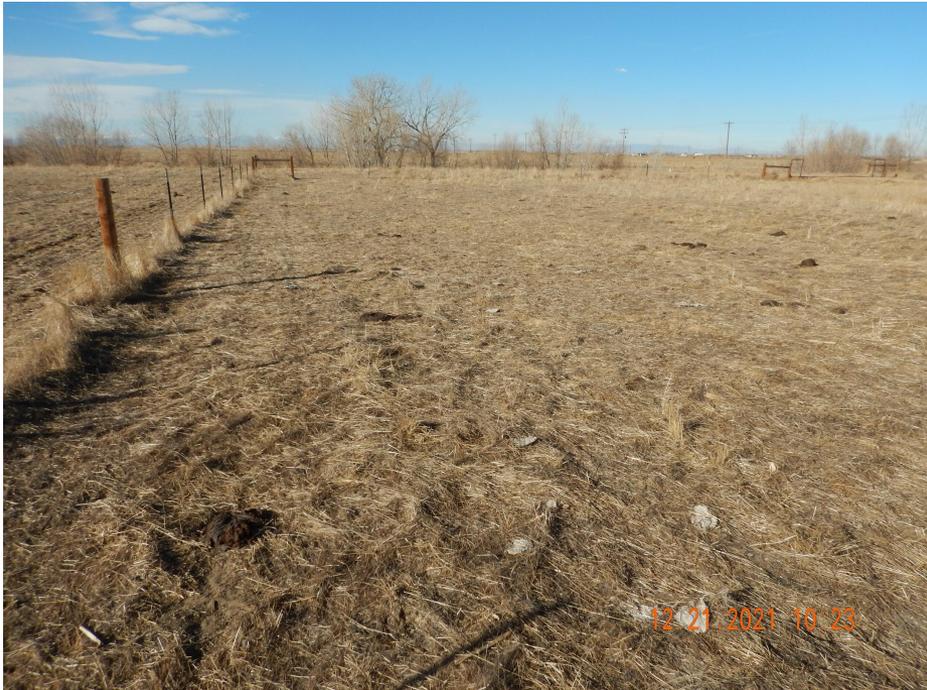
**Photo 1.** Photo taken from the southern interim reclamation area of the well location, facing West. Photo illustrates interim reclamation areas have been grazed. Interim reclamation areas appear to have a higher abundance of cheatgrass than the previous inspection.

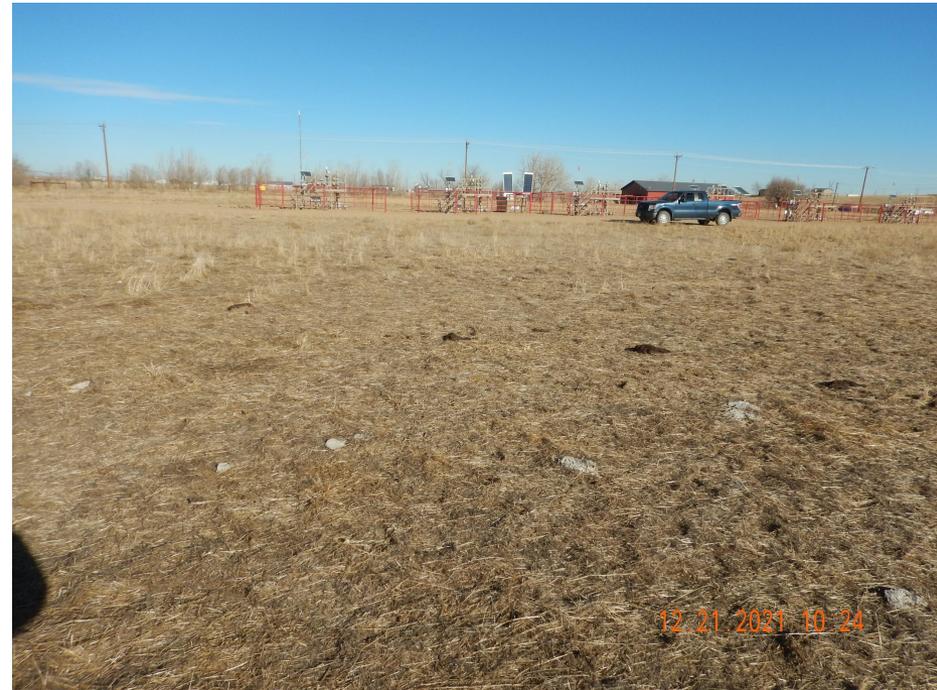
**Photo 2.** Photo taken from the southern interim reclamation area of the well location, facing North. See comments under Photo 1.

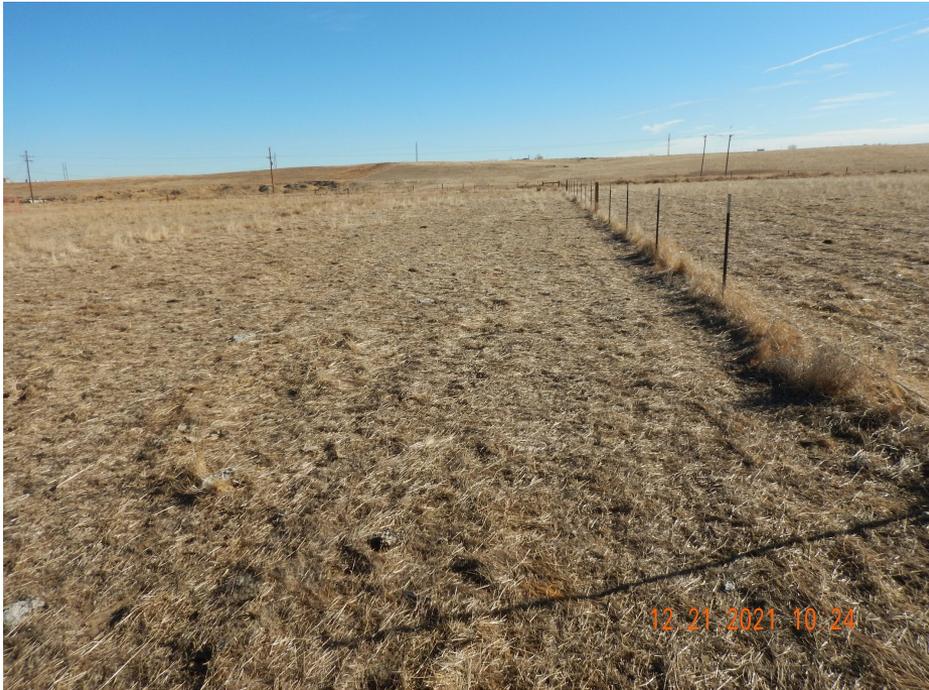
**Photo 3.** Photo taken from the southern interim reclamation area of the well location, facing East. See comments under Photo 1.

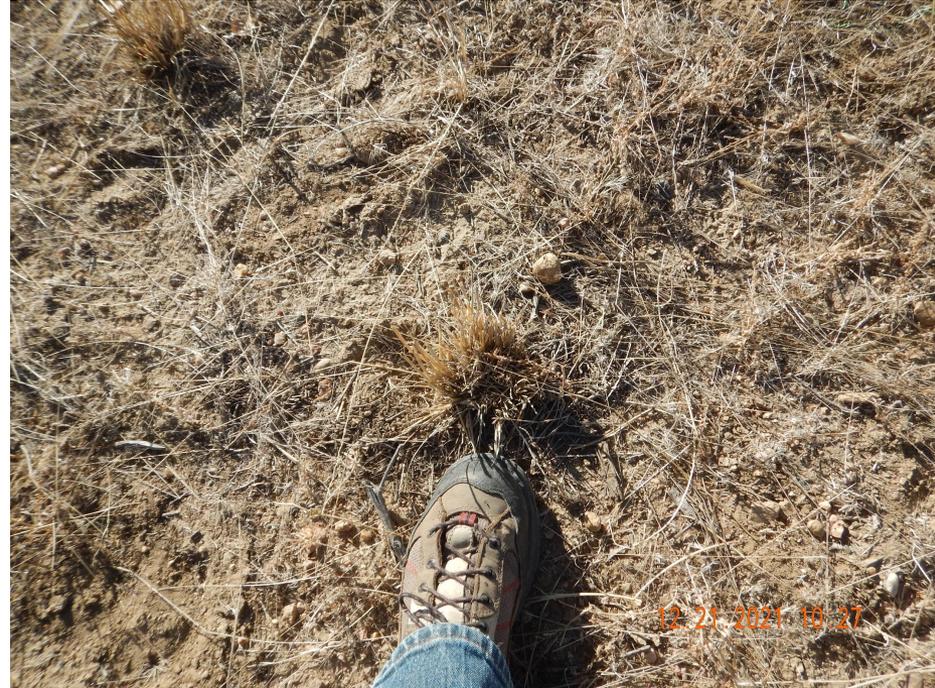
**Photo 4.** Photo taken from a portion of the interim reclamation area. Photo illustrates desirable vegetation that has been grazed.

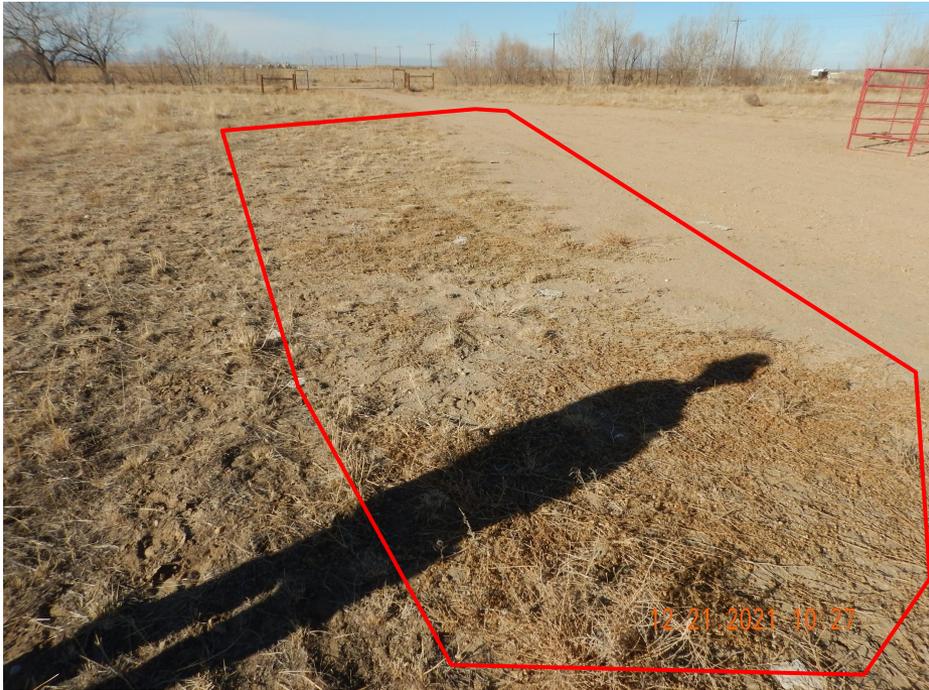
**Photo 5.** Photo taken from the southern interim reclamation area of the well location, facing West. See comments under Photo 6.

**Photo 6.** Photo taken from a portion of the interim reclamation area. Photo illustrates a List C Colorado noxious weed, puncture vine.
