Inspection Photos  
Operator: Arkoma  
API: 067-05482  
Date: 12/22/2021

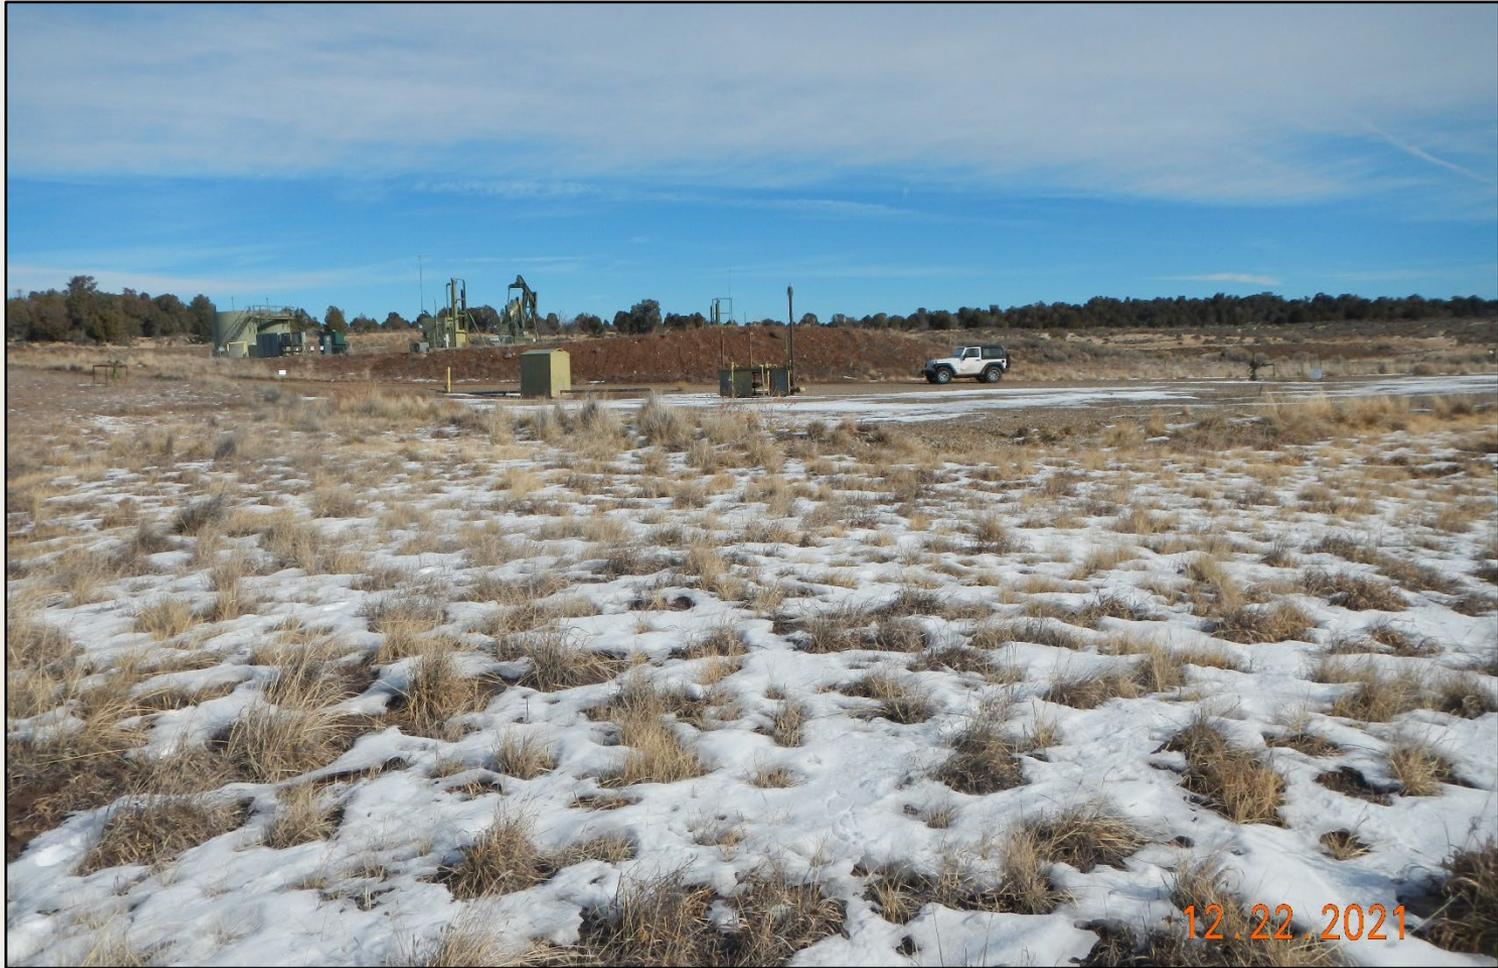
Photo 1. View of the southern project area from the southwestern corner facing center. Revegetation is progressing with western wheatgrass, smooth brome, and intermediate wheatgrass. Revegetation at final reclamation needs to be representative of the surrounding reference area.

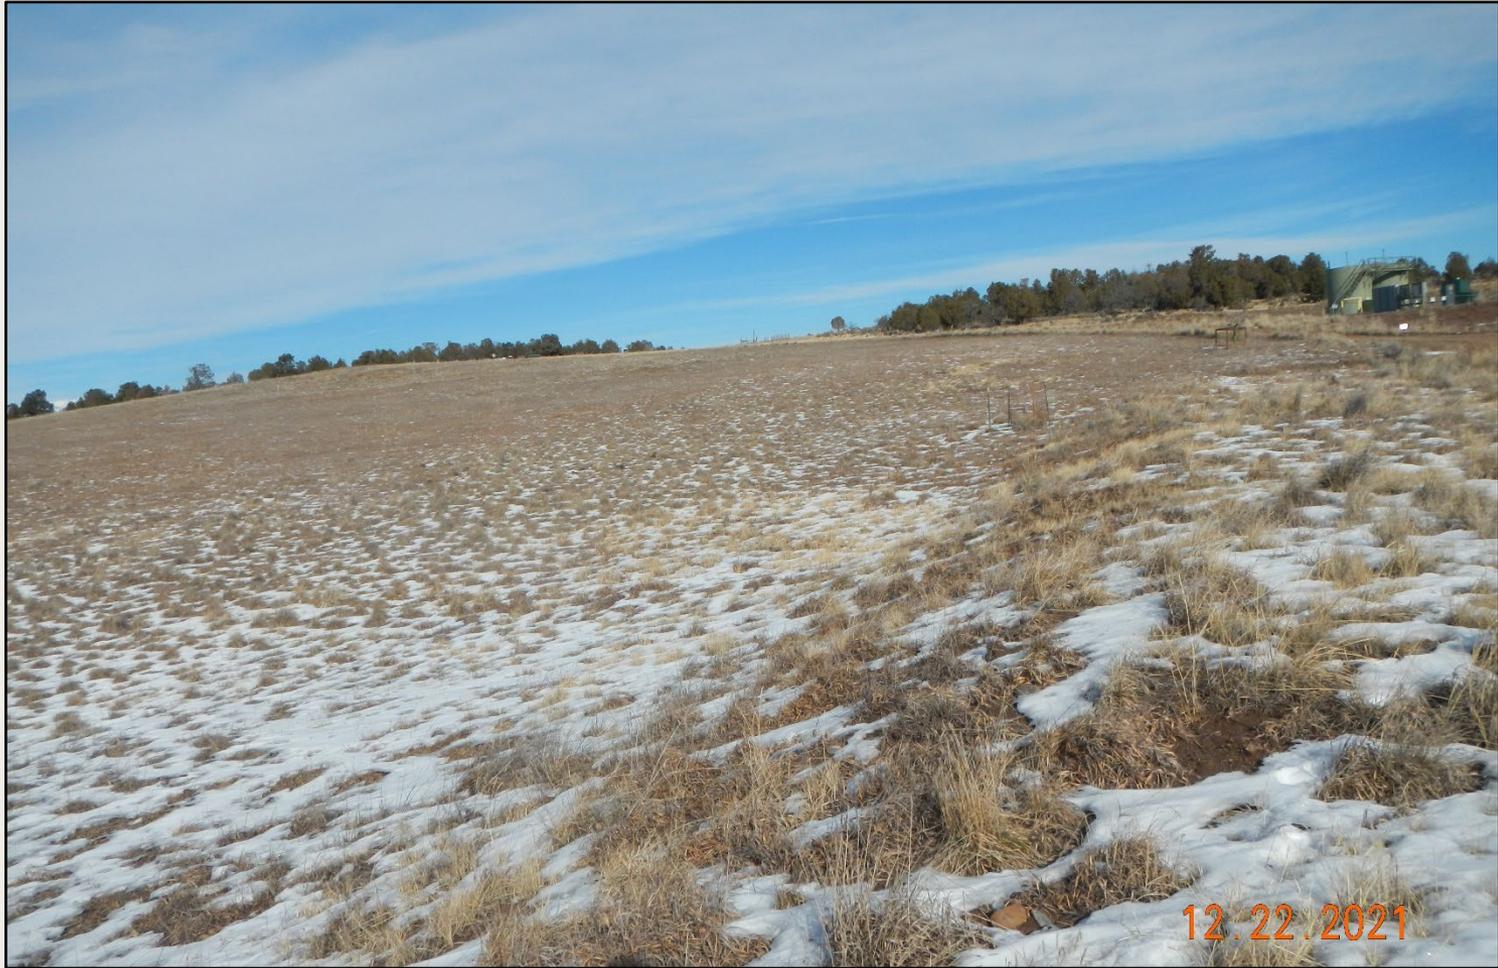
Photo 2. View of the western fill slope from the southwestern corner facing northward.

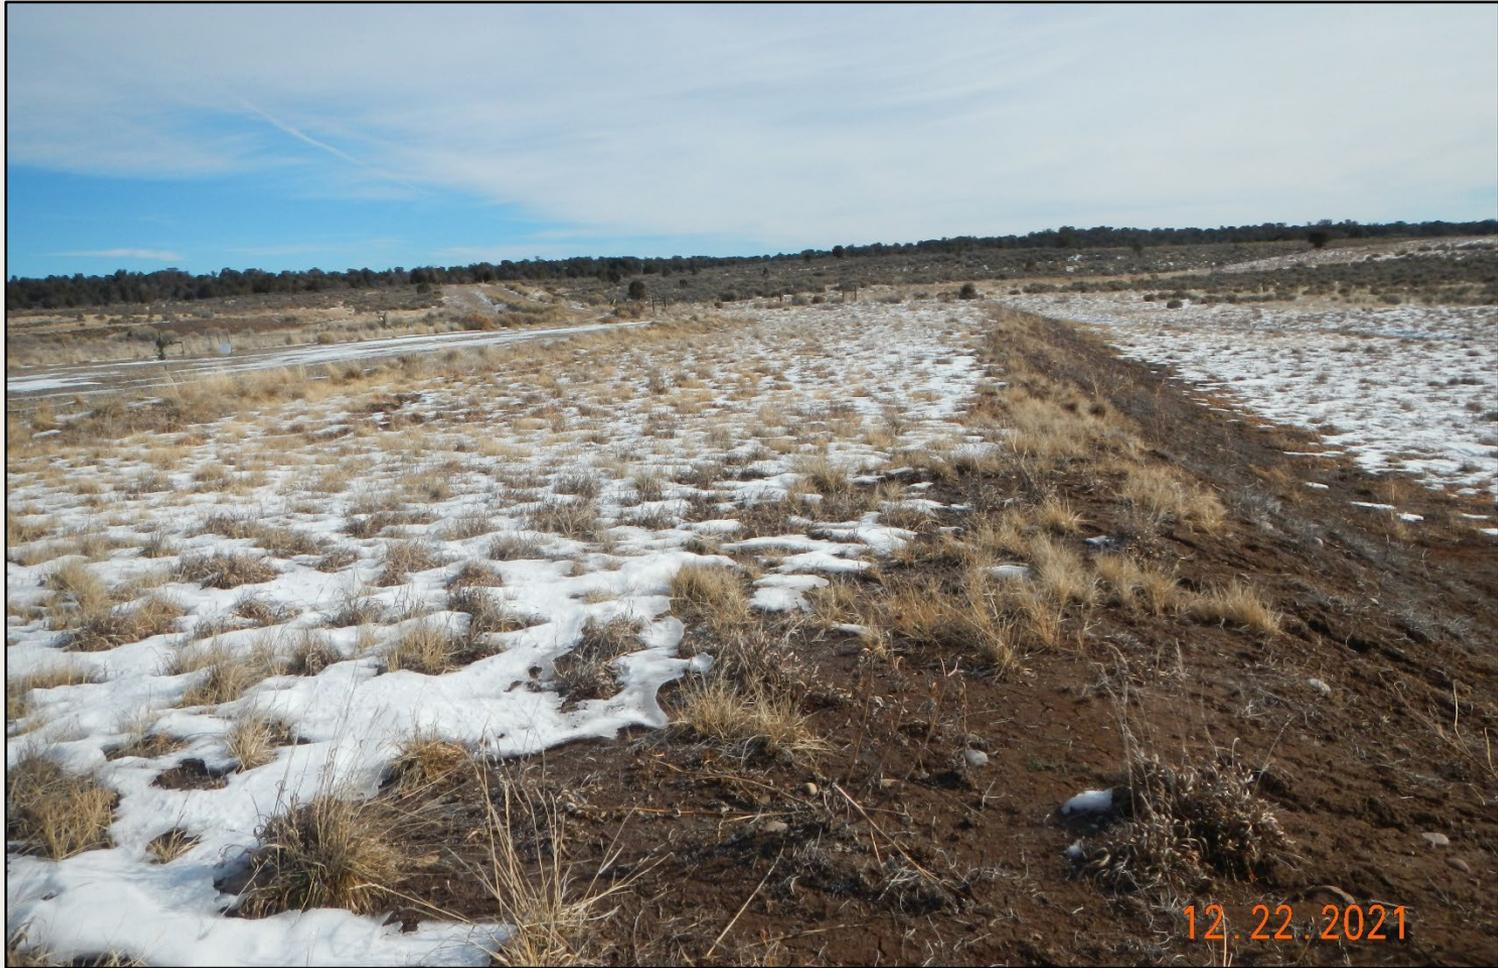
Photo 3. View of the southern fill slope from the southwestern corner facing eastward.

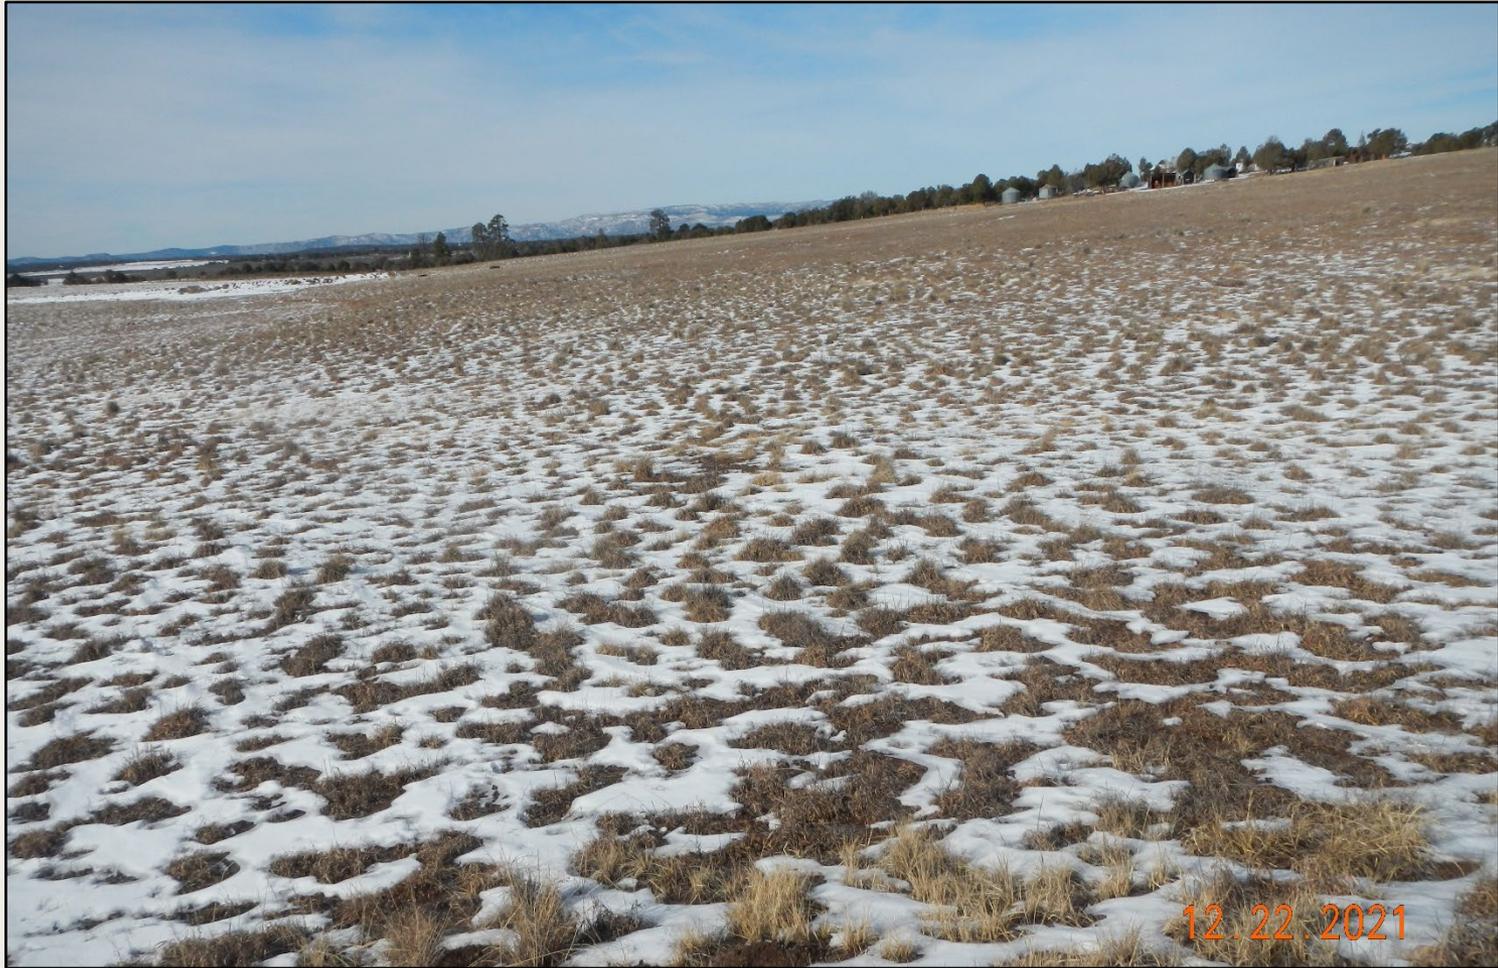
Photo 4. View of the reference area comprised of open grass field with western wheatgrass, smooth brome, and crested wheatgrass.
