Inspection Photos

API: 061-05145

Operator: WESTERN OPERATING COMPANY

Inspection Date: 1/12/2022

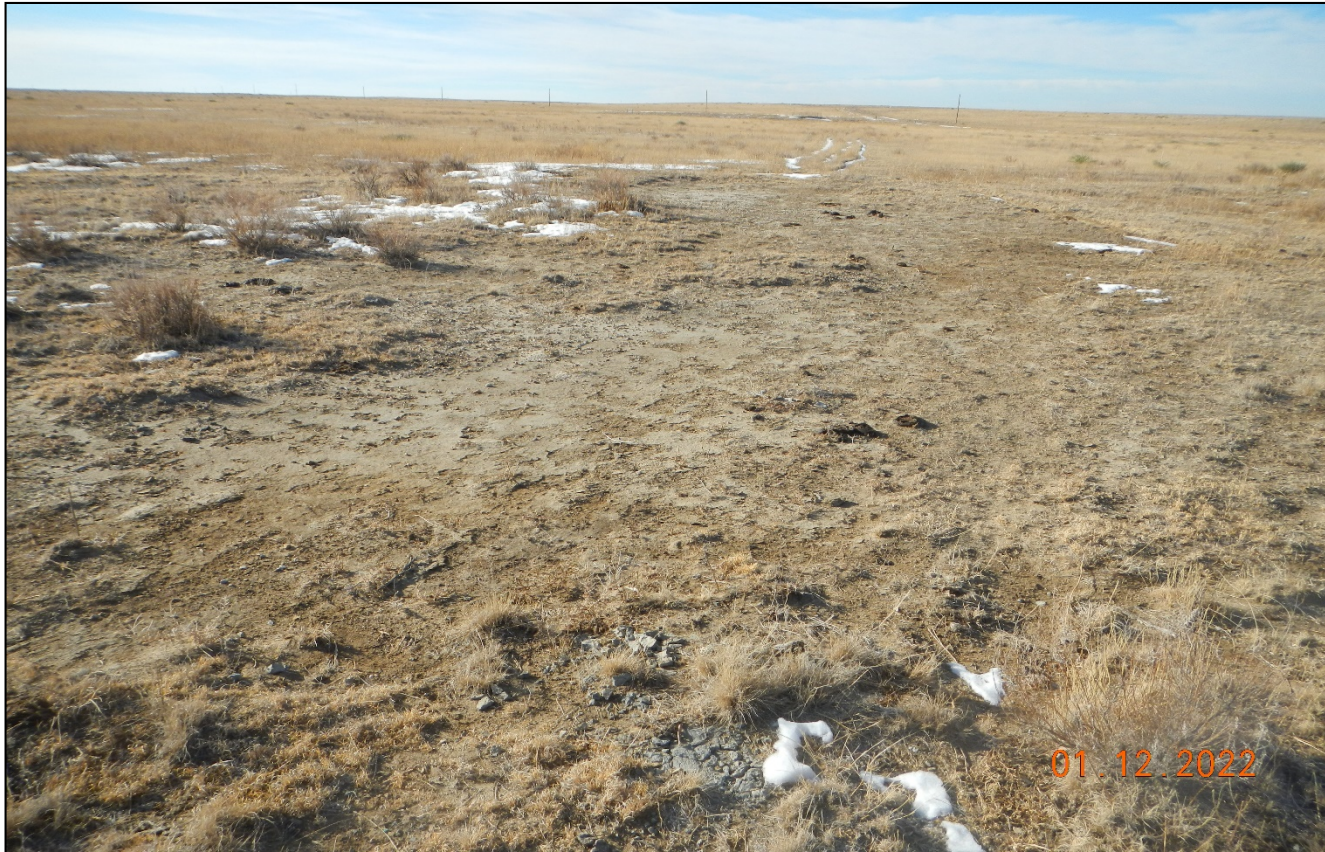
Photo 1. Facing south toward the location. There are areas at the location that are bare of vegetation.

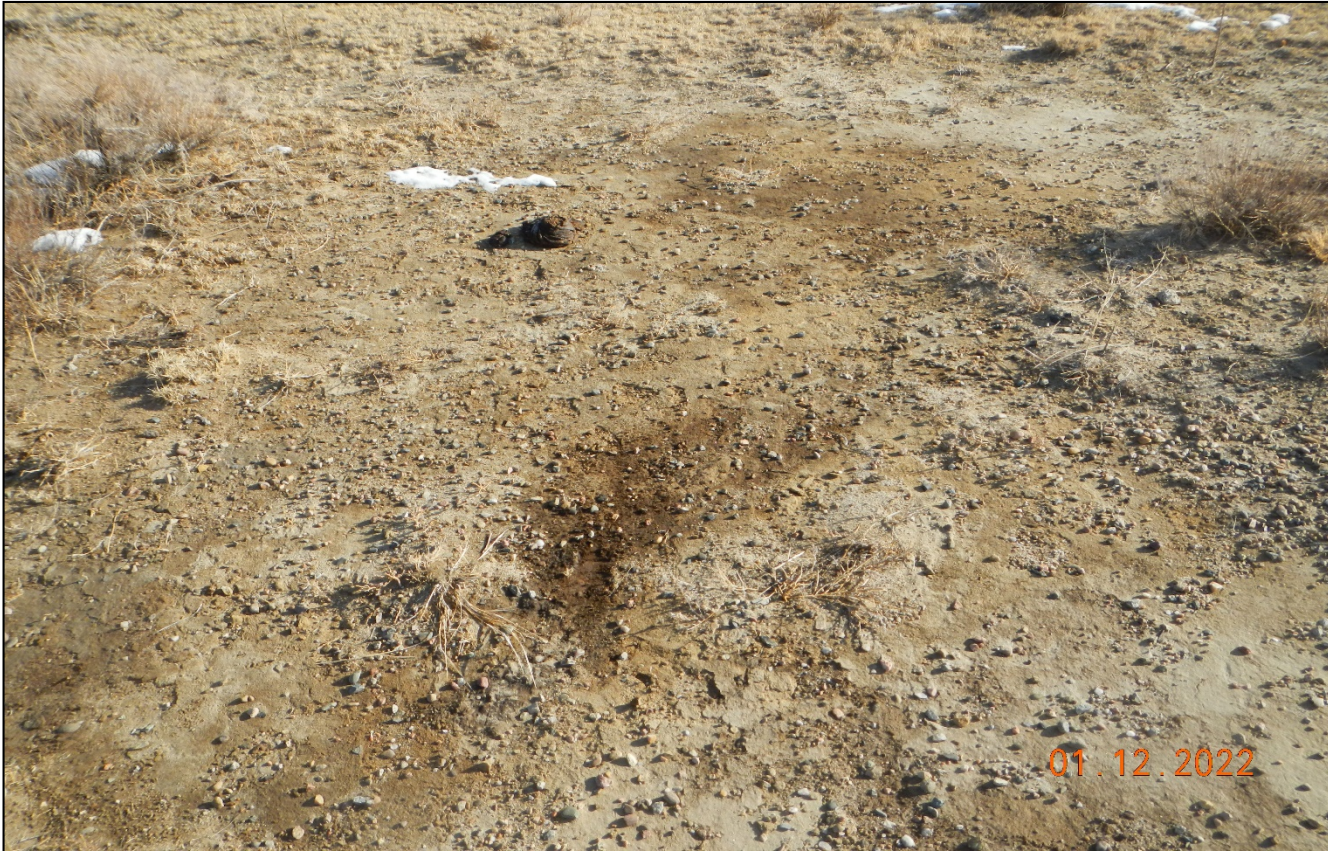
Photo 2. Ground cover at center of the location. There is darkened soils in this area with a hydrocarbon odor. Contaminated soils need to be properly removed and disposed.

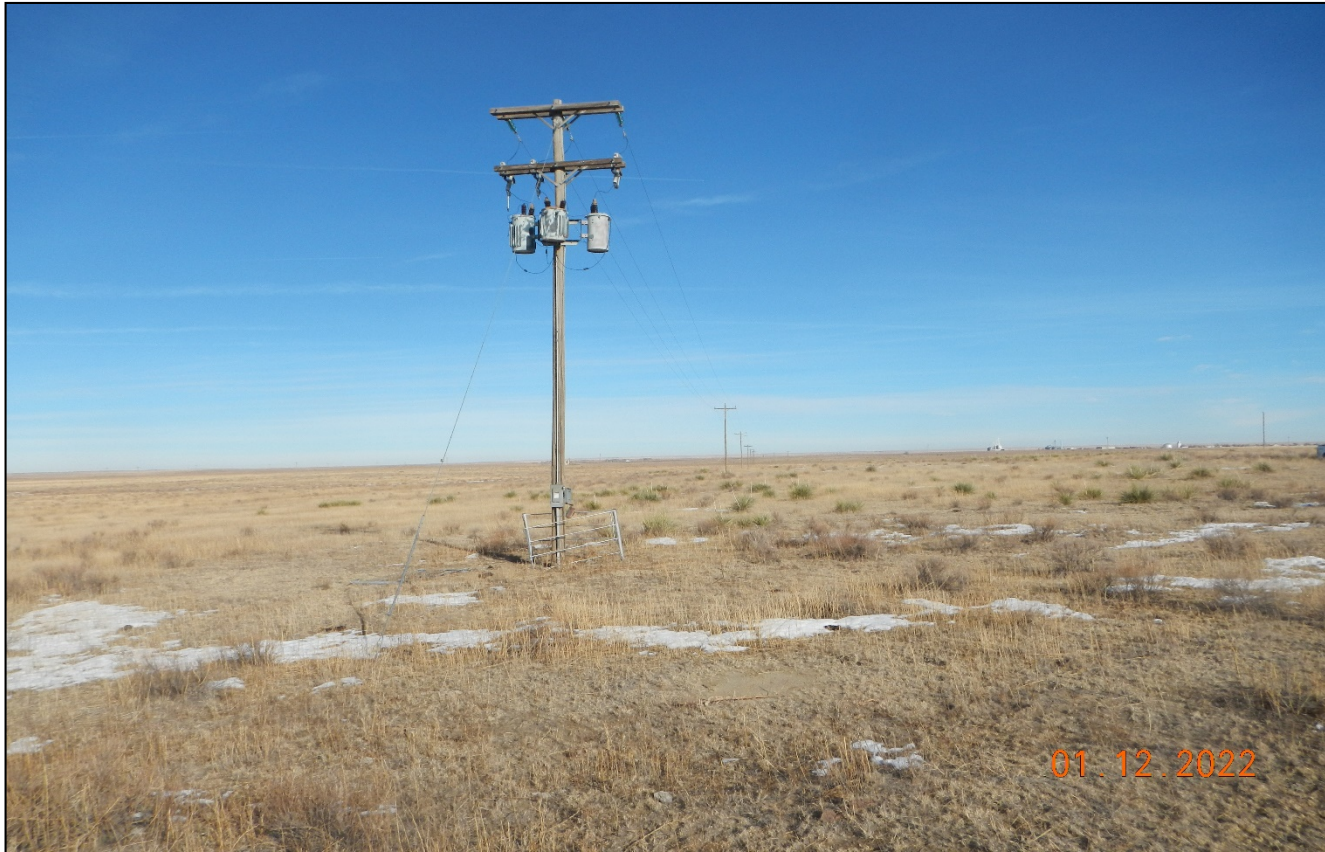
Photo 3. The powerline used for operating the well dead ends at the location and the entire unused portion of the powerline must be removed.
