# Inspection Photos

API: 061-06353

Operator: STRACHAN EXPLORATION

Inspection Date: 1/11/2022

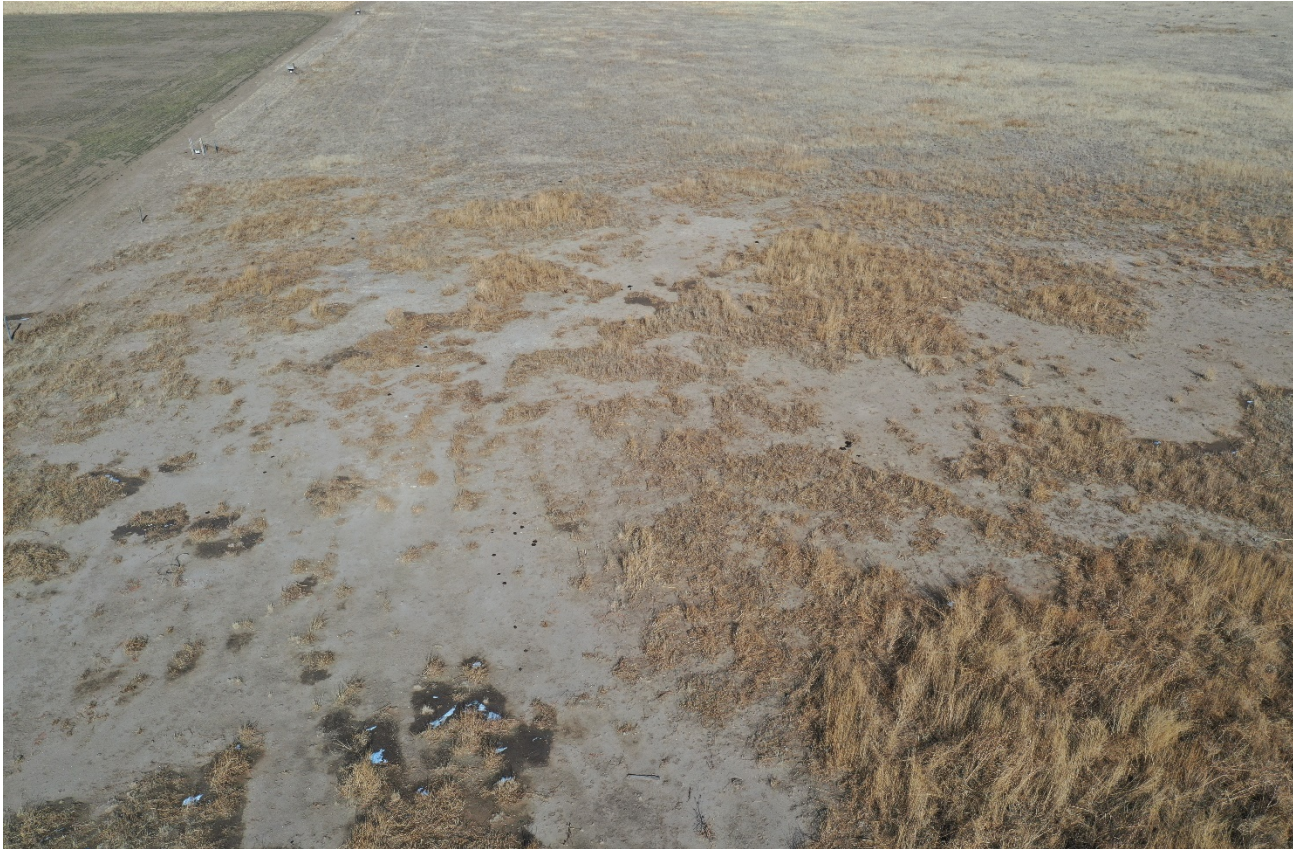
**Photo 1.** Drone aerial photo facing north toward the abandoned location. The location has not been reclaimed per Rule 1004.

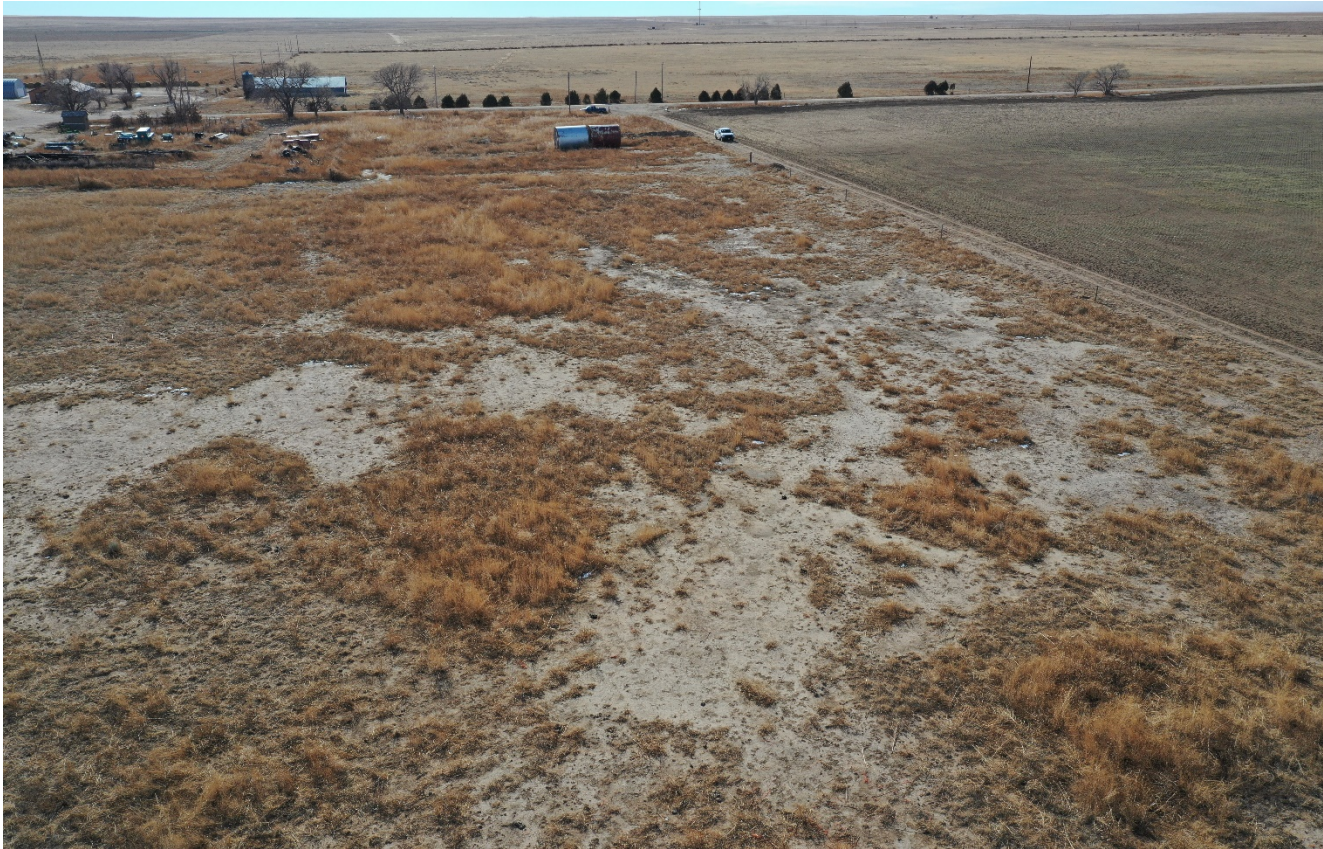
**Photo 2.** Facing southwest at the location. The location remains mostly bare of vegetation growth and has not been reclaimed.

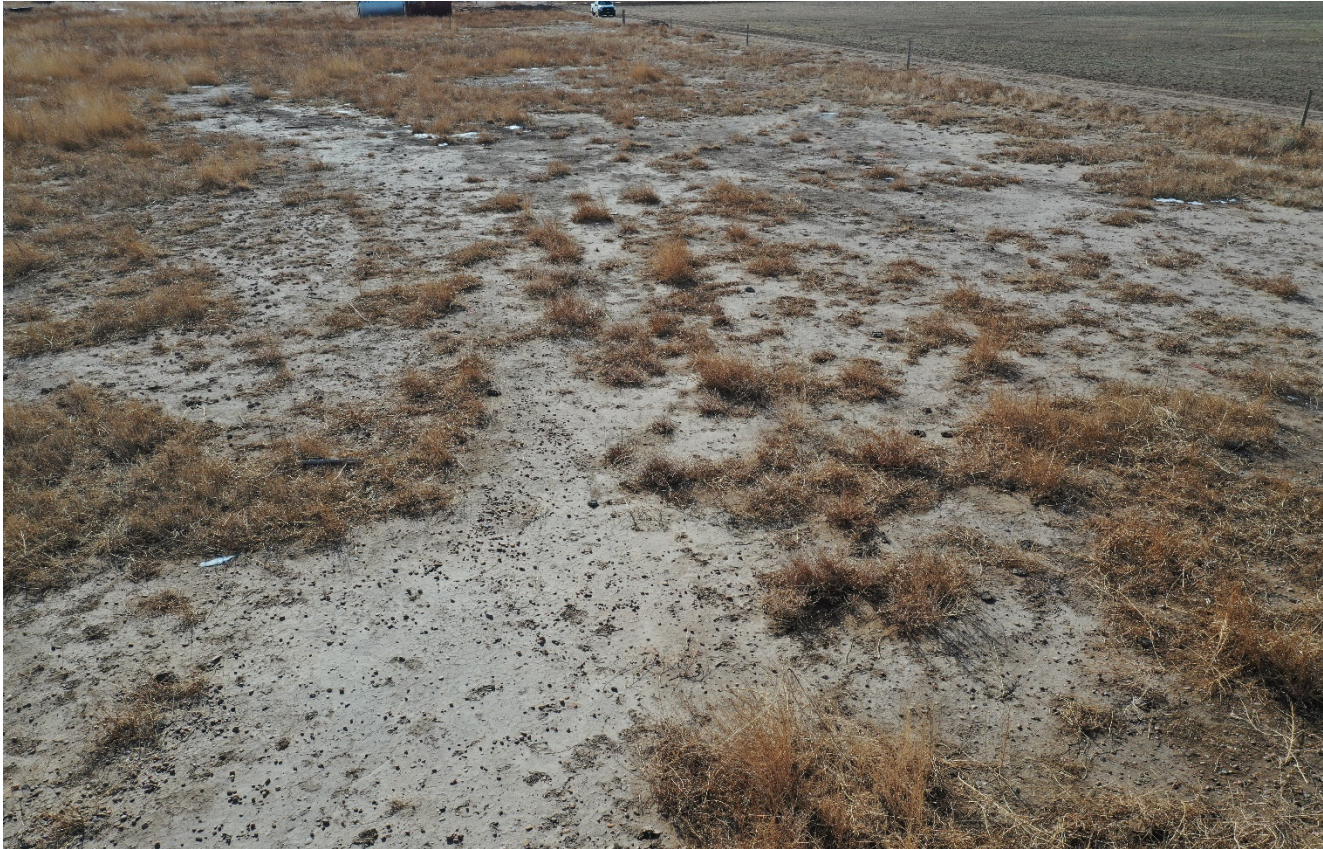
**Photo 3.** Facing southwest at the location. The location remains mostly bare of vegetation growth and has not been reclaimed.

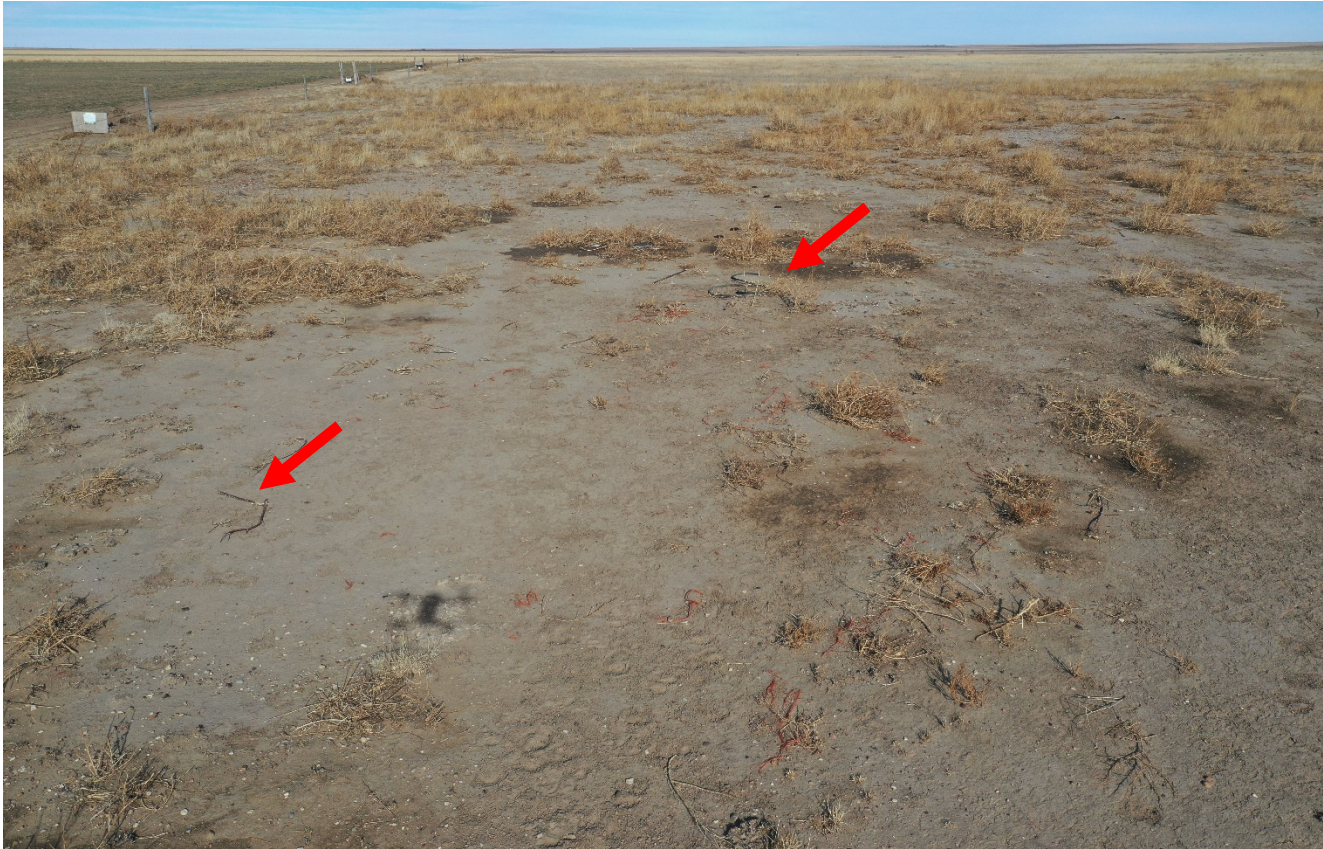
**Photo 4.** Facing north at the location. The location has not been reclaimed and there is debris that remains shown at red arrows.

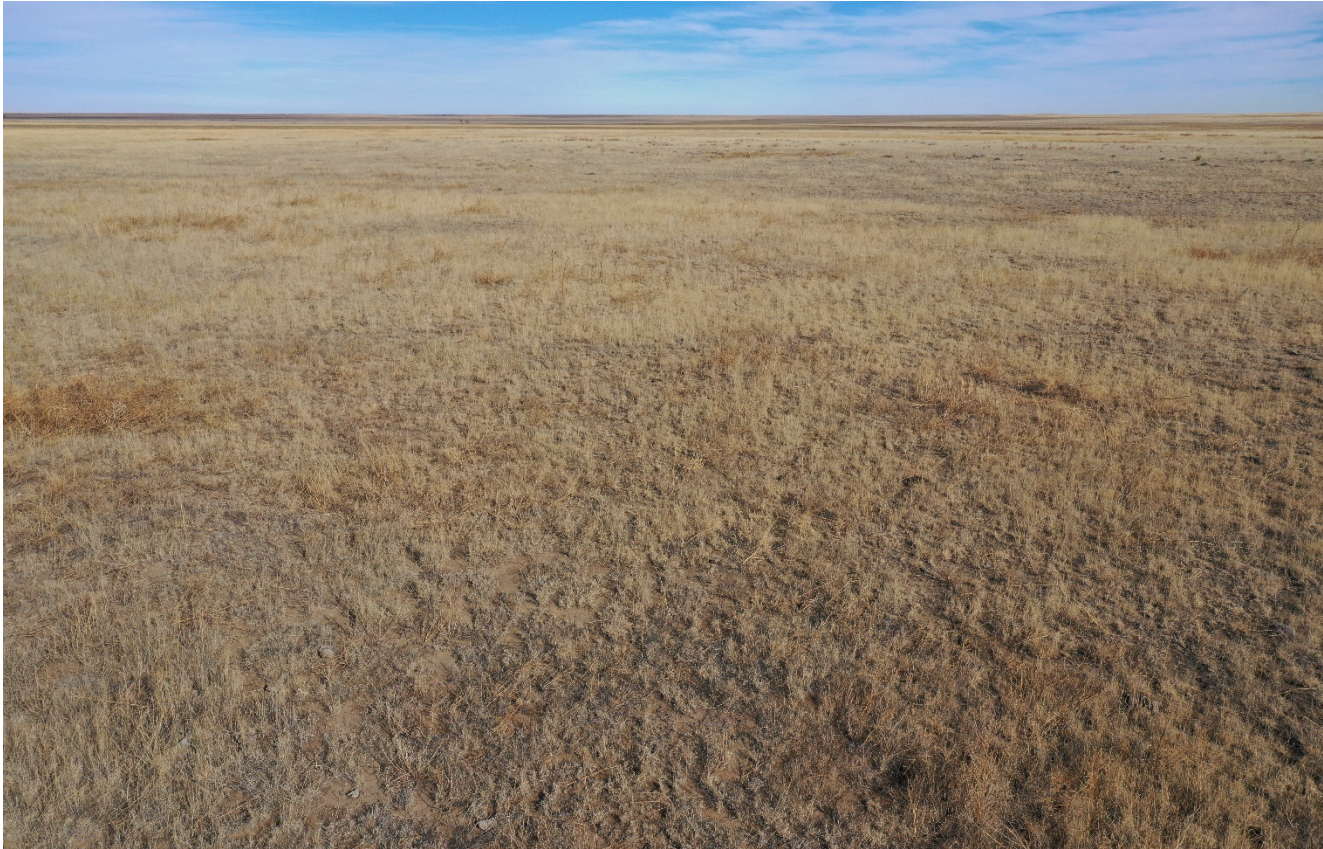
**Photo 5.** Facing north toward the surrounding undisturbed pasture which consists of Blue grama, Sand drop seed, among other native species.
