Inspection Photos

API: 061-06023

Operator: WESTERN OPERATING COMPANY

Inspection Date: 1/12/2022

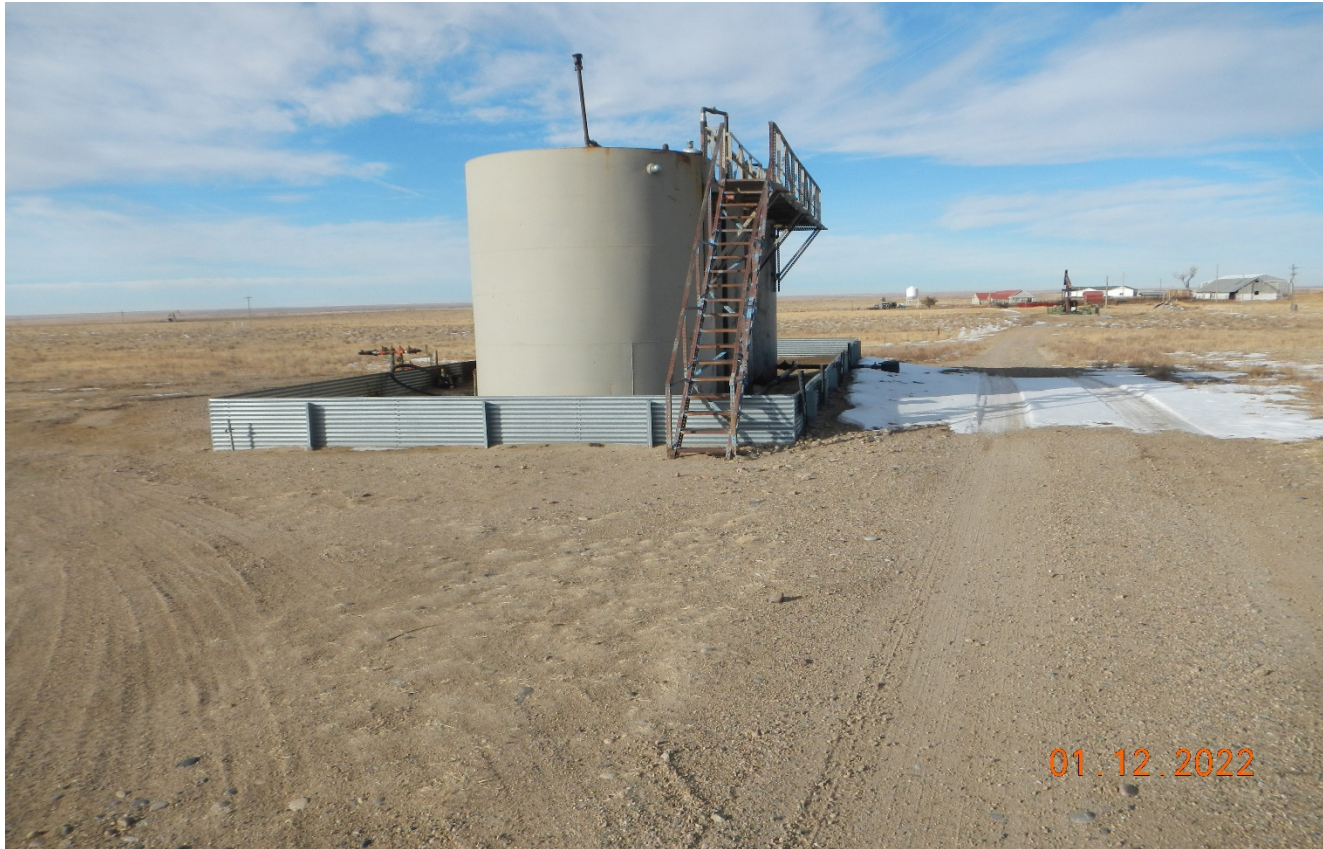
Photo 1. Facing west toward the tank battery. The well site is located at red arrow. The tank battery is not fenced to prevent livestock entry. Previous corrective action was not completed.

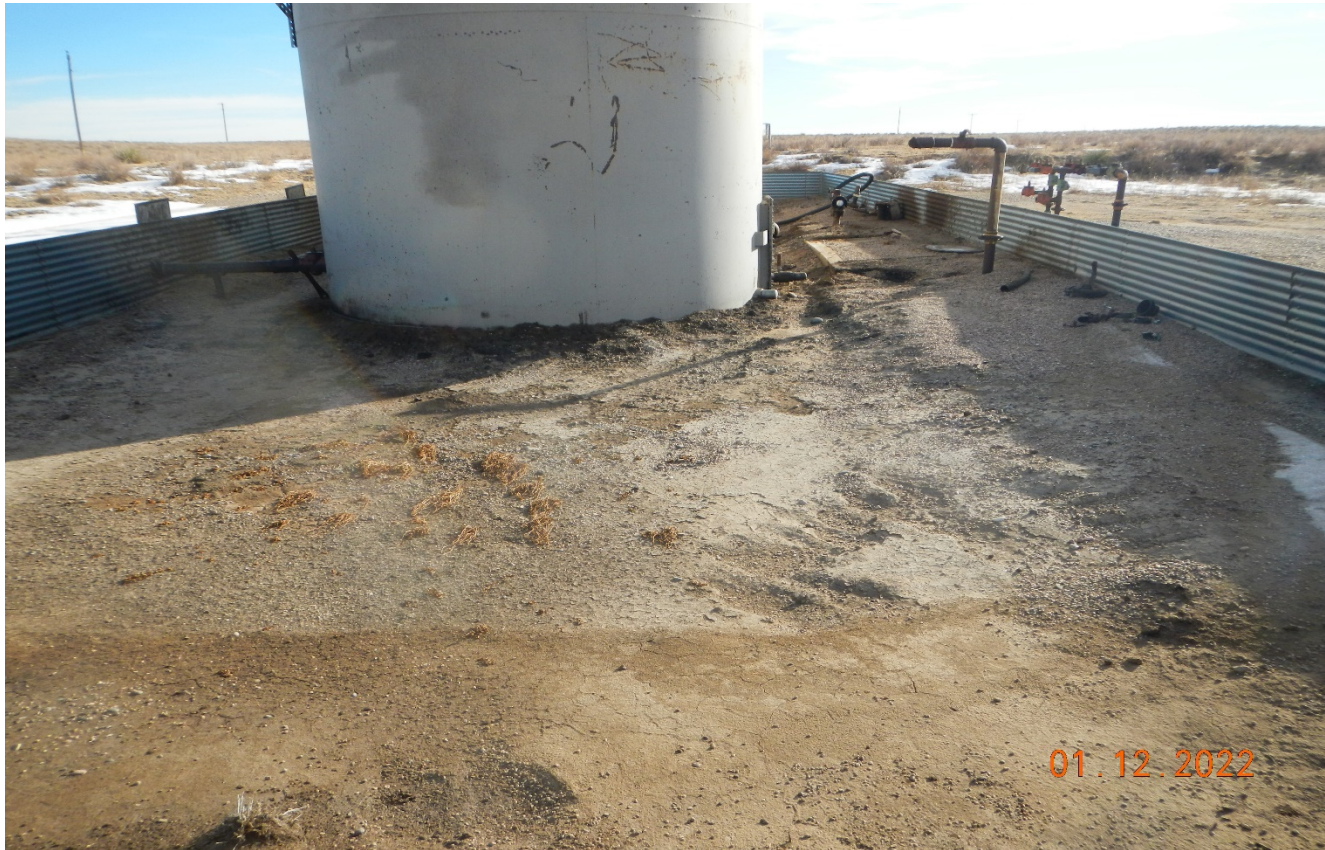
Photo 2. There is oil stained soil around the tanks which need to be cleaned up. Previous corrective action was not completed.

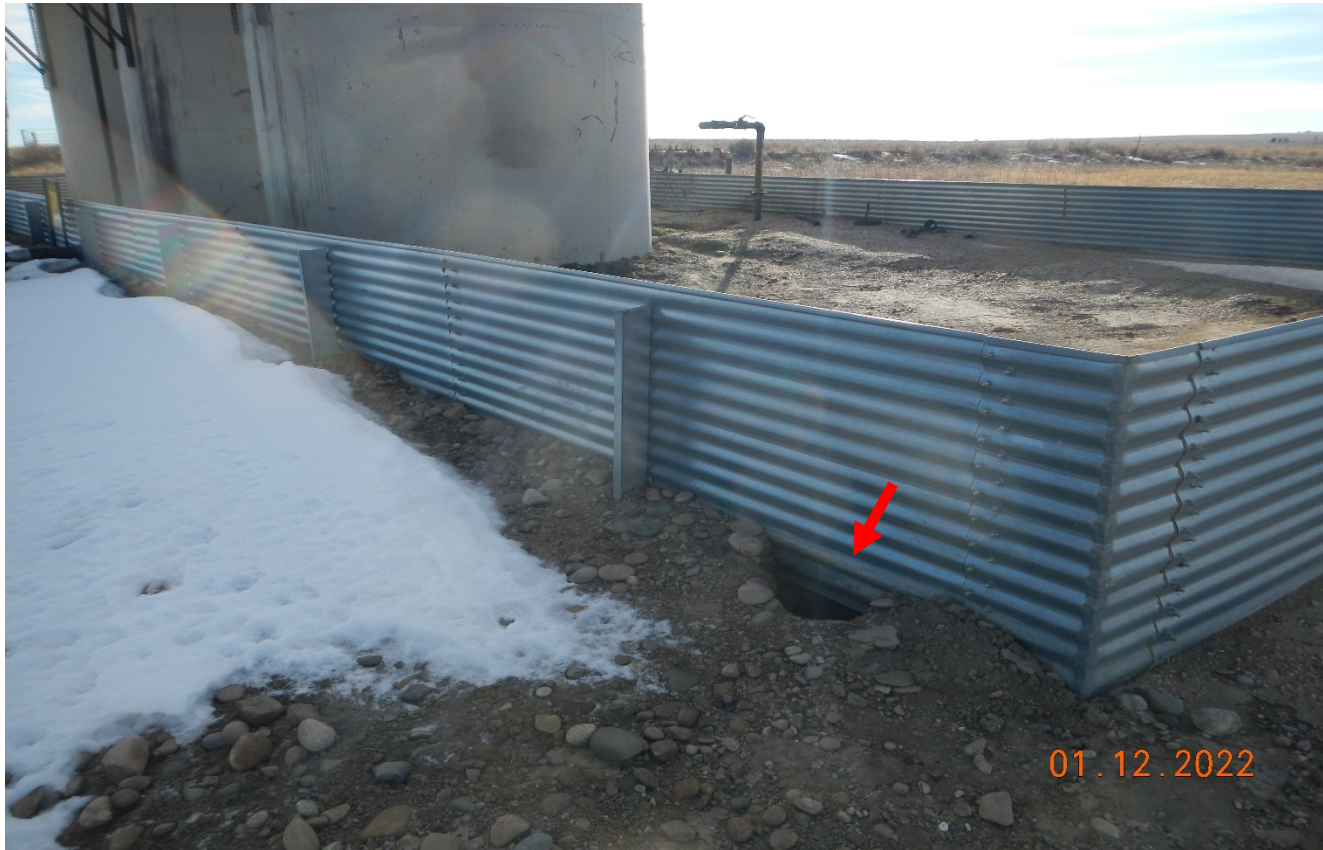
Photo 3. There is a hole at the outside edge compromising the secondary containment of the tank battery. Previous corrective action was not completed.

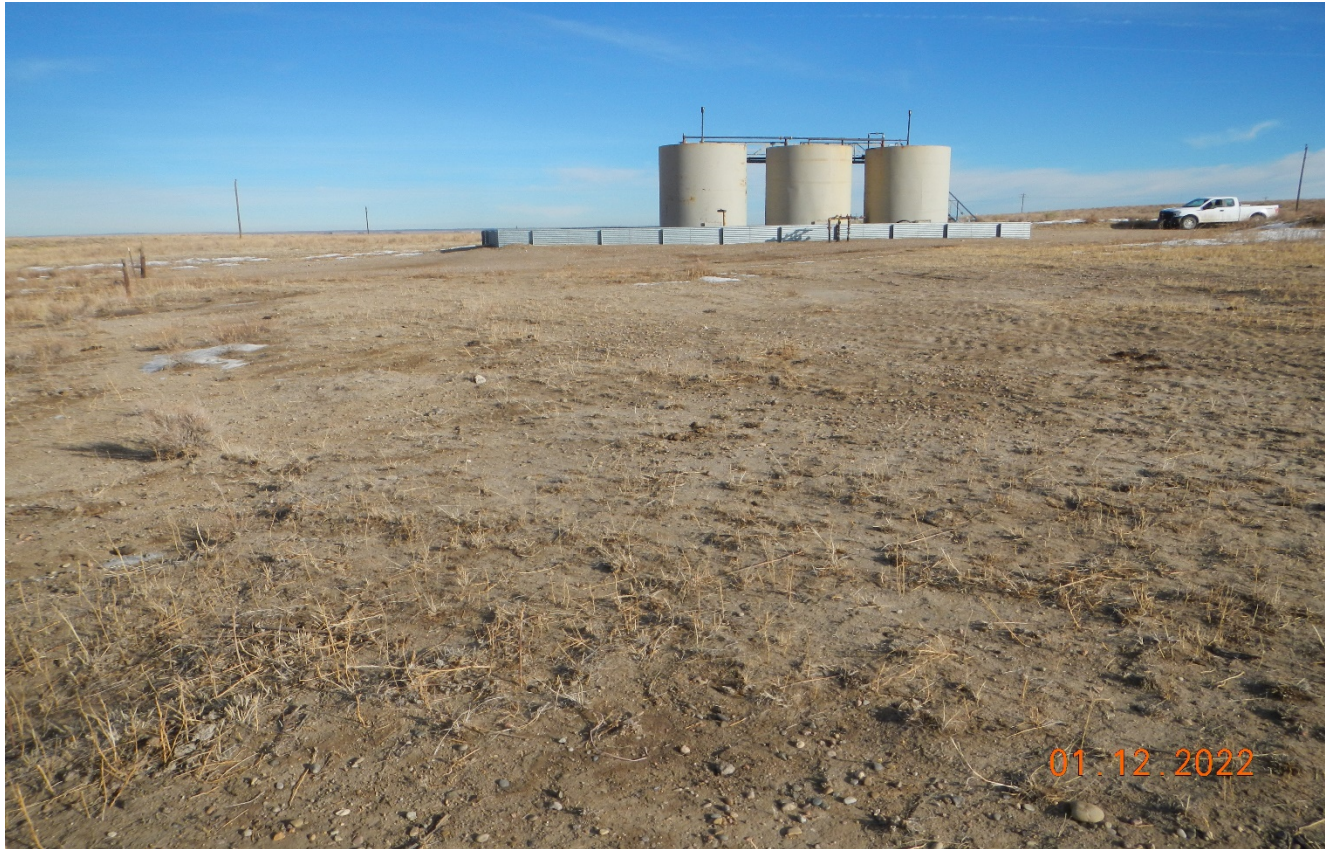
Photo 4. Facing north toward the tank battery. The area of disturbance south of the tank battery is bare of vegetation with compacted soils. This area needs to be reclaimed. Previous corrective action was not completed.

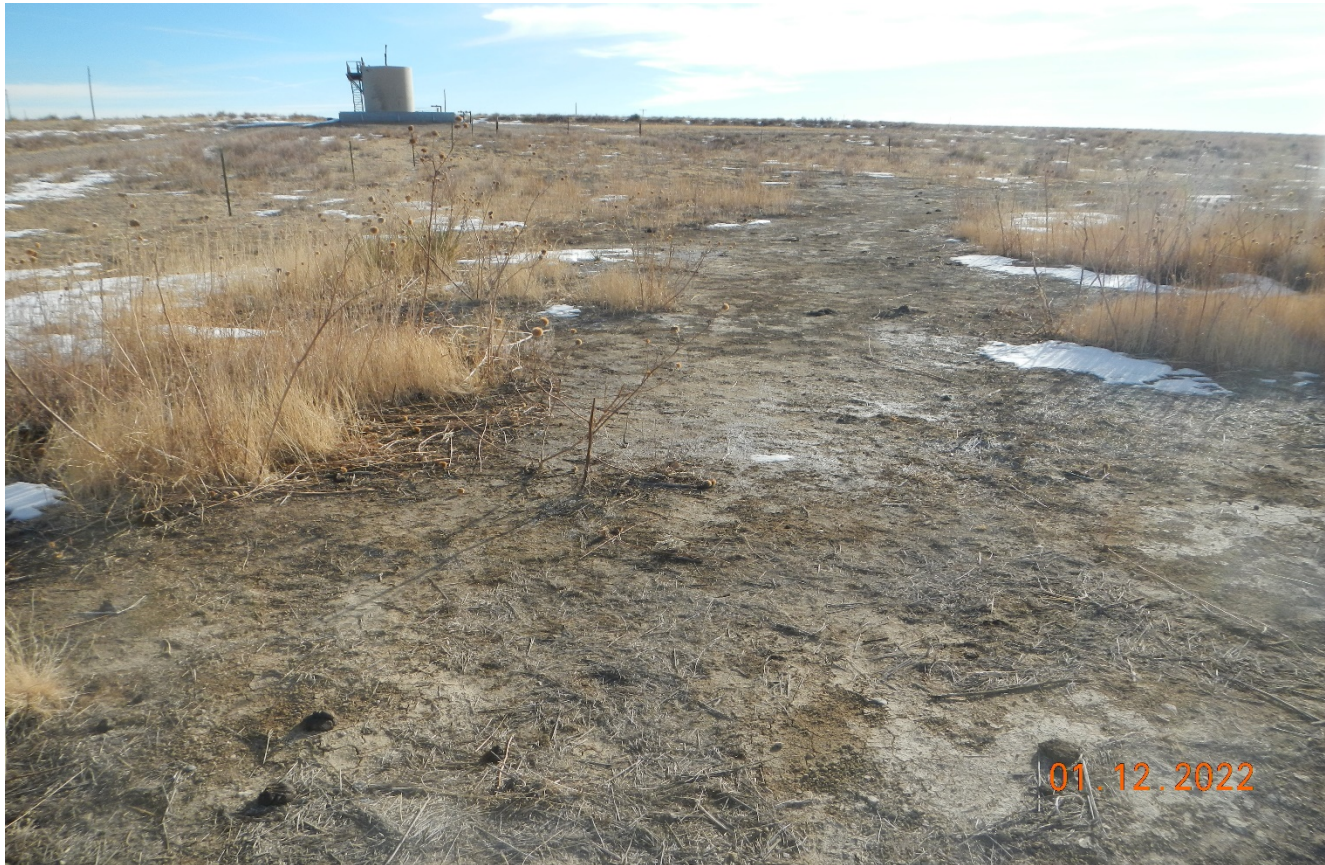
Photo 5. Facing east approximately 275' west of the tank battery. A former spill had occurred in this area as shown by bare and oil stained soils. An electric fence has been installed around this area.

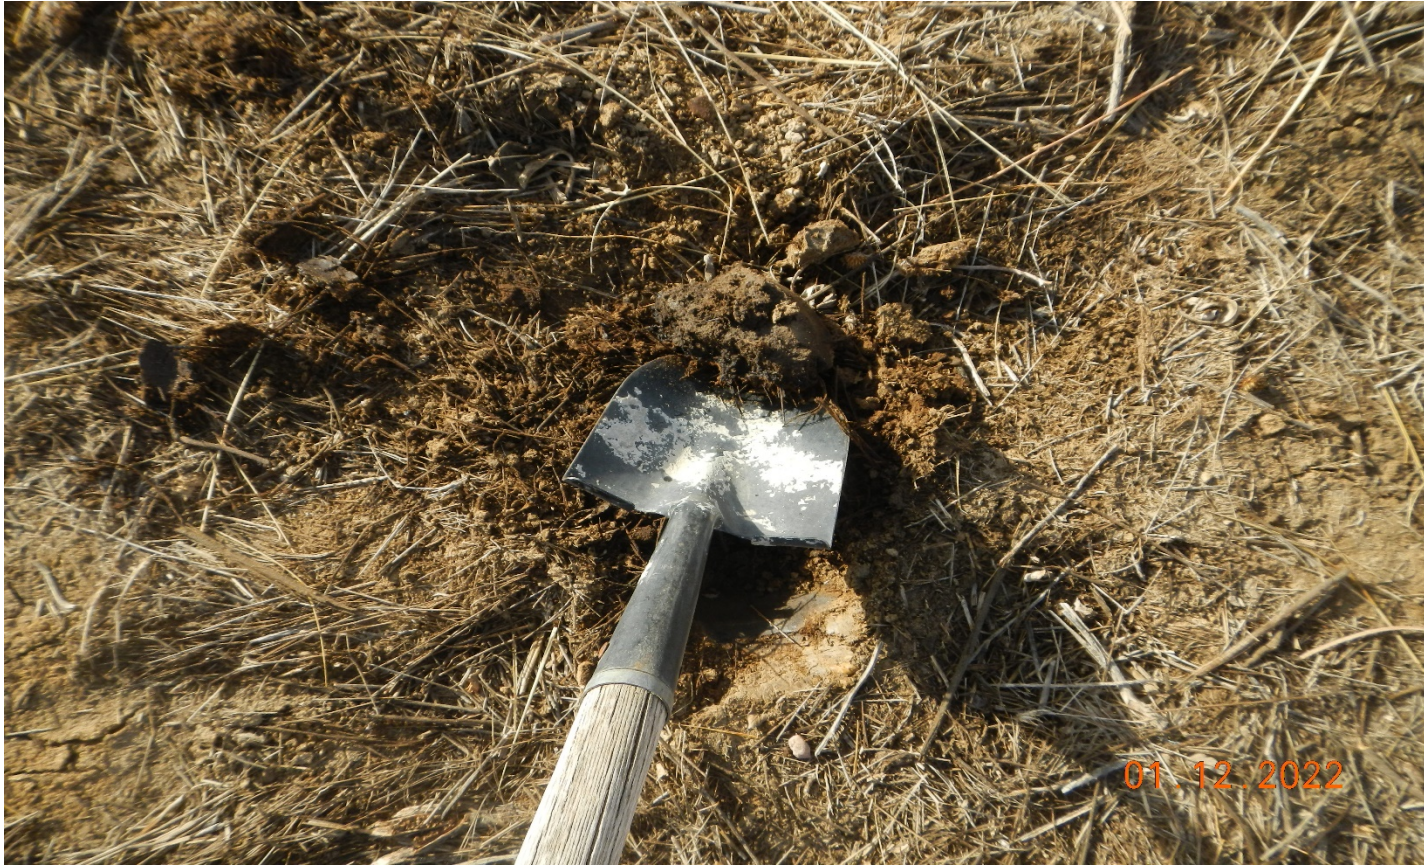
Photo 6. The soil at the spill area was dug a few inches down to show oily soils. The contaminated soils have not been cleaned up and removed.

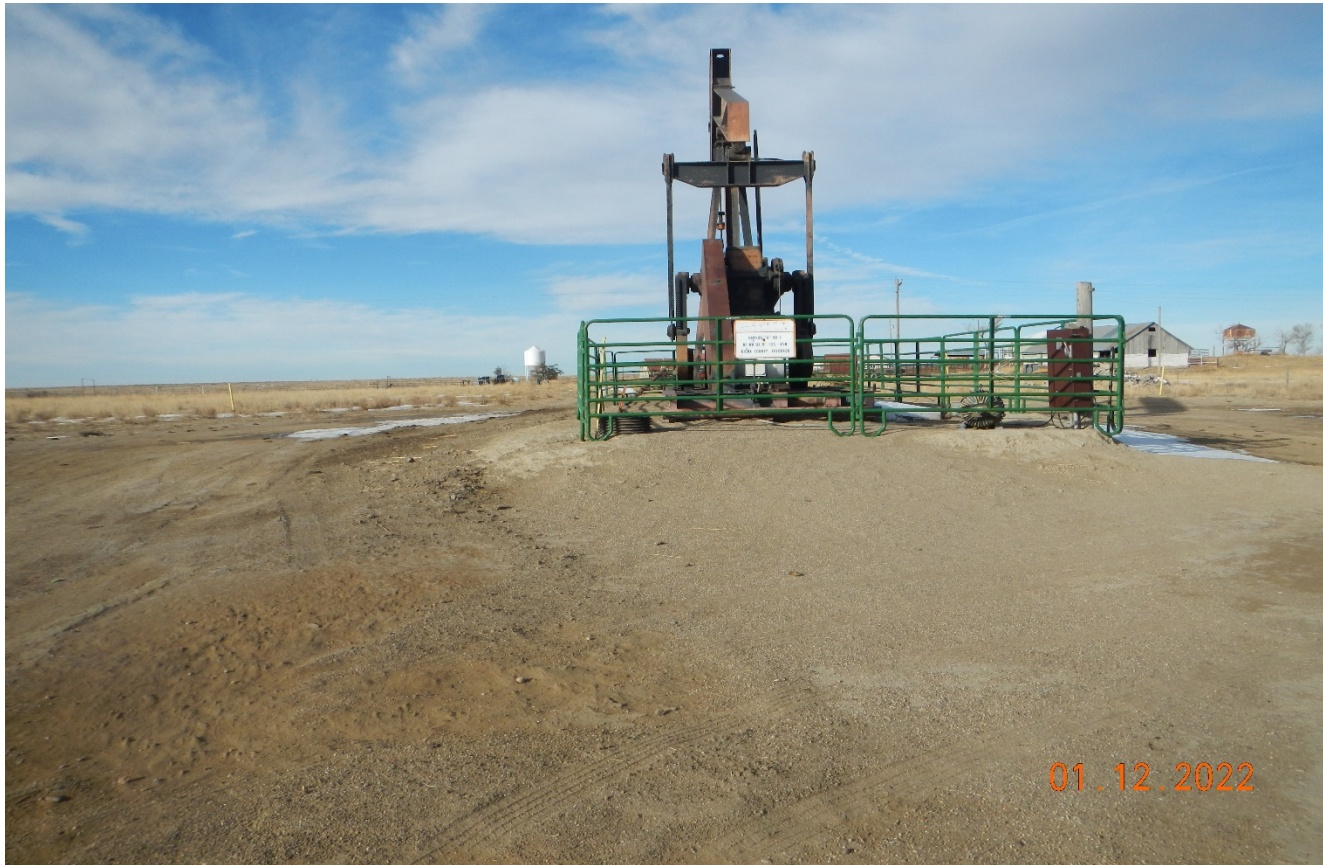
Photo 7. Facing toward the well site which is approximately 500' west of the tank battery.
