Inspection Photos

Location Name: GETTY-PAN AM 19-A

Location ID: 314813

Spill/Release ID: 481420

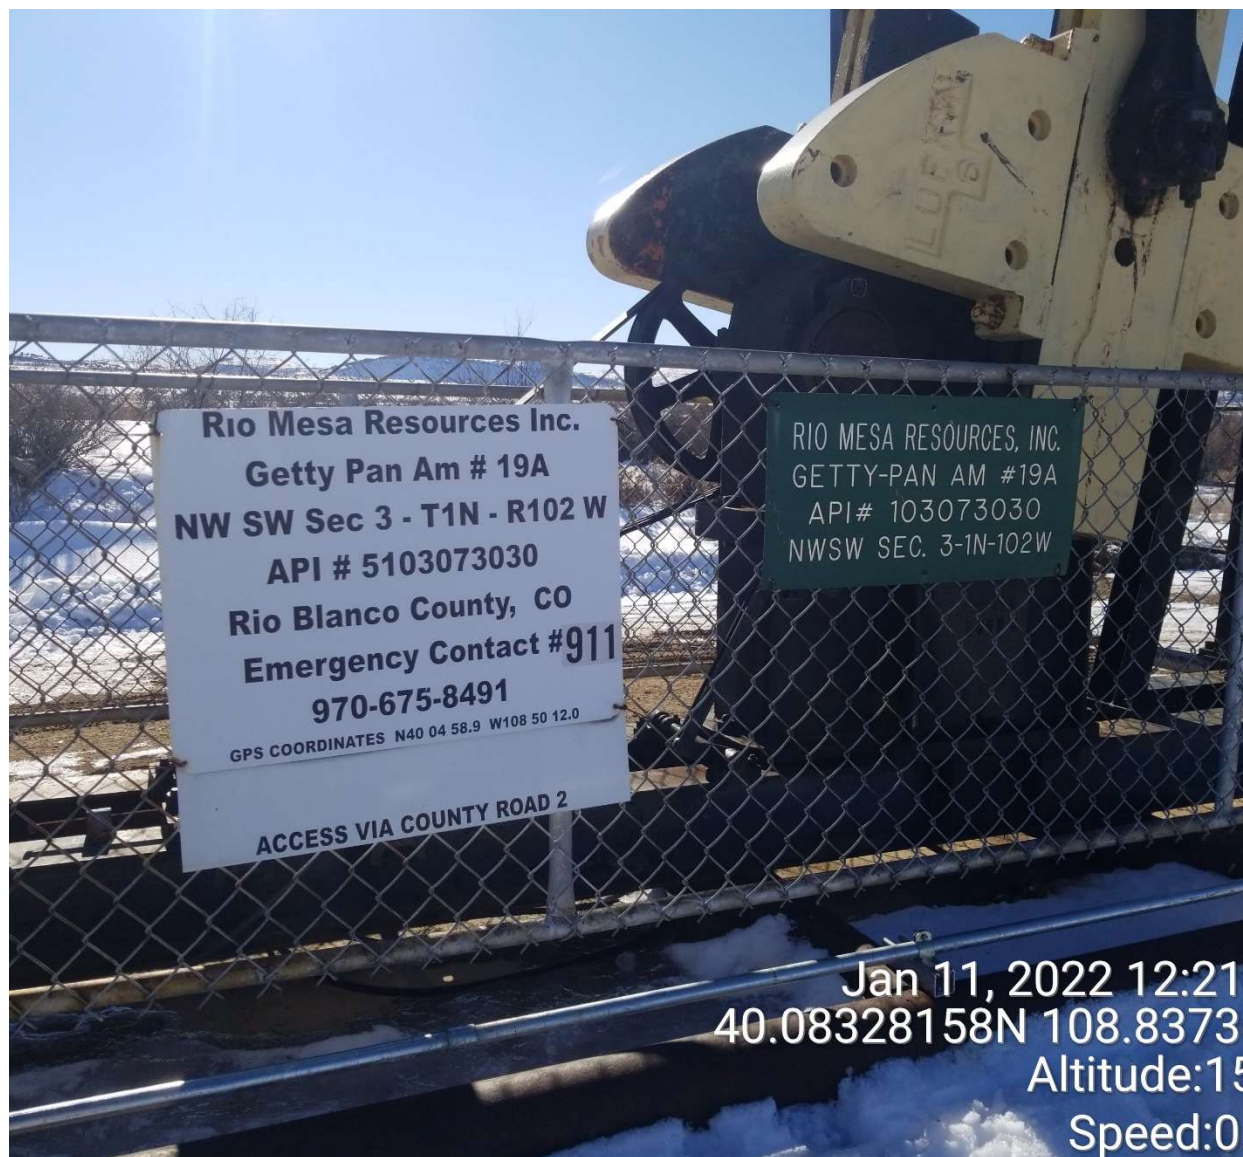
Wellhead signage, note wellhead signage reflects the incorrect operator.

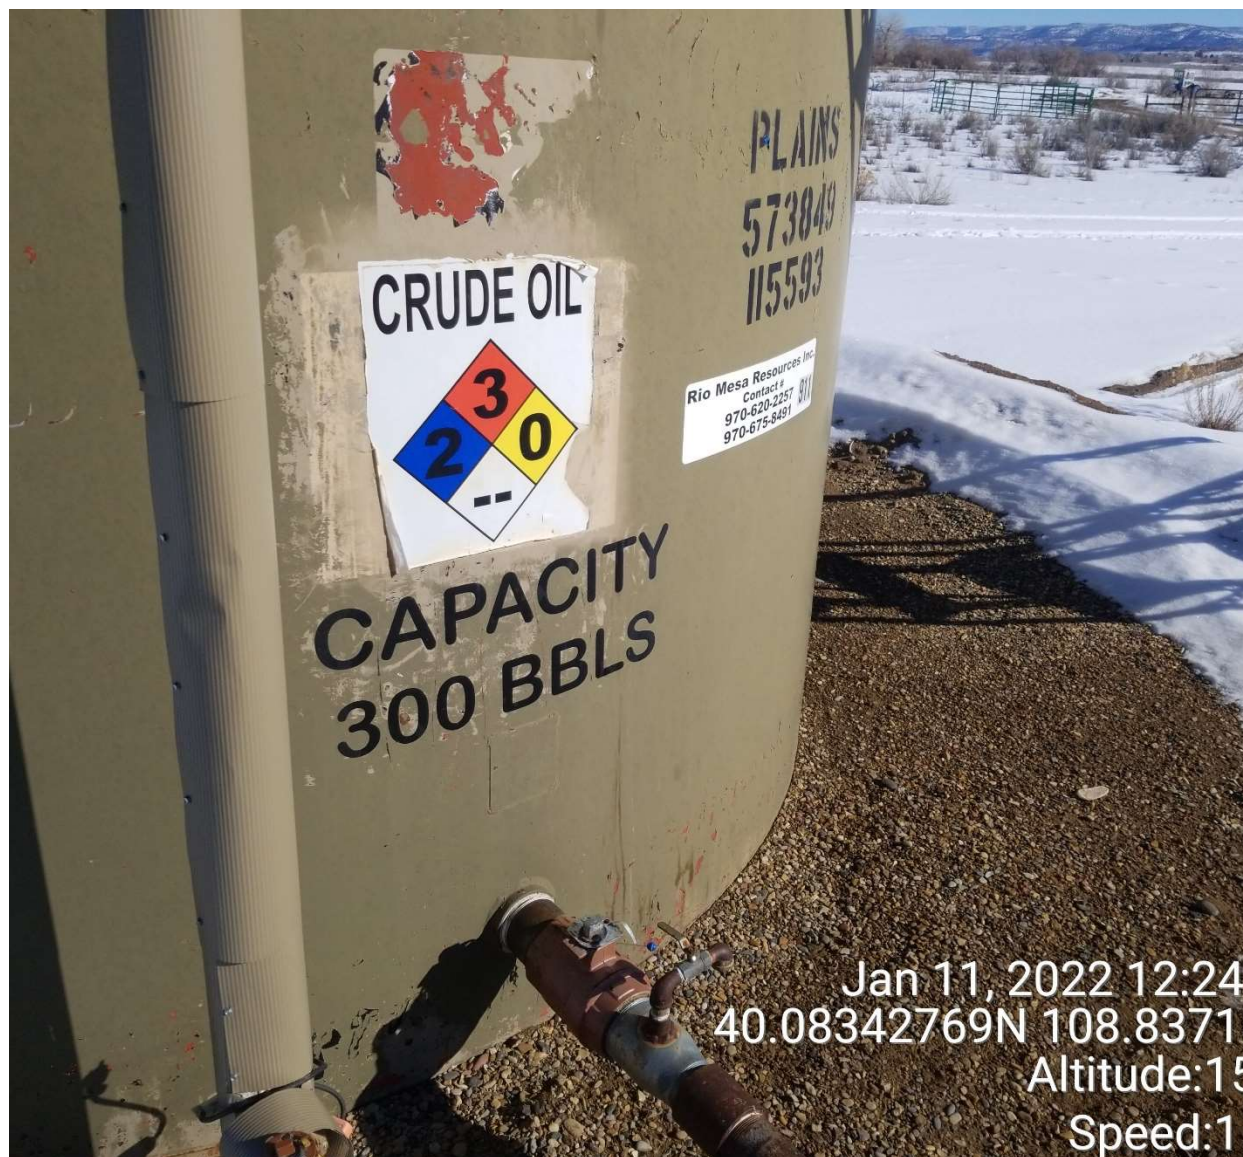
Tank signage, note tank signage
reflects the incorrect operator.

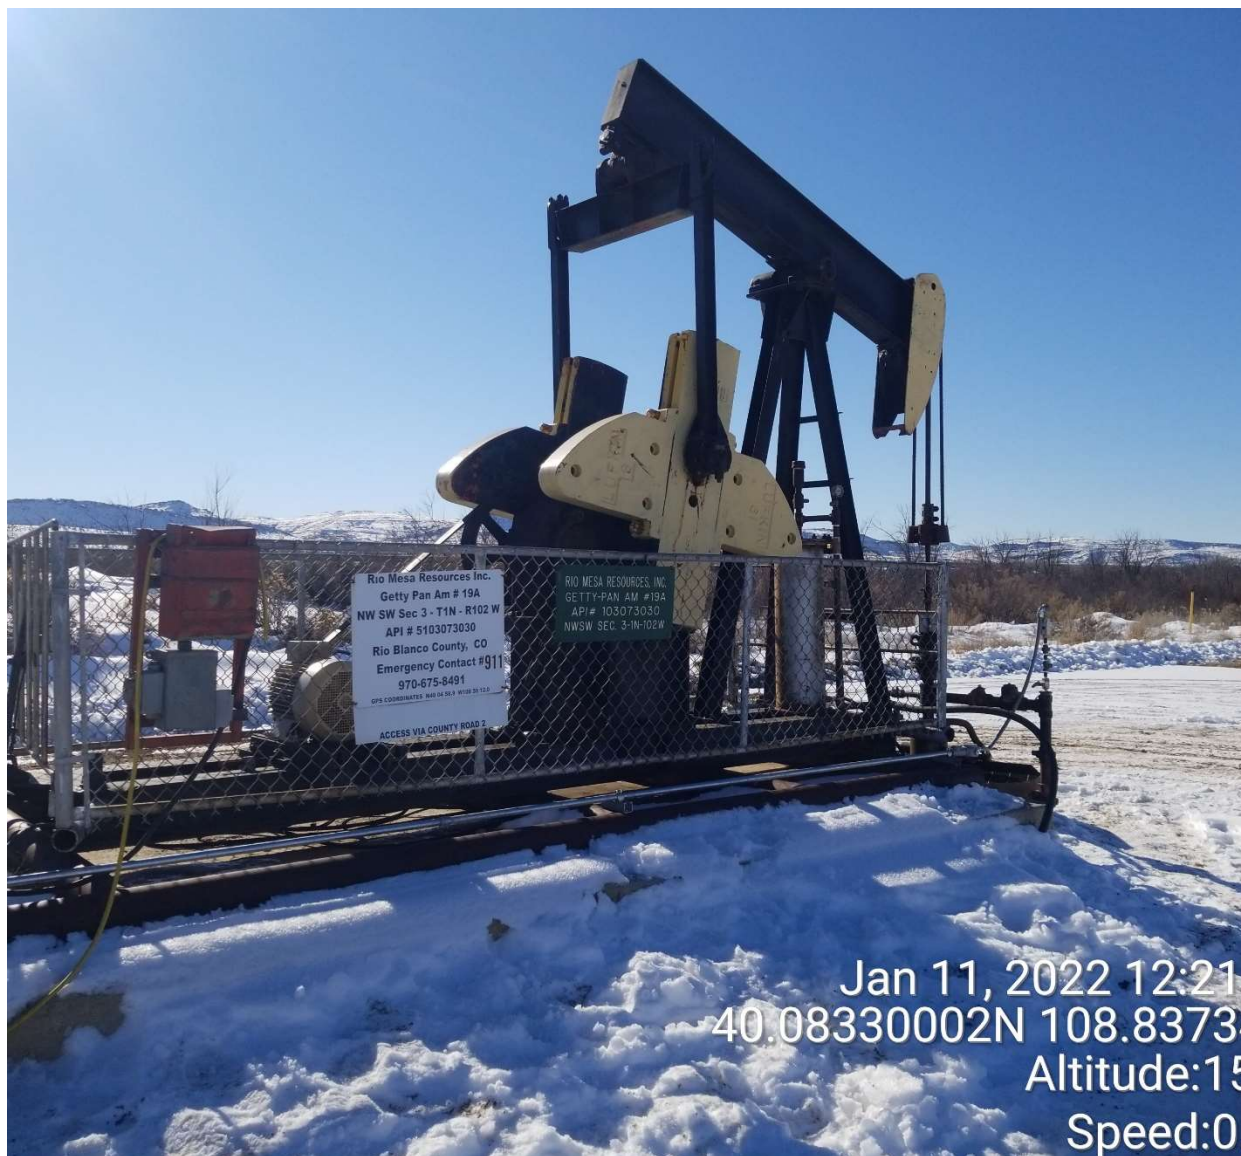
**GETTY-PAN AM 19-A Pump Jack,
note wellhead signage reflects the
incorrect operator.**

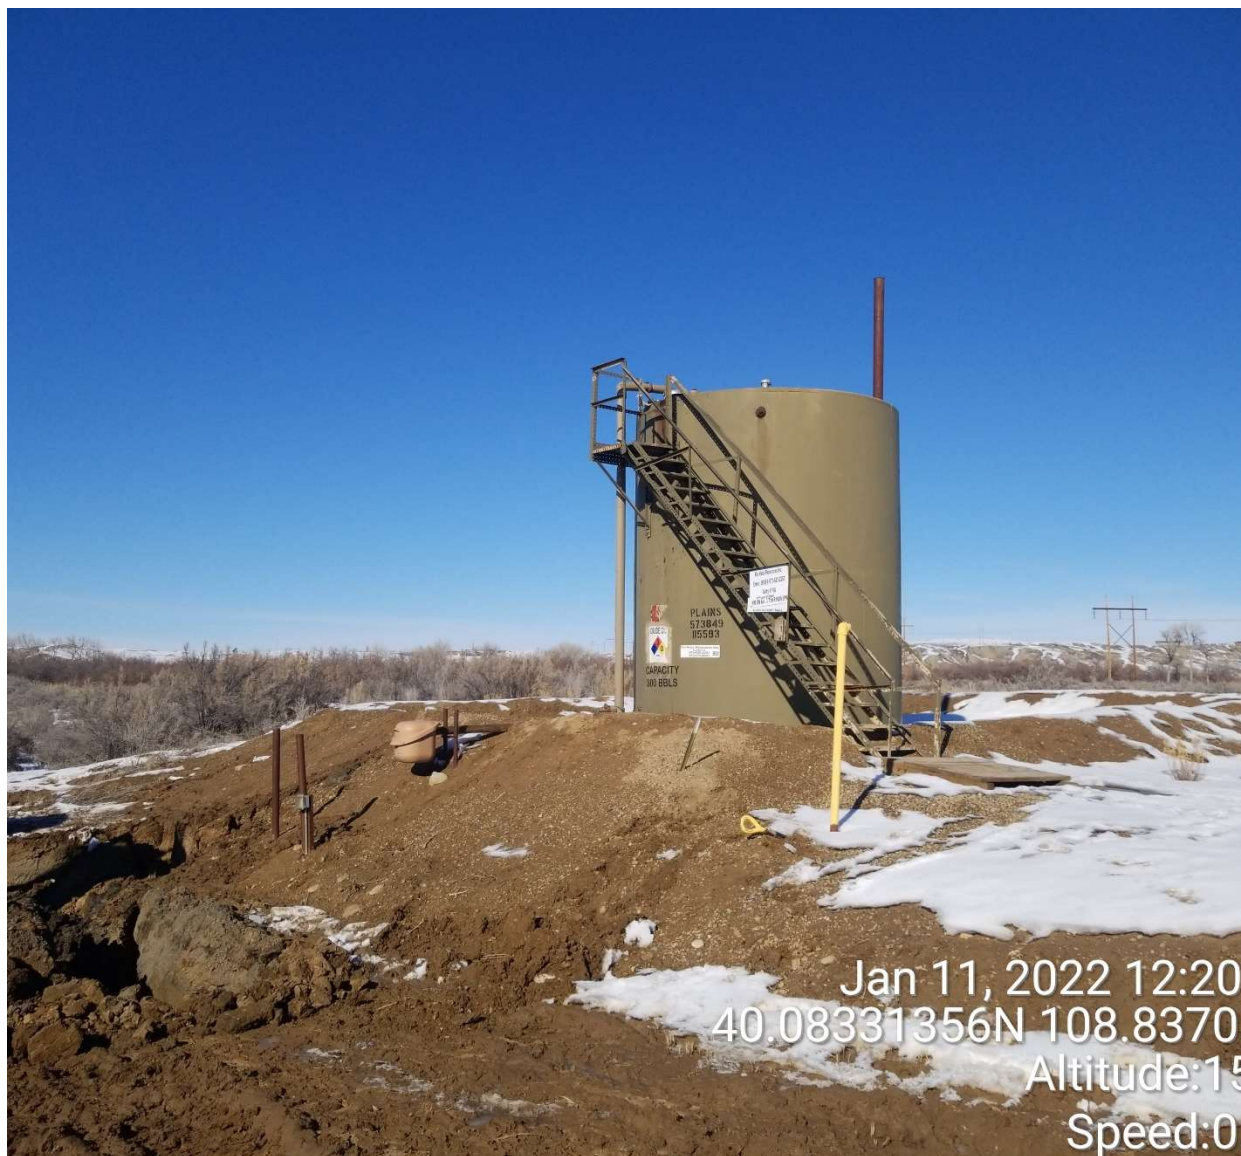
**GETTY-PAN AM 19-A Tank Battery,
note the eastern corner of the
excavation in the bottom left hand
corner of the photo.**

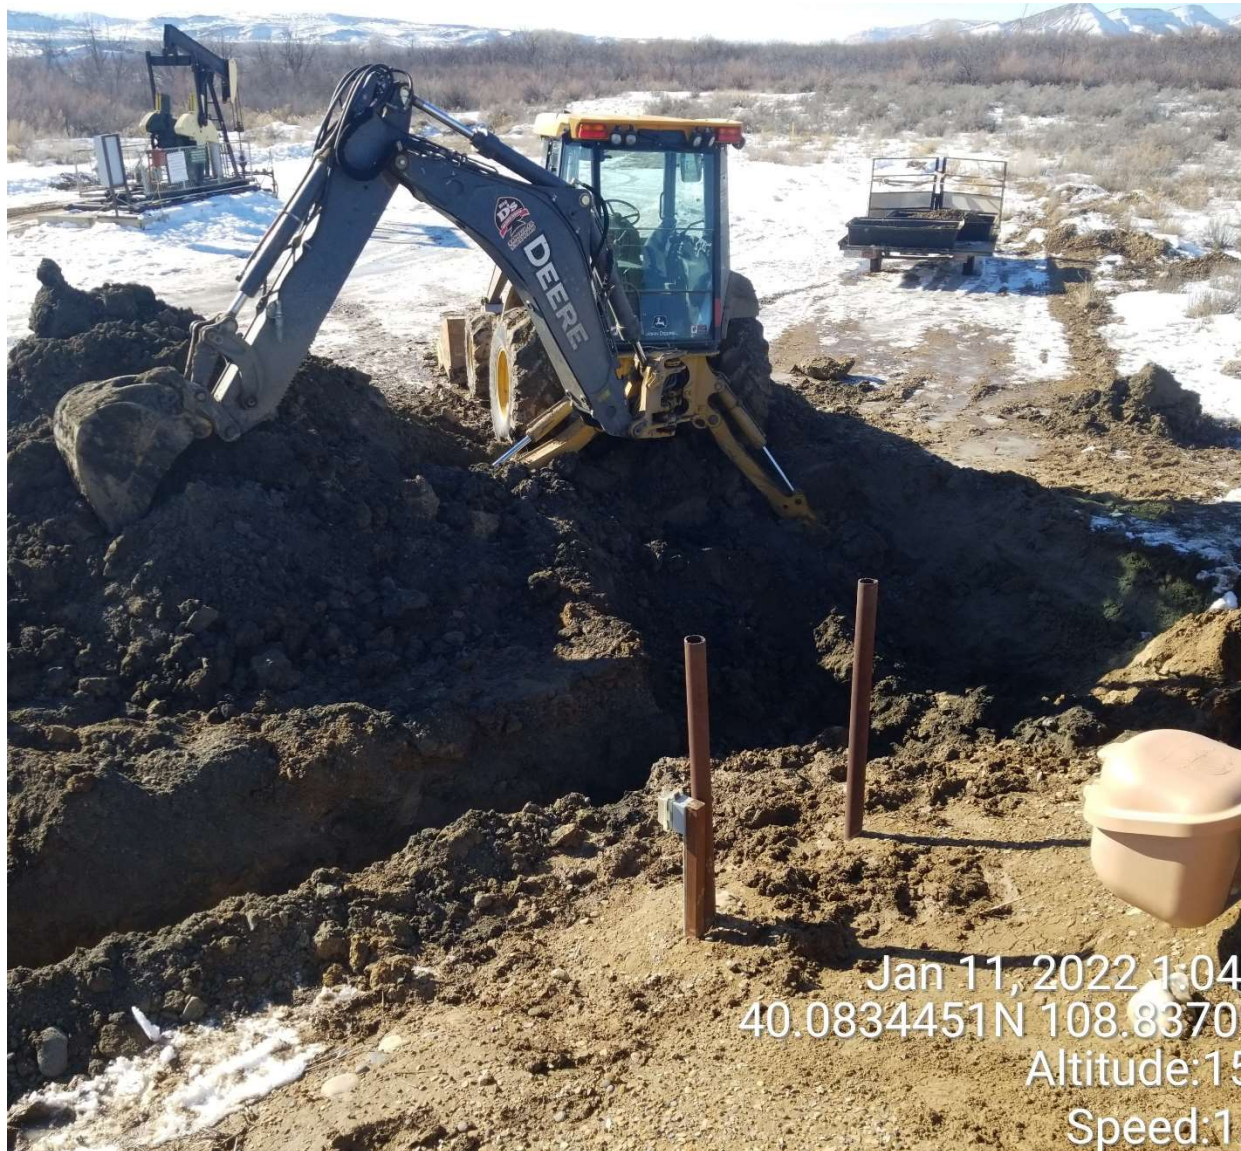
Excavation as seen from the southwest side of the Tank Battery secondary containment structure. Note the GETTY-PAN AM 19-A Pump Jack in the background of the photo.

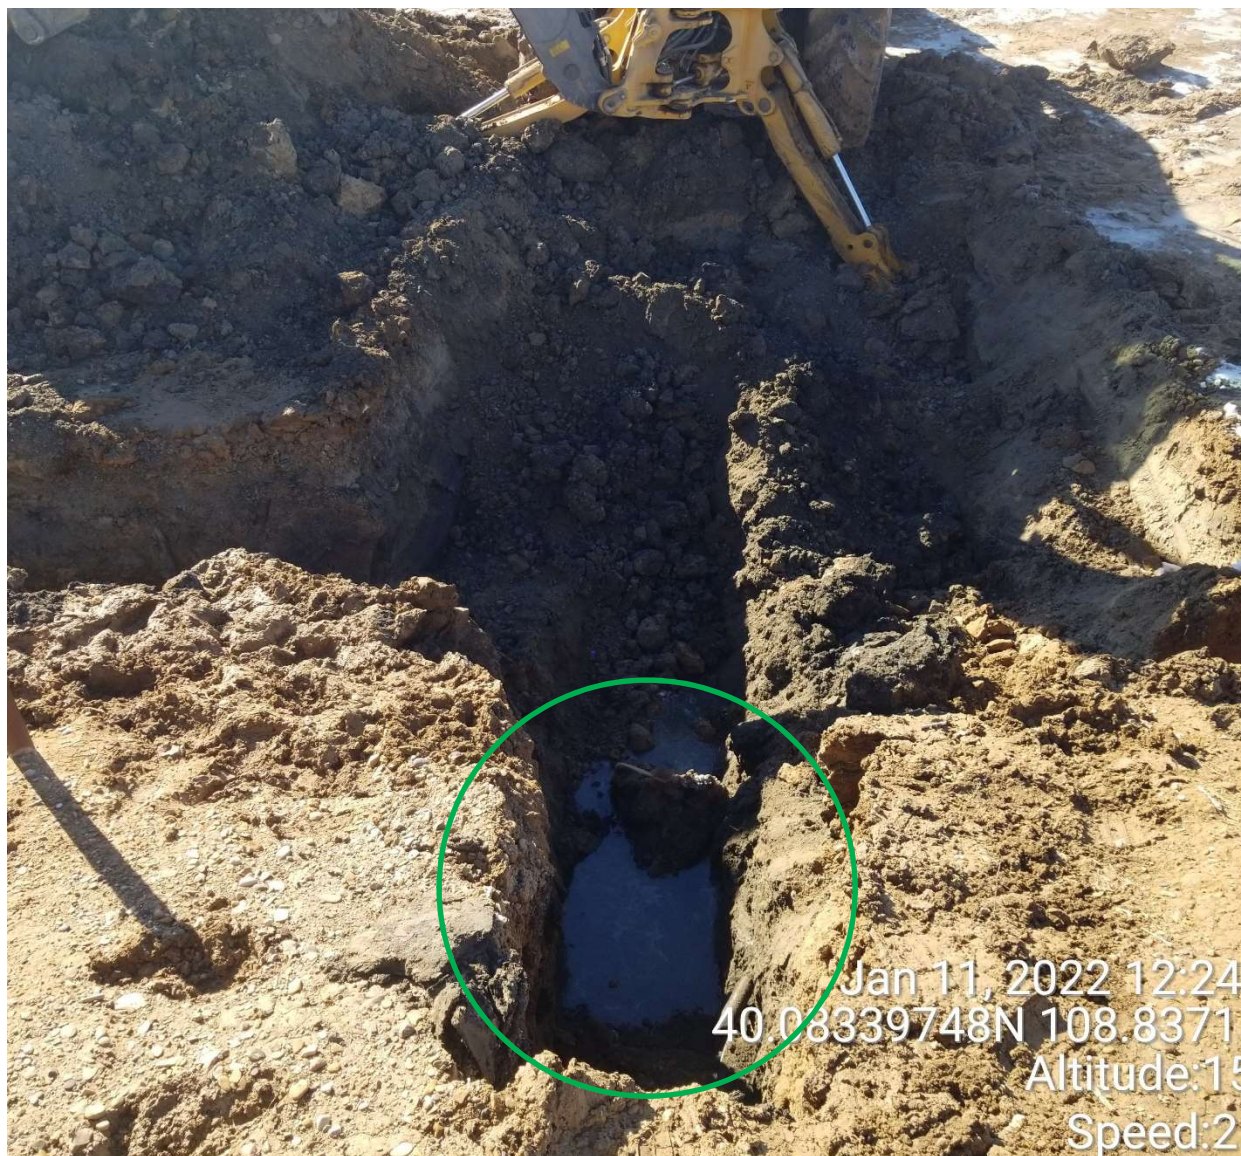
Excavation as seen from the southwest side of the Tank Battery secondary containment structure. Note the presence of potentially impacted groundwater within the deeper section of the excavation (green area).

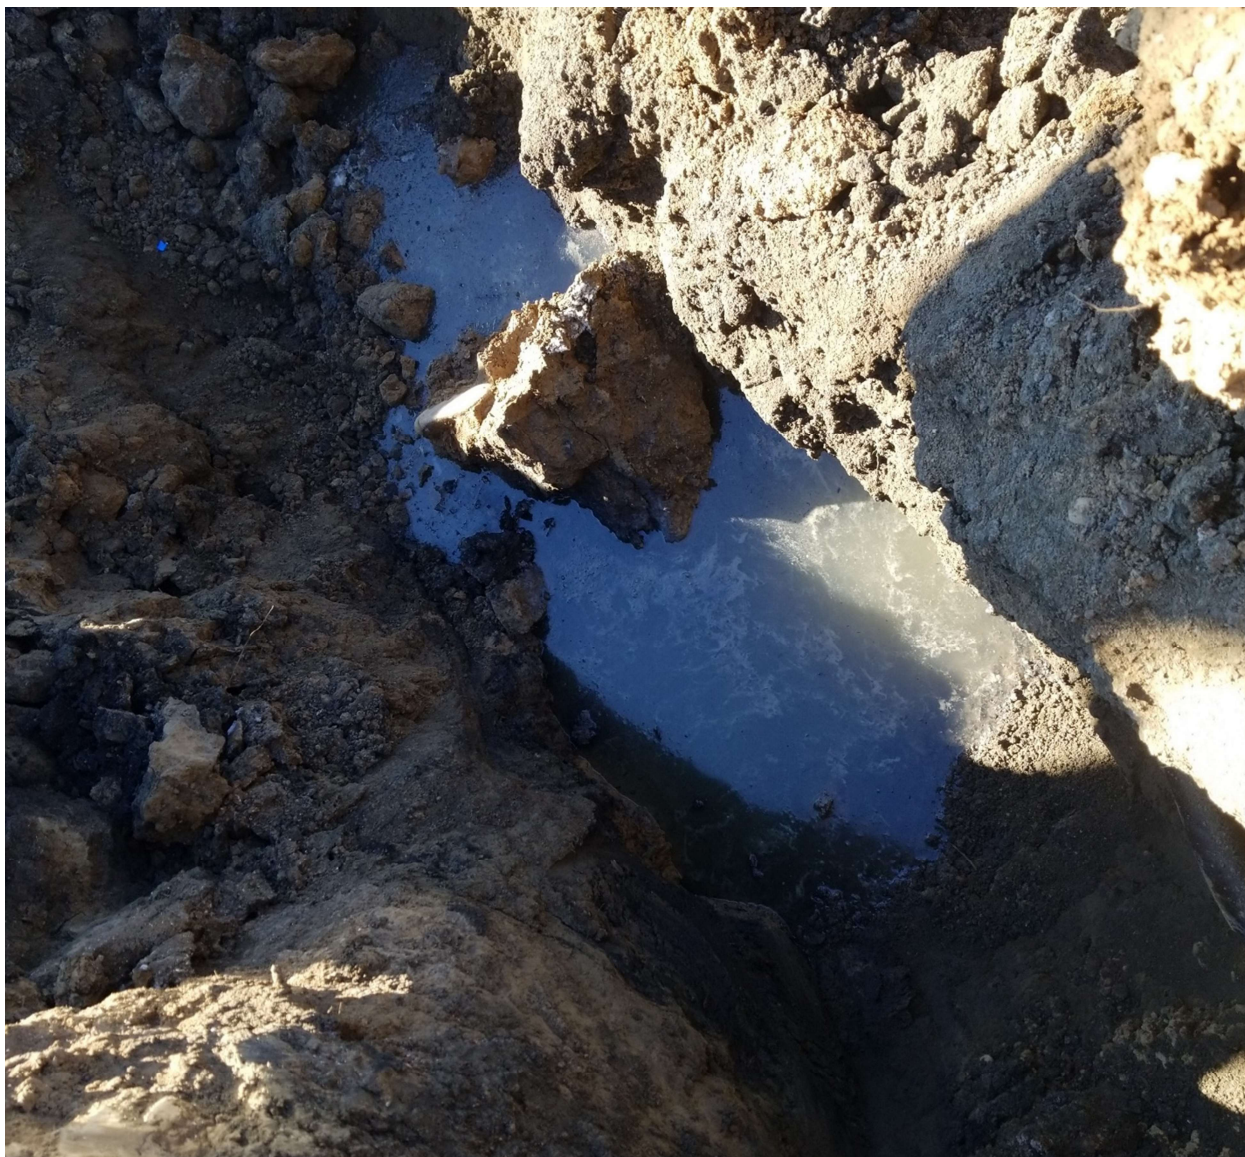
Excavation as seen from the southwest side of the Tank Battery secondary containment structure. Note the presence of potentially impacted groundwater within the deeper section of the excavation.

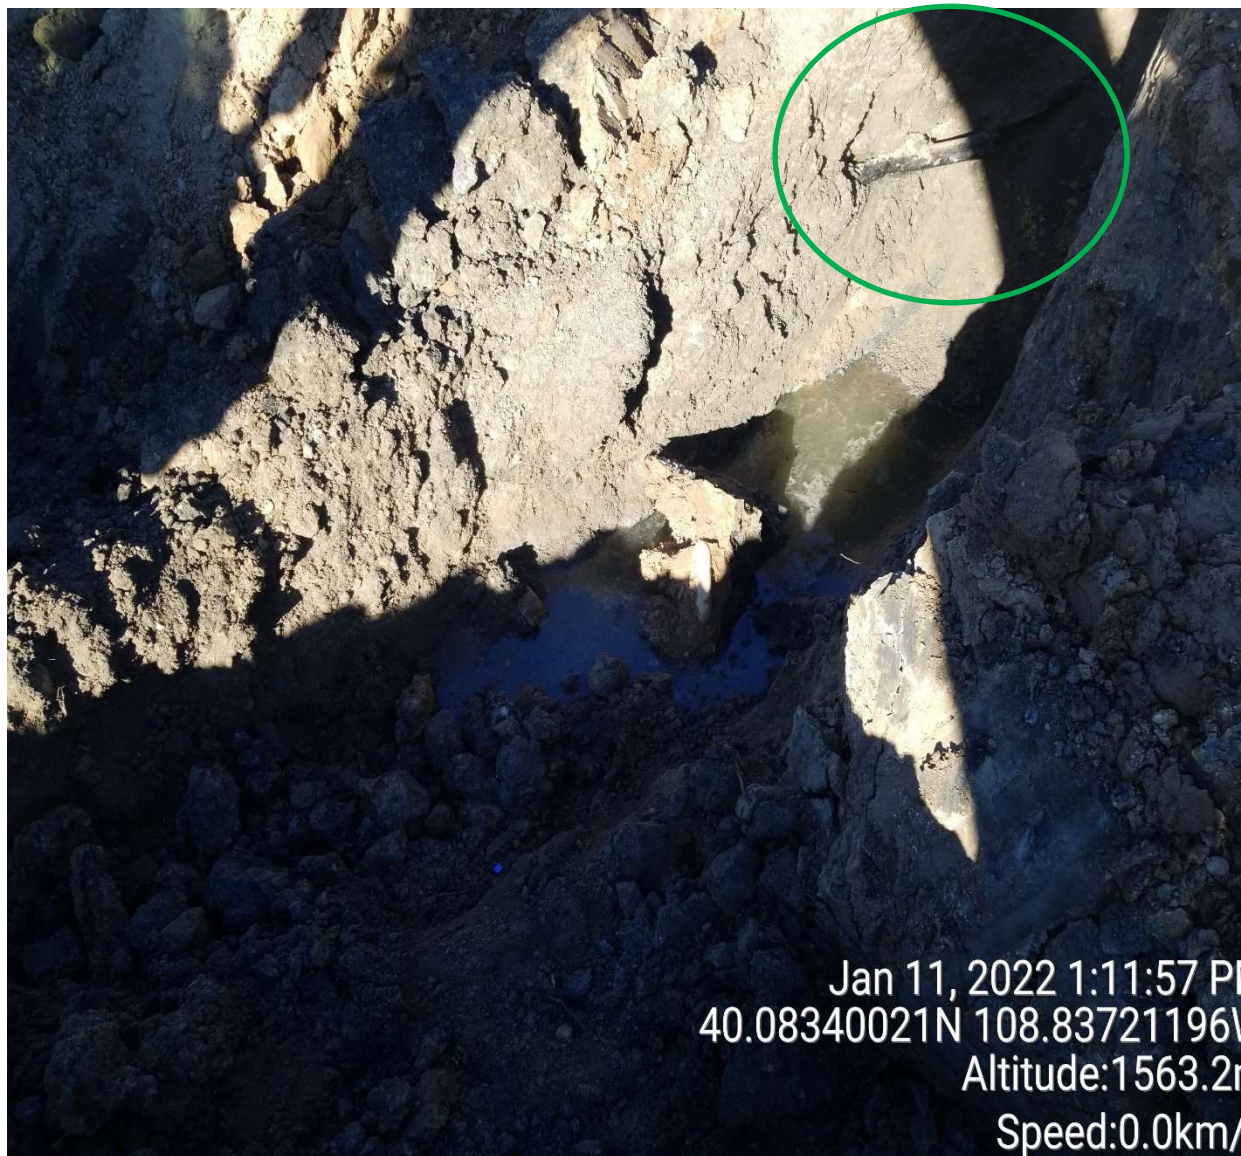
Excavation with the presence of potentially impacted groundwater. Note the flowline in the upper section of the photo (green area).

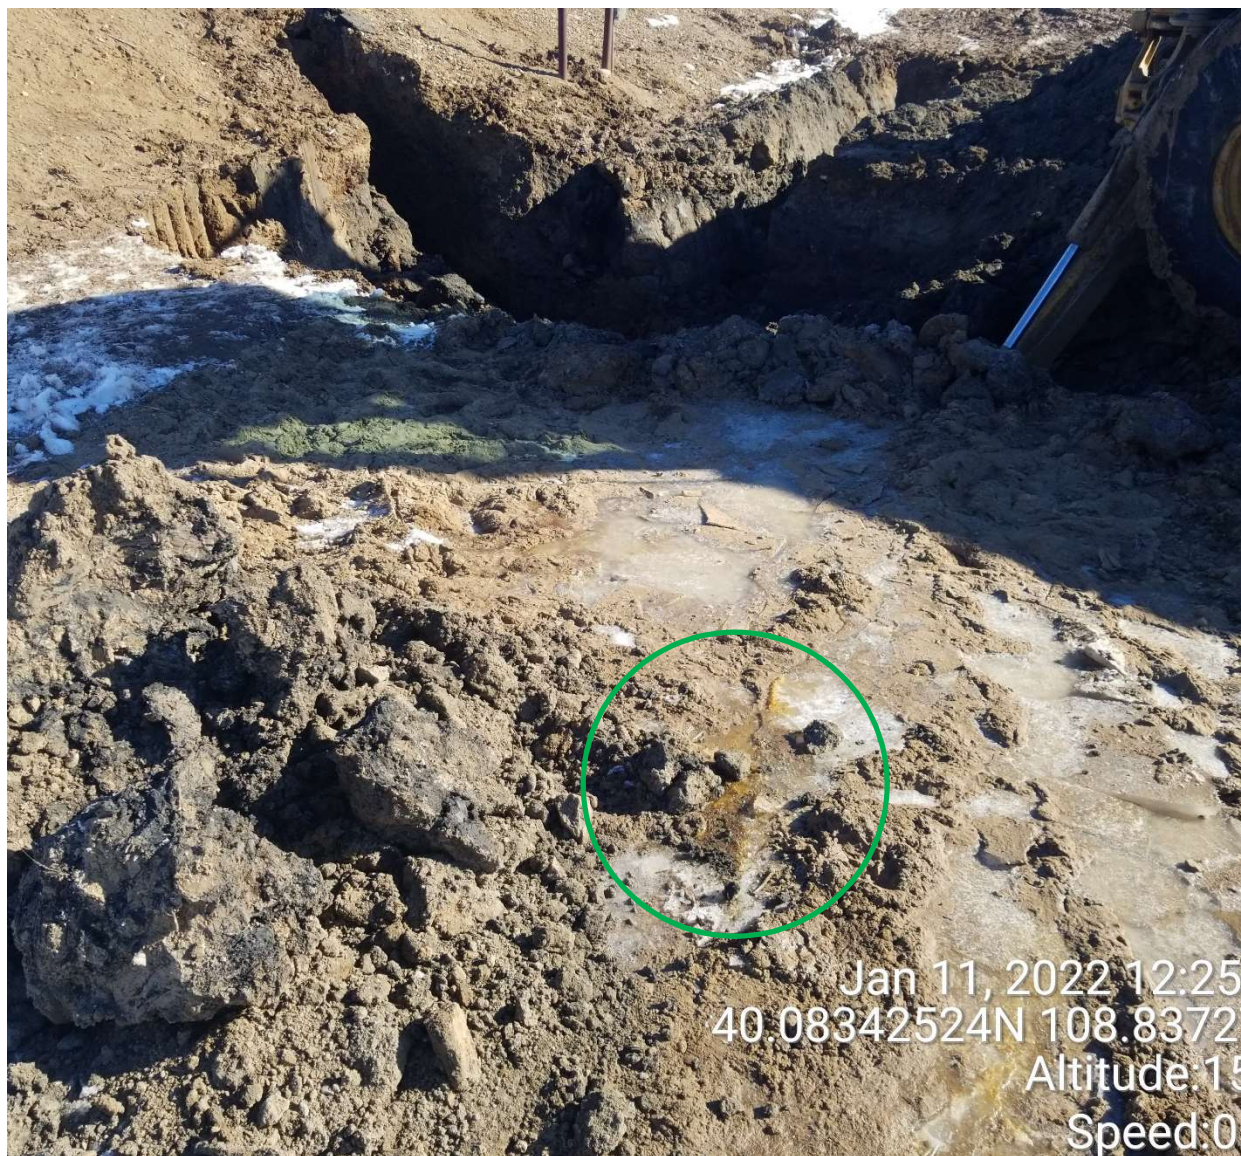
Condensate was present in various amounts and locations around the excavation (green area).

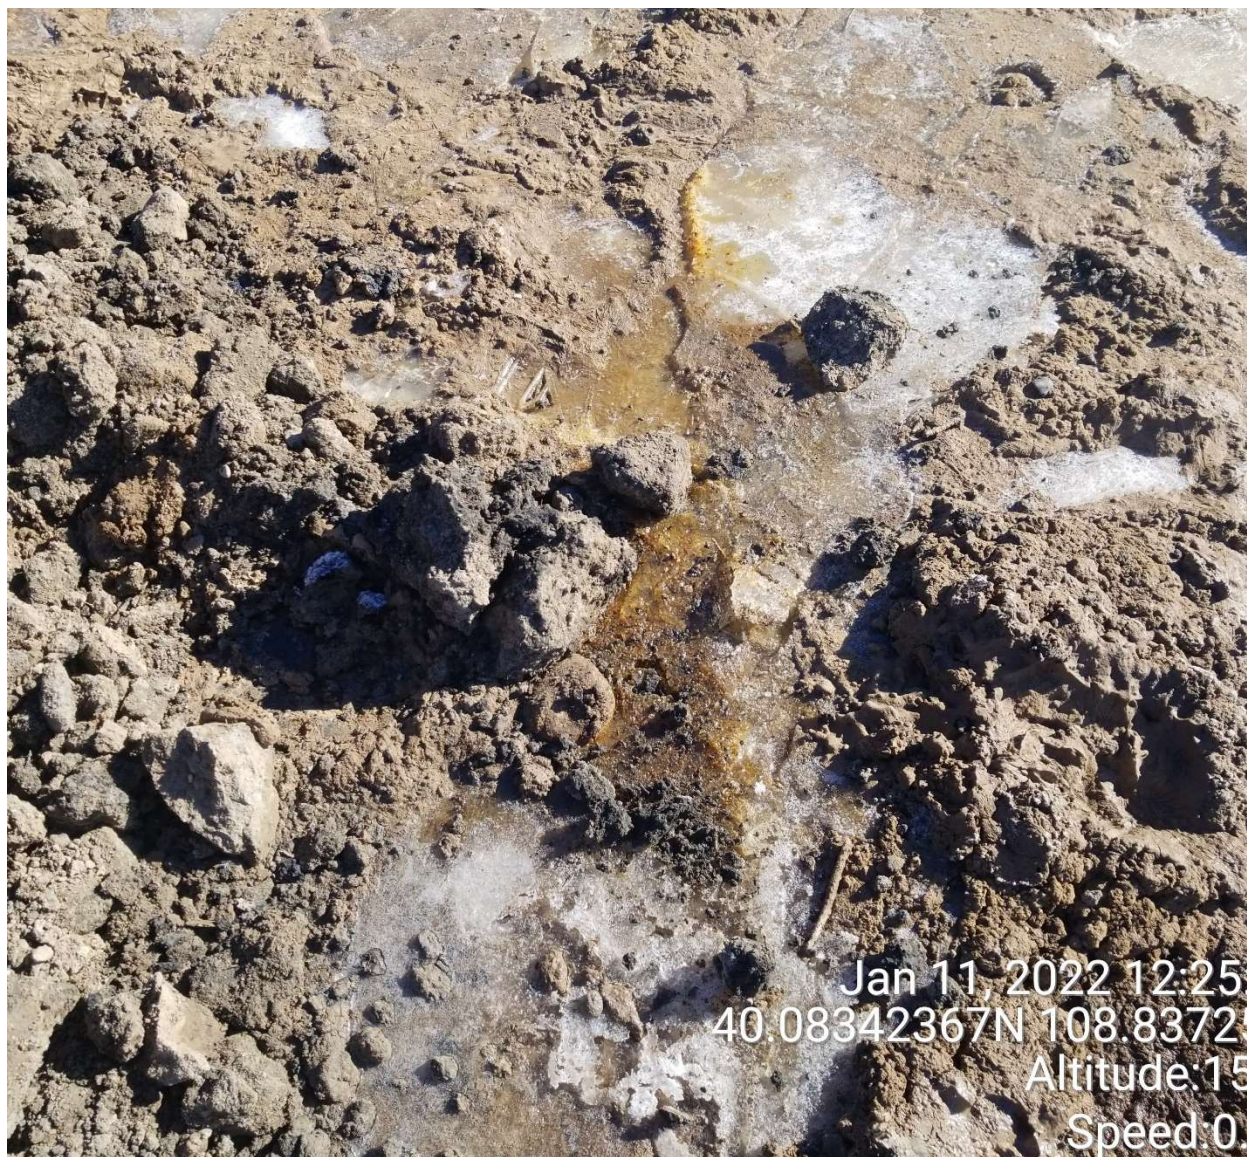
Close up of the green area in the previous photo.

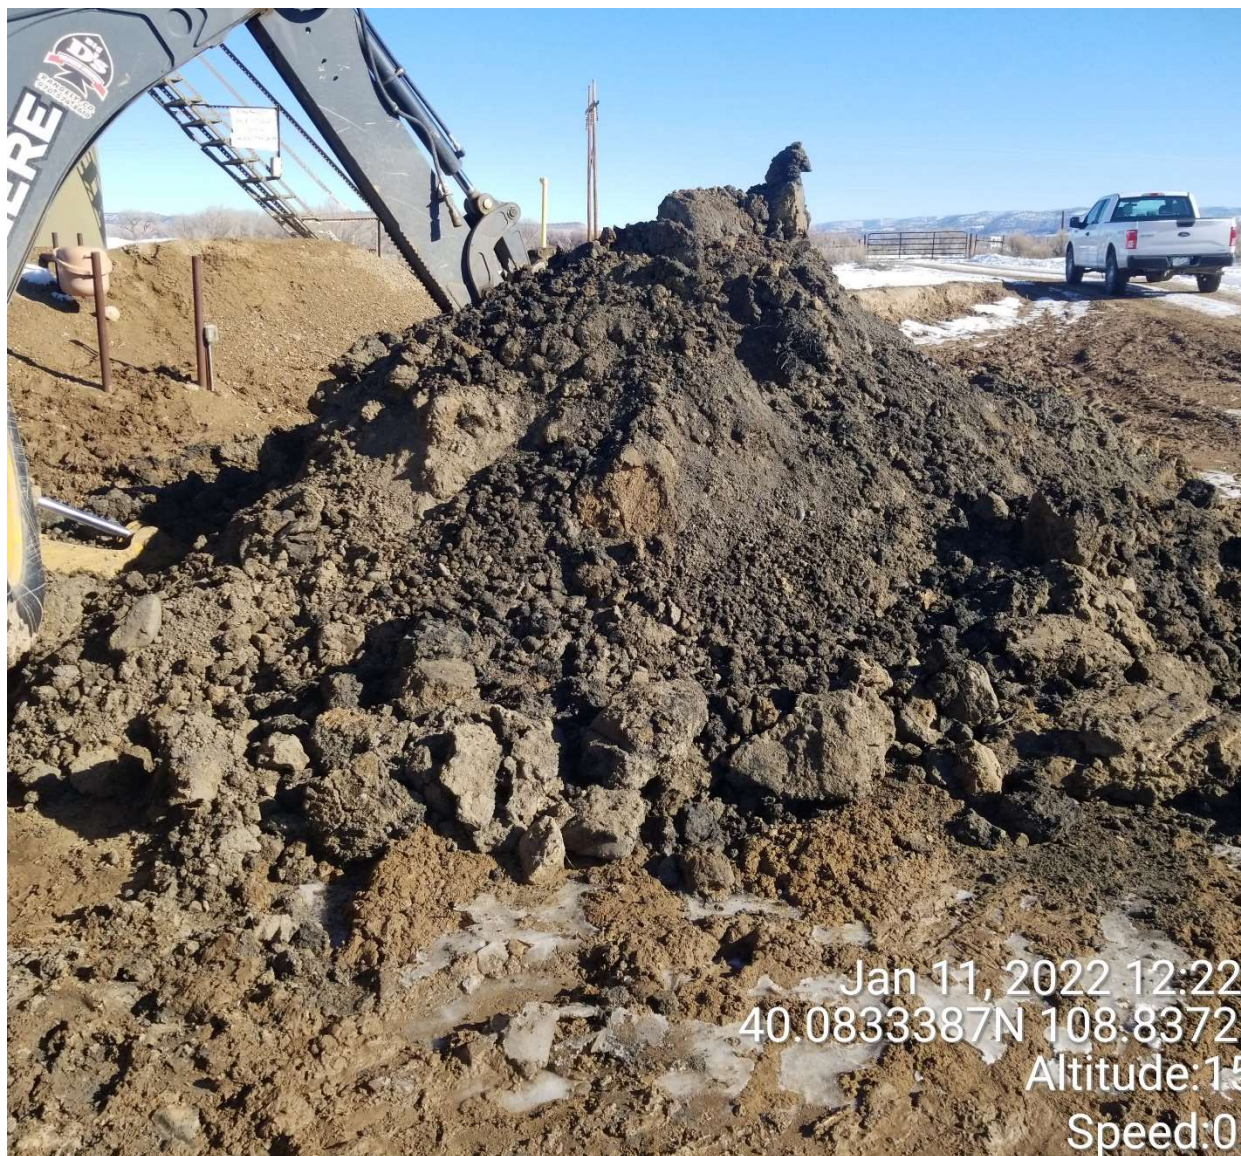
Stockpiles of potentially impacted material with a detectable hydrocarbon odor located around the southwest side of the excavation. Note the lack of BMPs around the stockpiles of potentially impacted material to prevent the contamination of stormwater, surface water, groundwater, and soil.

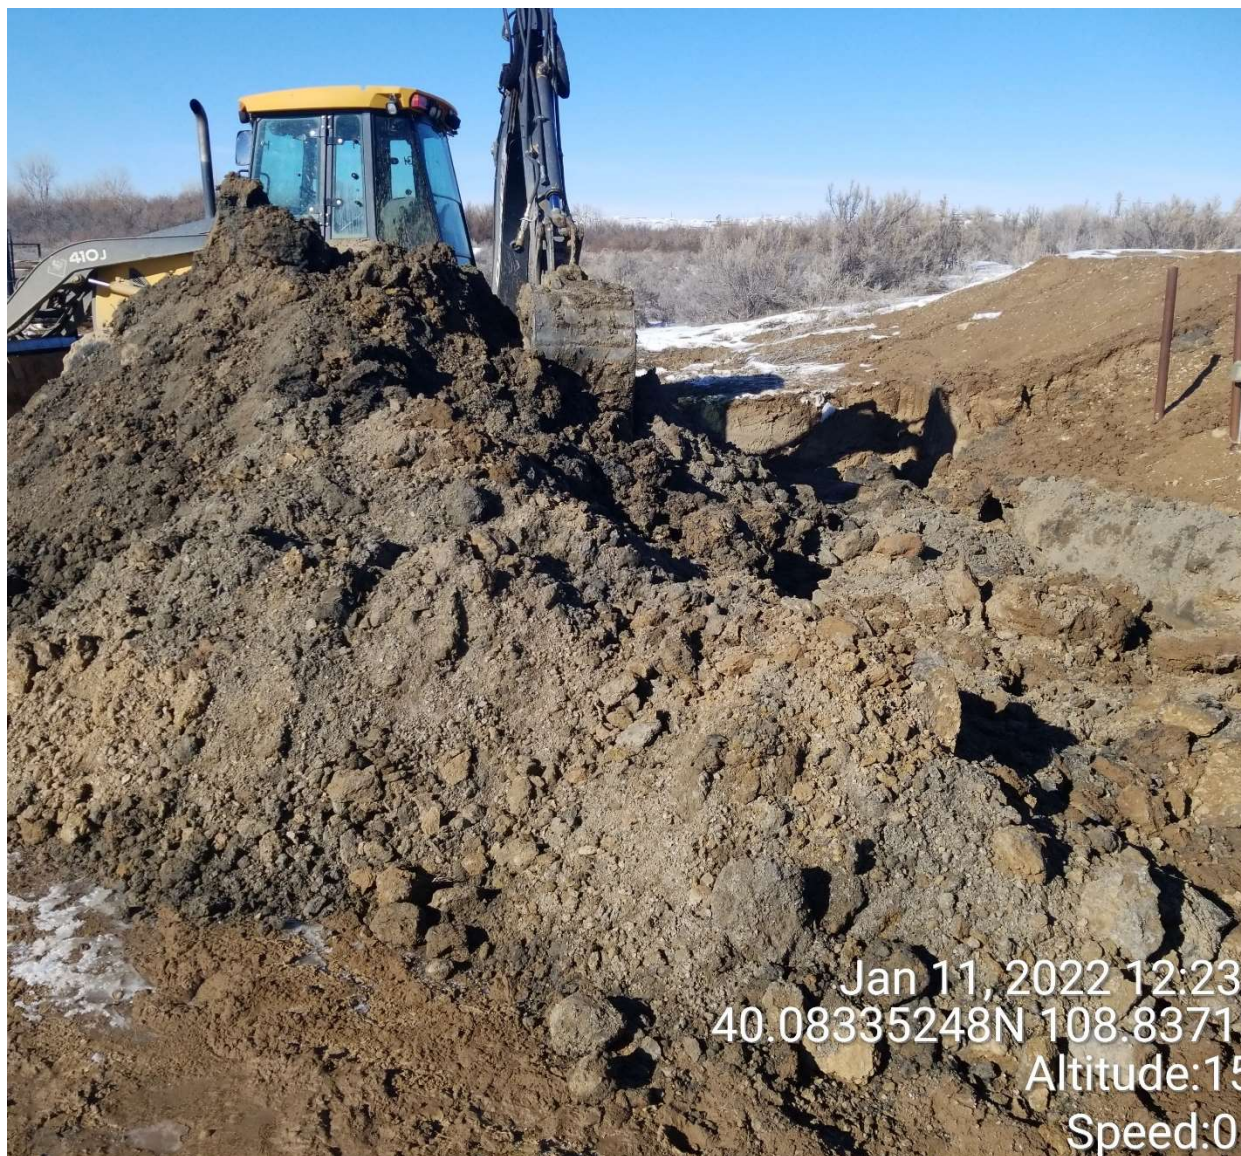
Stockpiles of potentially impacted material with a detectable hydrocarbon odor located around the southwest side of the excavation. Note the lack of BMPs around the stockpiles of potentially impacted material to prevent the contamination of stormwater, surface water, groundwater, and soil.

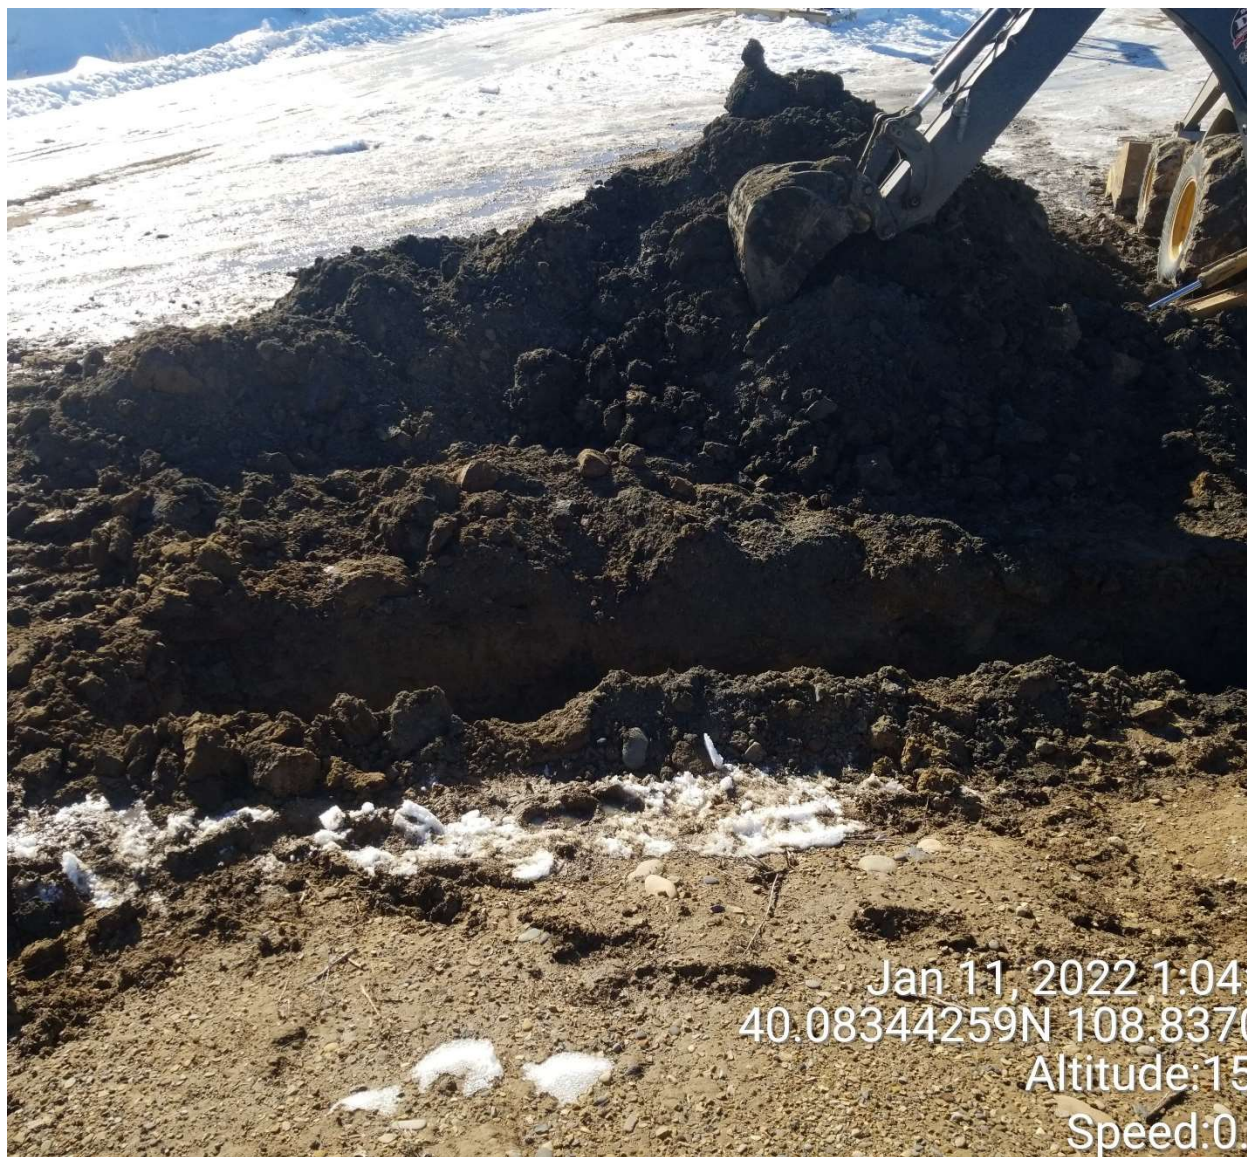
Stockpiles of potentially impacted material with a detectable hydrocarbon odor located around the southwest side of the excavation. Note the lack of BMPs around the stockpiles of potentially impacted material to prevent the contamination of stormwater, surface water, groundwater, and soil.

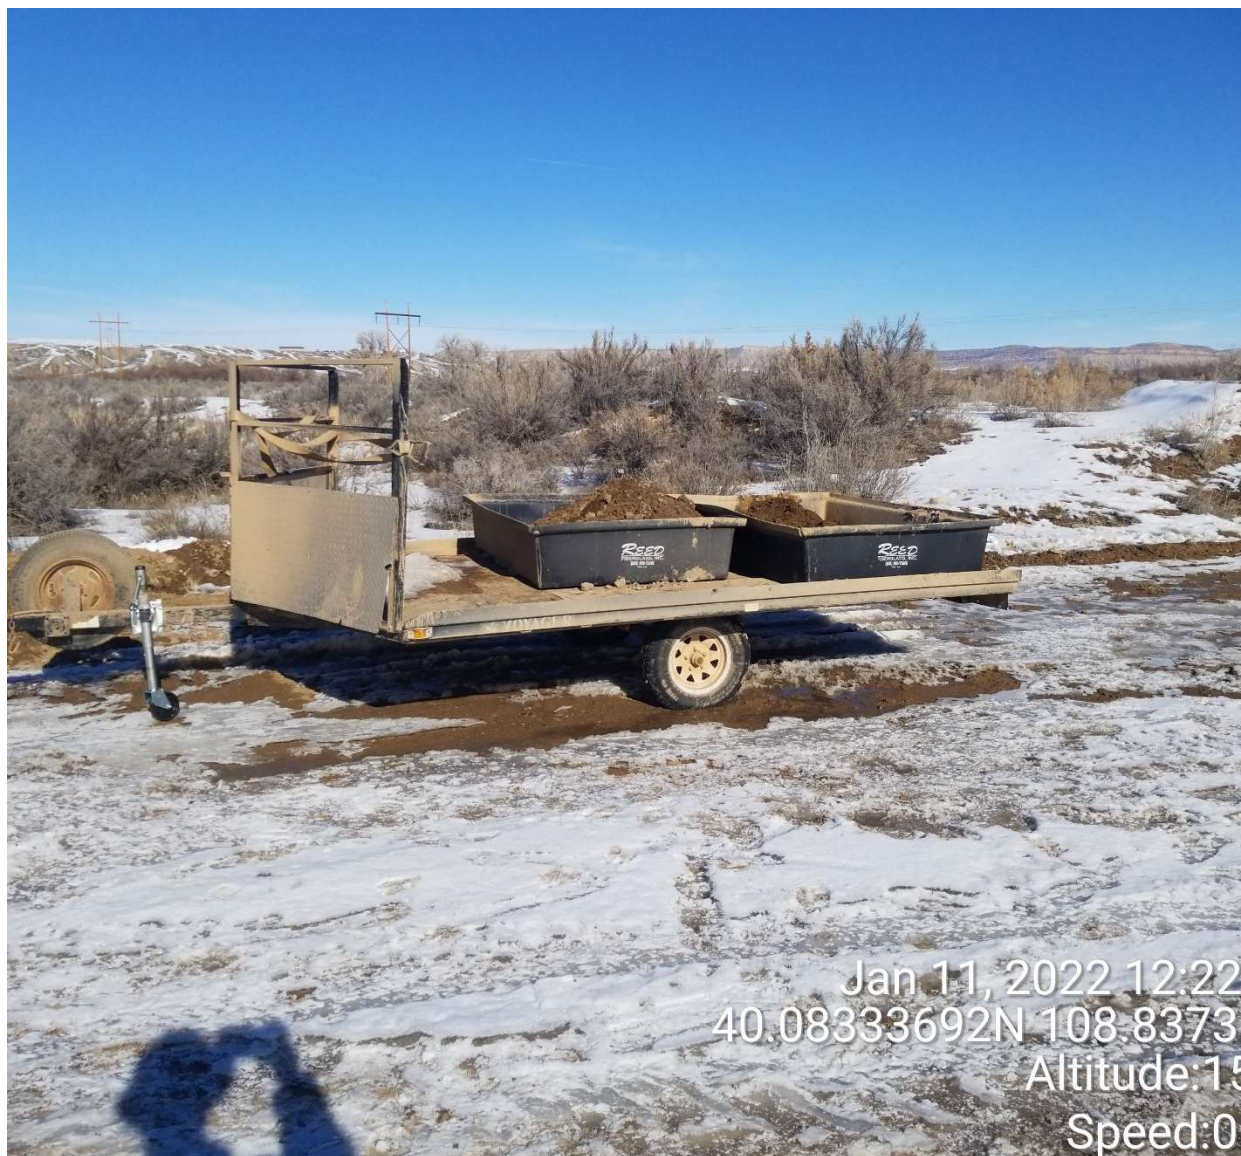
**Troughs containing potentially
impacted material and condensate
on a trailer west of the excavation.**

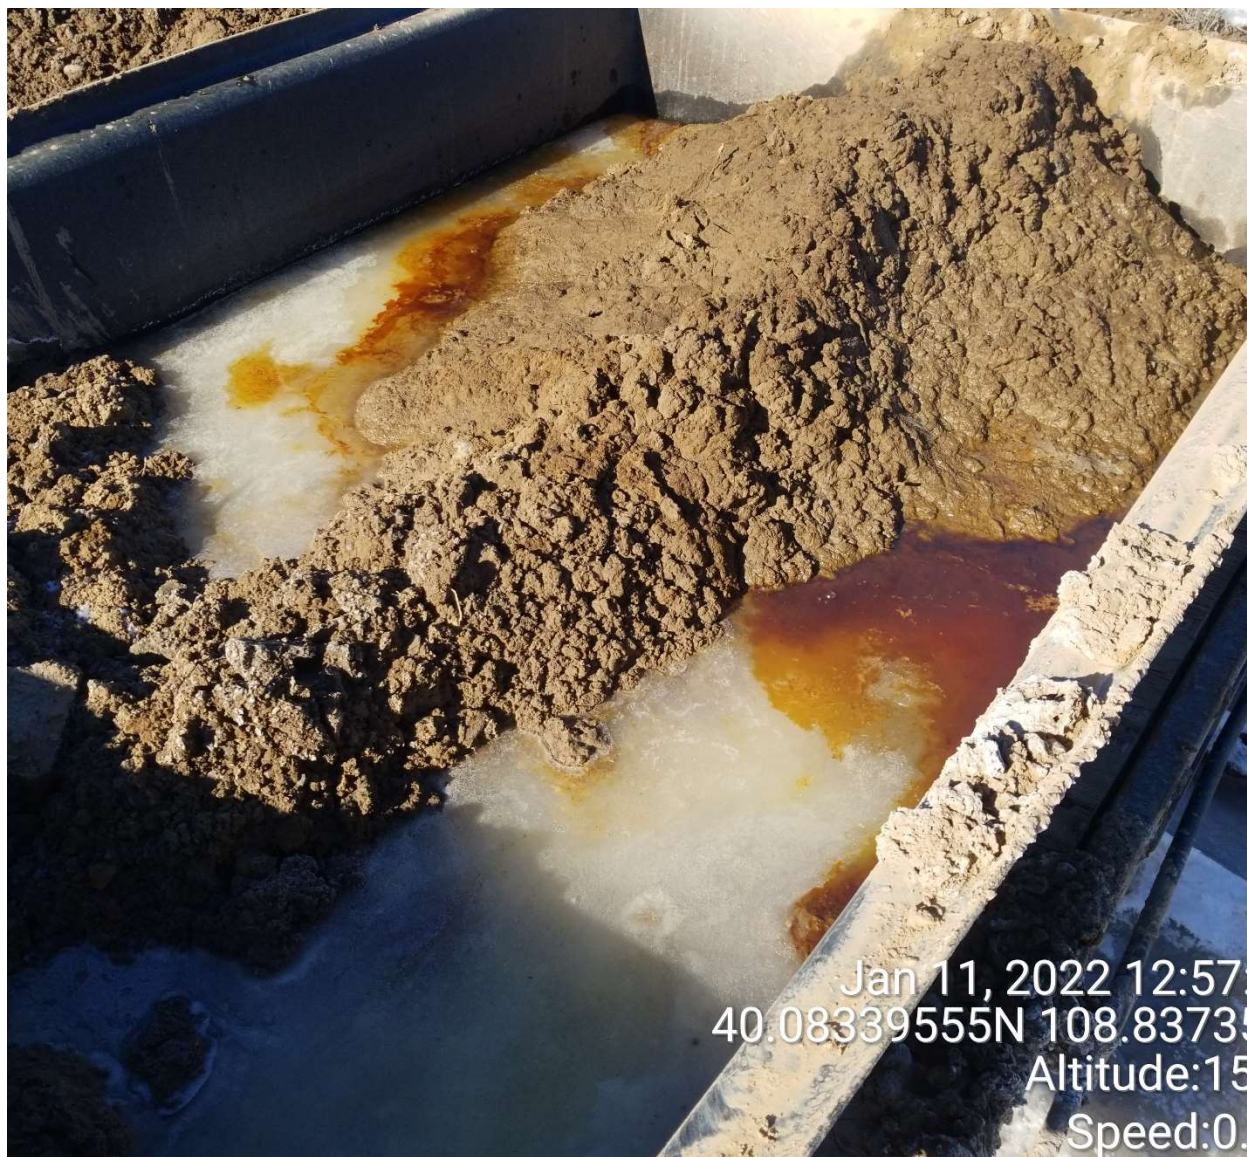
**Trough containing potentially
impacted material and condensate
on a trailer west of the excavation.**
