Inspection Photos

Location Name: GETTY-PAN AM 19-A

Location ID: 314813

Spill/Release ID: 481420

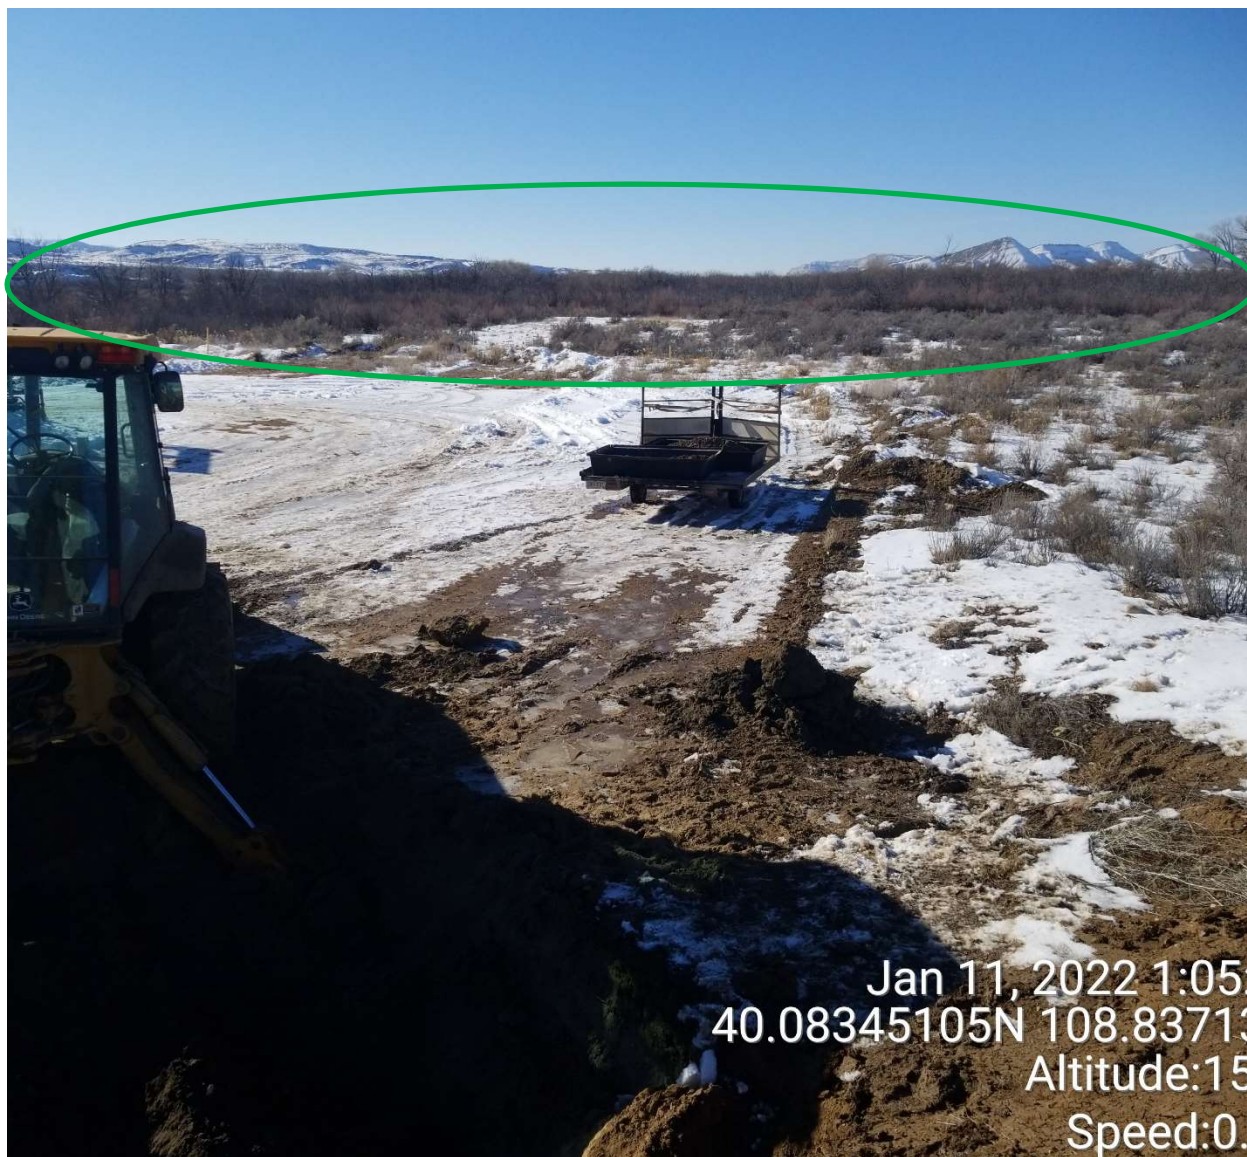
Troughs containing potentially impacted material and condensate on a trailer west of the excavation. Note the White River in the background of the photo (green area).

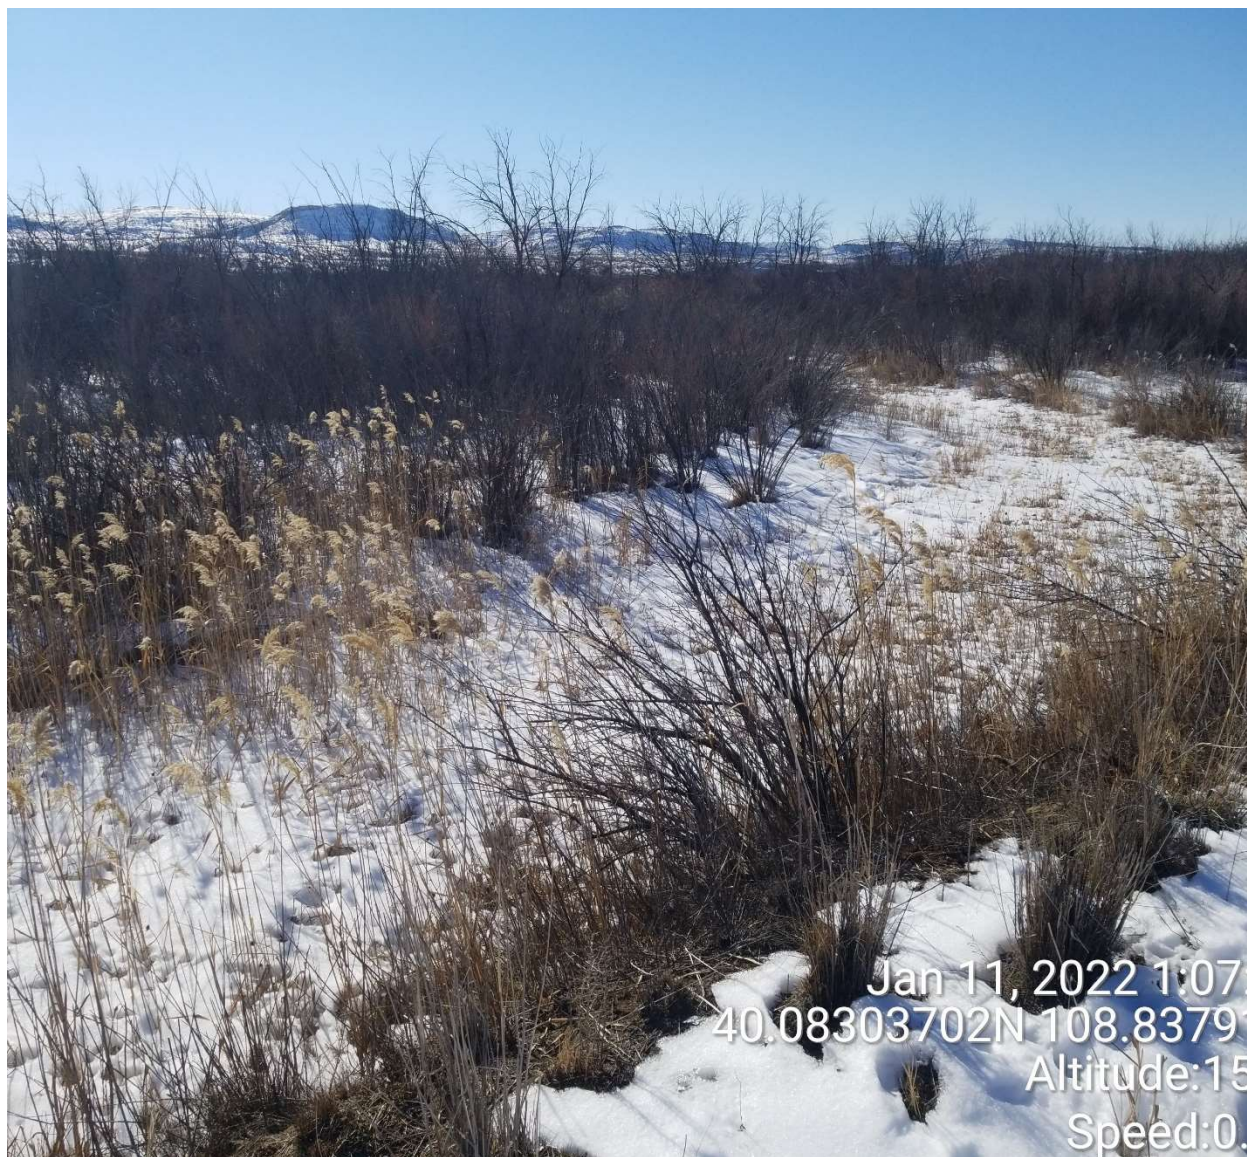
**White River located approximately
150 feet from the spill/release
point.**
