# Final Reclamation Inspection

Operator: PDC ENERGY INC - 69175

Location ID: 322959

Inspection Photos  
Location Name: Brown 20-2  
Location ID: 322959

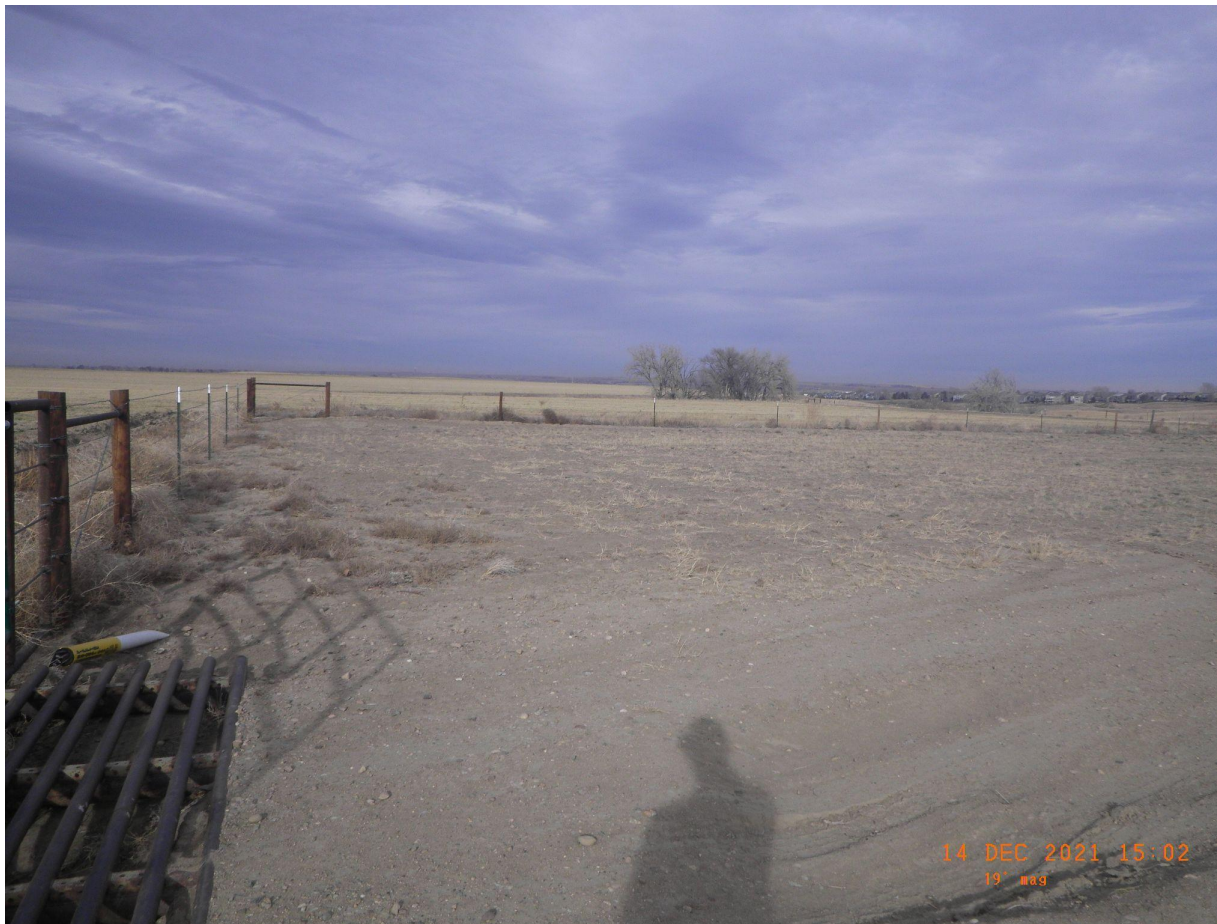
**Photo 2.** Overview photo of the tank battery taken at ground level from the southern edge looking north. Note: gravel road runs through tank battery and well pad disturbances.

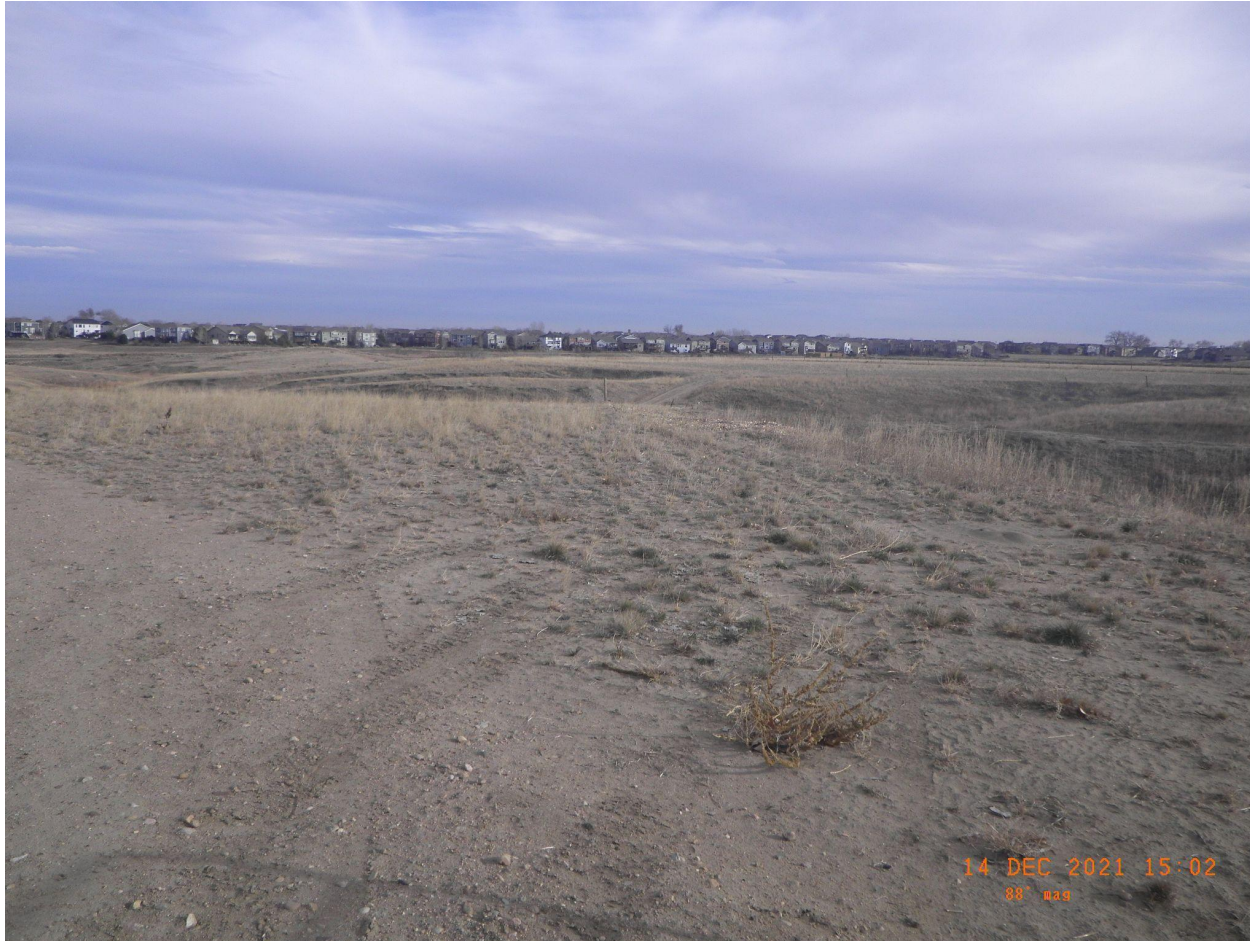
**Photo 3.** Overview of the well pad taken at ground level from the northern edge looking south.

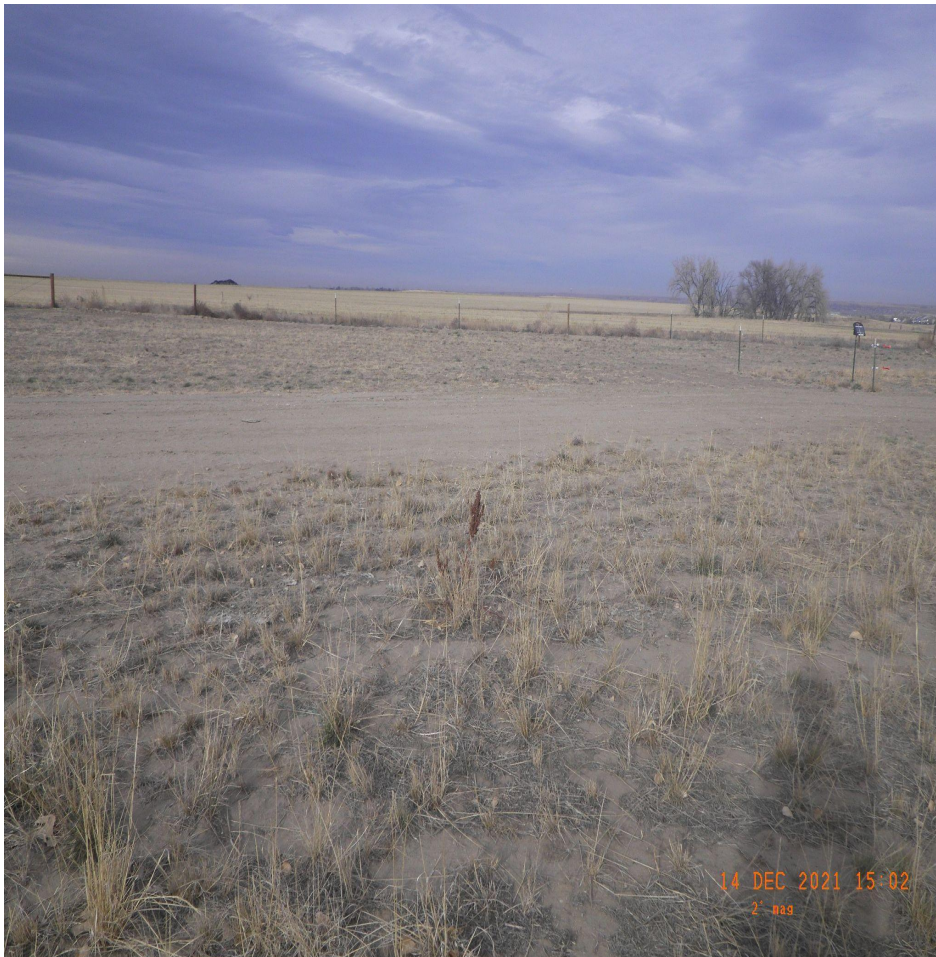
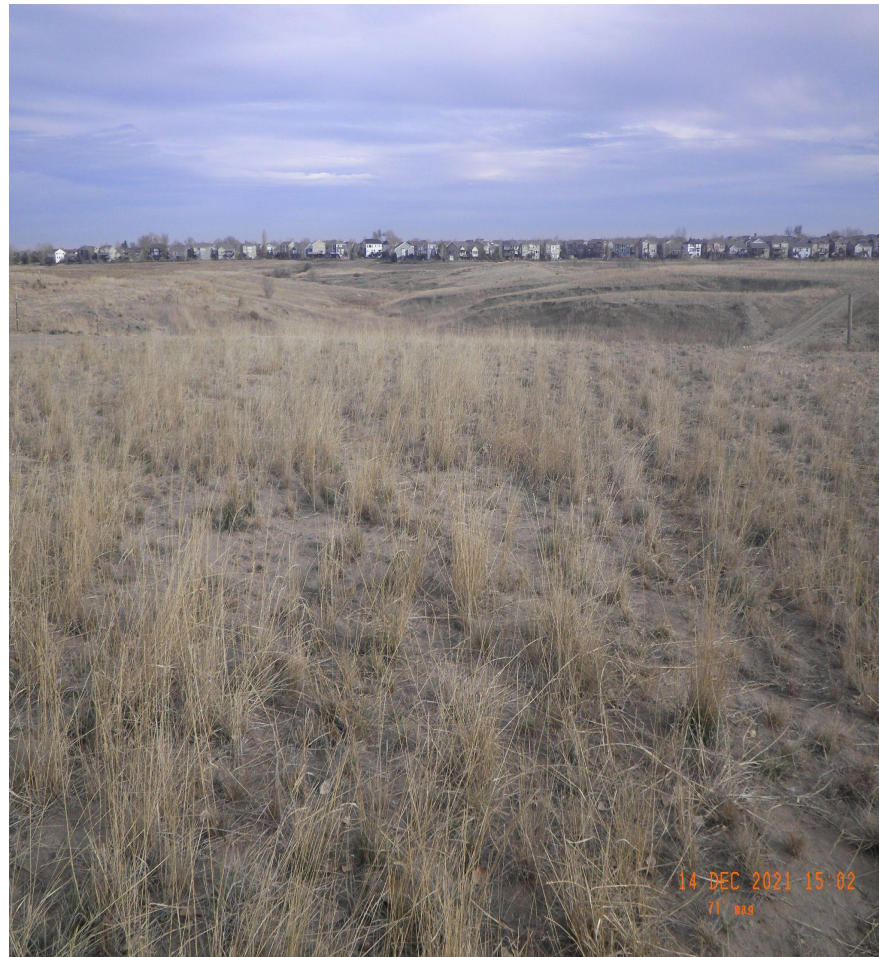
**Photo 4.** Photos taken from the middle of the well pad. Left photo facing north and right photo facing east. See photo descriptions under photo 5.

**Photo 5.** Photos taken from the middle of the well pad. Left photo facing south and right photo facing west. The photos show that the well pad vegetation has not yet established and shows signs of possible aeolian erosion (petistaled plants observed).

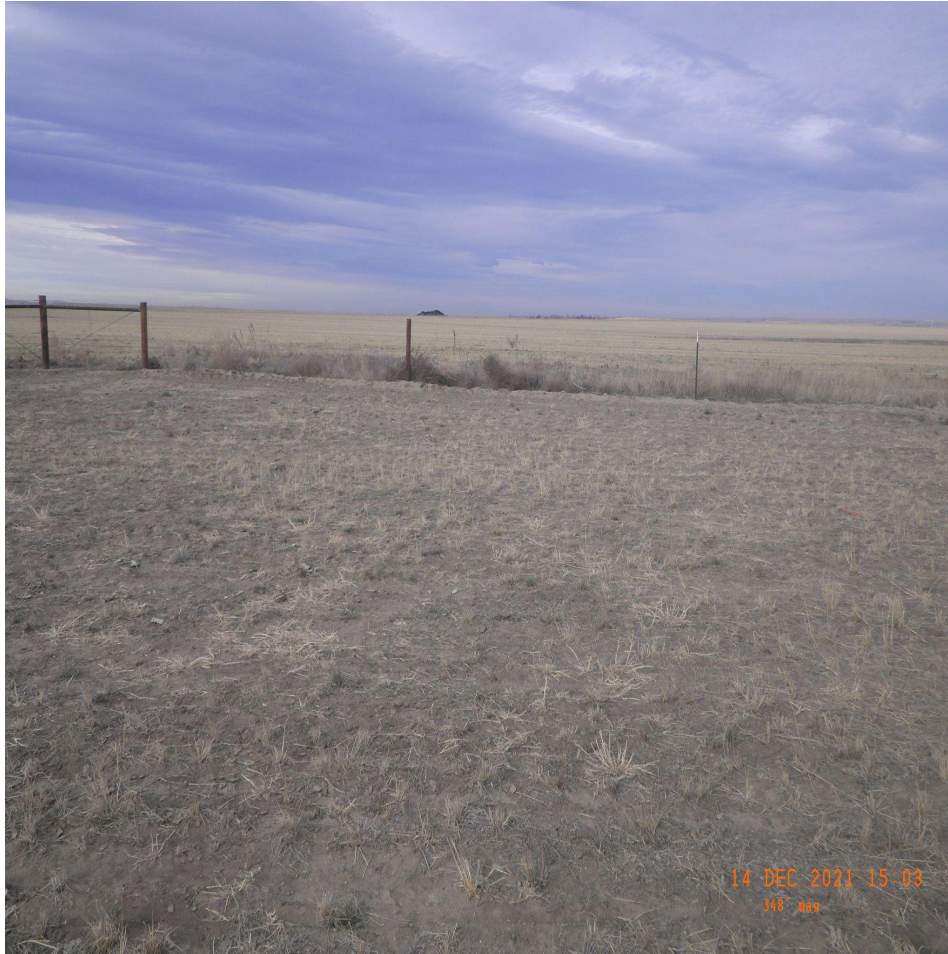
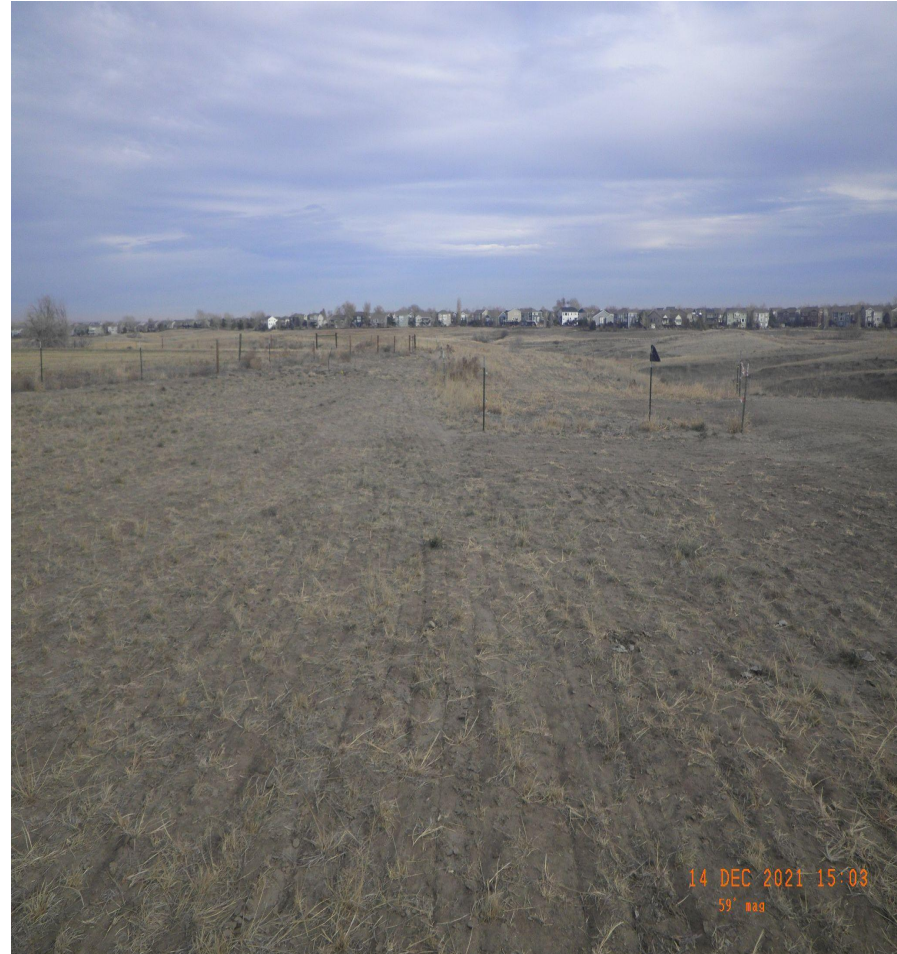
**Photo 6.** Photos taken from the middle of the tank battery. Left photo facing north and right photo facing east. See description under photo 7.

**Photo 7.** Photos taken from the middle of the well pad. Left photo facing south and right photo facing west. The photos show that the vegetation within the reclaimed tank battery have not yet properly established.

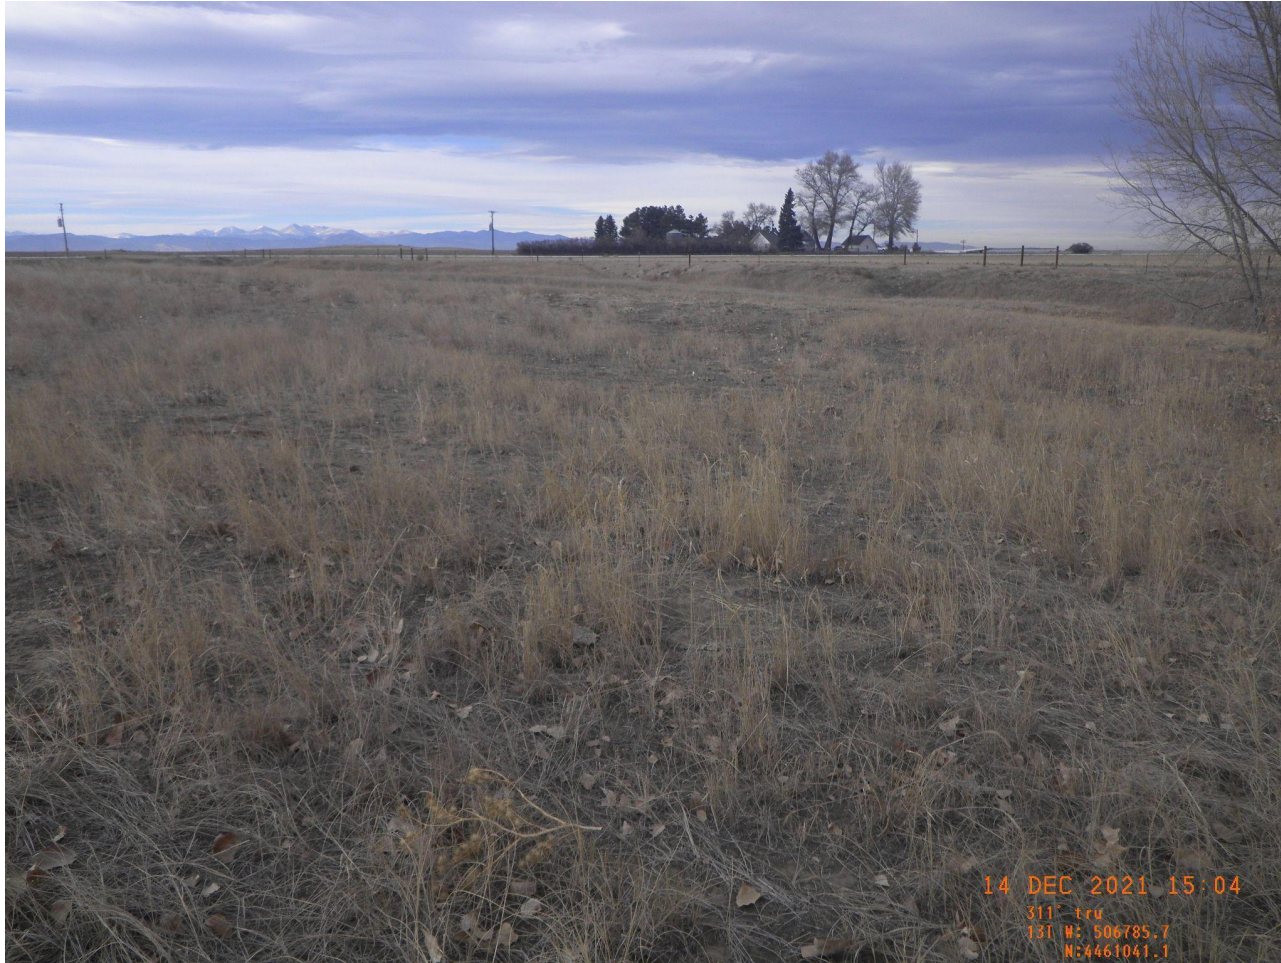
**Photo 8.** Reference area to the south of the well pad/tank battery.
