Inspection Photos

API: 009-05157

Operator: PONCHO PRODUCTION COMPANY

Inspection Date: 2/1/2022

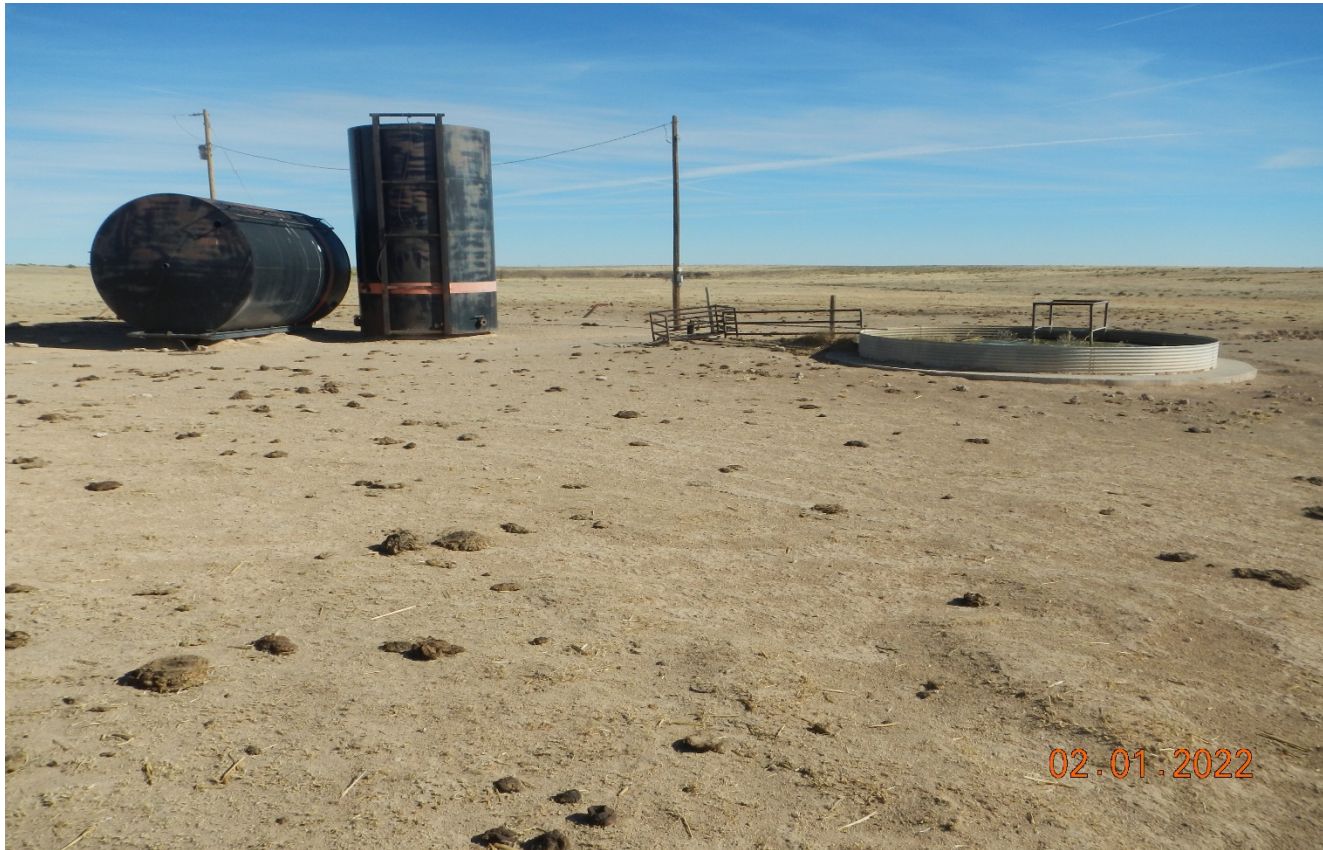
Photo 1. Facing southeast toward the location. There is a water well and stock tank at the location belonging to the landowner. The black two tanks shown were equipment from the well site which need to be removed.

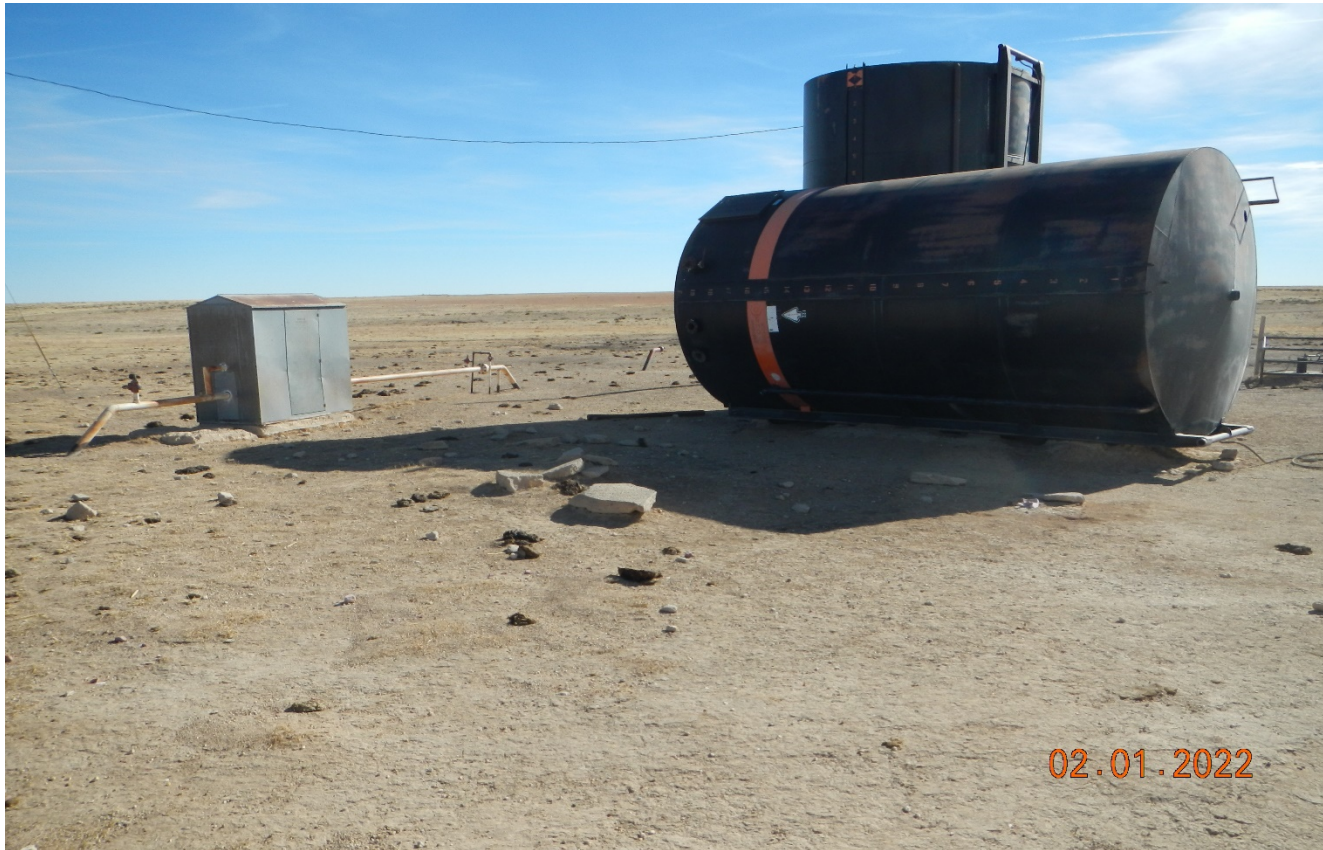
Photo 2. There are two tanks, pipe riser, meter run, and cement debris that remain. All equipment should have been removed within 3 months of well abandonment.

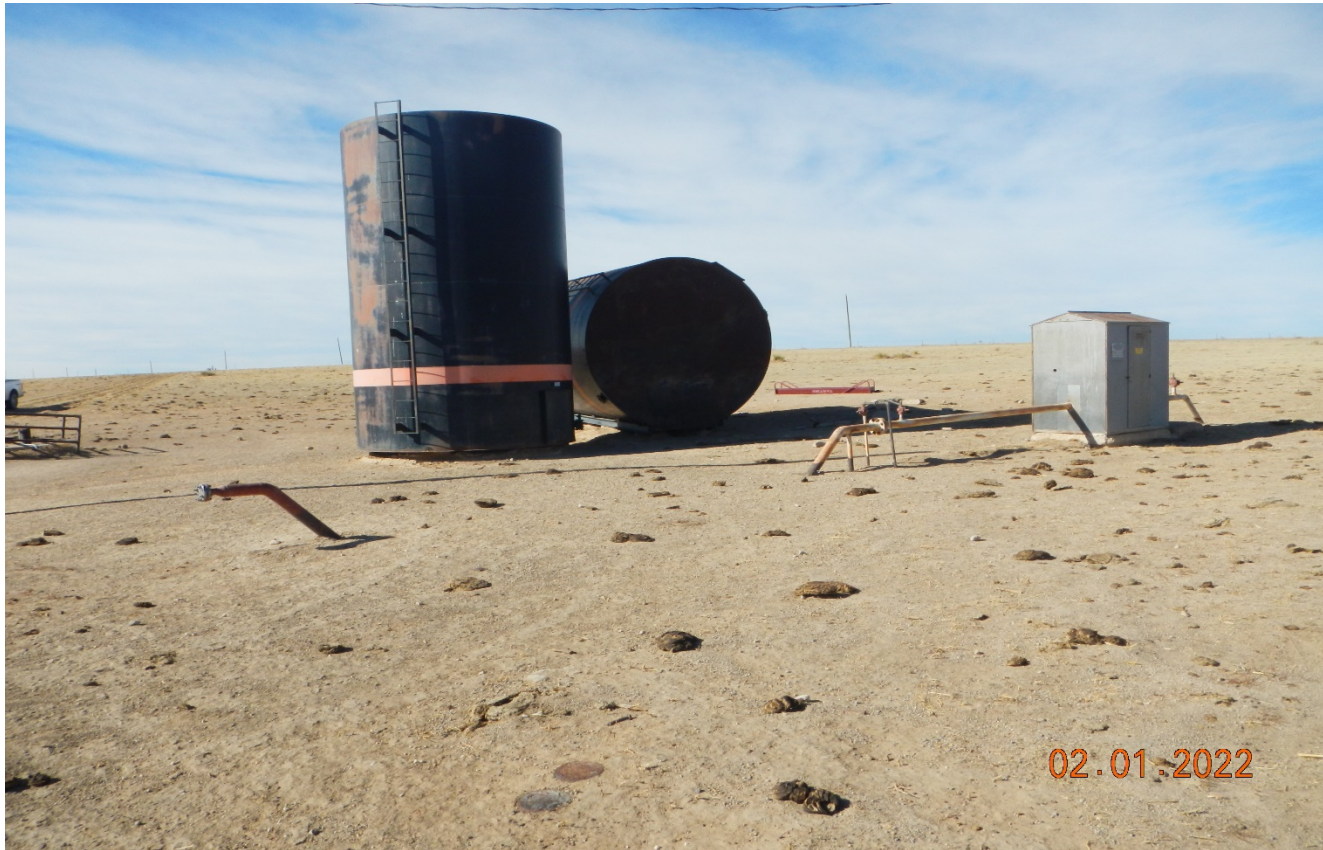
Photo 3. There are two tanks, pipe riser, and meter run that remain. All equipment should have been removed within 3 months of well abandonment.

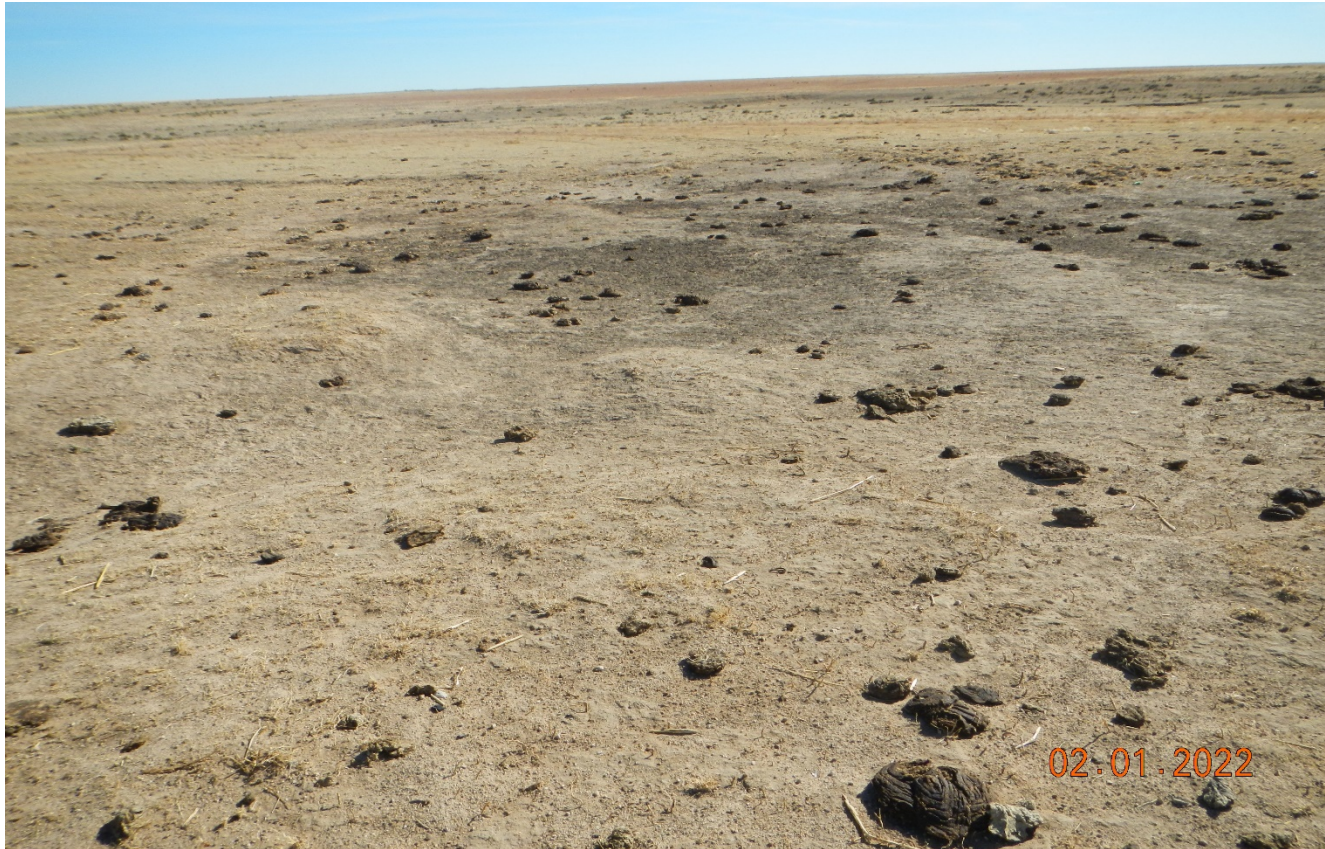
Photo 4. Facing southeast at the location. There are areas of the location with no vegetation growth which will need to be reclaimed.

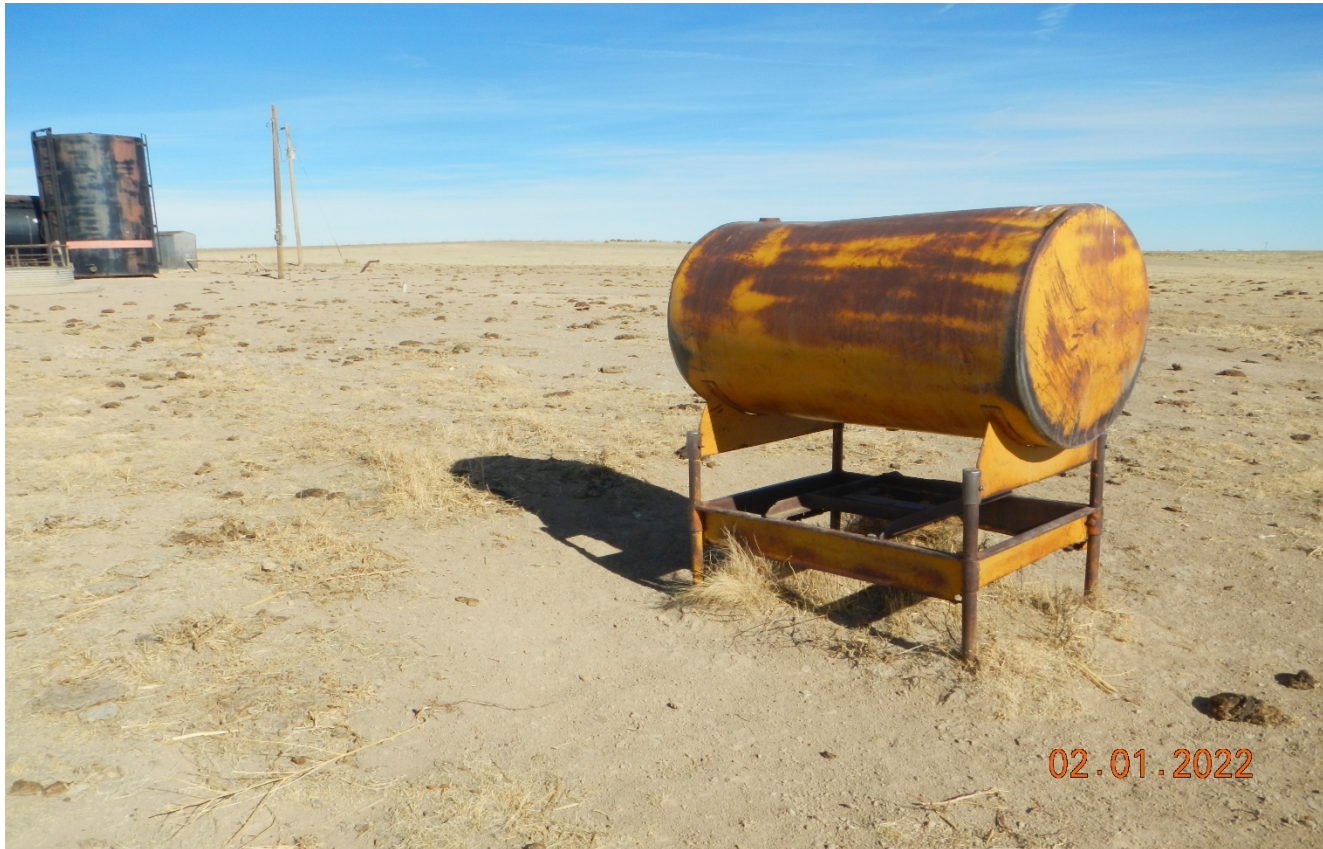
Photo 5. There is a yellow tank that remains at the southwest side of the location.

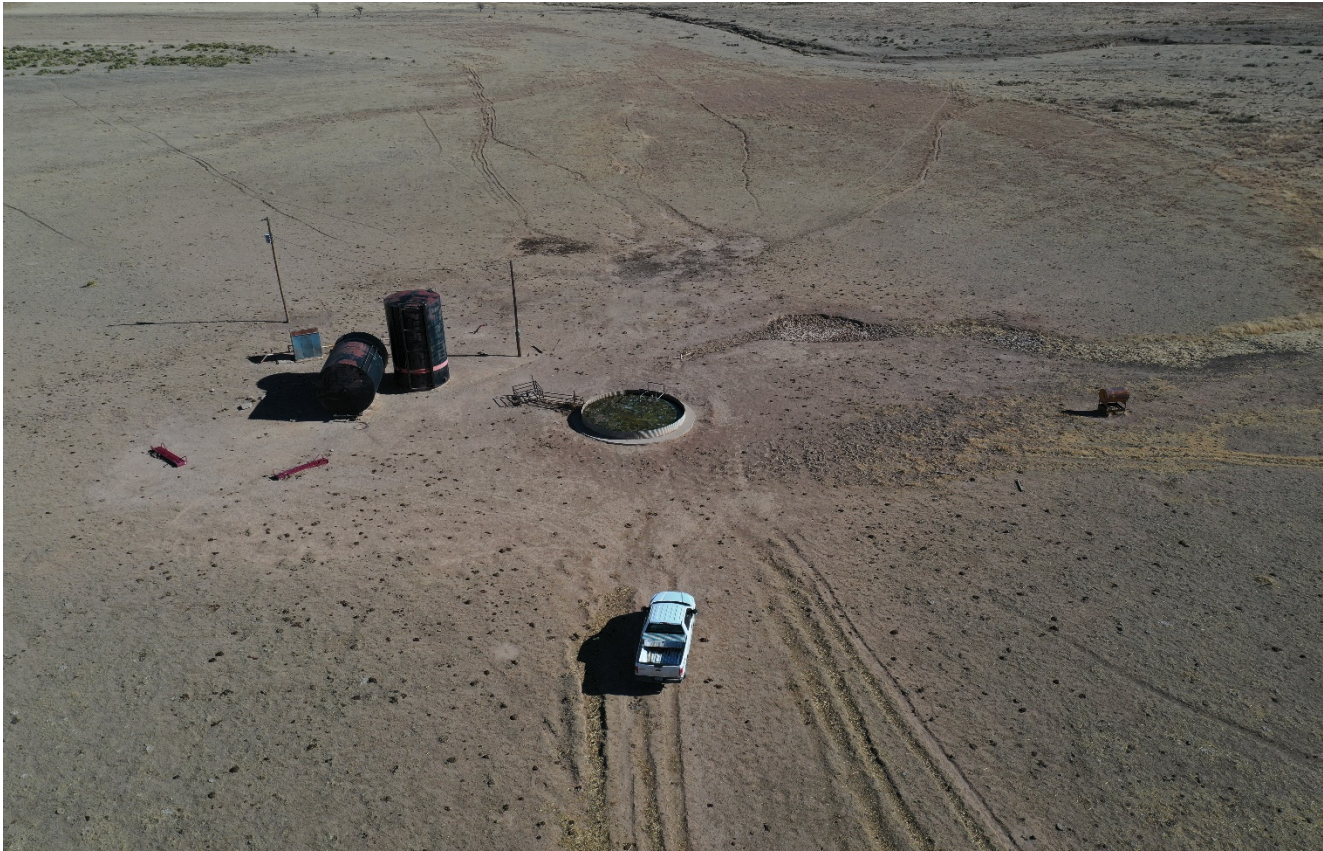
Photo 6. Drone aerial photo facing southeast toward the abandoned well site.

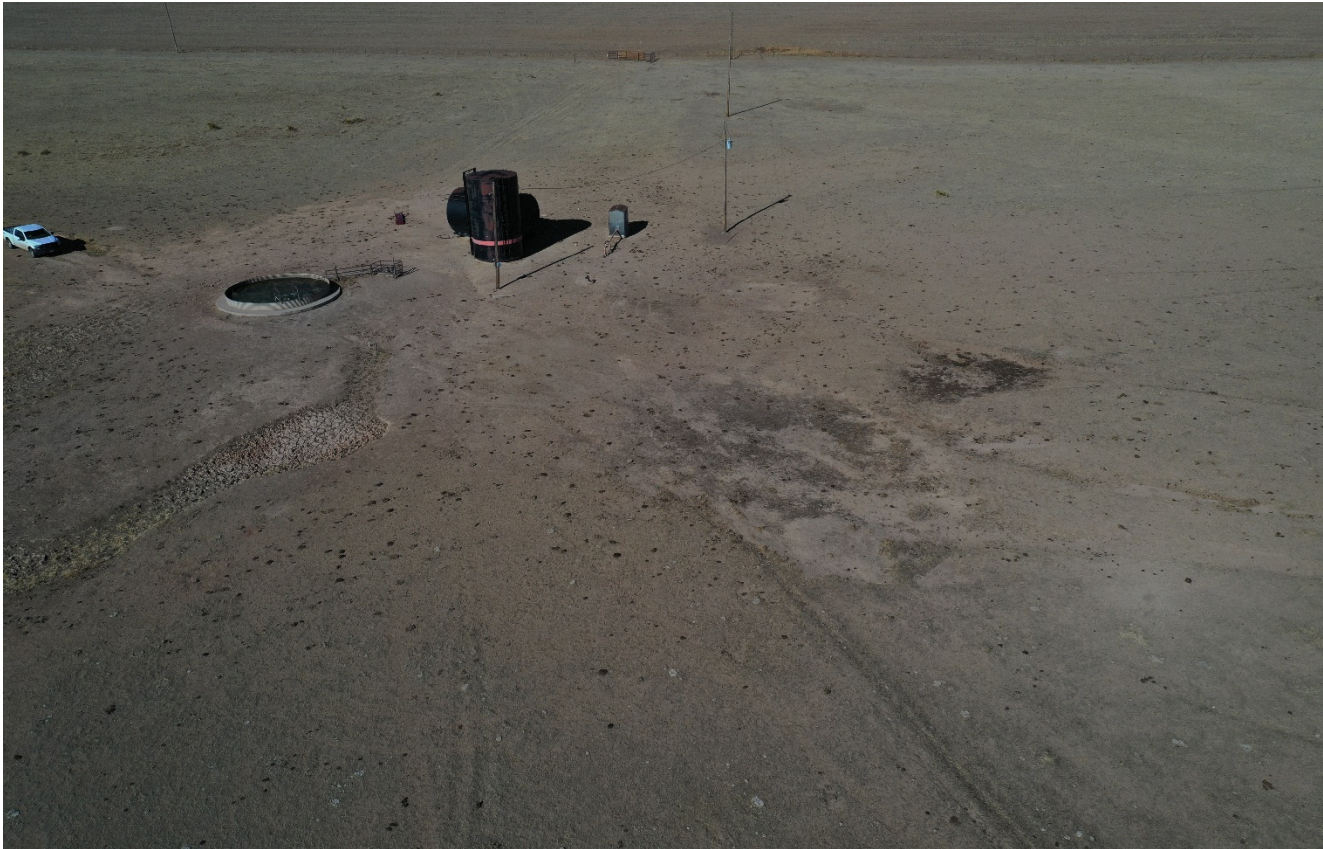
Photo 7. Drone aerial photo facing north toward the abandoned well site. There are areas that have no vegetation growth.
