# Inspection Photos

API: 017-06887

Operator: CITATION OIL & GAS CORP

Inspection Date: 2/10/2022

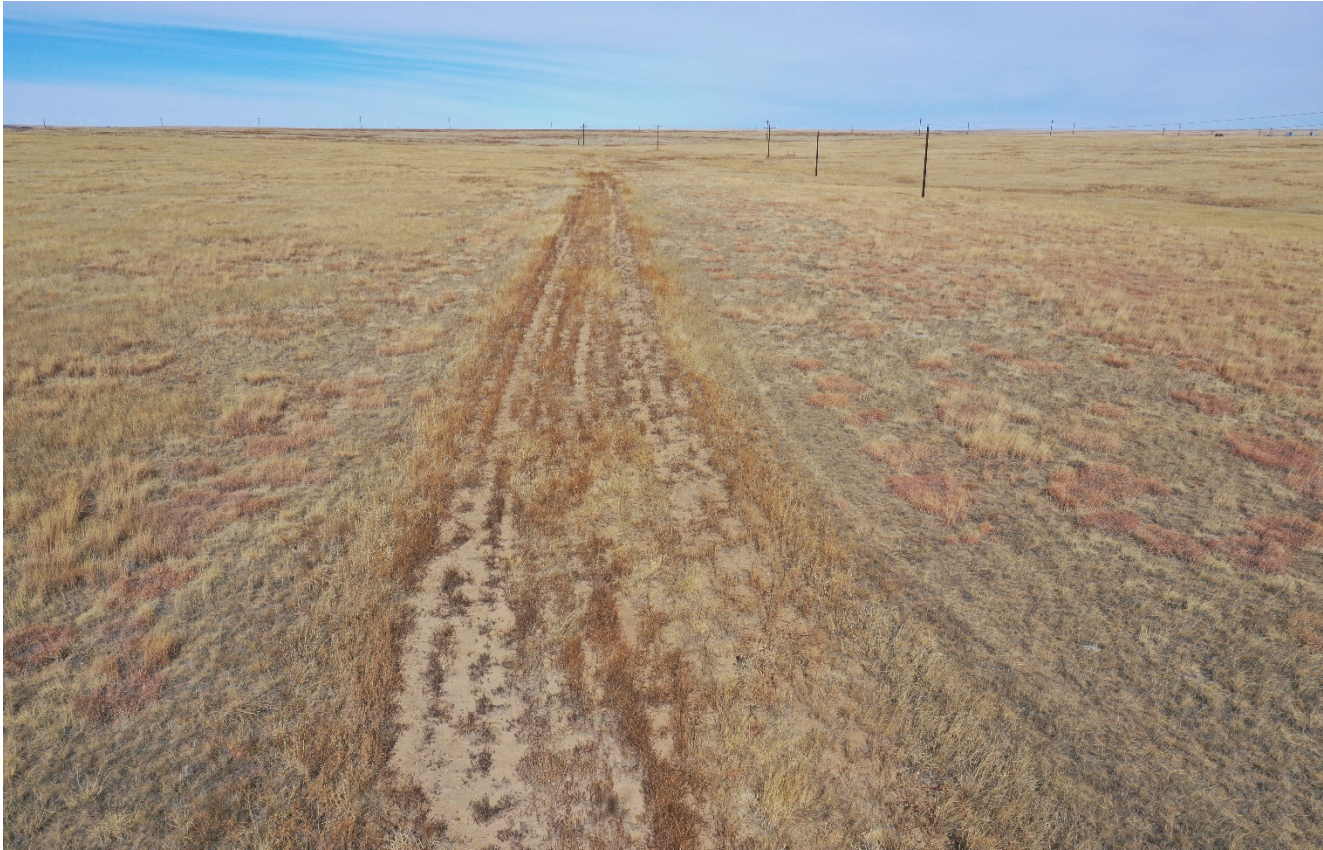
**Photo 1.** Facing north toward the former access road. There are areas along the road that have not established desirable vegetation and could benefit from additional reseeding.

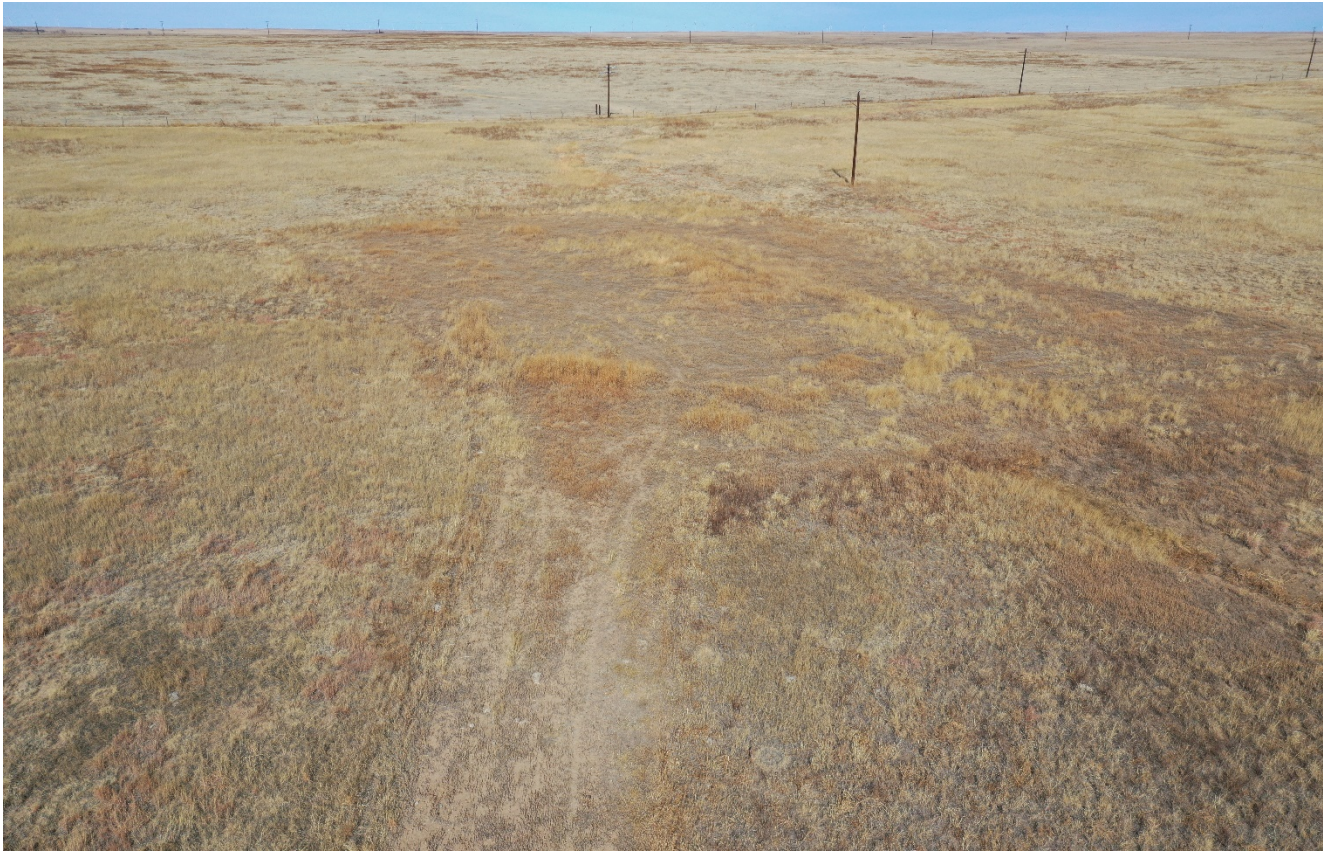
**Photo 2.** Drone aerial photo facing north toward the location.

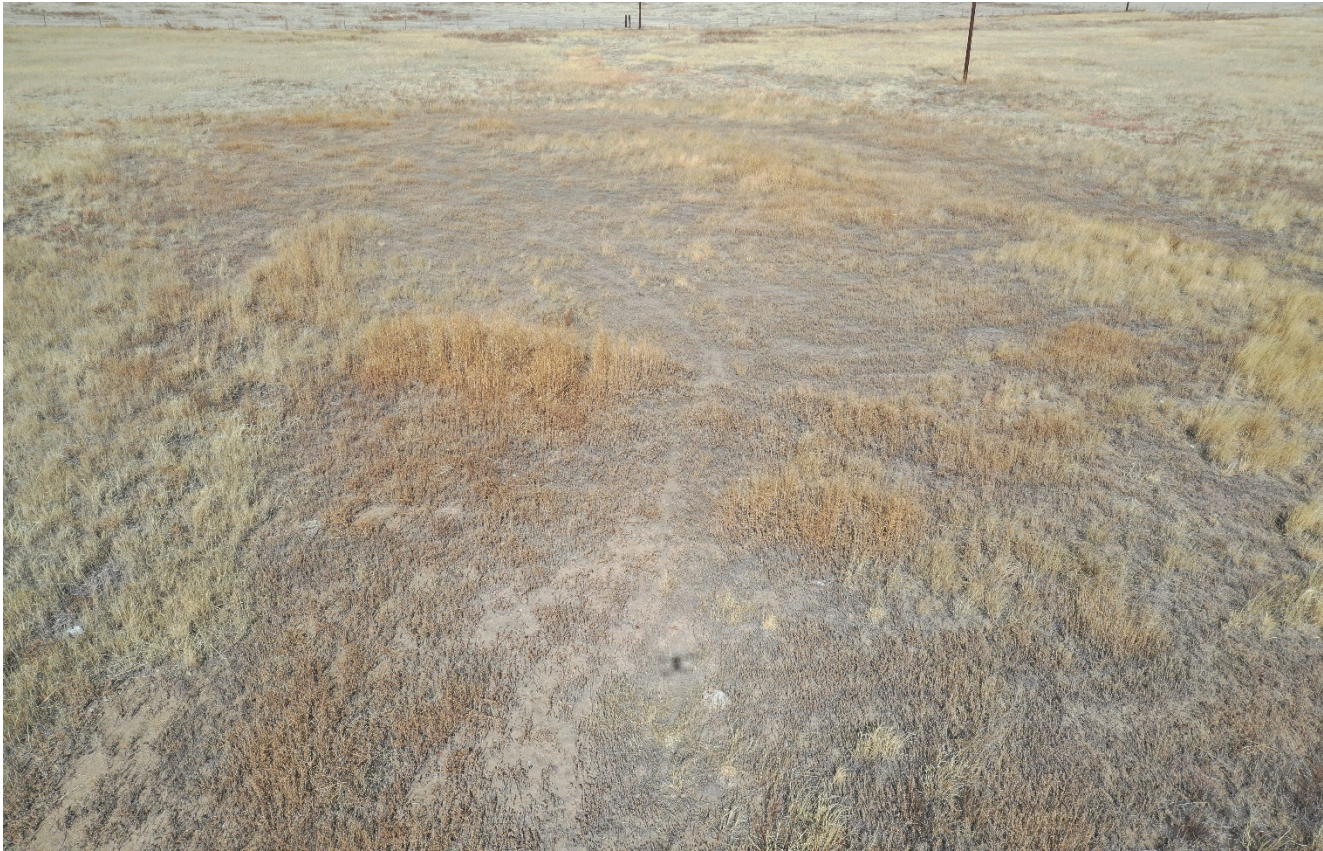
**Photo 3.** Facing down north toward the location. Most of the location consists of undesirable weeds (Kochia). The location will need to be reseeded.

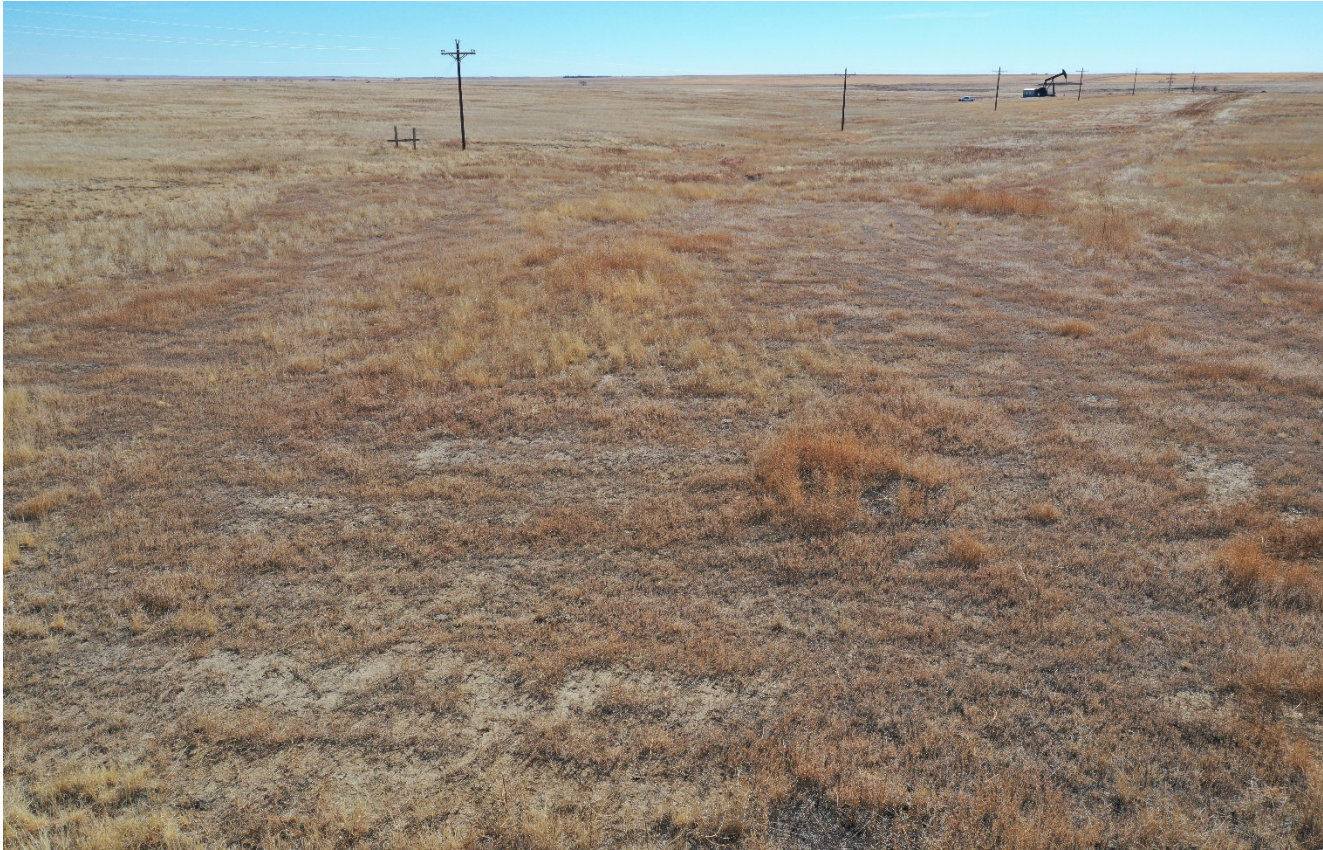
**Photo 4.** Facing southeast toward the location. Most of the location consists of undesirable weeds (Kochia). The location will need to be reseeded.
