Inspection Photos

02/14/2022

Operator: TEP ROCKY MOUNTAIN LLC #96850

Location ID: 335538

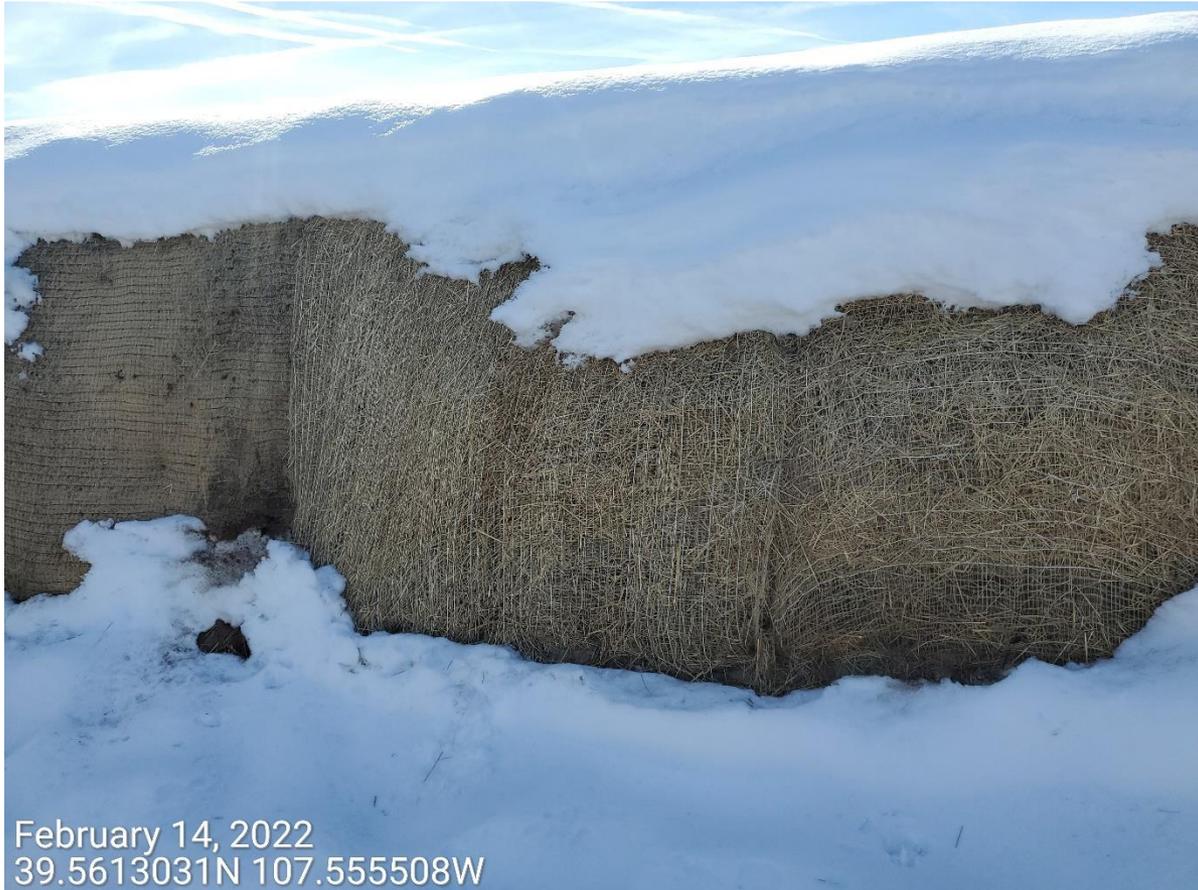
Photo 1: Photo taken from the cut slopes behind the separator equipment; erosion blankets have been maintained.

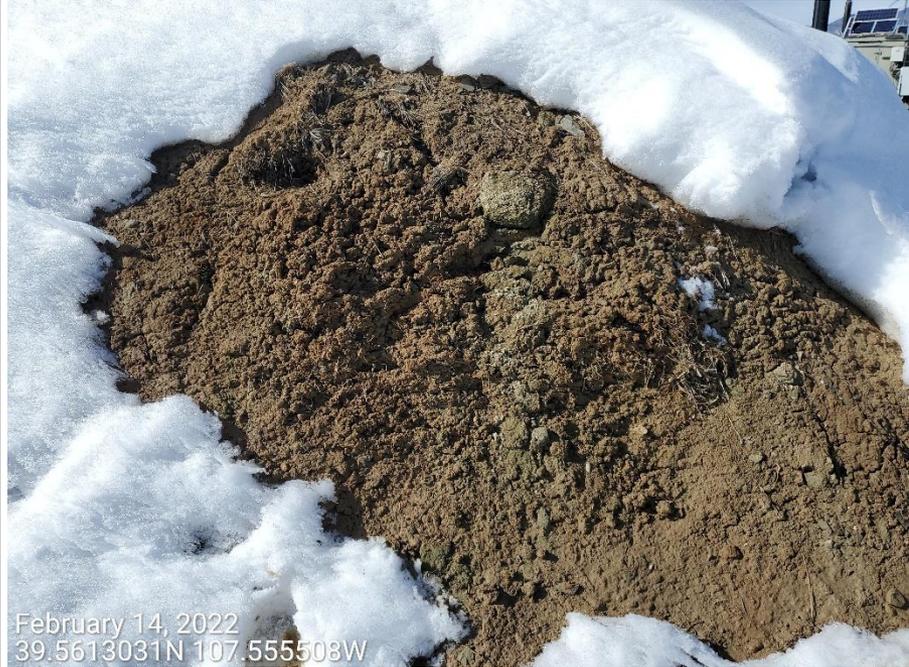
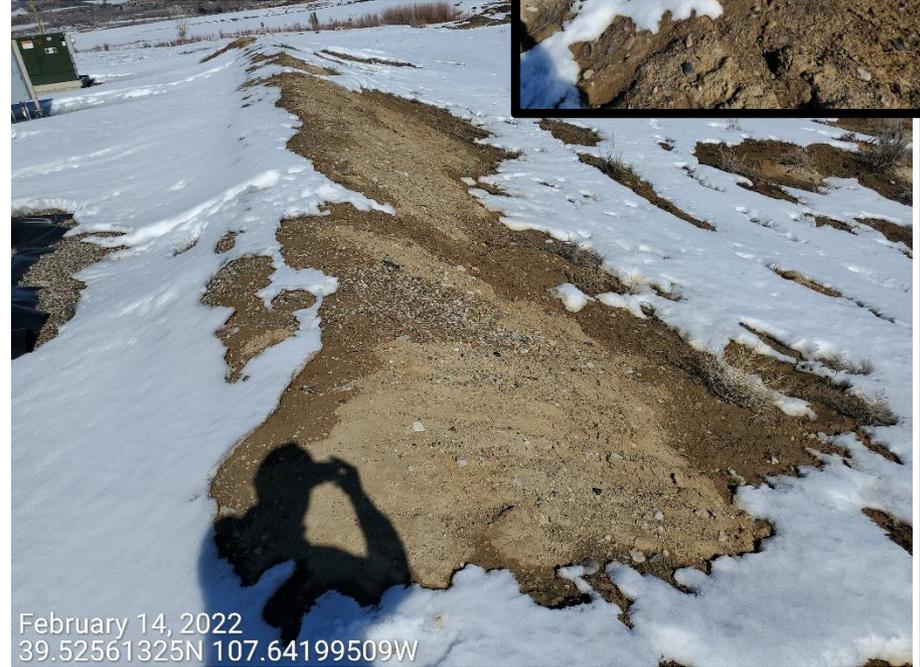
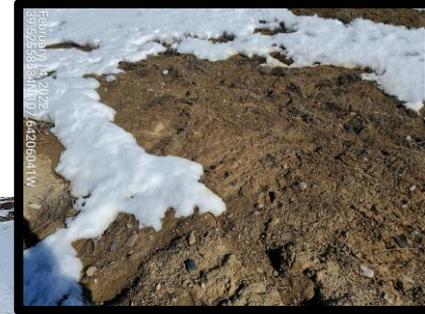
Photo 2: Photos taken from exposed areas of the cutslopes (photo left) and the eastern slopes of the Location (photo right). Unable to find evidence that control measures to protect and stabilize the slopes of the Location were installed or maintained. Photo insert top-right shows areas where rill erosion is evident on the eastern slopes.

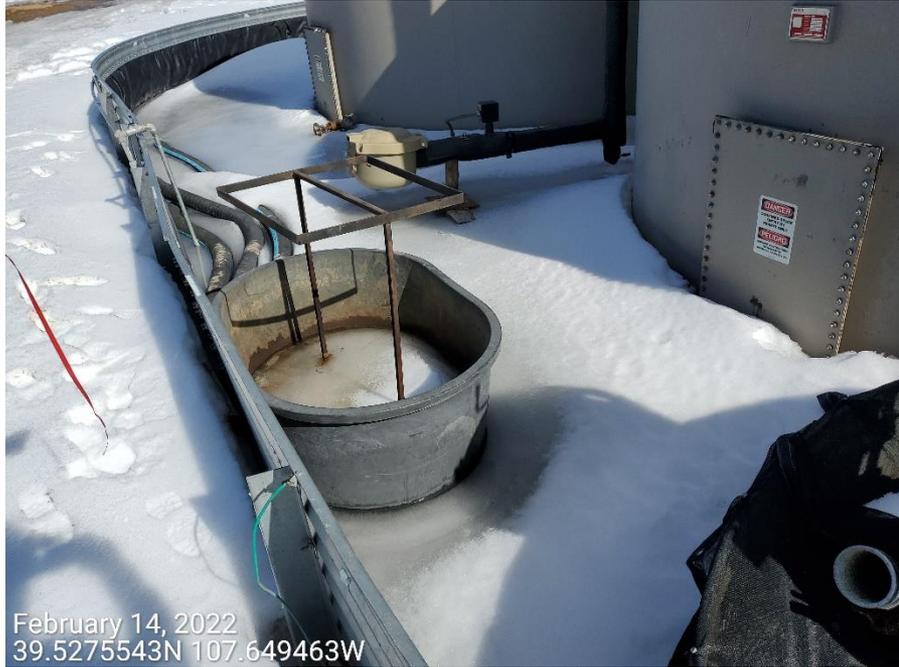
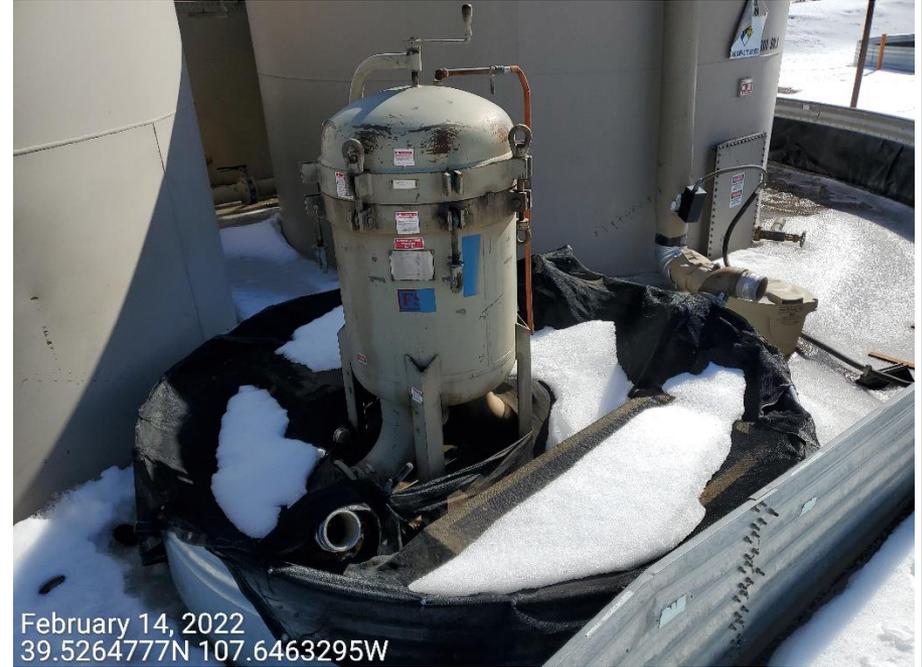
Photo 3: Photos taken from the tank battery on the east end of the Location. Photo shows examples of unused equipment observed stored within the tank battery containment BMP.

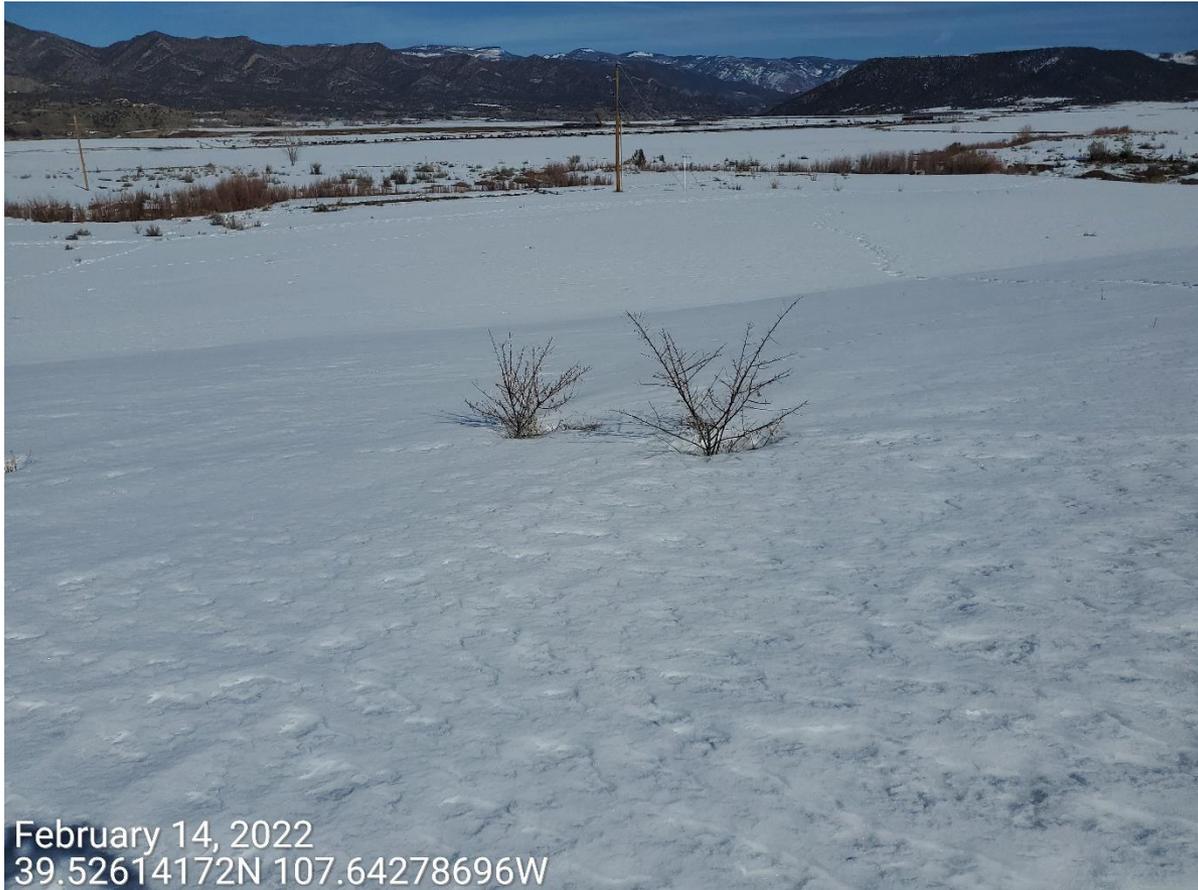
Photo 4: Photo shows example of noxious weeds (Russian Olive) that remain evident on the Interim Areas of the Location.

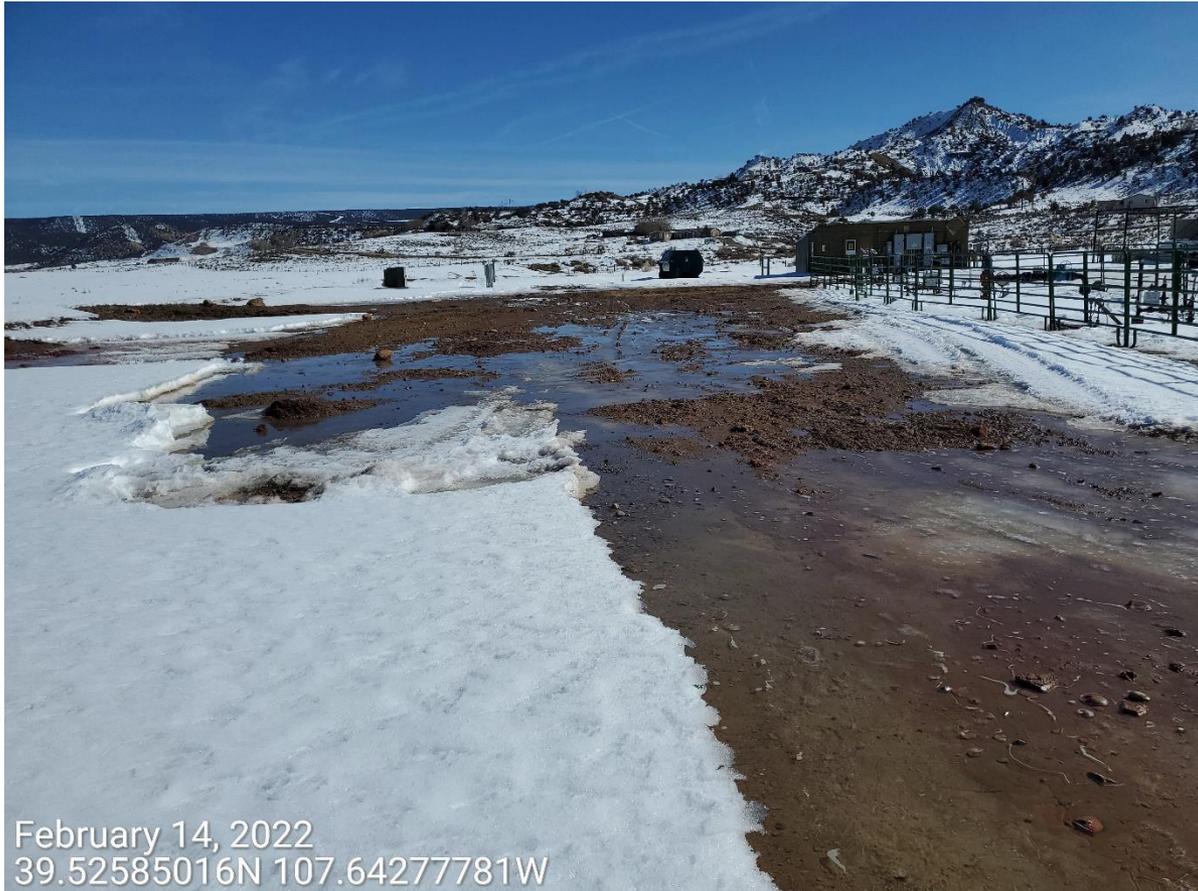
Photo 5: Photo taken from the northern end of the production area, facing south east. Areas of the production pad not covered with snow do not appear to be stabilized, and are at risk of vehicle tracking and sediment transport.
