Inspection Photos

Operator: TEP ROCKY MOUNTAIN LLC #96850

Location ID: 335534

Garfield County, CO

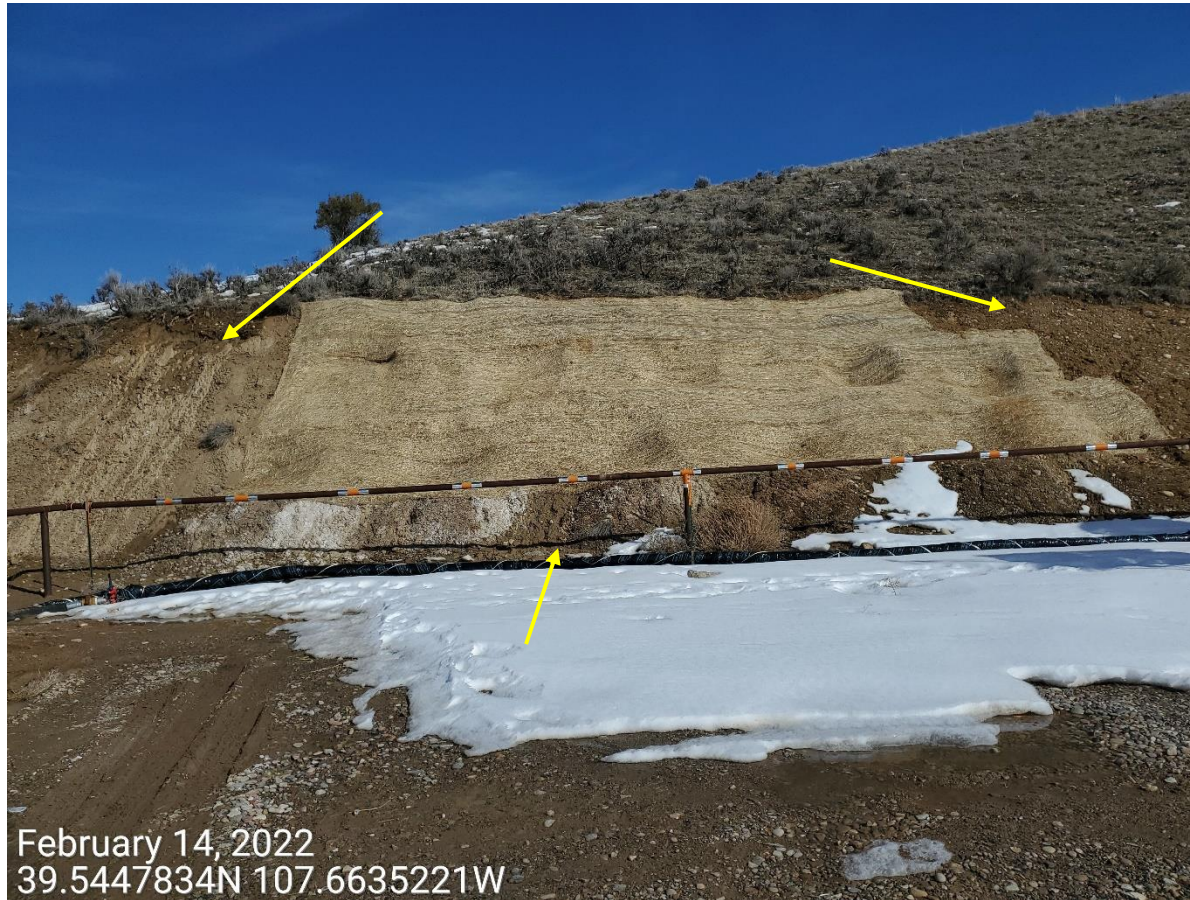
Photo 1: Photo taken from the east end of the Location, facing east. Photo shows Operator has implemented erosion control blankets on only a single section of the upper cut slopes of the Location. Control measures to protect and stabilize the remaining cut slopes left and right of the blanket seen in the photo, as well as slopes below the blanket.

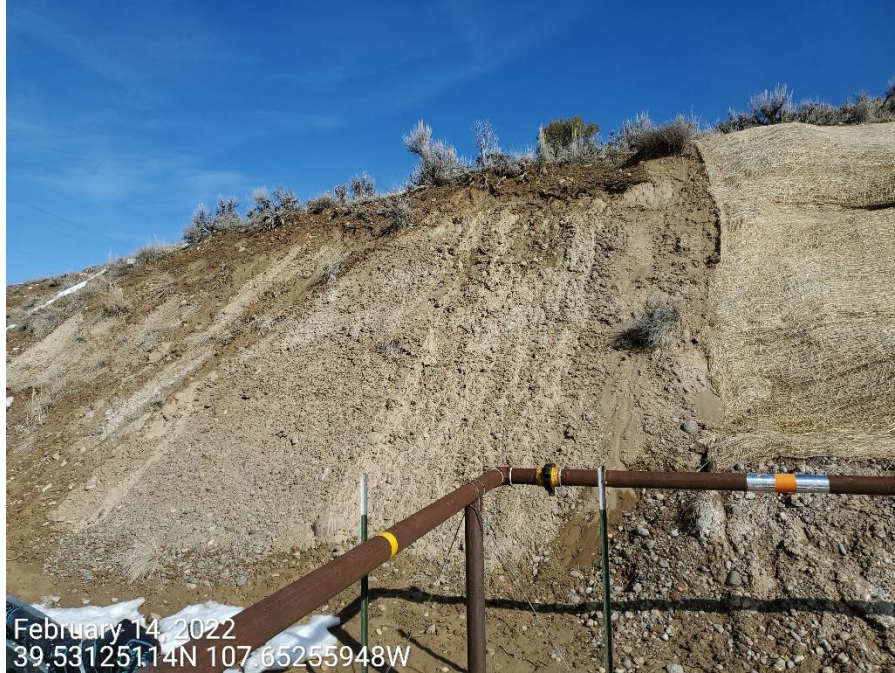
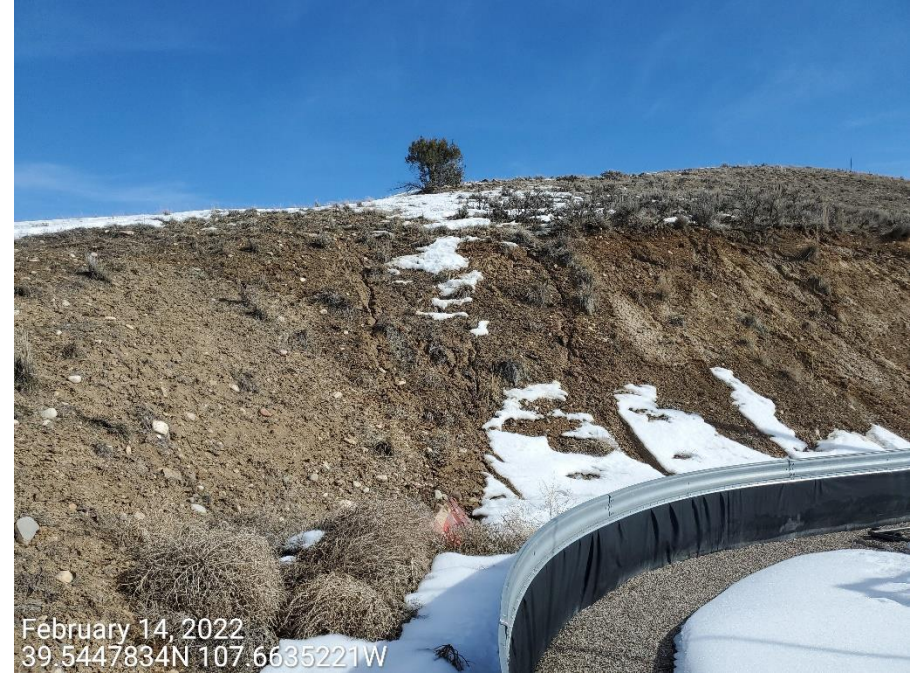
Photo 2: Photos taken from the cut slopes. Photos provide examples showing control measures to protect/stabilize the cut slopes of the Location remain missing or insufficient; erosion degradation evident.

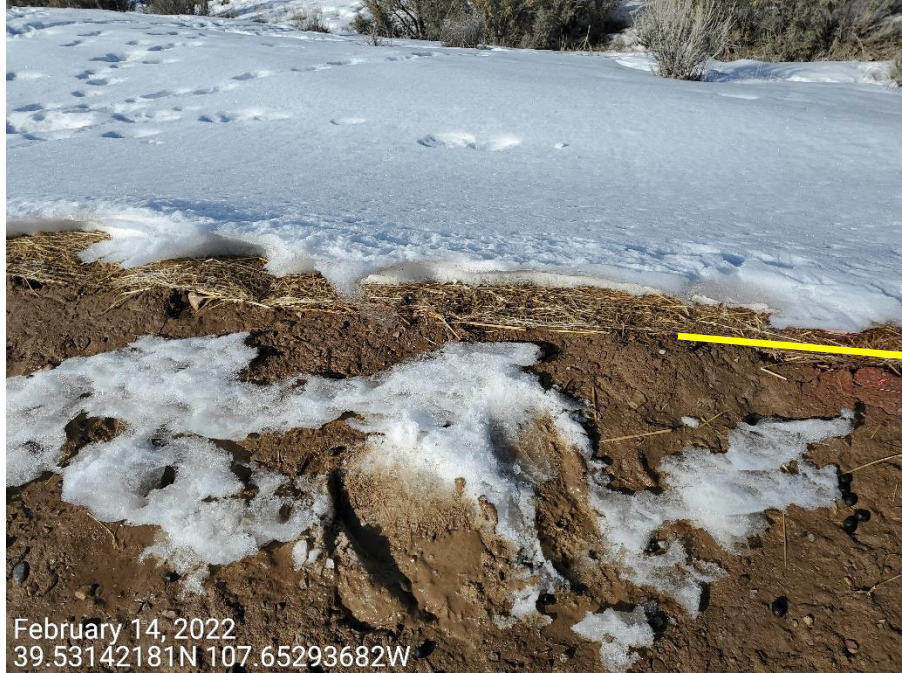
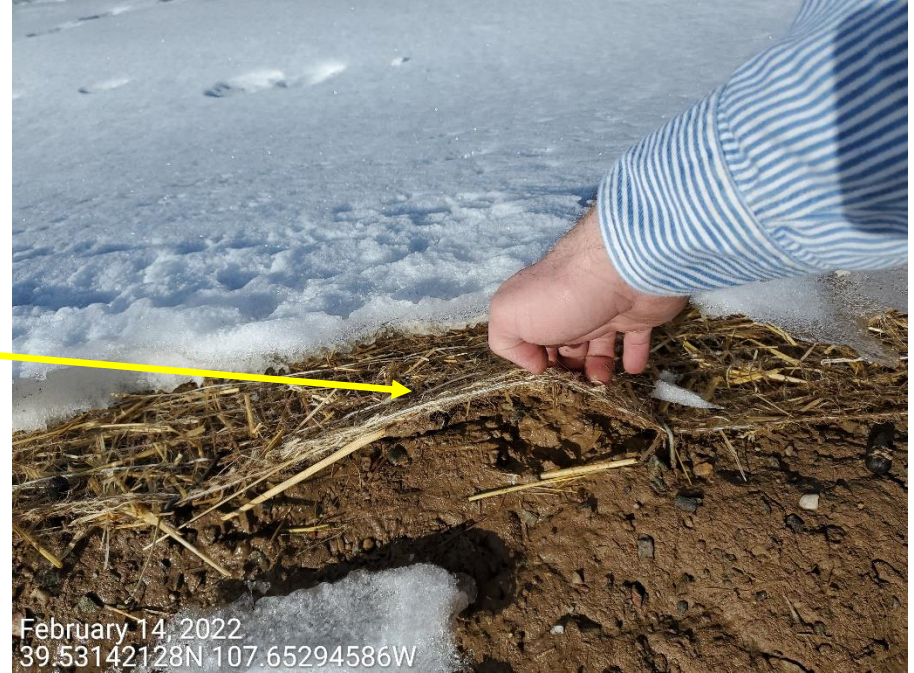
Photo 3: Photos taken from the slopes on the north end of the Location. Photo example showing that the blankets installed on the Location have not been installed in accordance with good engineering practices; blankets have not been properly trenched/anchored and backfilled.

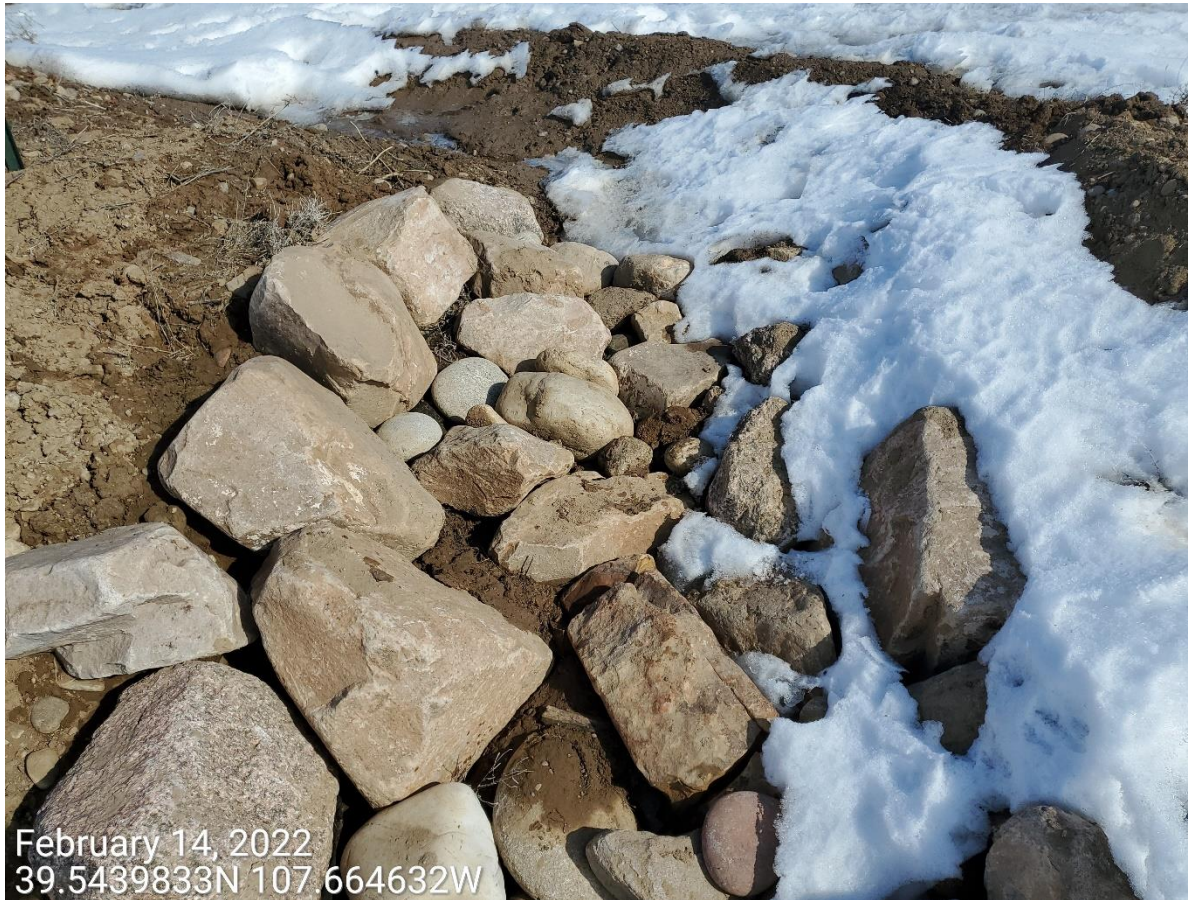
February 14, 2022
39.5439833N 107.664632W

Photo 4: Photo taken from the outlet on the west end of the Location; outlet has been re-installed with rip-rap and geotextile armoring.
