Inspection Photos  
Operator: Arkoma  
API: 067-05377  
Date: 2/15/2022

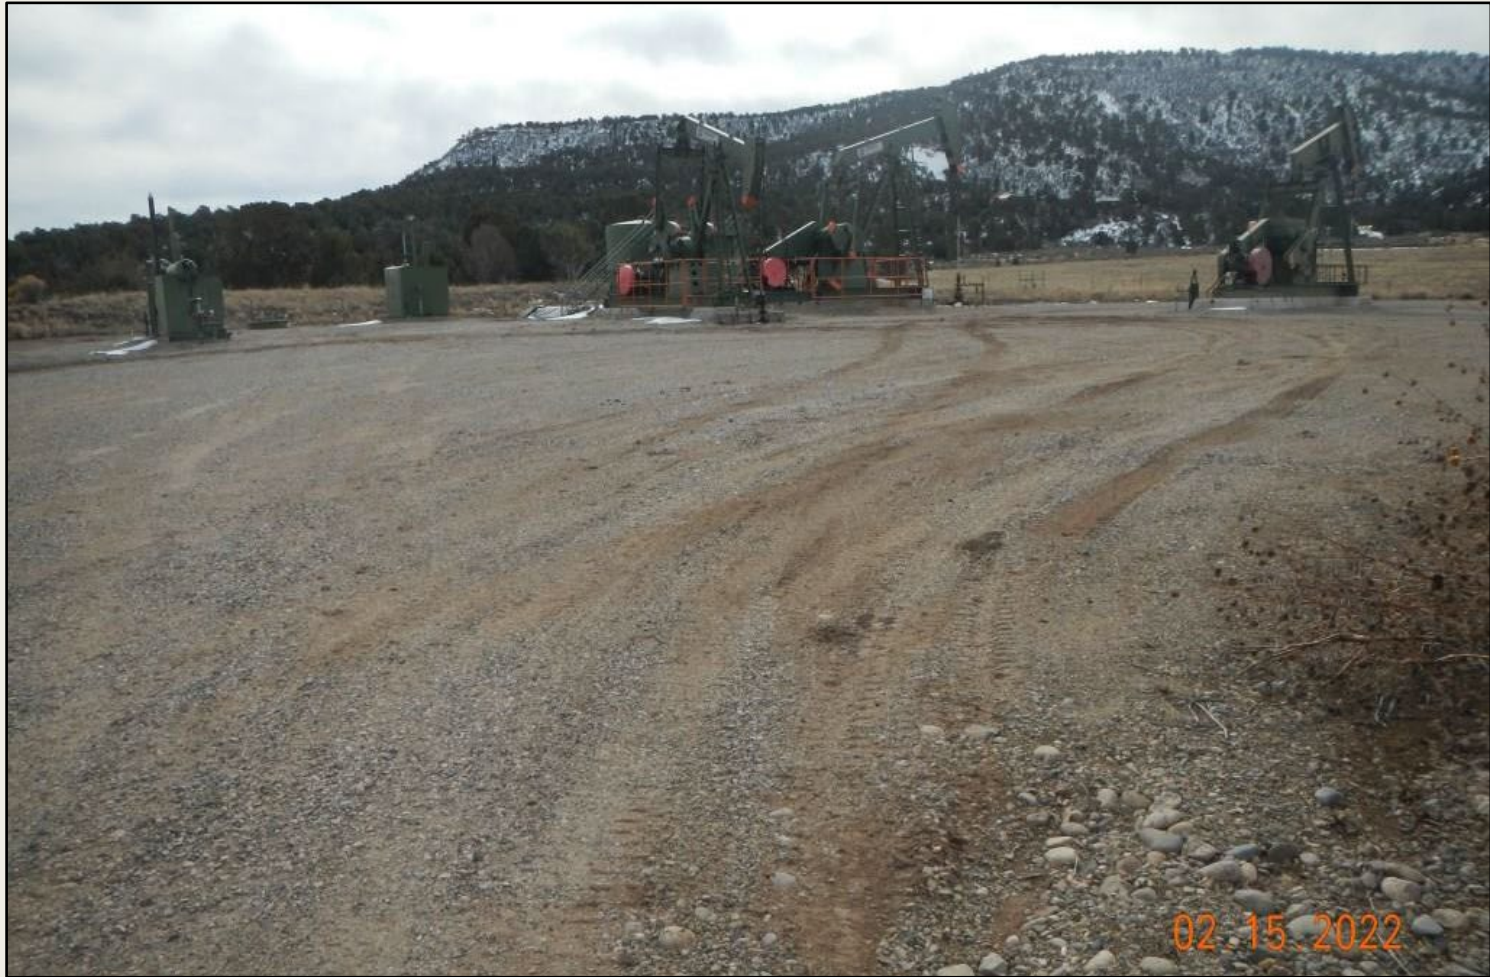
Photo 1. View of project area from the well pad entrance facing center.

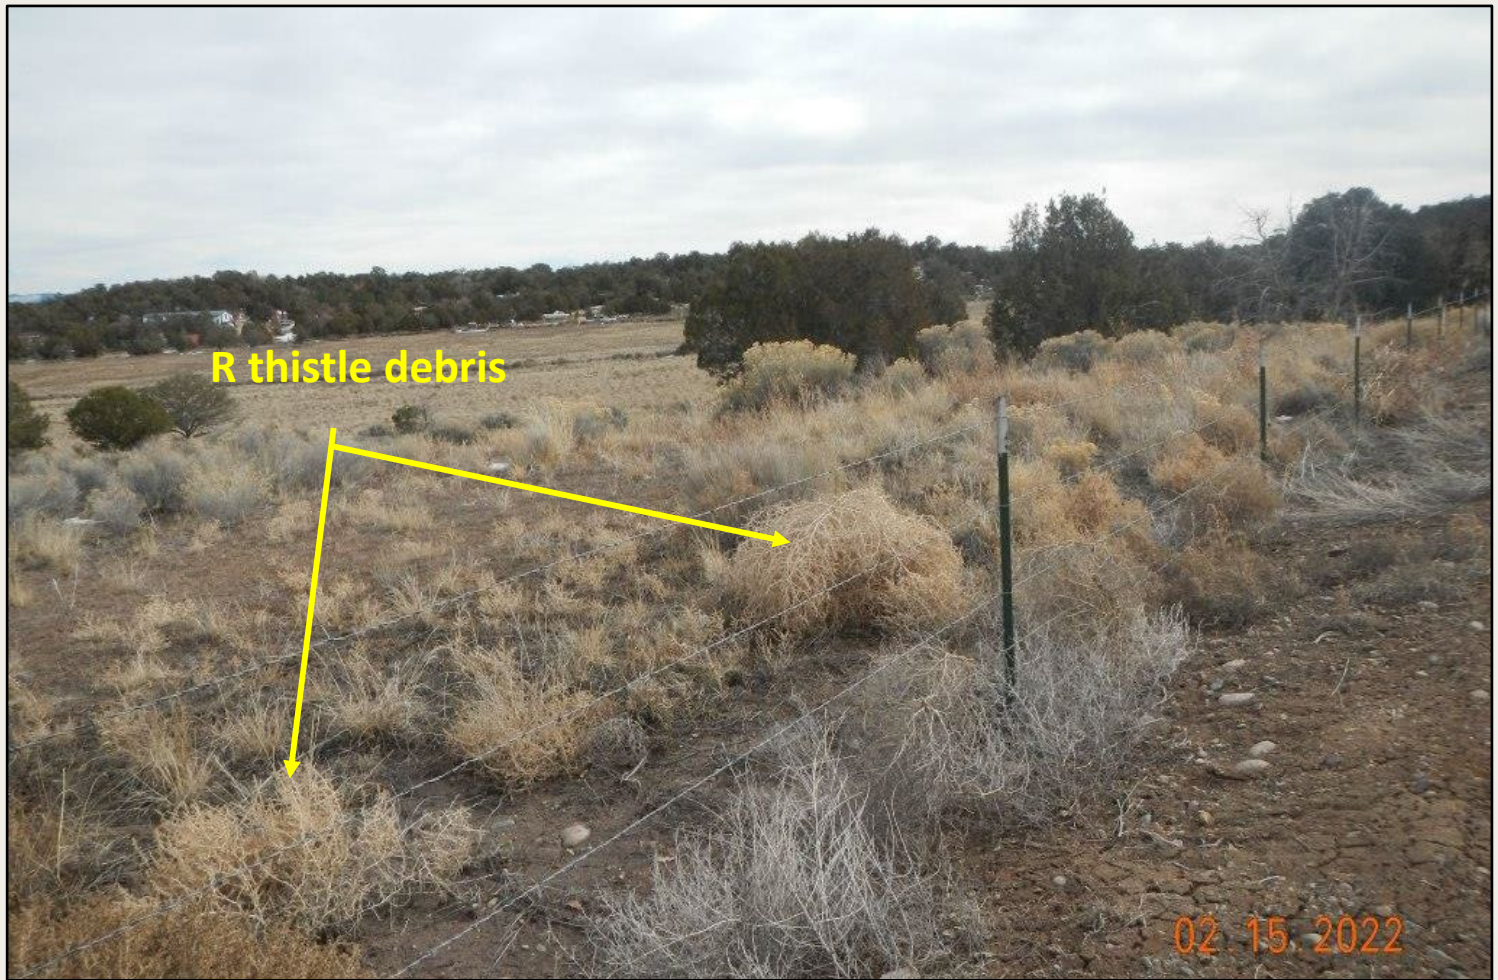
Photo 2. View of the northern project area from the northwestern corner facing eastward. Revegetation is progressing with smooth brome, crested wheatgrass, and western wheatgrass. Russian thistle debris needs to be removed and properly disposed of.

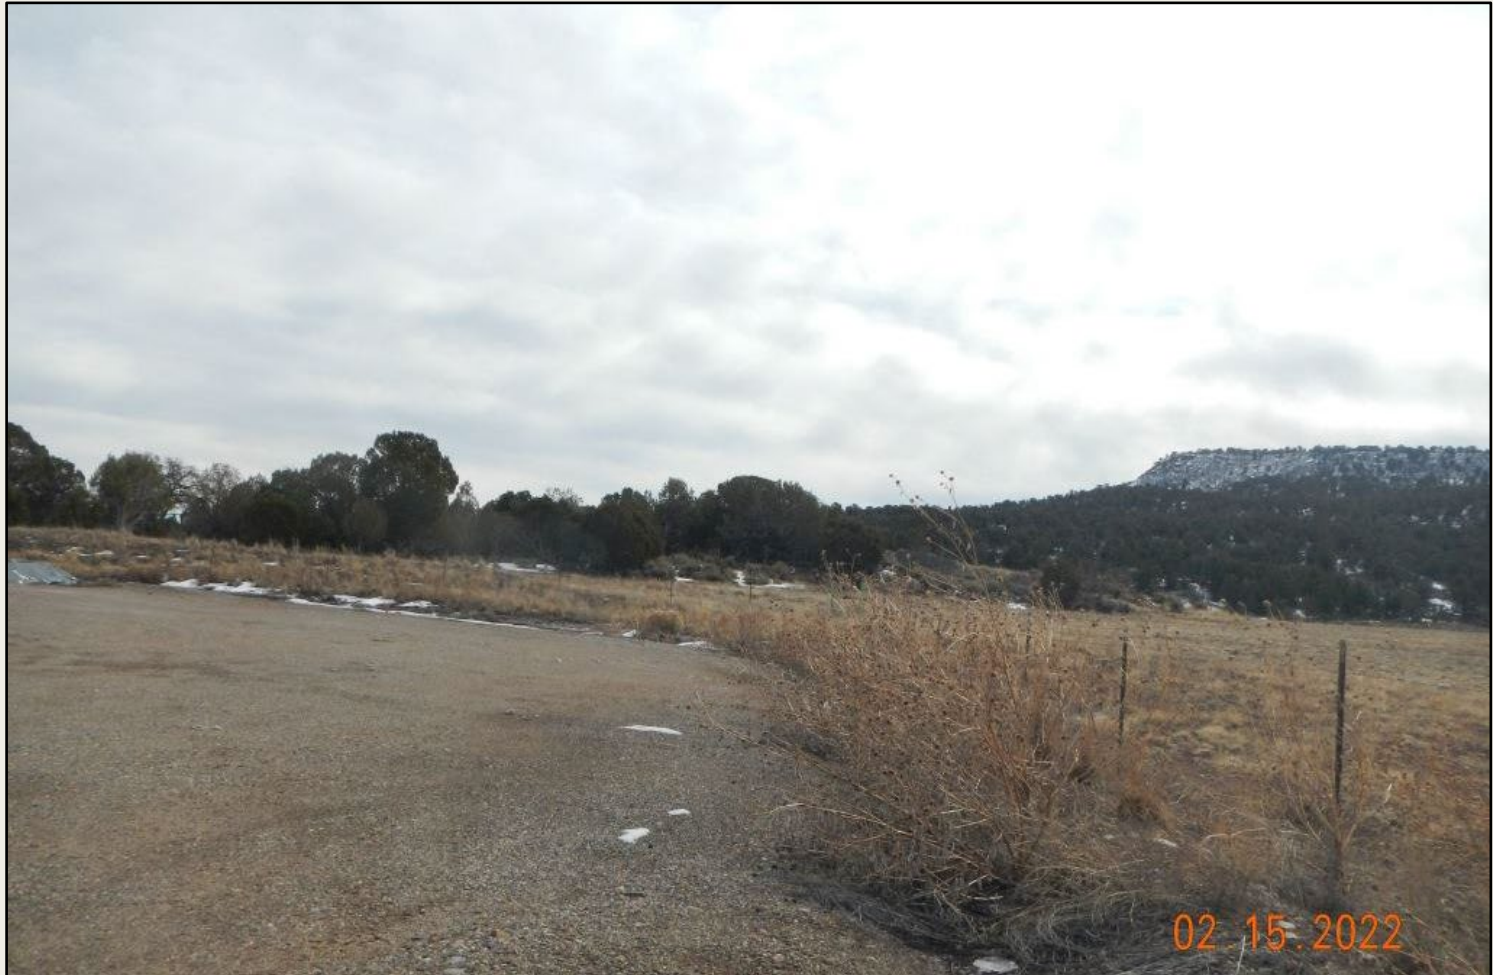
Photo 3. View of the western portion of the project area from the northwestern corner facing southward.

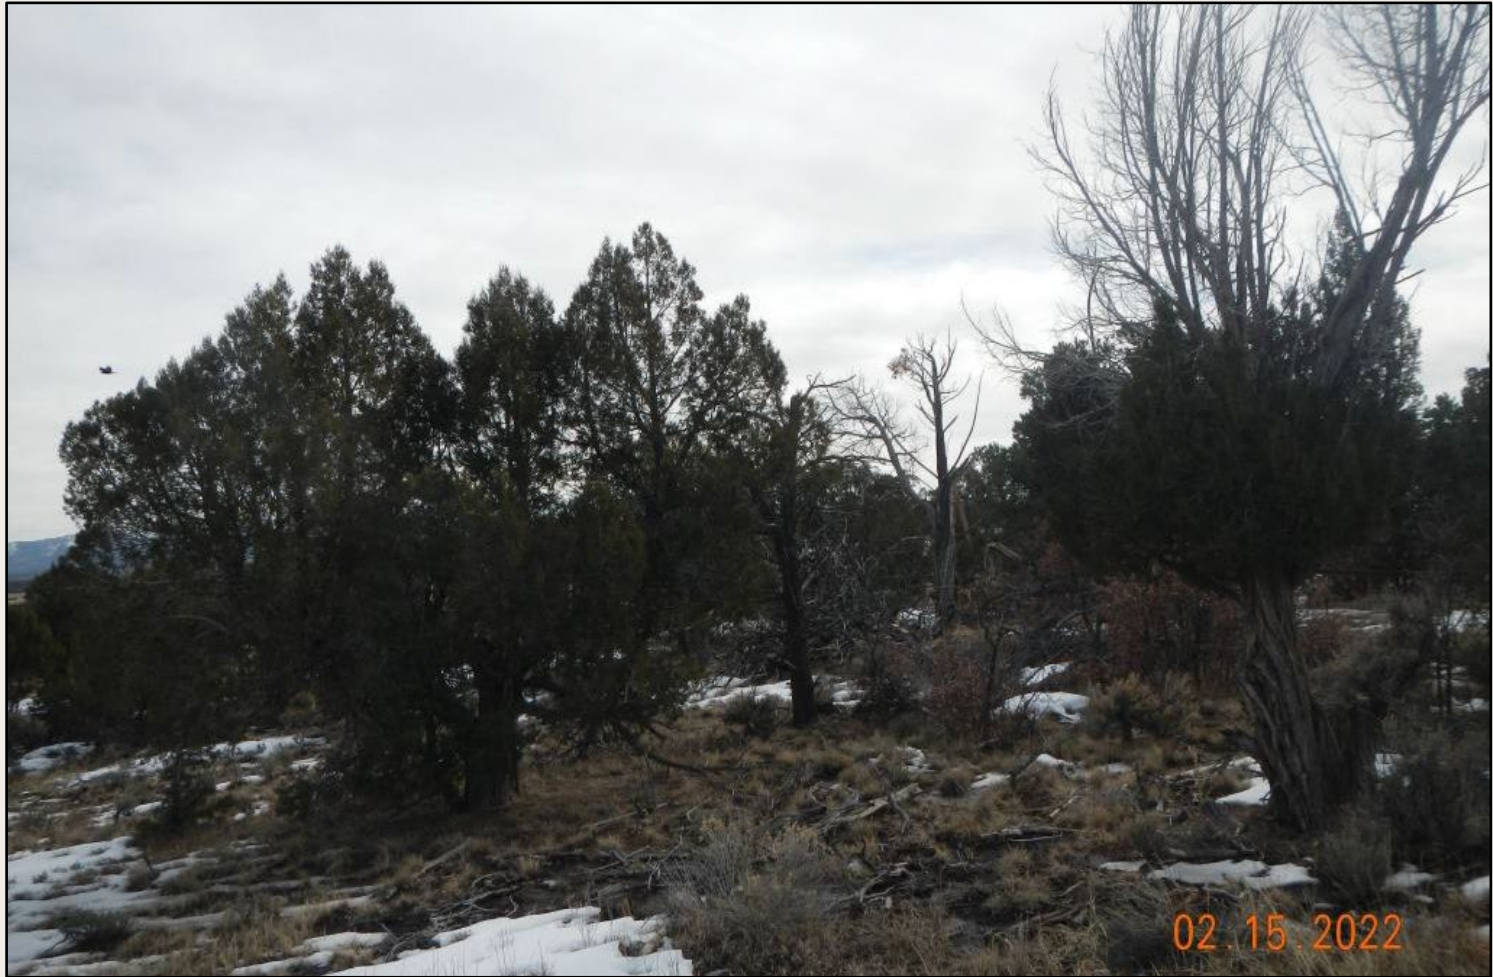
Photo 4. View of reference area vegetation comprised of pinyon and juniper woodland, with sagebrush, blue grama, Indian ricegrass, and yucca observed in the understory.
