Final Reclamation Inspection

Operator: SCHNEIDER ENERGY SERVICES INC - 76840

Location ID: 317498

Inspection Photos
Location Name: APRIL #12-14
Location ID: 317498

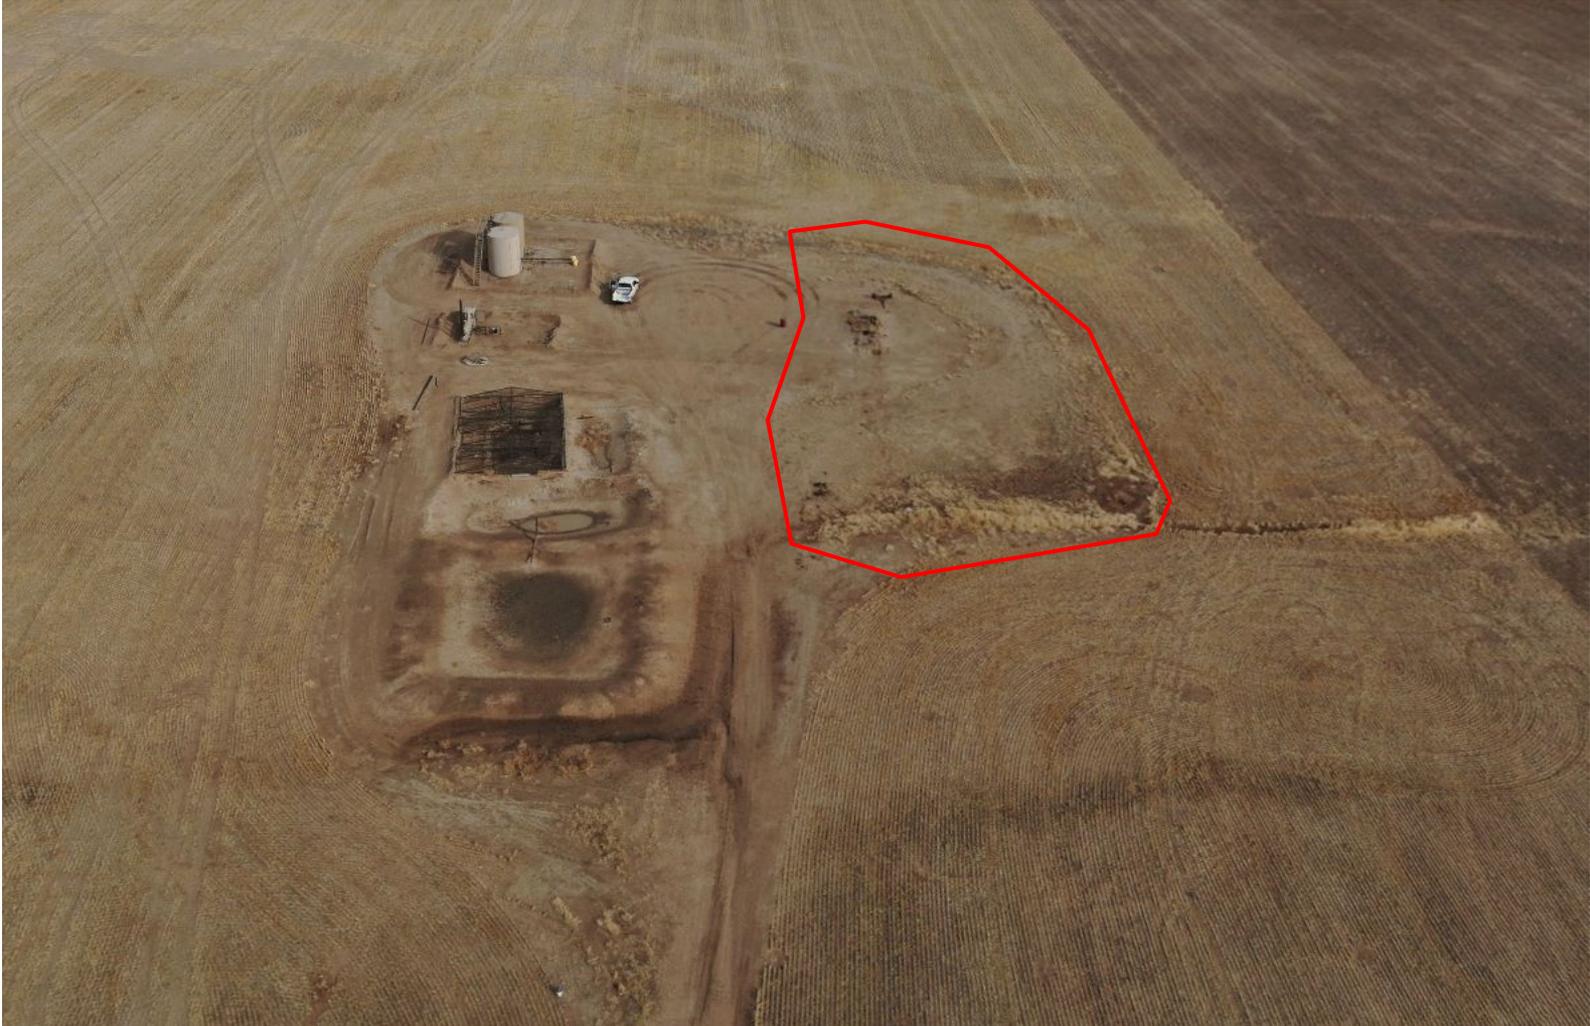
Photo 1. Drone aerial imagery illustrates the April #12-14 location. The photo illustrates the Operator has failed to complete final reclamation activities for the well location portion of the location (red polygon).

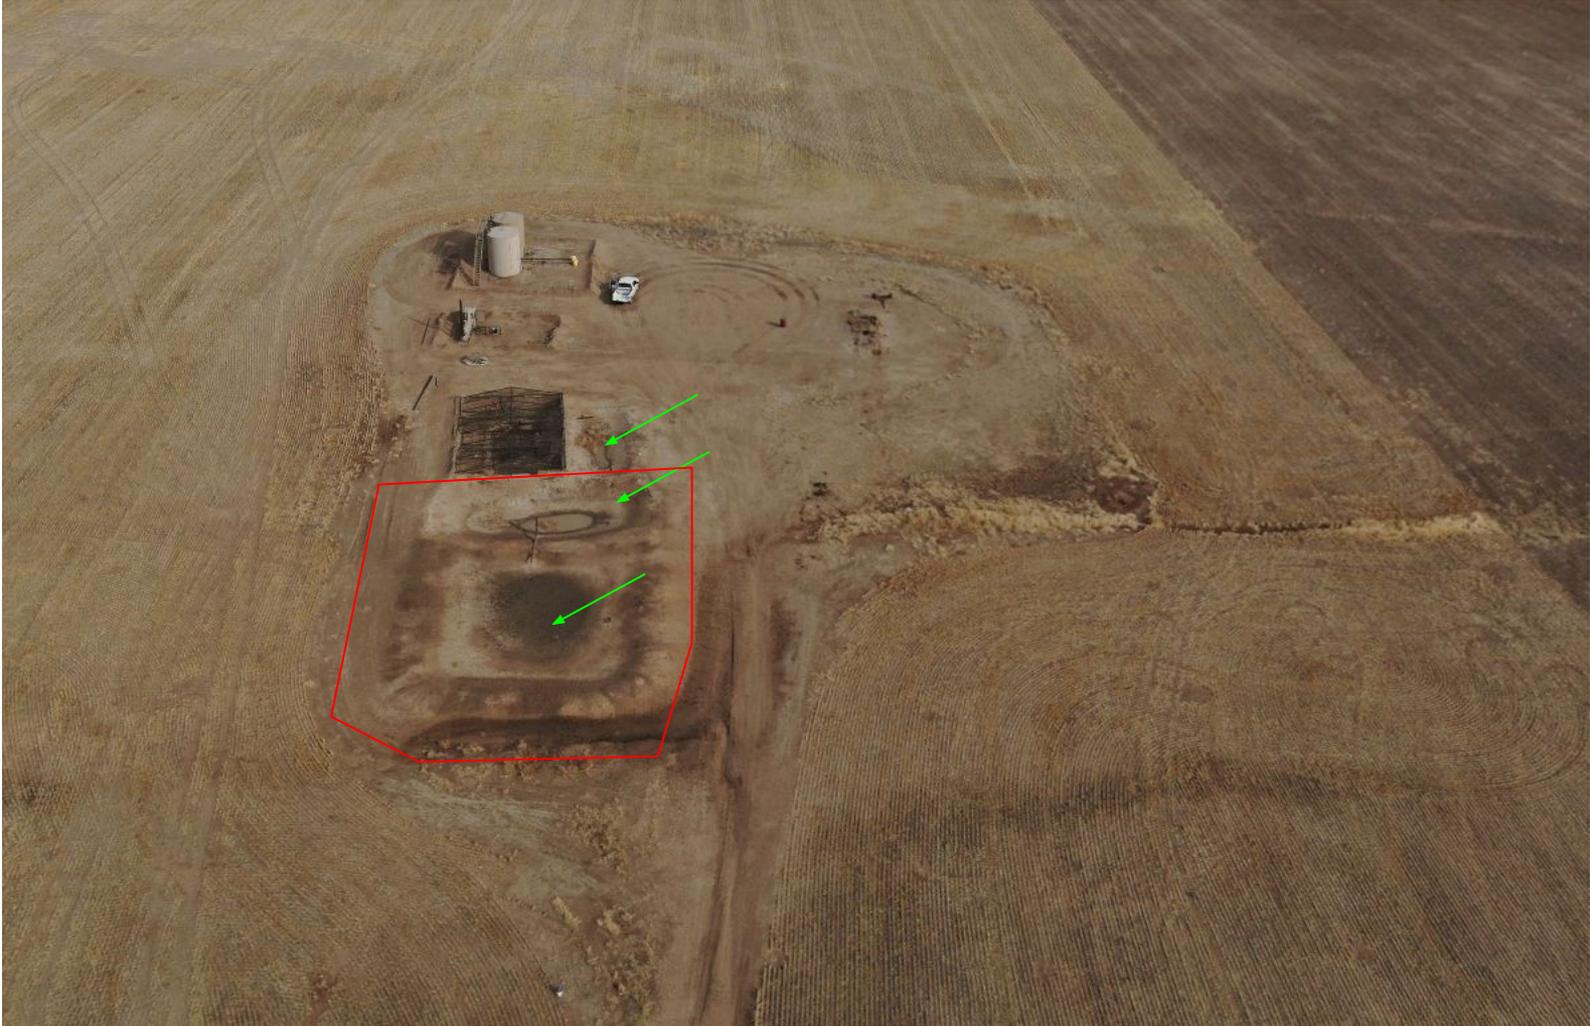
Photo 2. Operator is in process of closing 3 of the 4 pits per 900 series rules. Upon receiving final approval to close the pits, Operator shall further reduce the size of the location by returning 2 of the 3 pits back into crop production (red polygon).

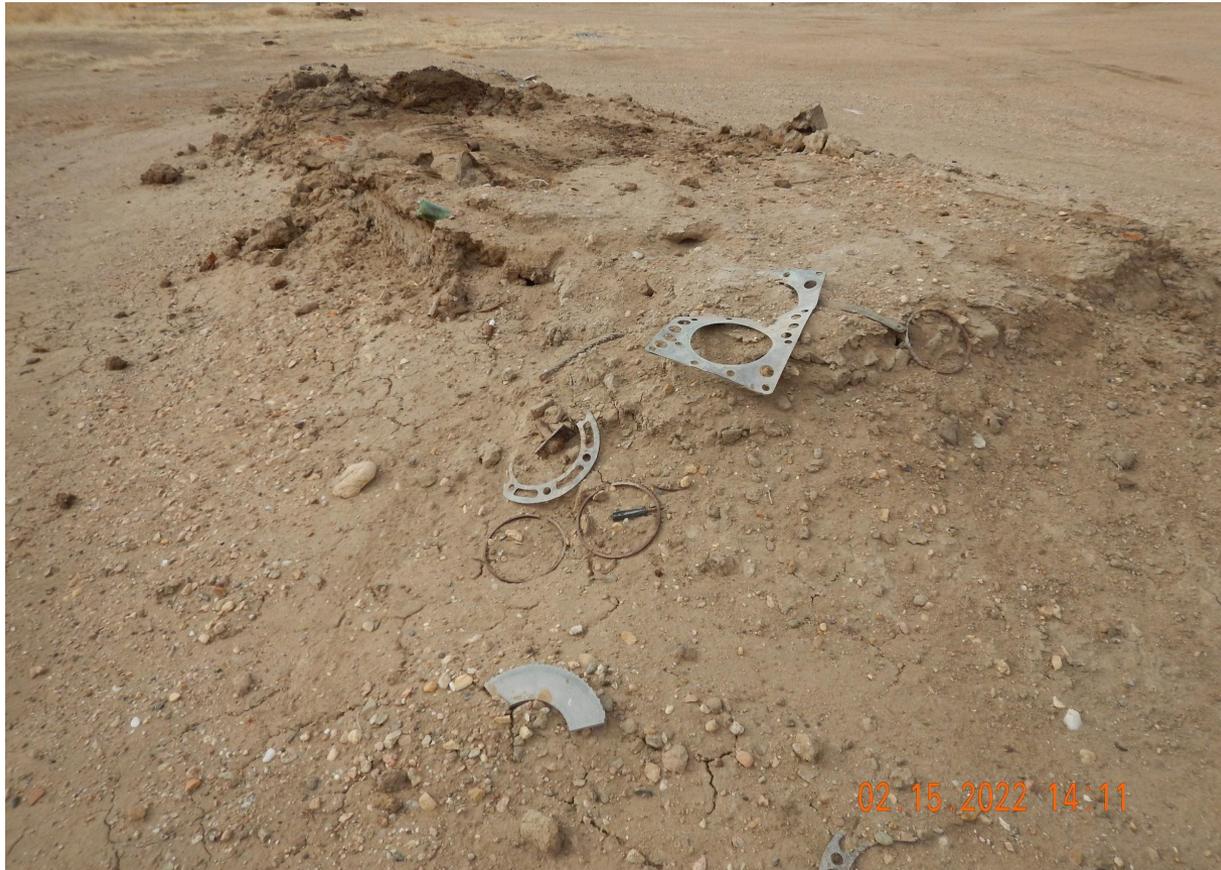
Photo 3. Photo taken from the wellhead. Photo illustrates Operator has not removed gravel and debris and recontoured the well location portion of the location.

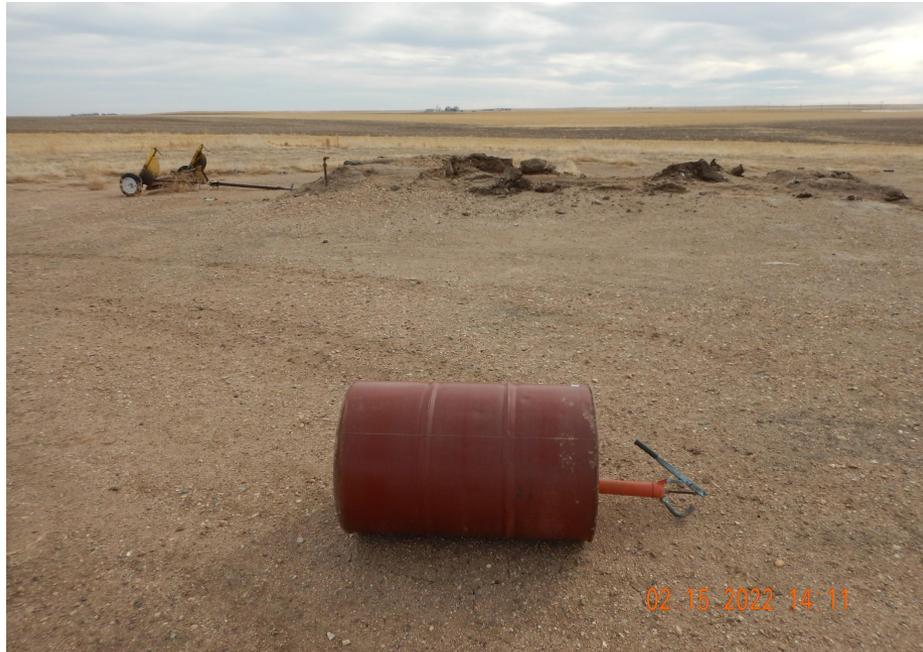
Photo 4. Photo taken from location, facing South. Photo illustrates poor “good housekeeping”. Note- COGCC Staff put the barrel upright, as there appear to be some liquid remaining inside the barrel.

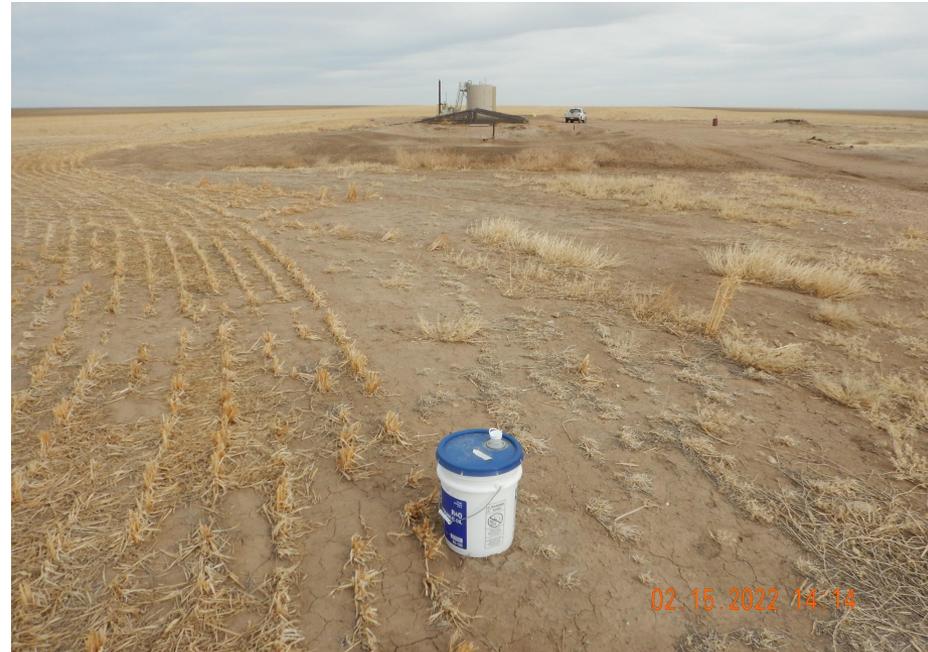
Photo 5. Photo taken west of the pits, facing East. Photo illustrates poor “good housekeeping”.

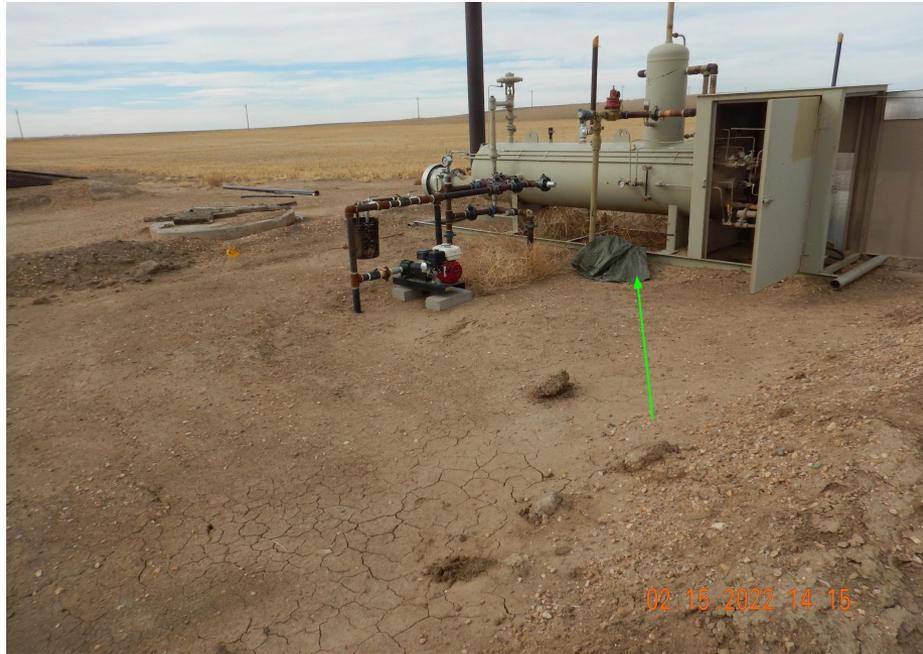
Photo 6. Photo taken from the separator, facing North. Photo illustrates poor “good housekeeping”.

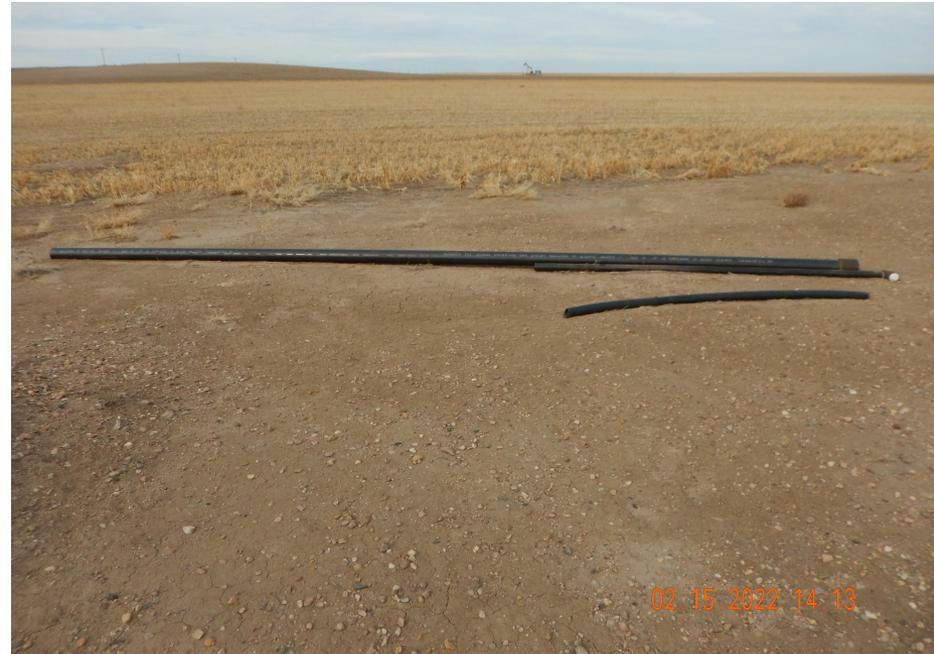
Photo 7. Photo taken from the northern location, facing North. Photo illustrates potentially unused equipment.
