Construction and Stormwater Inspection

February 25, 2022

Operator: BURLINGTON RESOURCES OIL & GAS LP - 26580

Location ID: 474845

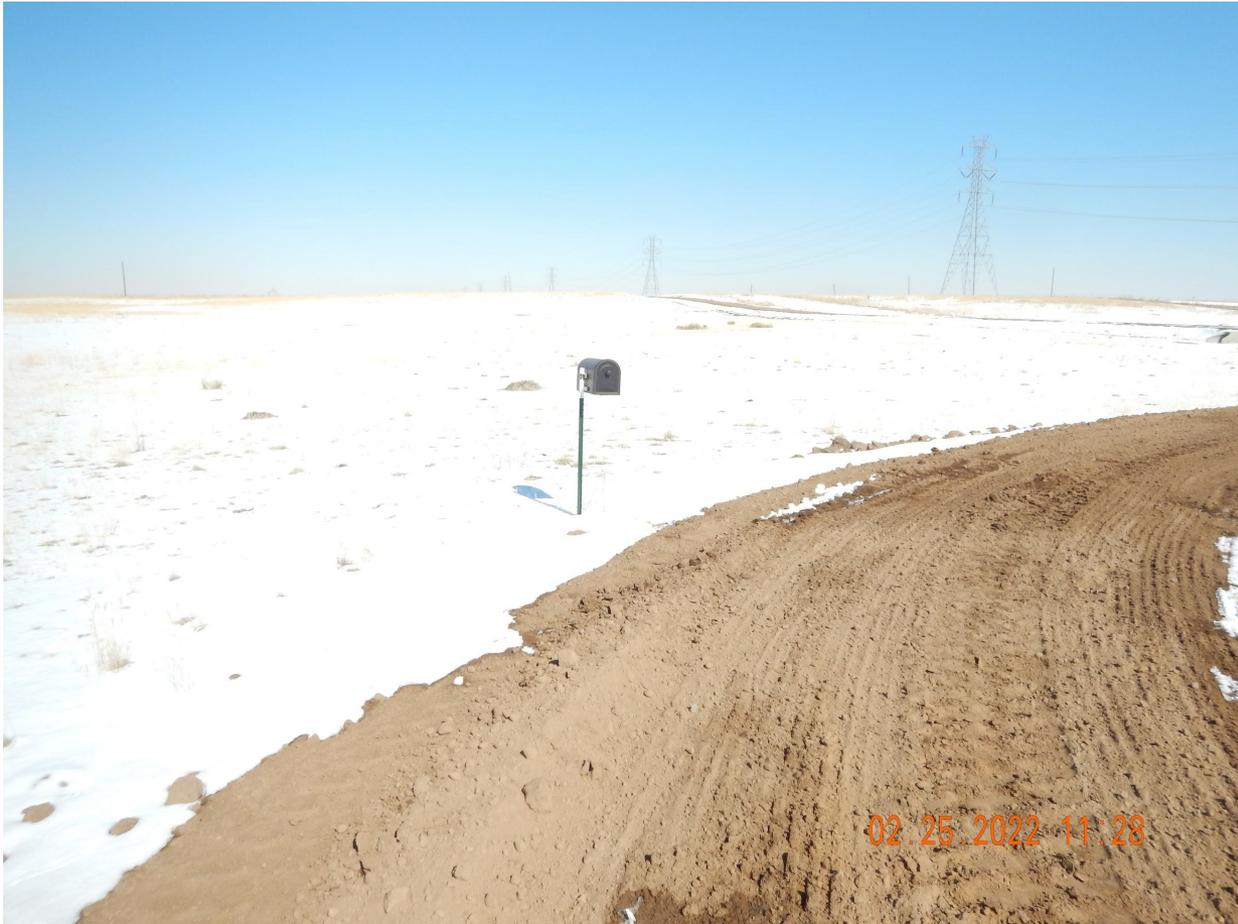
Photo 1. Photo taken from the entrance of location, facing North. Photo illustrates a mailbox with the approved forms to comply with Rule 406.c.

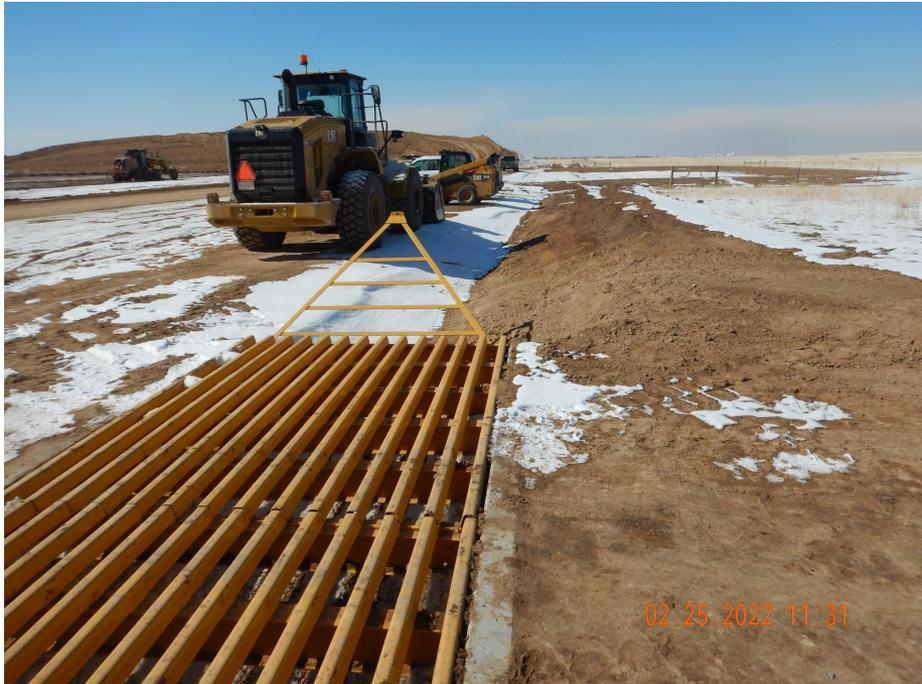
Photo 2. Photo taken from the entrance of location, facing West. Photo illustrates a ditch BMP that has been installed around the entire perimeter of location, which is directed to a stabilized outlet. Culverts are in process of being installed.

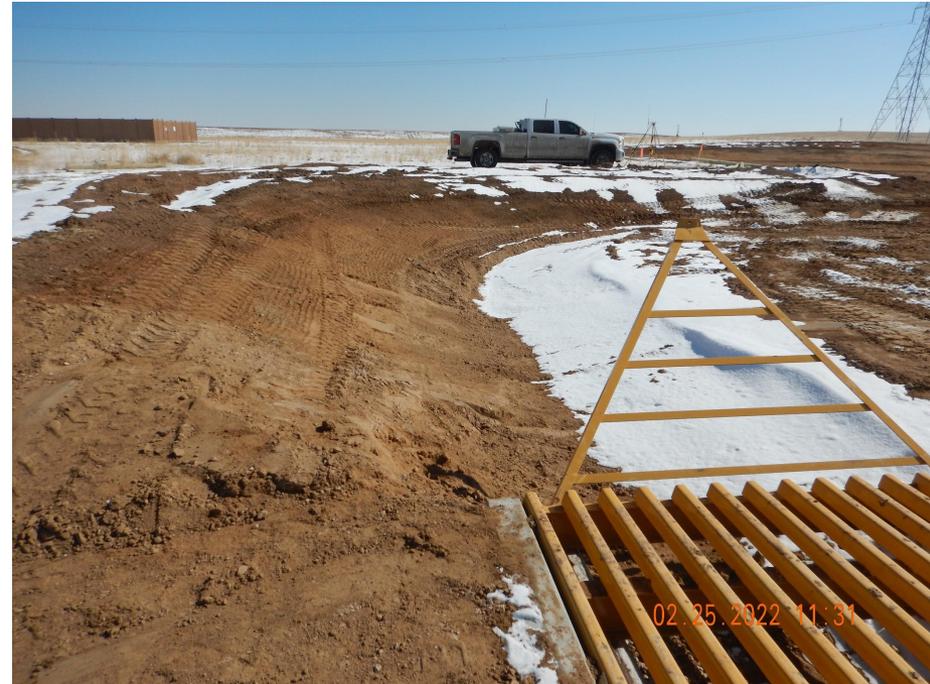
Photo 3. Photo taken from the entrance of location, facing East. See comments under Photo 2.

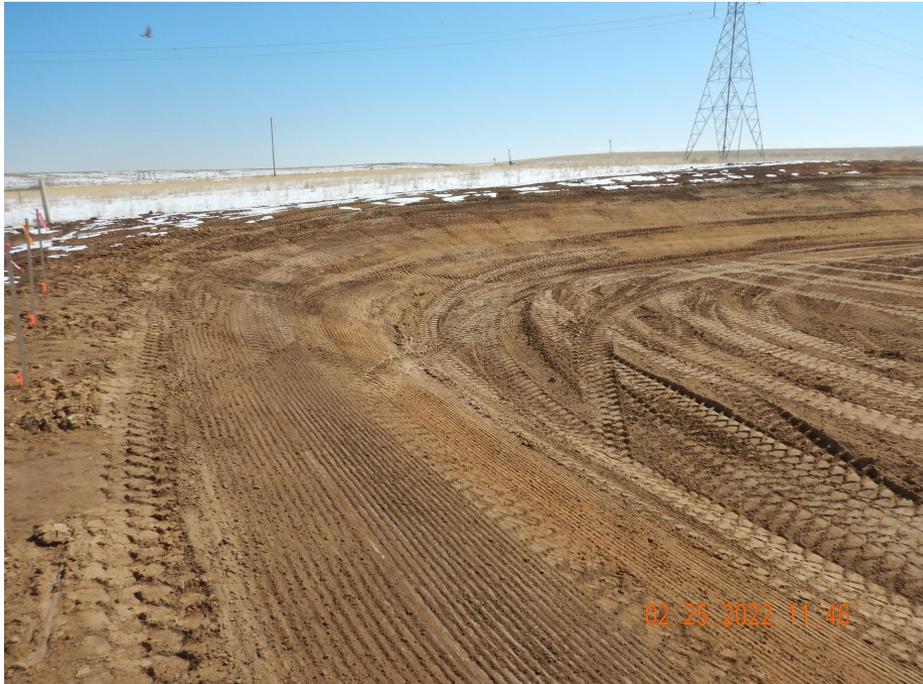
Photo 4. Photo taken from the northeastern location, facing East. See comments under Photo 2.

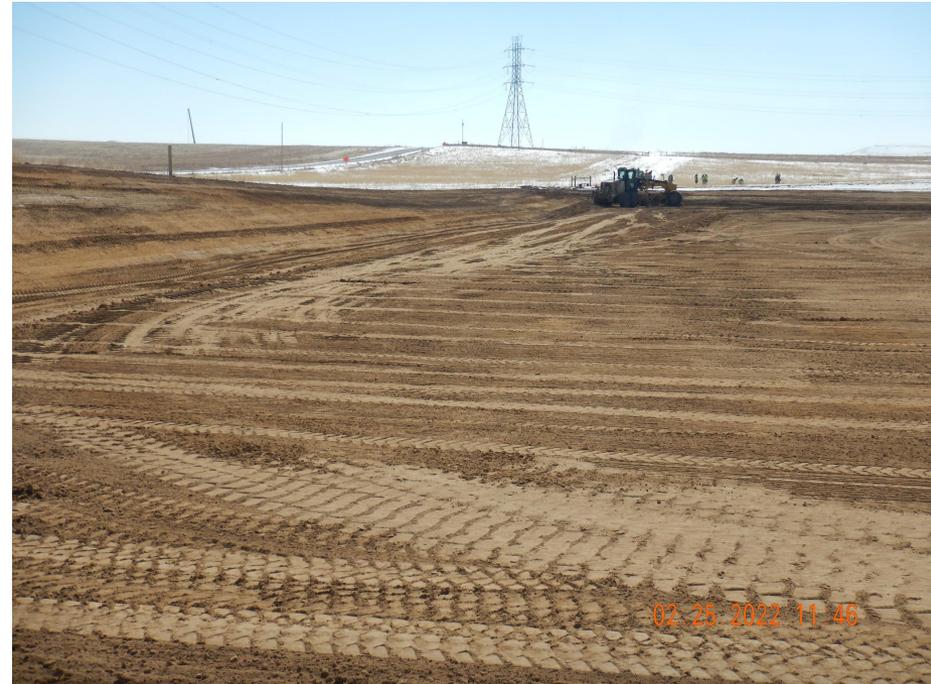
Photo 5. Photo taken from the northeastern location, facing South. See comments under Photo 2.

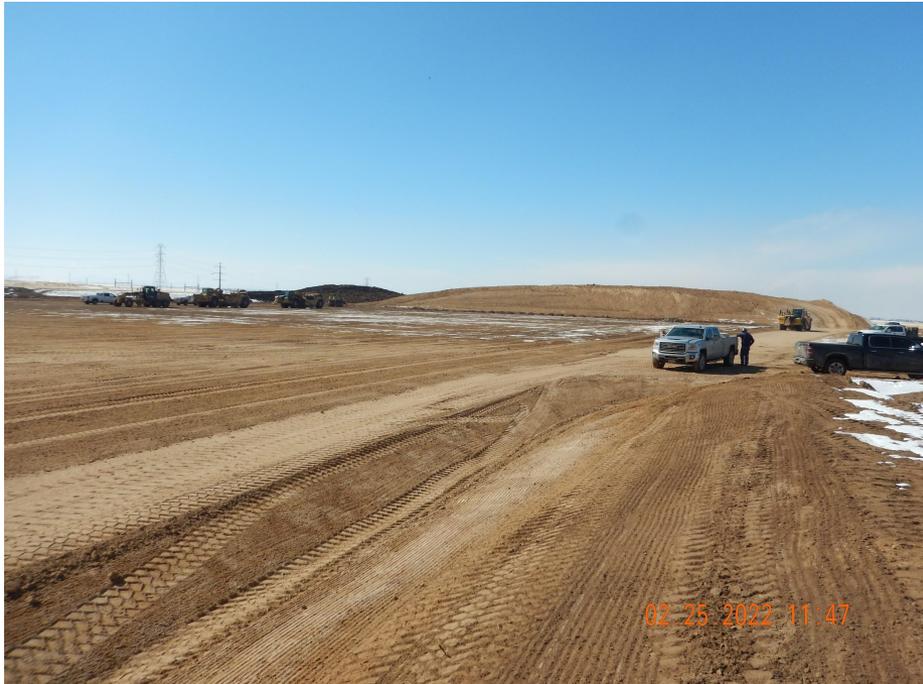
Photo 6. Photo taken from the northeastern location, facing West. Photo illustrates the topsoil stockpile along the western location.

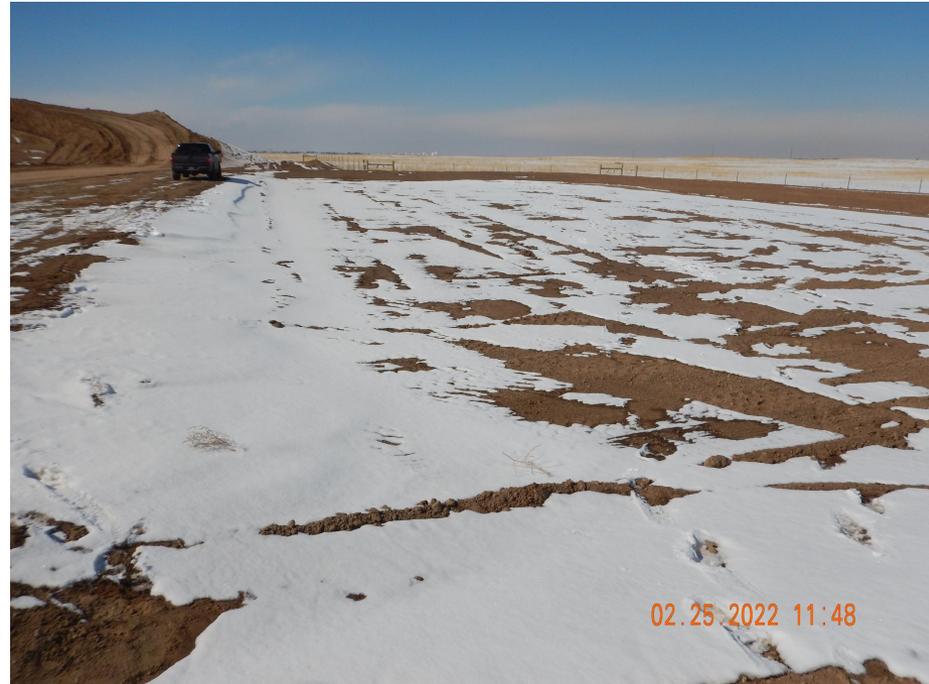
Photo 7. Photo taken from the northwestern location, facing West. Photo illustrates the sediment basin that has been engineered for a one hour, 100-year storm event.

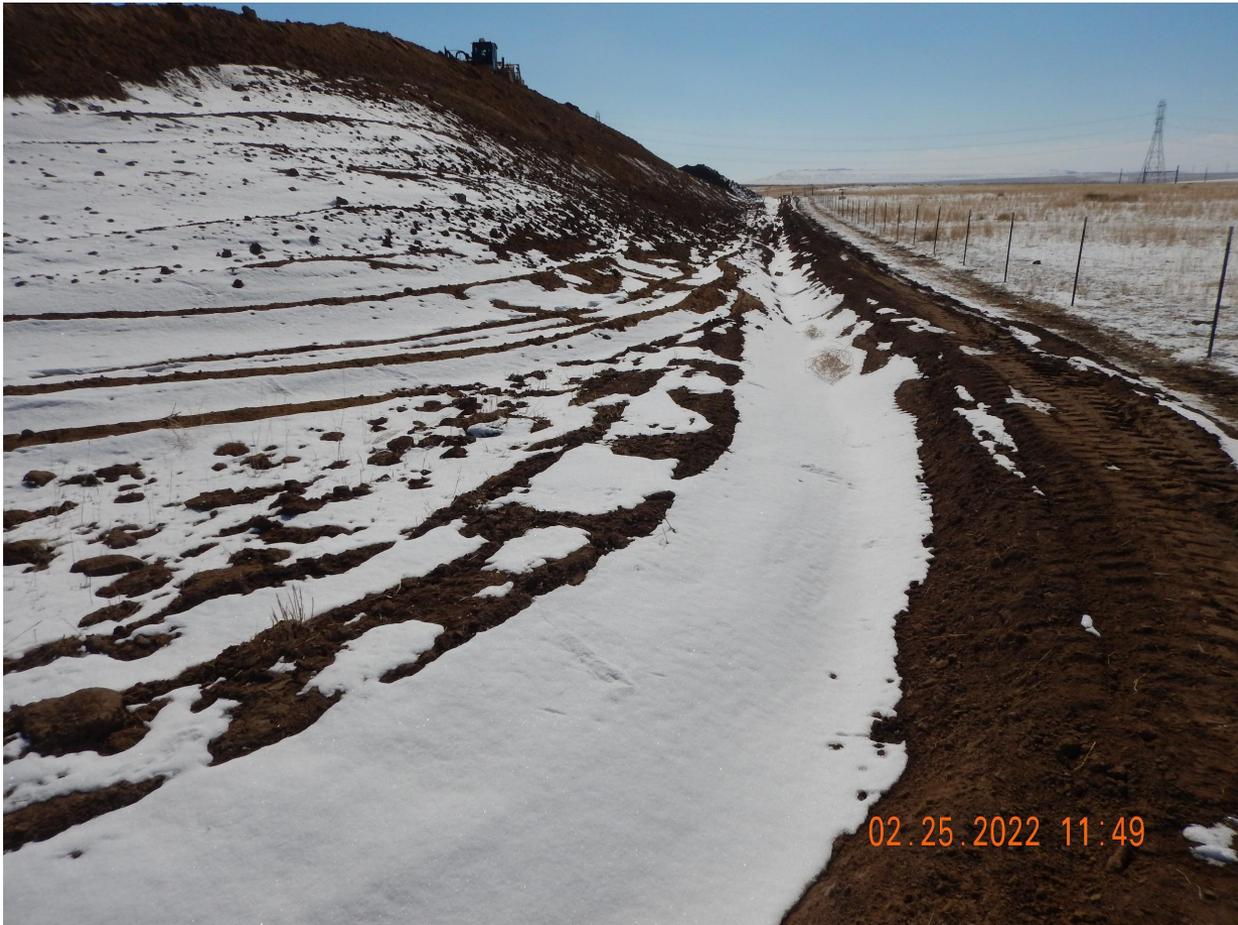
Photo 8. Photo taken from the northwestern location, facing South. See comments under Photo 2.
