Interim Reclamation Inspection

Operator: RENEGADE OIL & GAS COMPANY LLC - #74165

Location ID: 320644

Inspection Photos
Location Name: Lowry State #13-25
Location ID: 320644

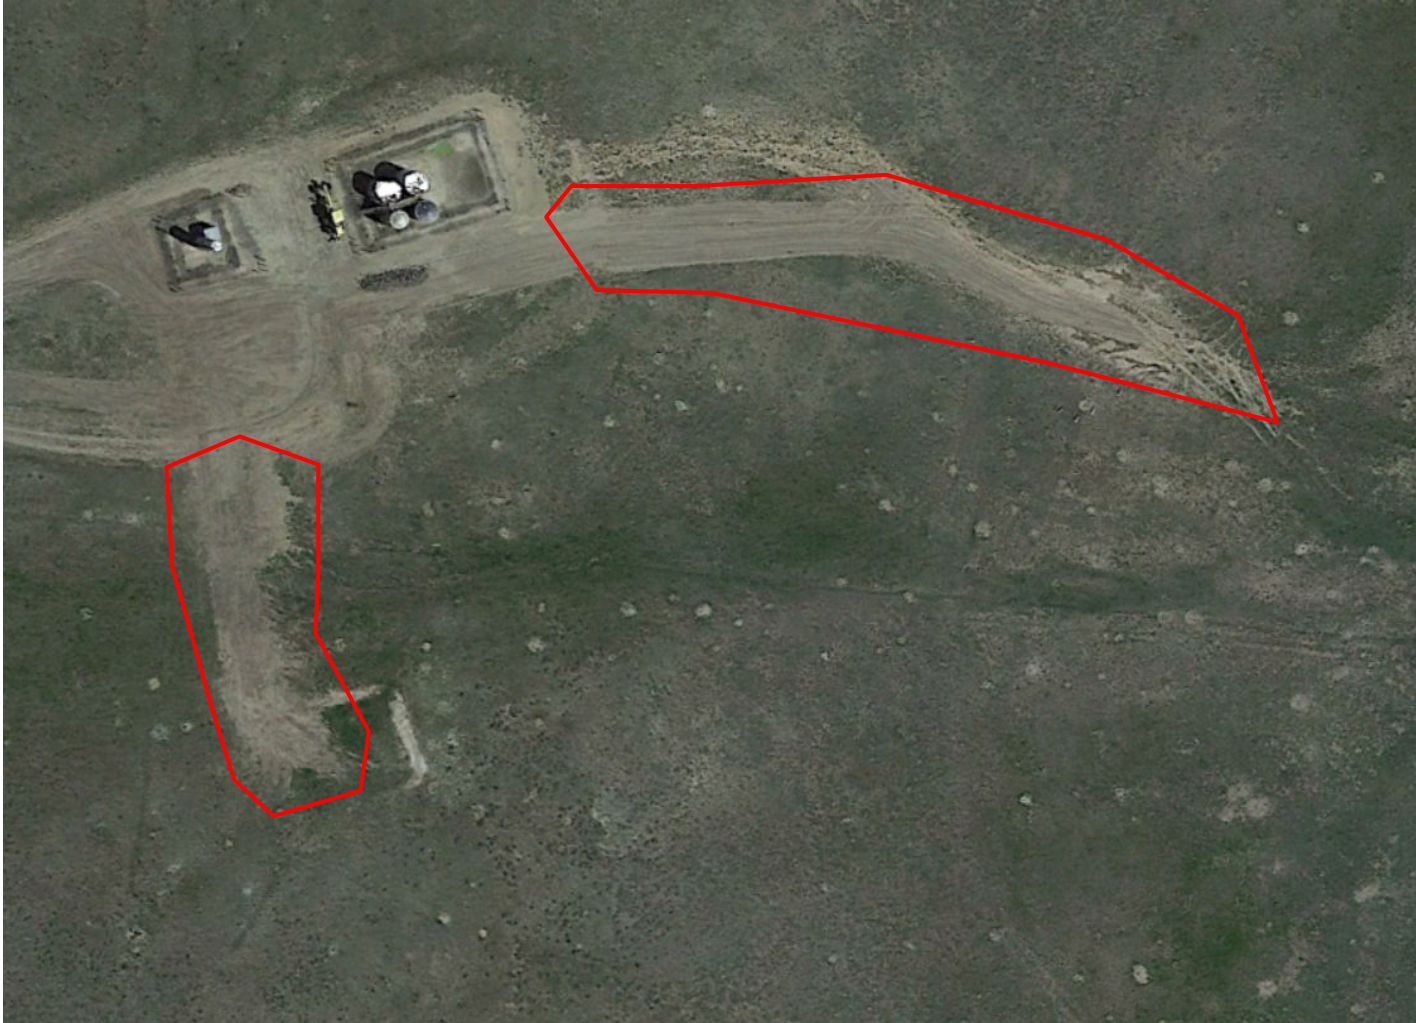
Photo 1. Google Earth aerial imagery from 6/10/2021 illustrating stormwater repair work and equipment removal work that needs to be seeded (red polygons).

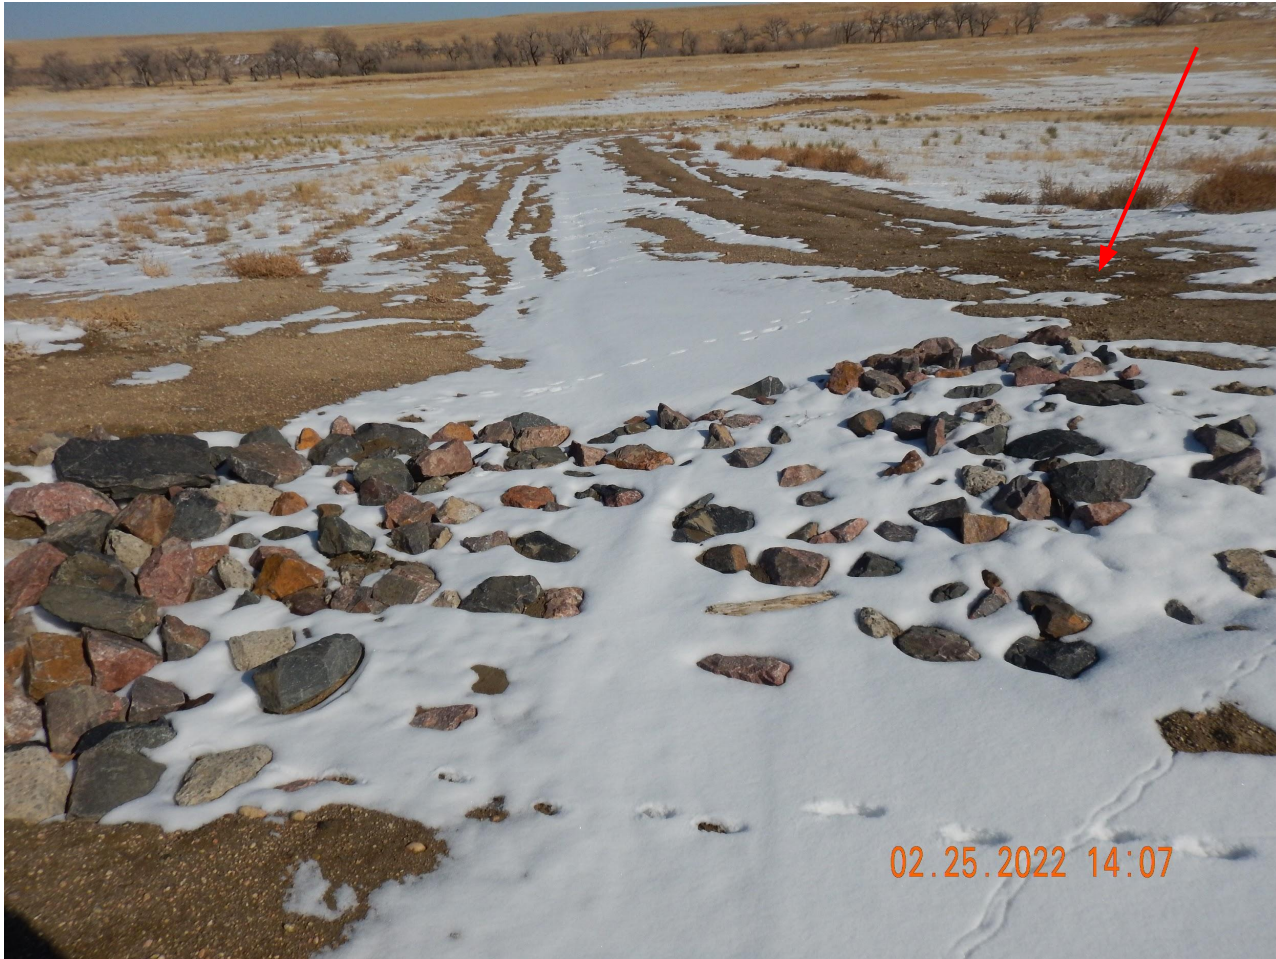
Photo 2. Photo taken from the eastern tank battery, facing East. Photo illustrates Operator has performed additional stormwater repair work but has not seeded the area. Some rill erosion was observed (red arrow) and should be repaired when performing seedbed prep.

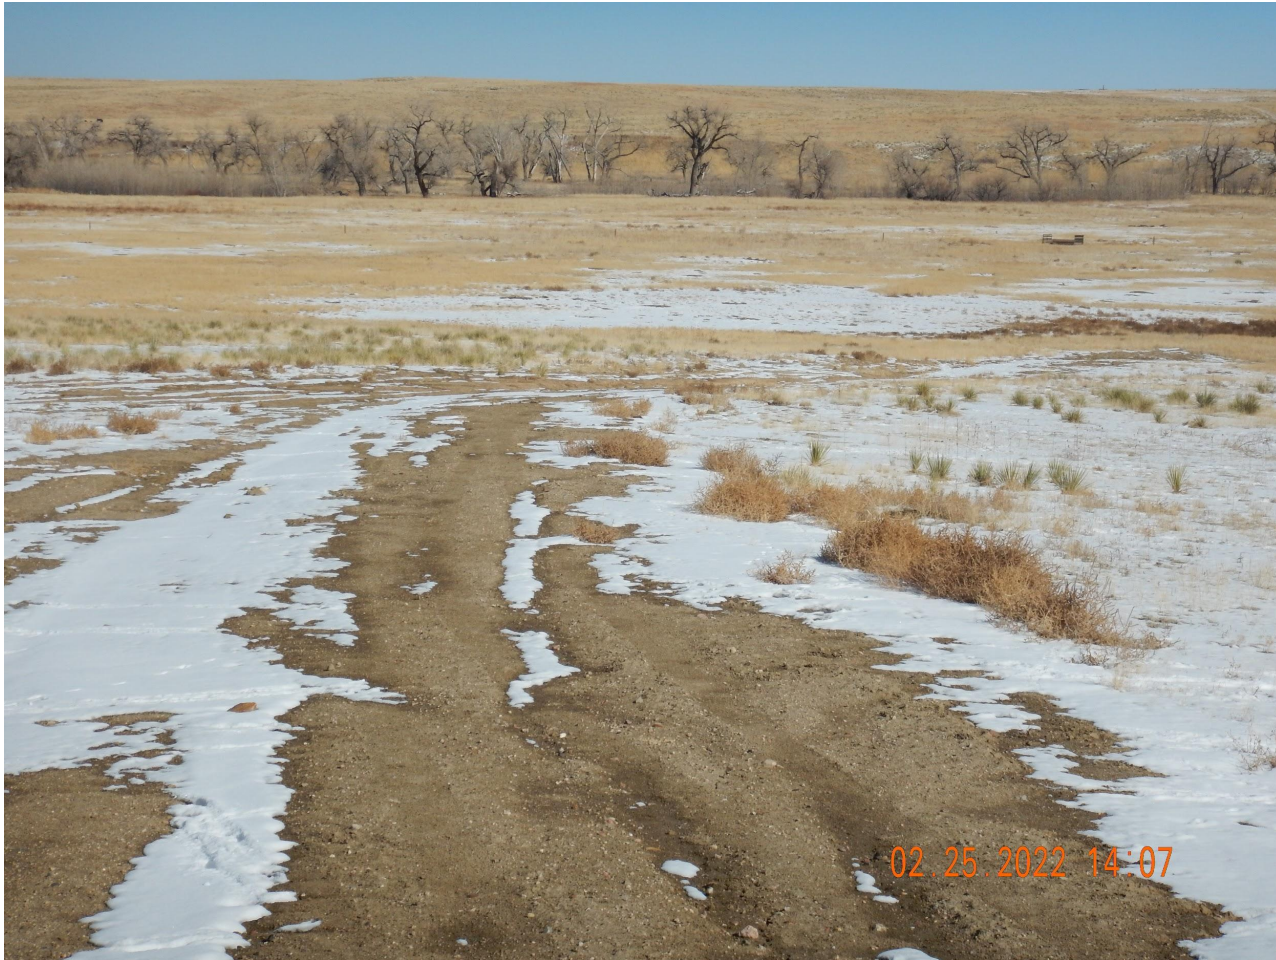
Photo 3. Photo taken from the eastern tank battery, facing East. See comments under Photo 2.

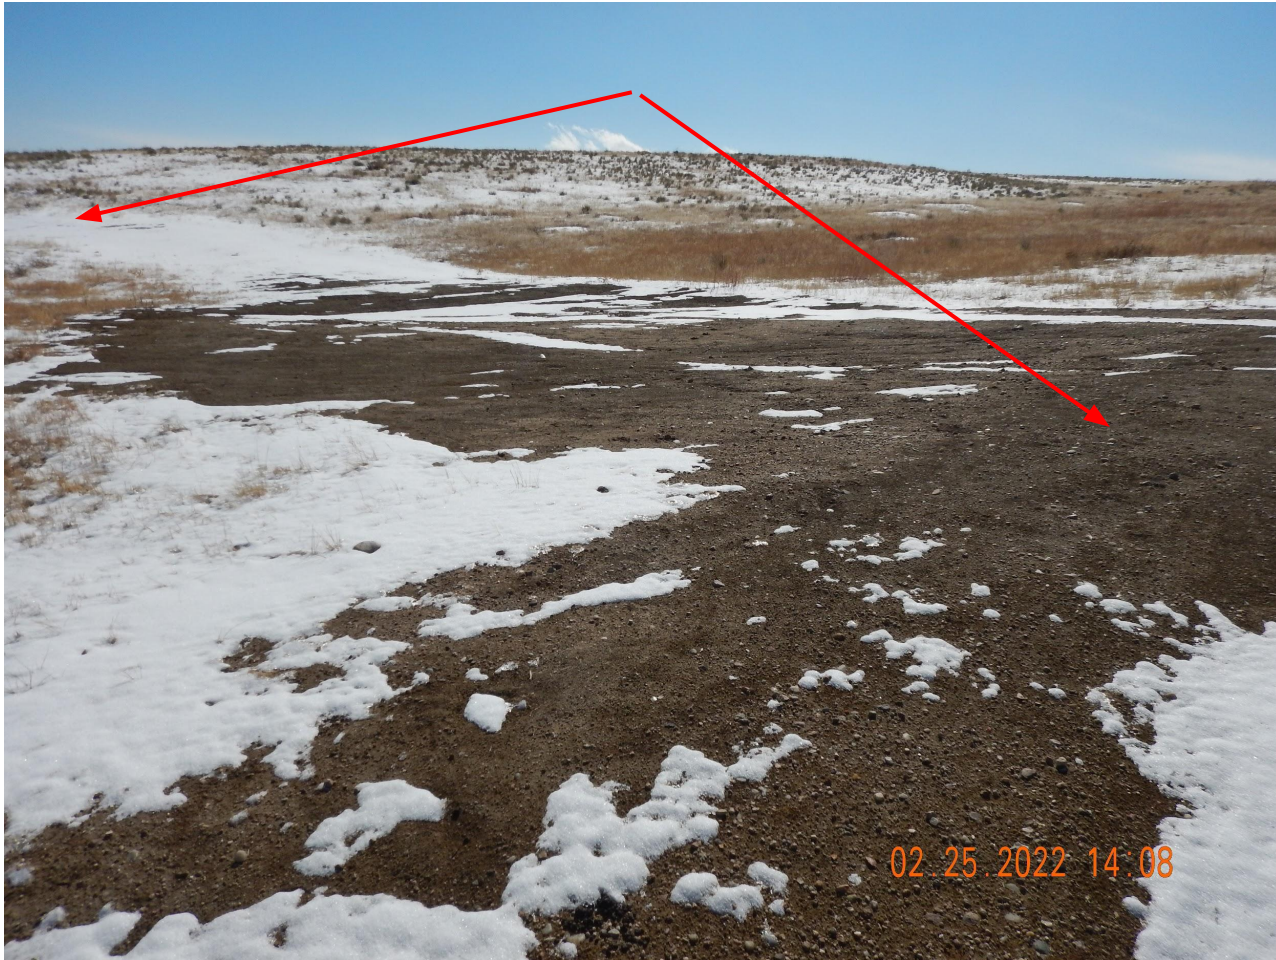
Photo 4. Photo taken from the southern tank battery, facing Southwest. Photo illustrates Operator has removed unused risers and the area needs to be seeded.
