## Inspection Photos

Location Name: UPRR-BESSIE 1

Location ID: 320144

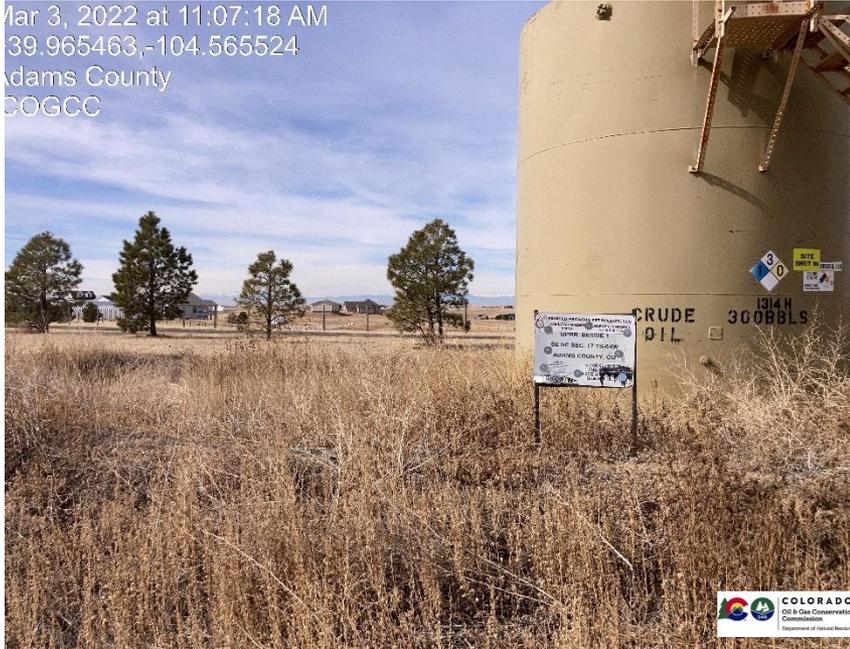
Mar 3, 2022 at 11:07:18 AM  
39.965463,-104.565524  
Adams County  
COGCC

**Pic 1 tank, weeds are unmanaged on location.**

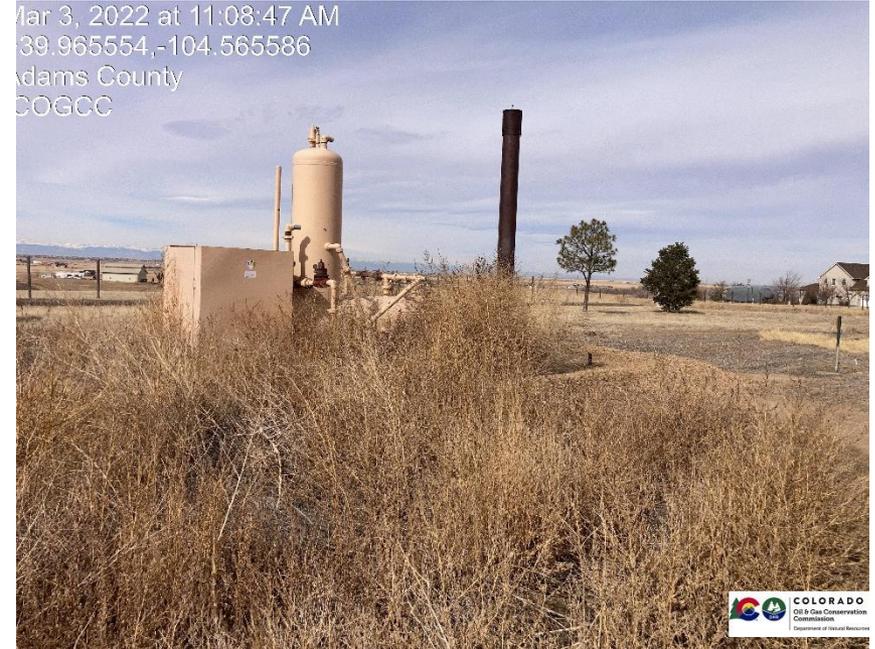
Mar 3, 2022 at 11:08:47 AM  
39.965554,-104.565586  
Adams County  
COGCC

**Pic 2 Separator, weeds unmanaged on location**

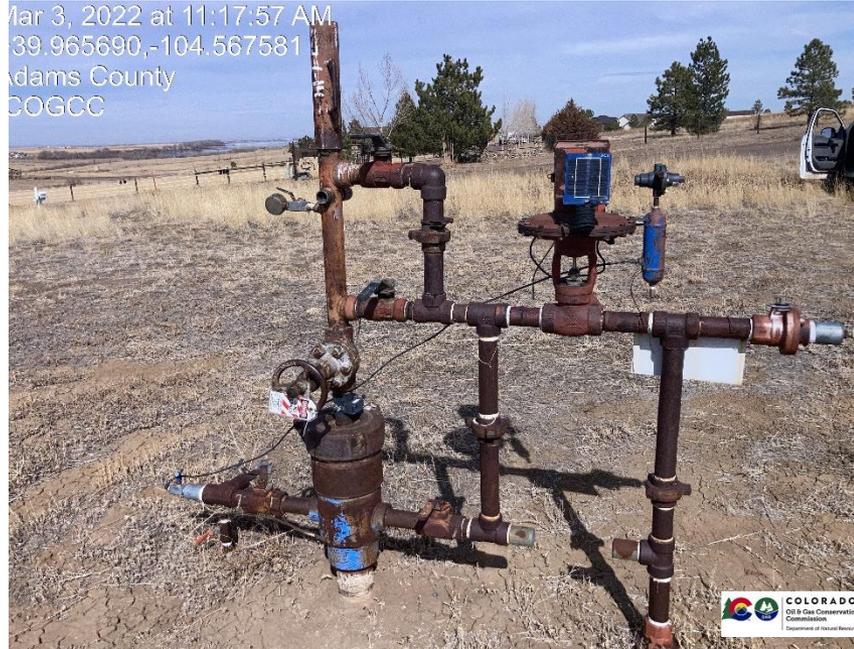
**Pic 3 wellhead, master valve and flowline valves were in the close position at time of inspection.**

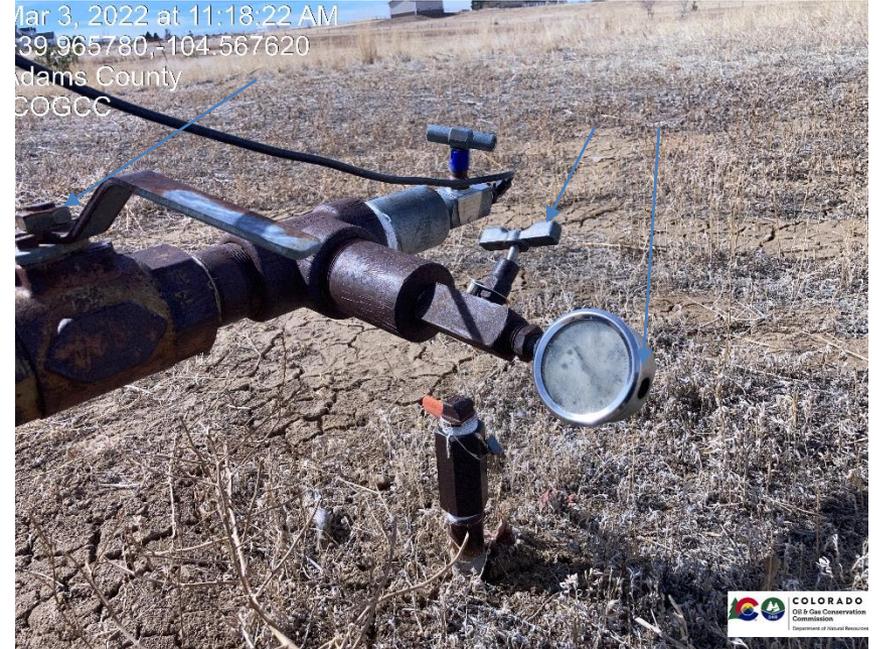
**Pic 4 During inspection it was discovered that the wellhead was leaking gas out of the top of gauge pictured. Ball valve is seized in the slight open position, needle valve was open and shut during inspection. Needle valve is damaged and still has a slight leak of gas.**
