Inspection Photos

Location Name: State Horth 13-16 & State Horth 22-16

Location ID: 320045

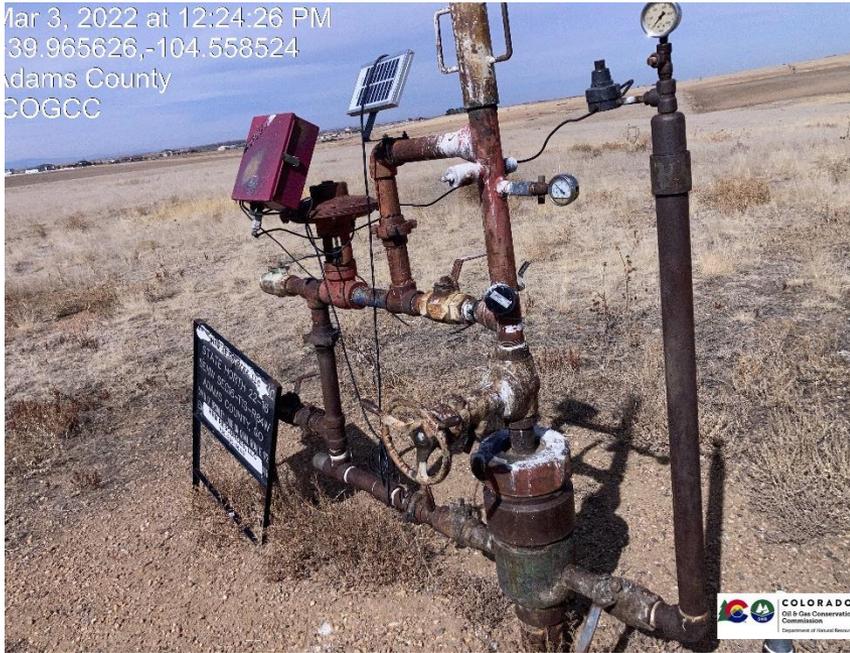
Mar 3, 2022 at 12:24:26 PM
39.965626,-104.558524
Adams County
COGCC

Pic 1 State Horth 22-16. At time of inspection master valve, and flow lines were in the open position. During inspection master valve and flowline valves were put in the close position.

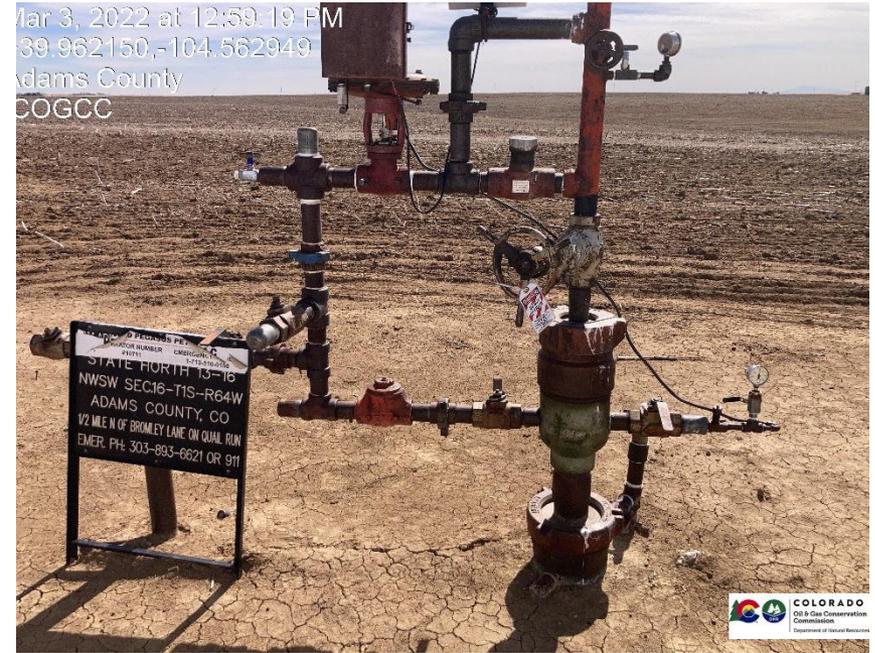
Mar 3, 2022 at 12:59:19 PM
39.962150,-104.562949
Adams County
COGCC

State Horth 13-16. At time of inspection casing valves and master valve were in the open position. During inspection master valve, and

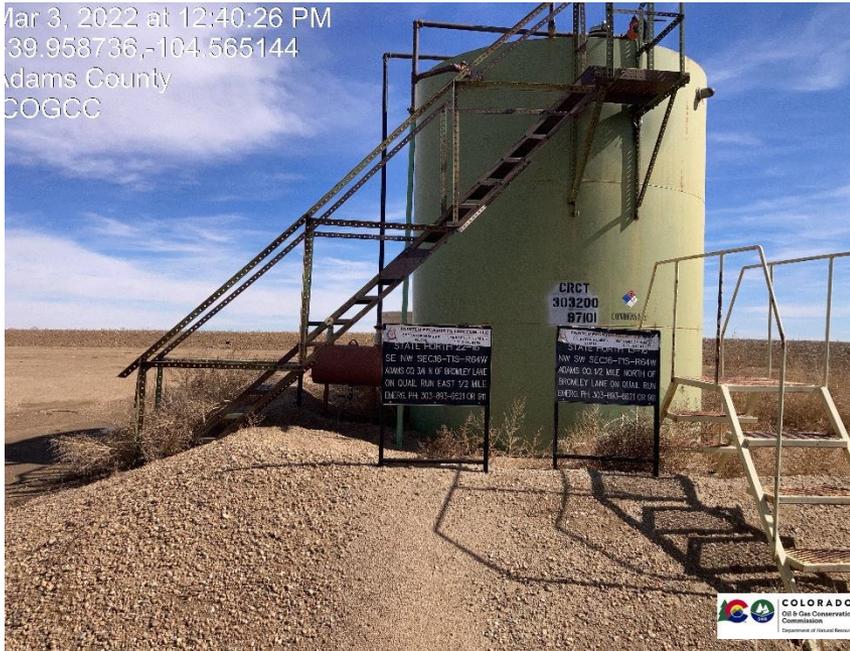
Mar 3, 2022 at 12:40:26 PM
39.958736,-104.565144
Adams County
COGCC

Pic 3 Tanks, weeds unmanaged on location, at time of inspection unable to access tanks due to weed growth on location .

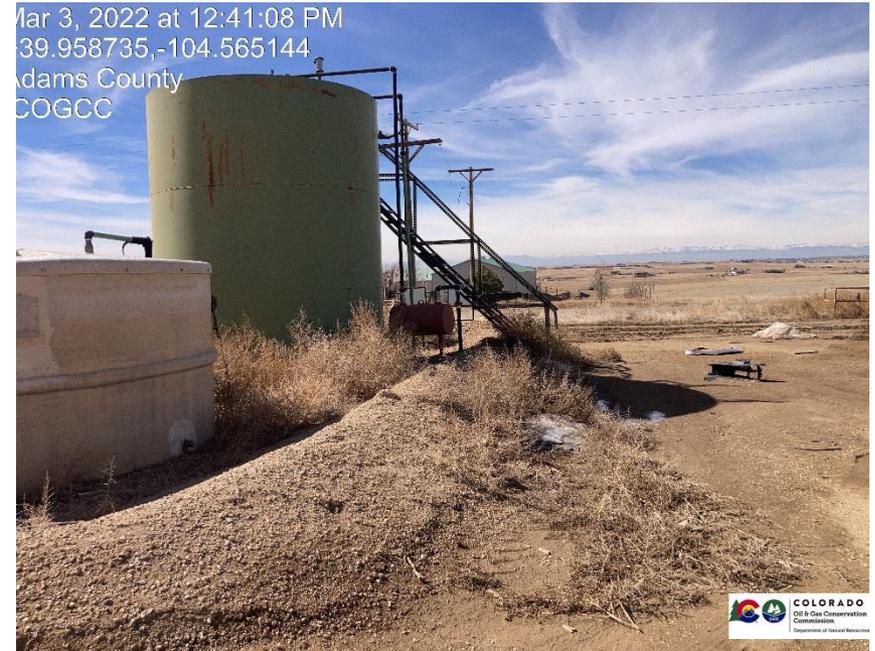
Mar 3, 2022 at 12:41:08 PM
39.958735,-104.565144
Adams County
COGCC

Pic 4 trash, and weeds on location.

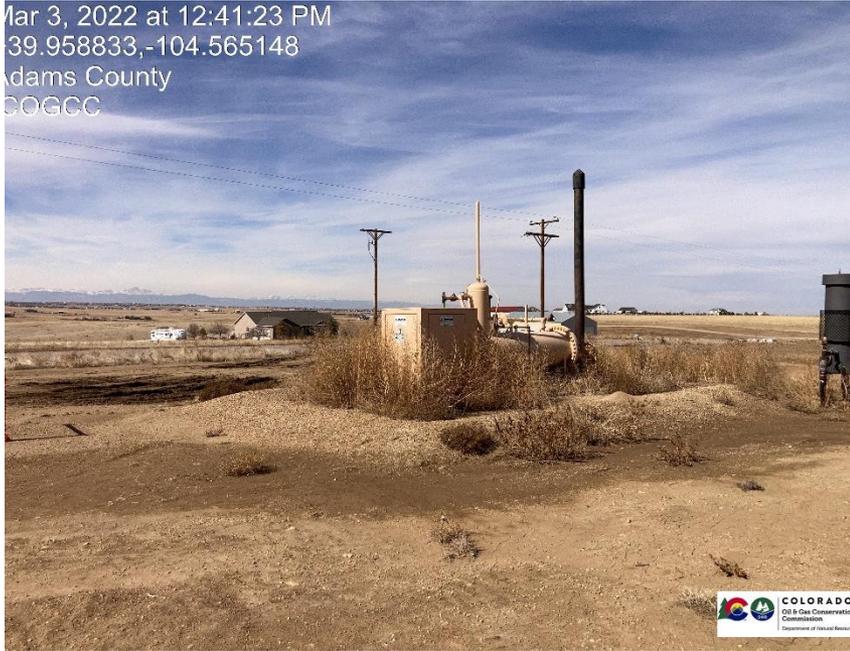
Mar 3, 2022 at 12:41:23 PM
39.958833,-104.565148
Adams County
COGCC

**Pic 5 separator, ECD, abandoned gas meter
run. Trash on location.**
