Inspection Photos

Operator: LARAMIE ENERGY LLC - 10433

Location ID: 312741

Mesa County, CO

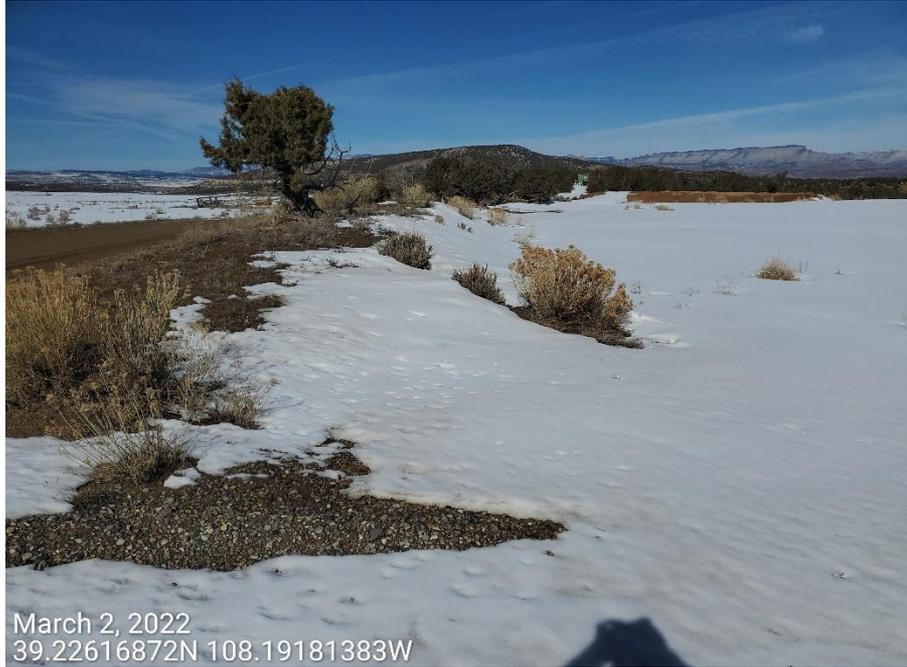
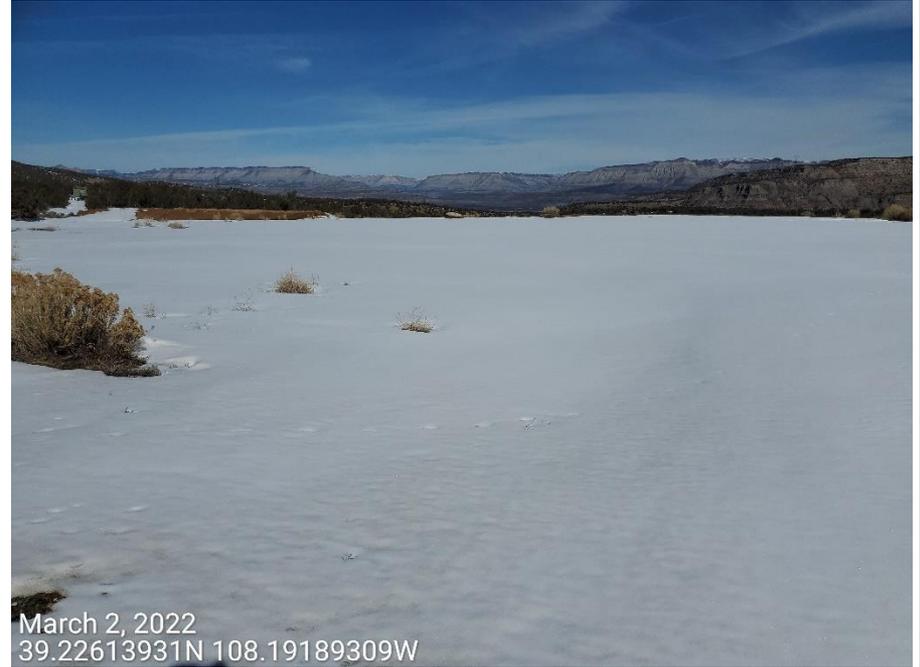
Photo 1: Photos taken from the south end of the Location. Photos 1-2 provide an overview of the Location from northwest, north, northeast to southeast. Photos show that final reclamation of the Location (recontouring/regrading/revegetation) has not been performed in accordance with 1004 rules.

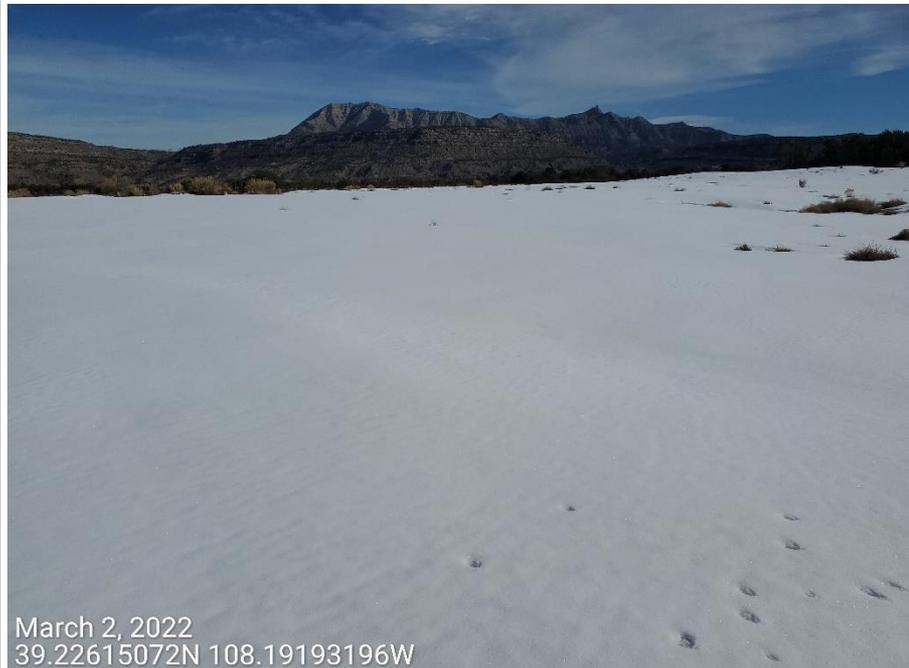
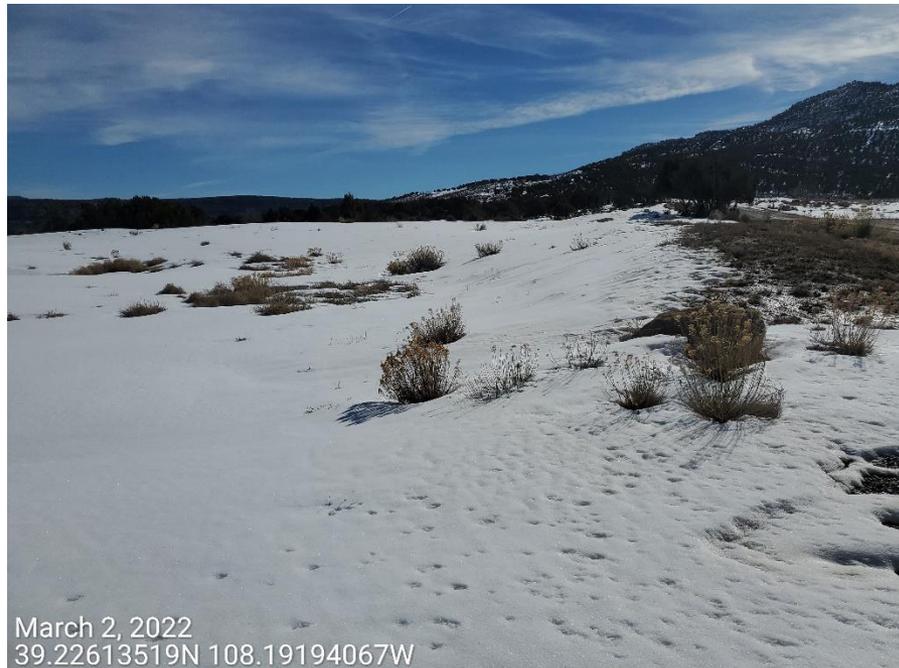
Photo 2: See comments under photo 1.

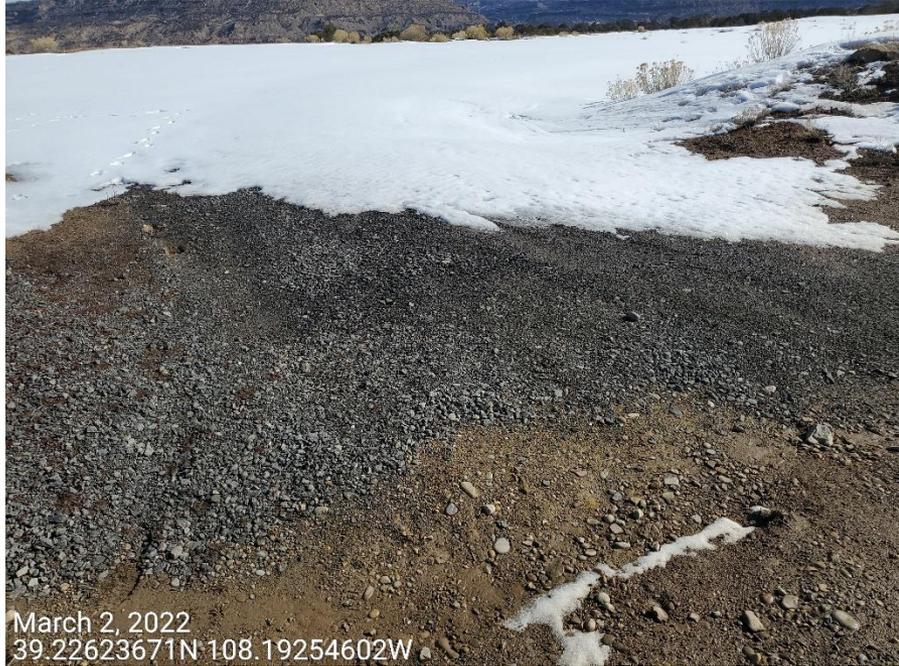
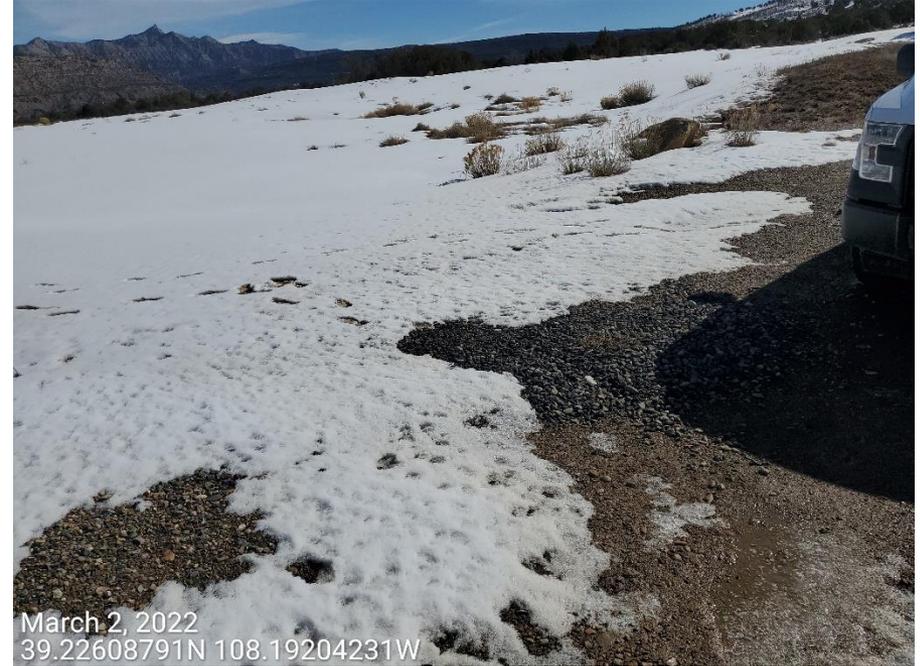
Photo 3: Photos taken from the two Location entrances on the south end of the Location. Photos show gravel/road base remaining on the Location.

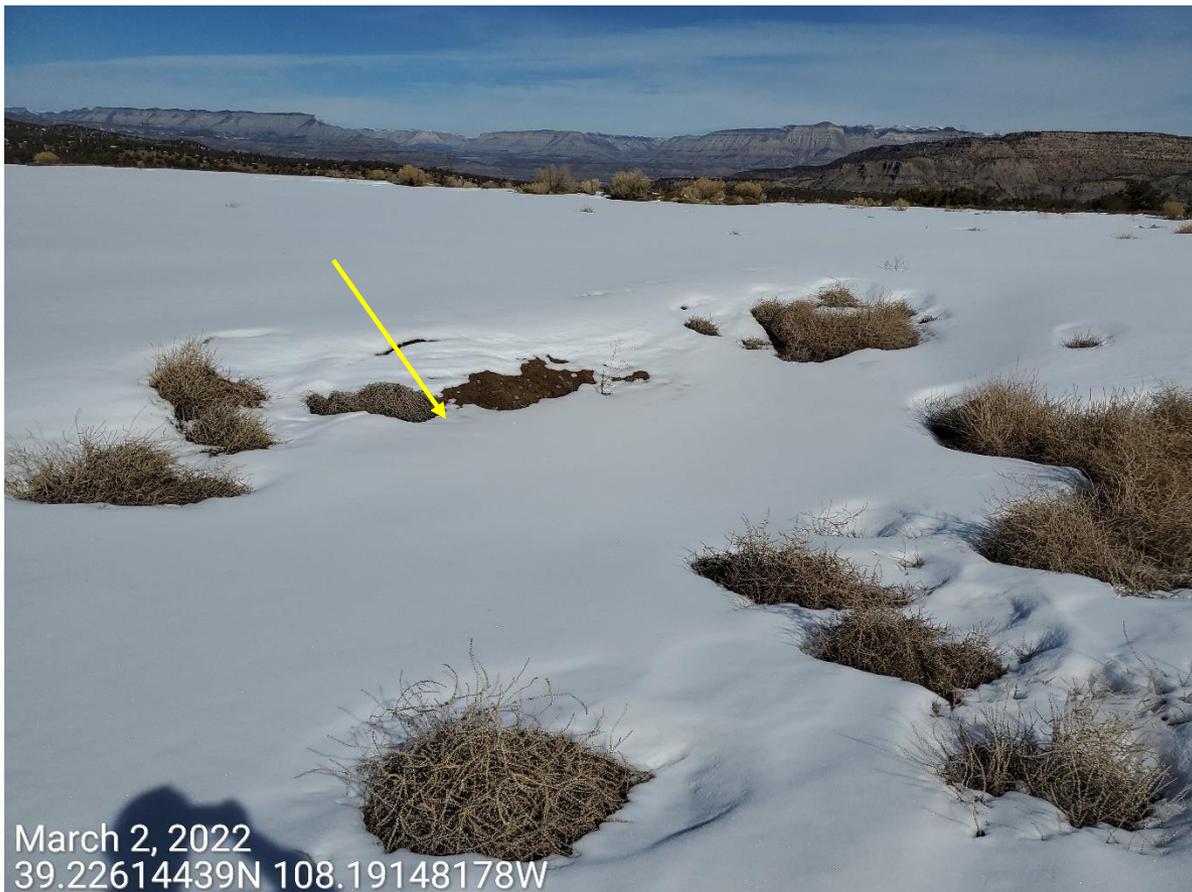
Photo 4: Photo taken from the east end of the Location, facing northwest. Photo shows areas of the Location where subsidence issues are evident or a pit remains.

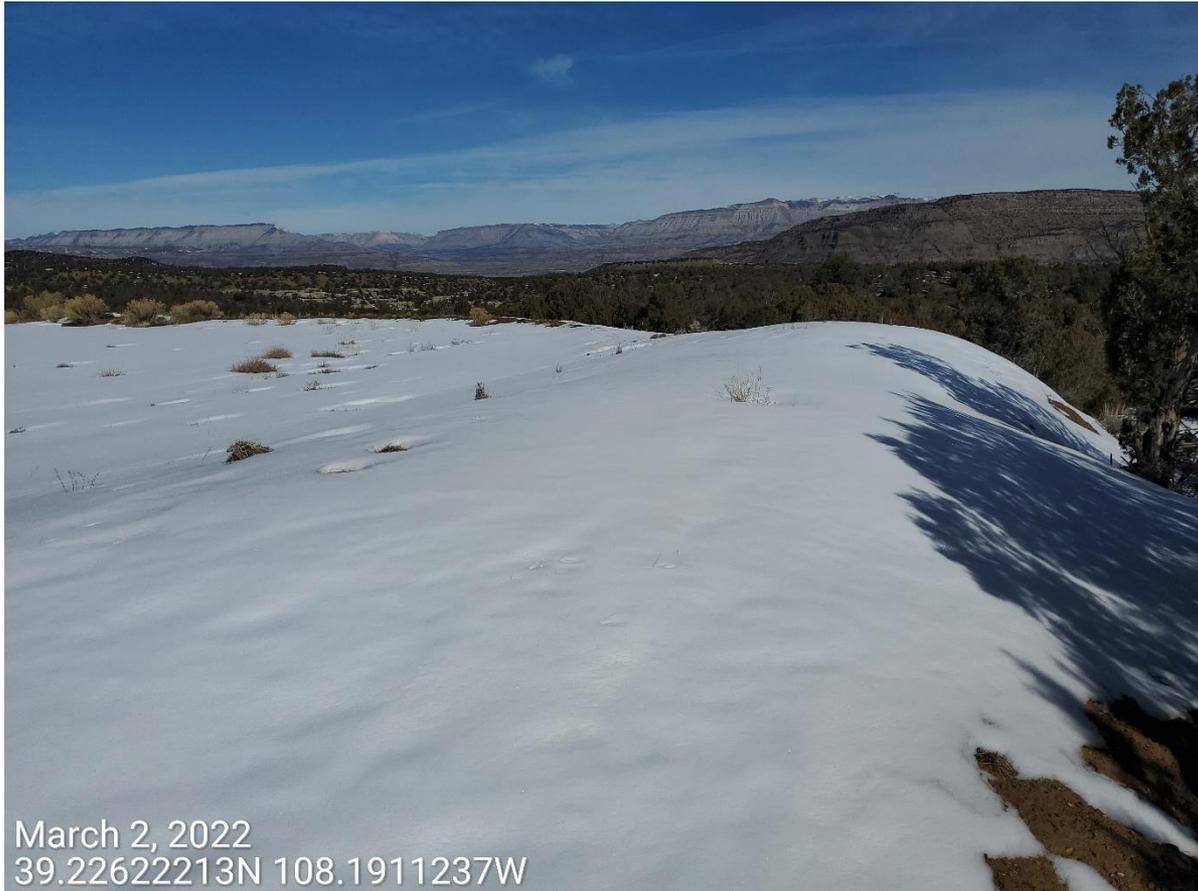
Photo 5: Photo taken from the east end of the Location facing north. Photo an example showing slopes of the Location have not been recontoured/reclaimed; cut/fill slopes remain evident.

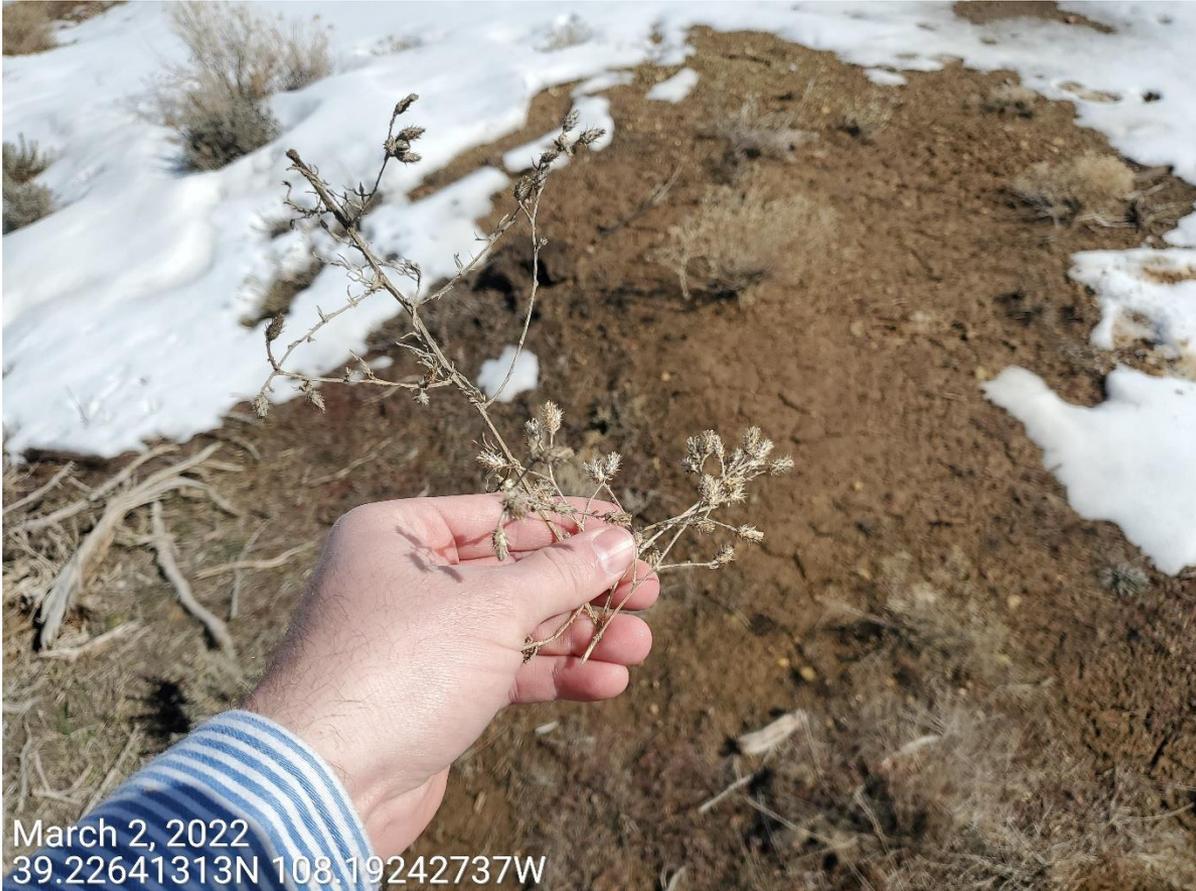
Photo 6: Photo shows example of noxious knapweed debris observed of the Location; vegetation evident on the Location is predominantly undesirable plant species, including Russian thistle.
