Inspection Photos

03/02/2022

Operator: GORDON ENGINEERING INC -
34720

Location ID: 312560
Mesa County, CO

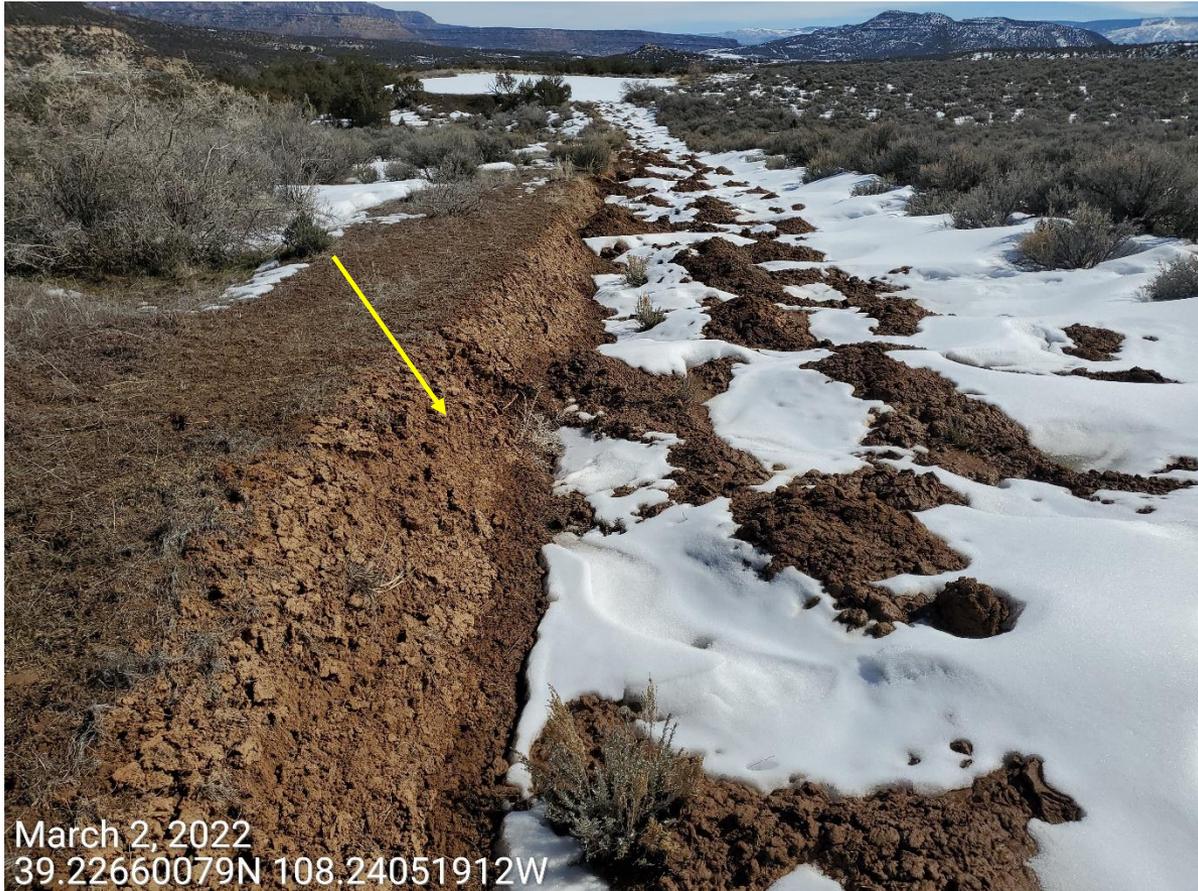
Photo 1: Photo taken from the access road, facing east. Photo taken from the access road. Photo example showing access road has not been recontoured/regraded/reclaimed in accordance with 1004 rules.

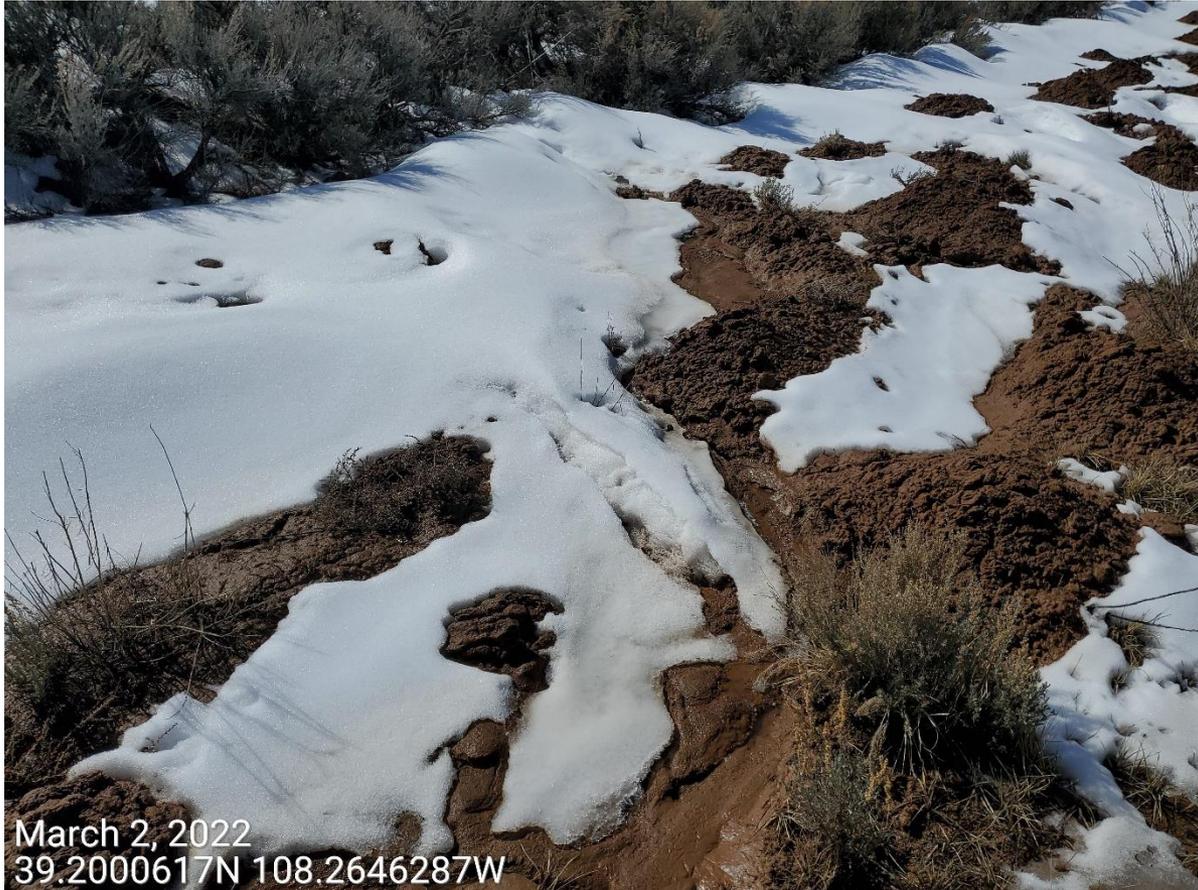
Photo 2: Photo taken from the access road. Photo shows Operator has “pot-holed” the access road. Soil piles resulting from this operation have been left loose and unstabilized, and is considered a pollutant source; sediment transport and erosion from the soil piles evident.

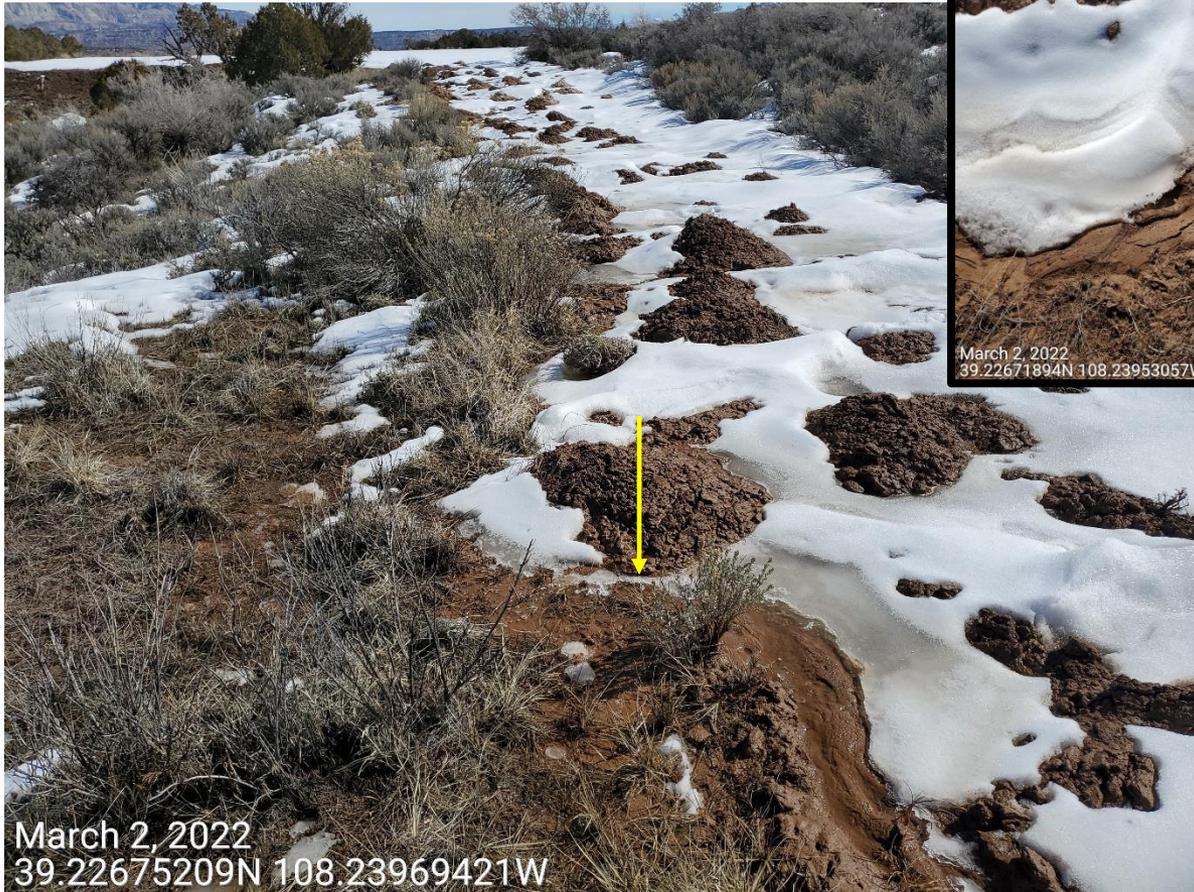
Photo 3: Continued from photo 2. Photo shows Operator has “pot-holed” the access road. Photos show sediment transport and deposition observed to do unstabilized soils at access road.

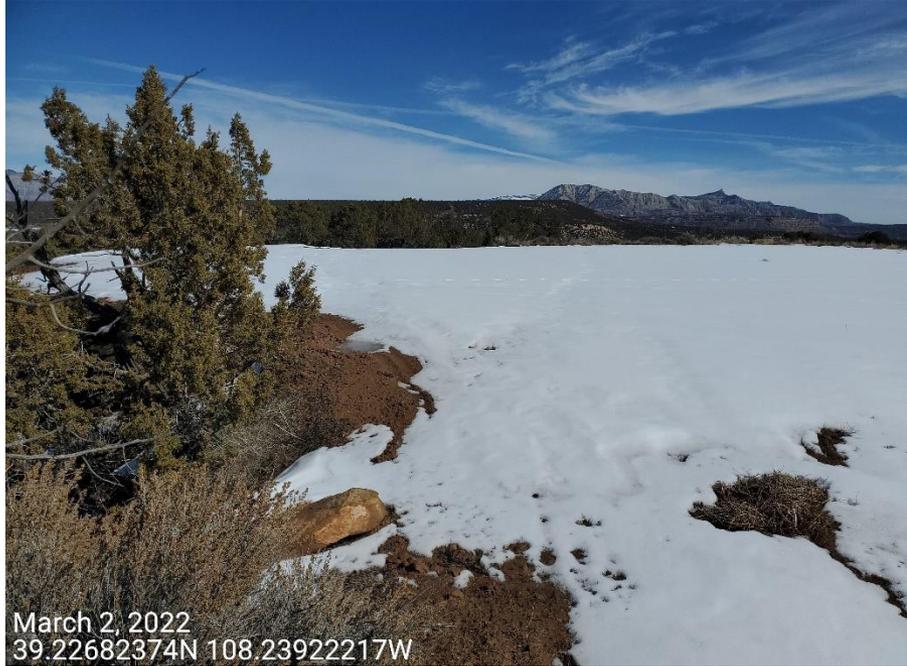
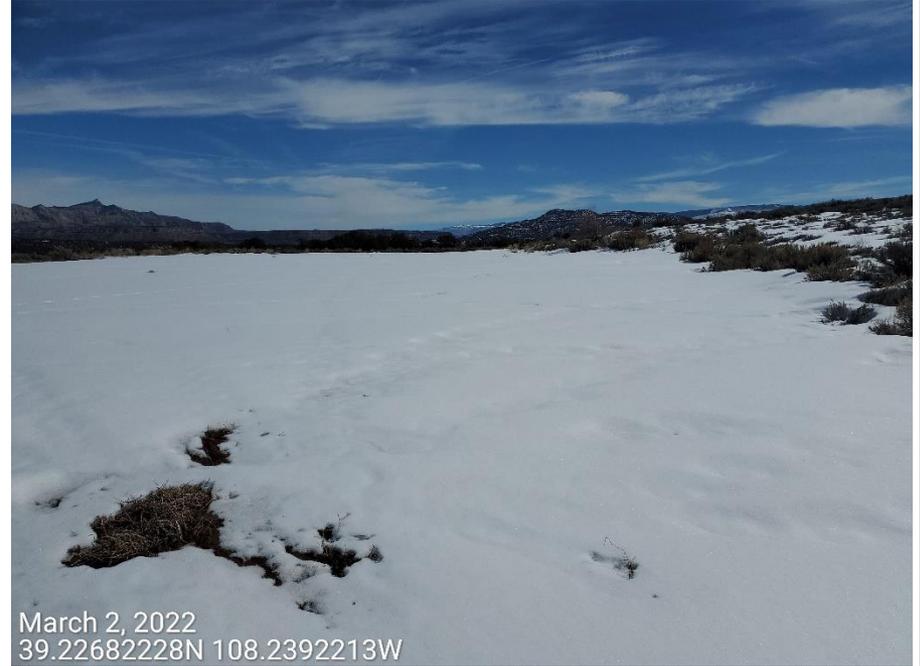
Photo 4: Photos taken from the west end of the Location facing northwest and east. Photos show Location has not been recontoured/regraded or reclaimed in accordance with 1004 Rules.

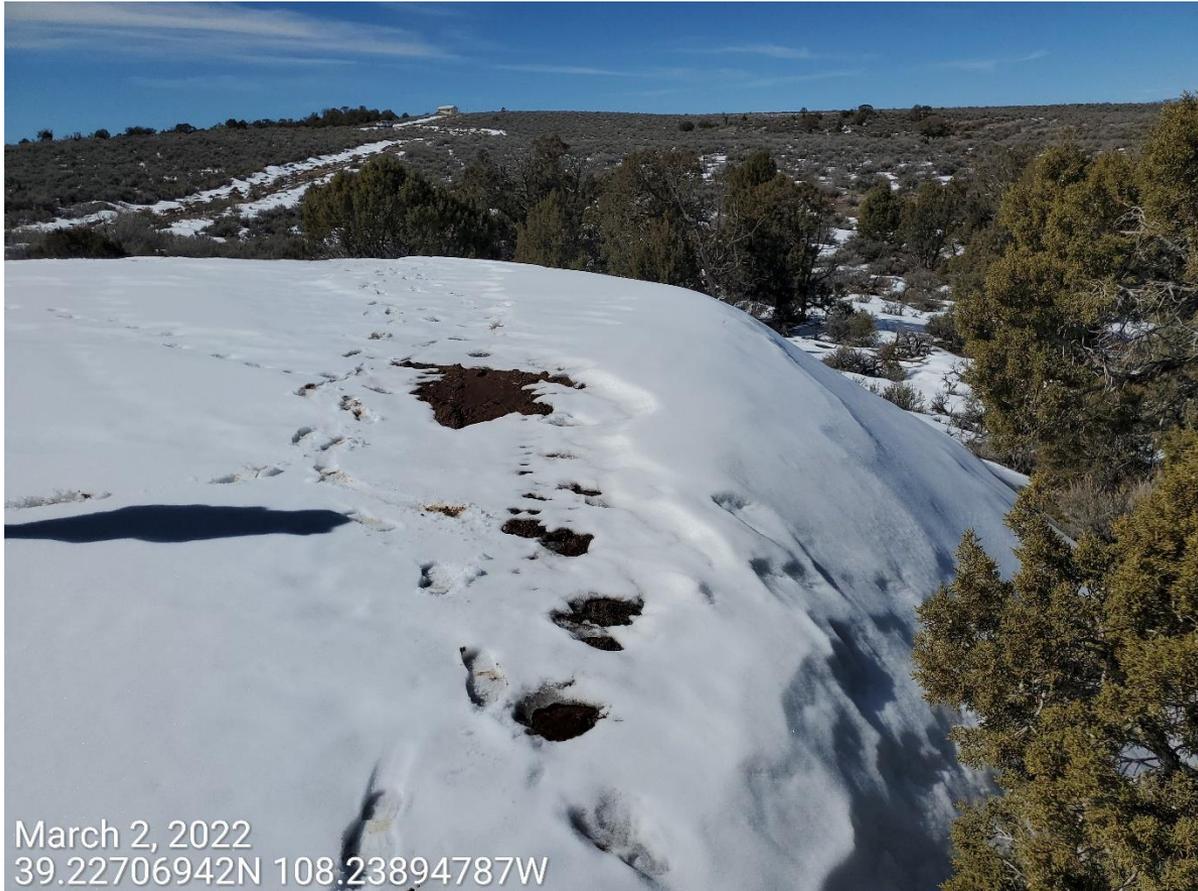
Photo 5: Photo taken from the northwest end of the Location. Photo provides example showing fill slopes; Location has not been recontoured/regraded and reclaimed in accordance with 1004 rules.
