# Inspection Photos

Operator: CAERUS PICEANCE LLC - 10456

Location ID: 312422

Mesa County, CO

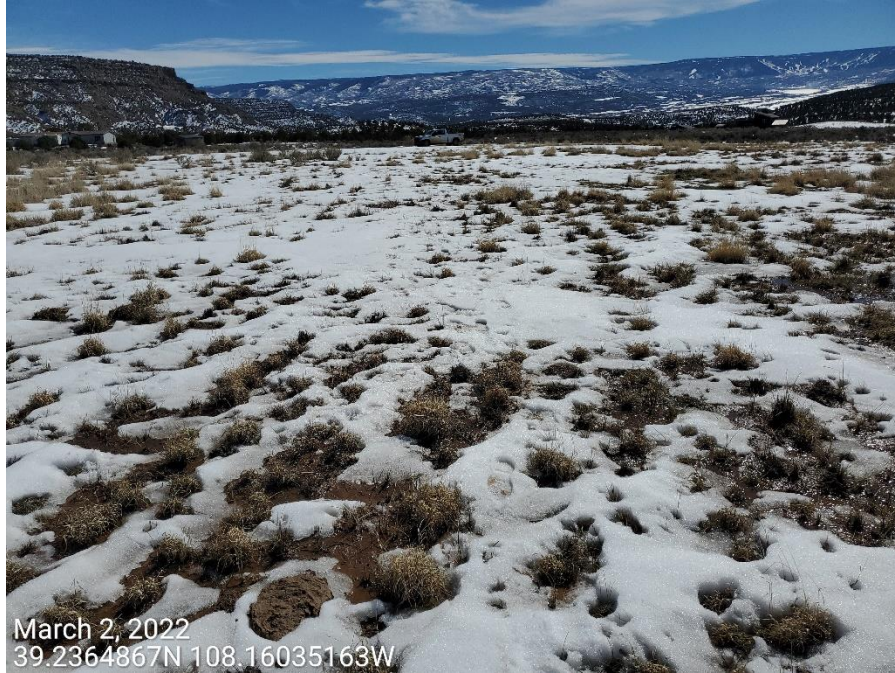
**Photo 1:** Photo left taken from the north end of the Location, facing south. Photo shows vegetative establishment on the north end of the Location appears to be progressing towards 1004 standards.

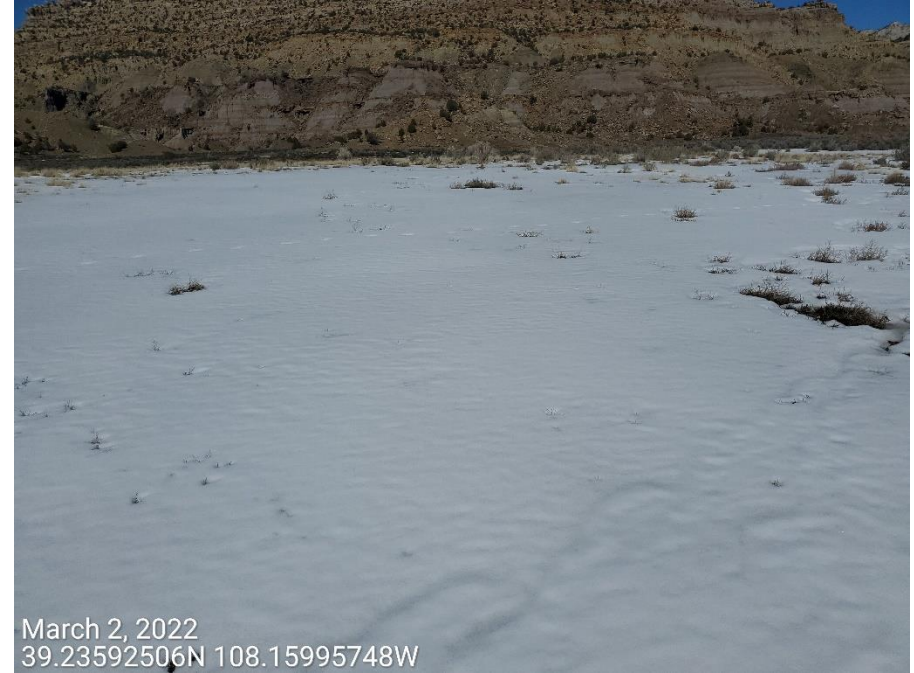
Photo right taken from the south end of the Location, facing northeast. Photo shows areas of the Location where desirable vegetative establishment was not evident; limited visibility due to snow cover prevent an accurate assessment of the reclamation, however these areas may require additional reclamation in order to meet 1004 standards. A followup inspection be conducted to determine compliance with 1004 Rules.
