Inspection Photos
Operator: Simcoe
API: 067-09336
Date: 3/2/2022

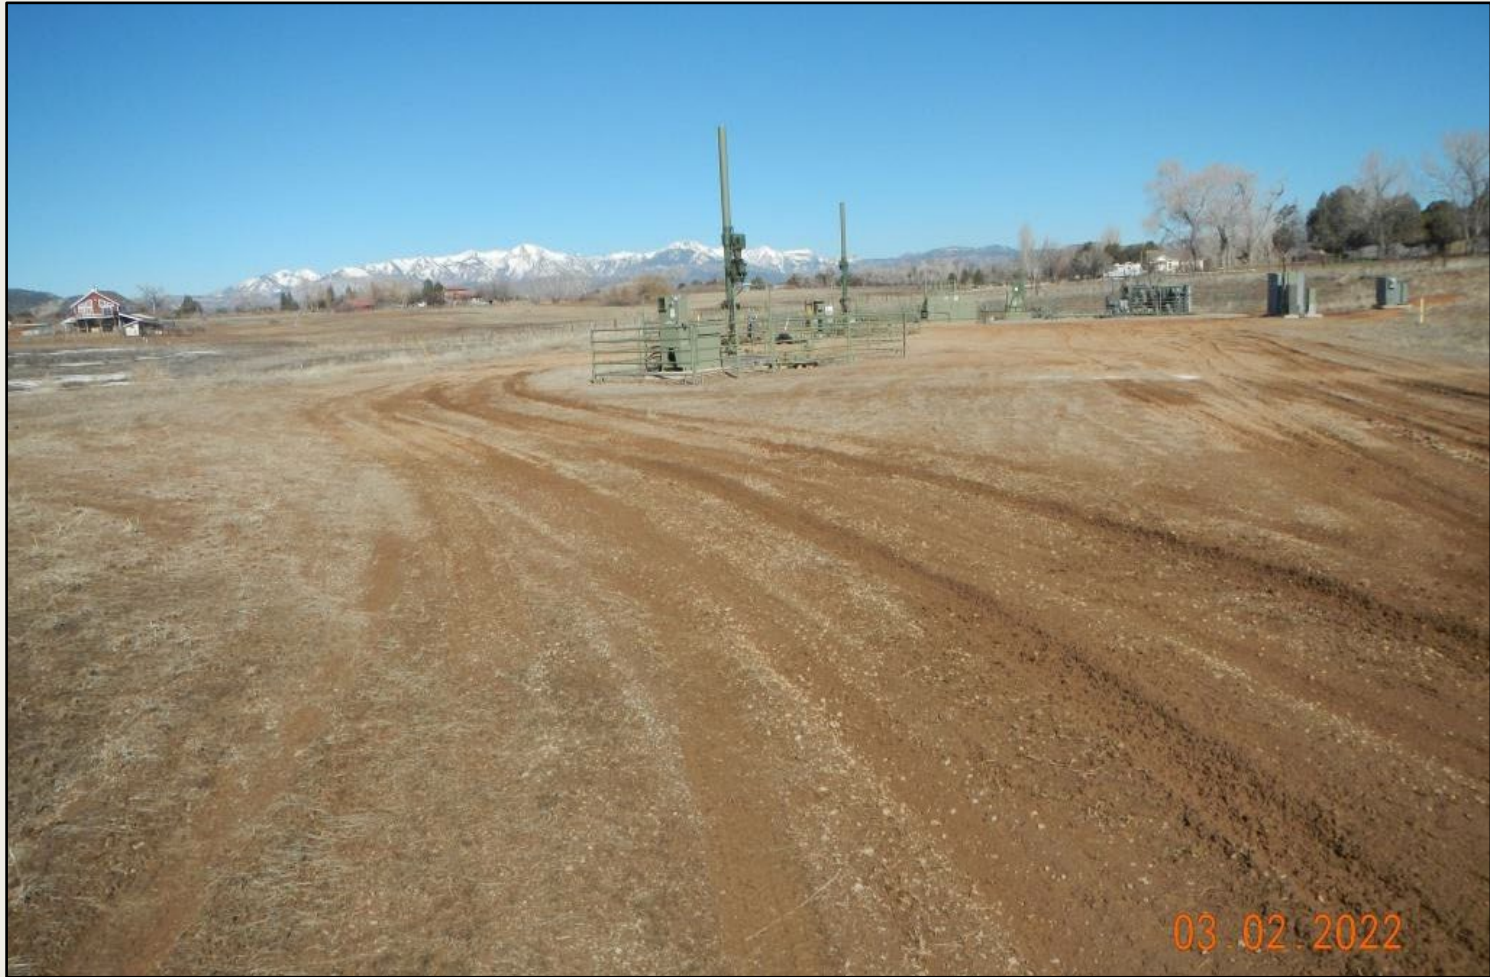
Photo 1. View of project area from the well pad entrance facing center.

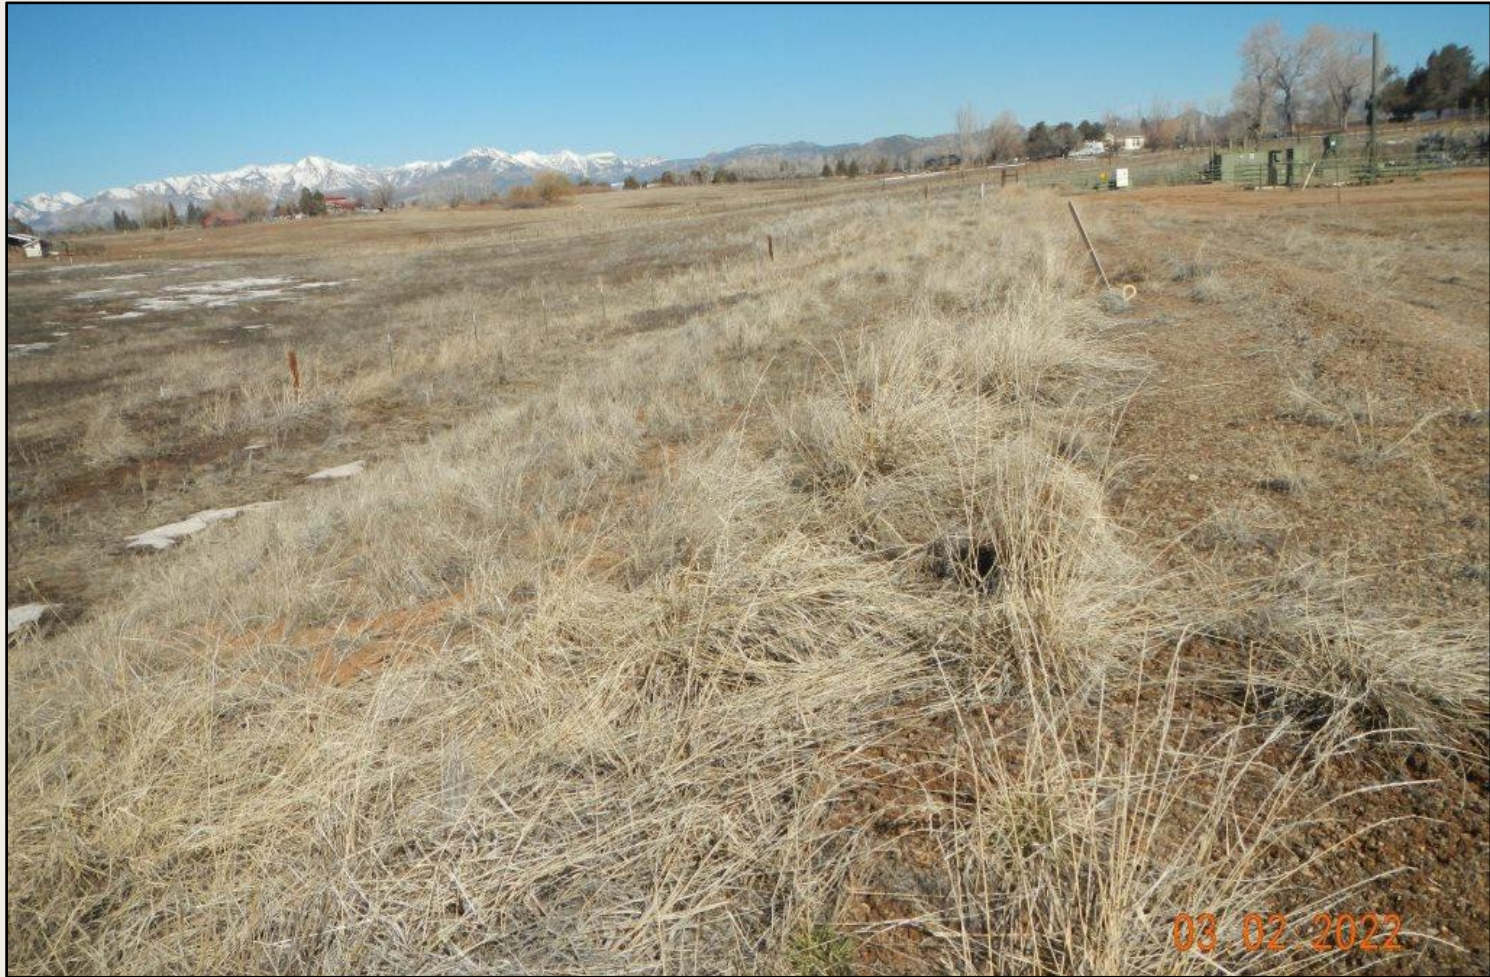
Photo 2. View of the western project area from the southwestern corner facing northward. Revegetation is progressing largely with intermediate wheatgrass, crested wheatgrass, and western wheatgrass.

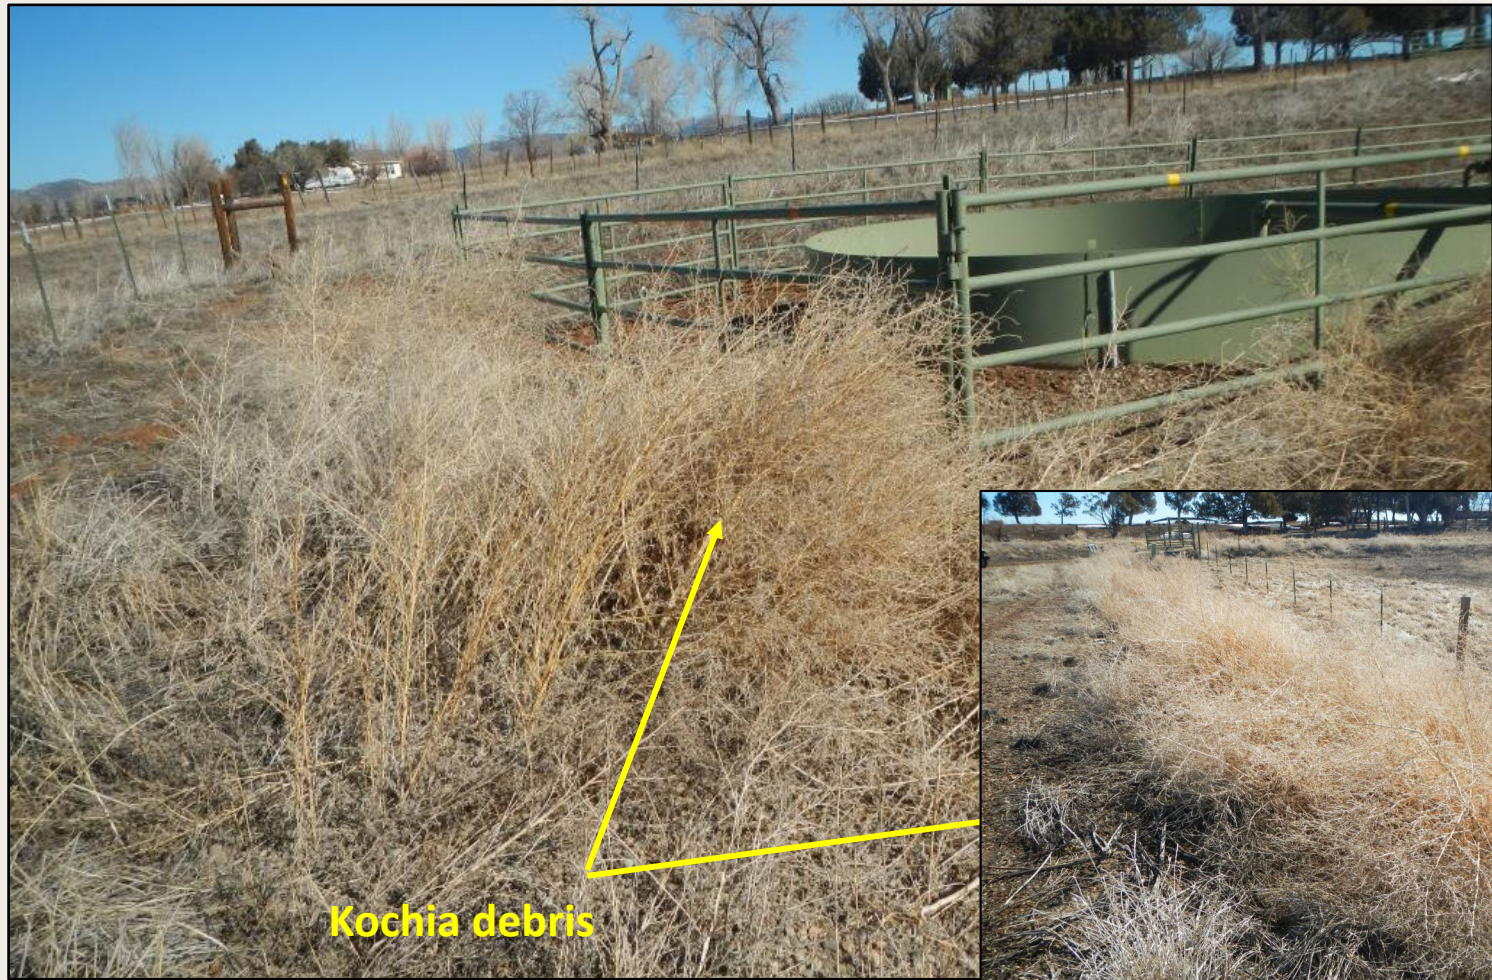
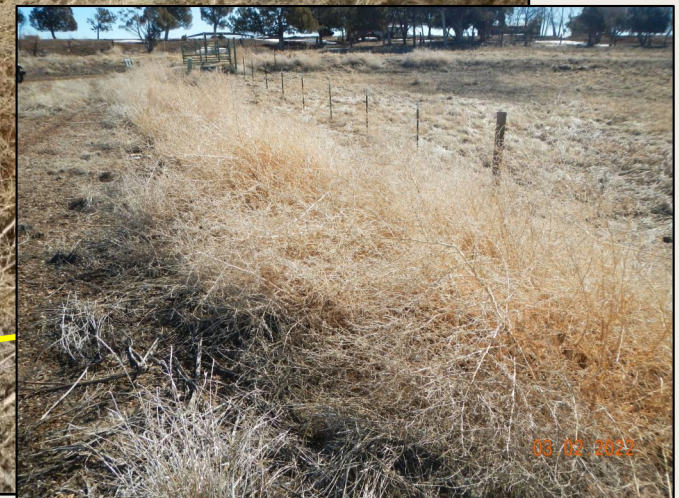
Photo 3. View of kochia debris, up to 4-ft tall observed on the well pad and in the southern project area (inset).

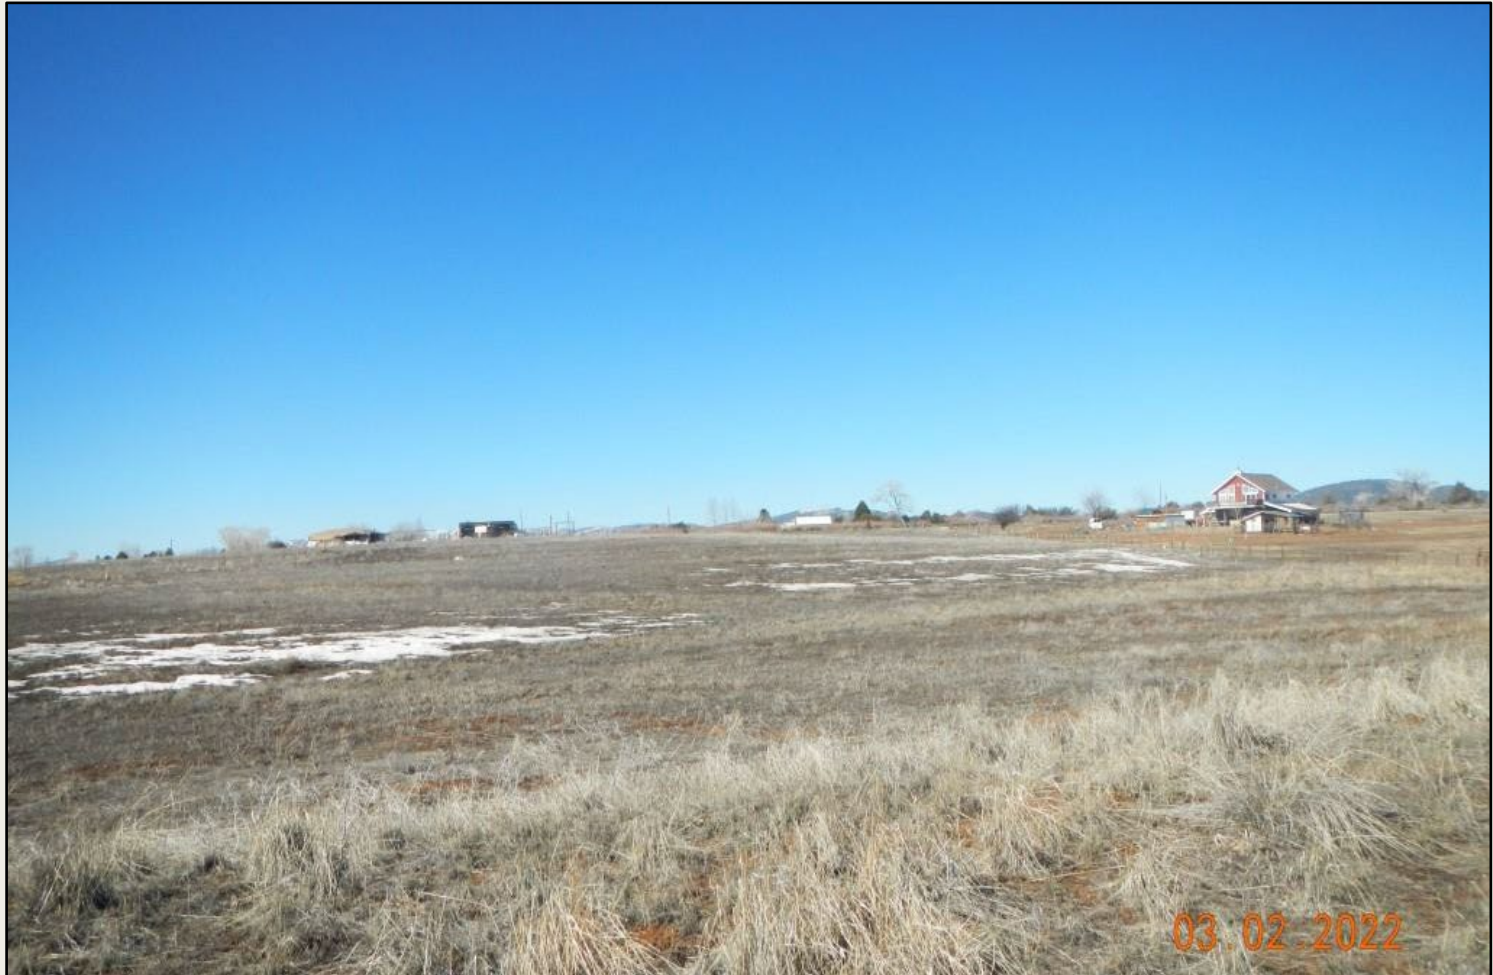
Photo 4. View of reference area comprised of open grass field with smooth brome, crested wheatgrass, and western wheatgrass observed.
