Inspection Photos
Operator: Simcoe
API: 067-07423
Date: 3/2/2022

Photo 1. View of project area from the well pad entrance facing center.

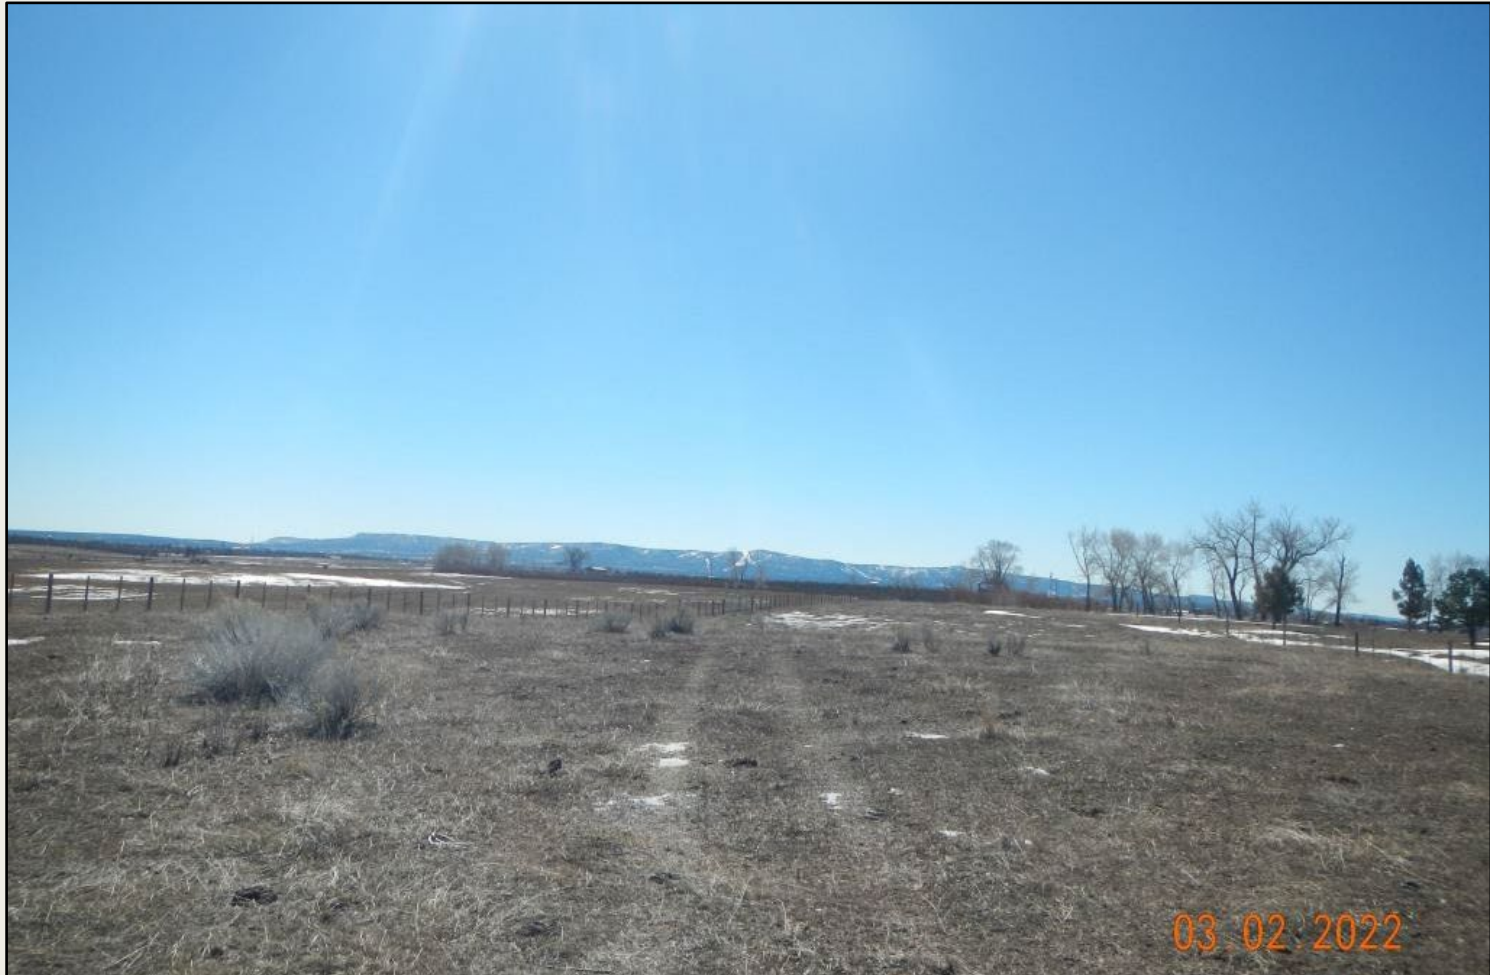
Photo 4. View of reference area comprised of open grass field mixed with sagebrush shrubland, crested wheatgrass, and western wheatgrass observed.
