Interim Reclamation and Stormwater Inspection

March 7, 2022

Location Name: Circle B Land Tract 5 /21-692

Inspection Document #: 702800013

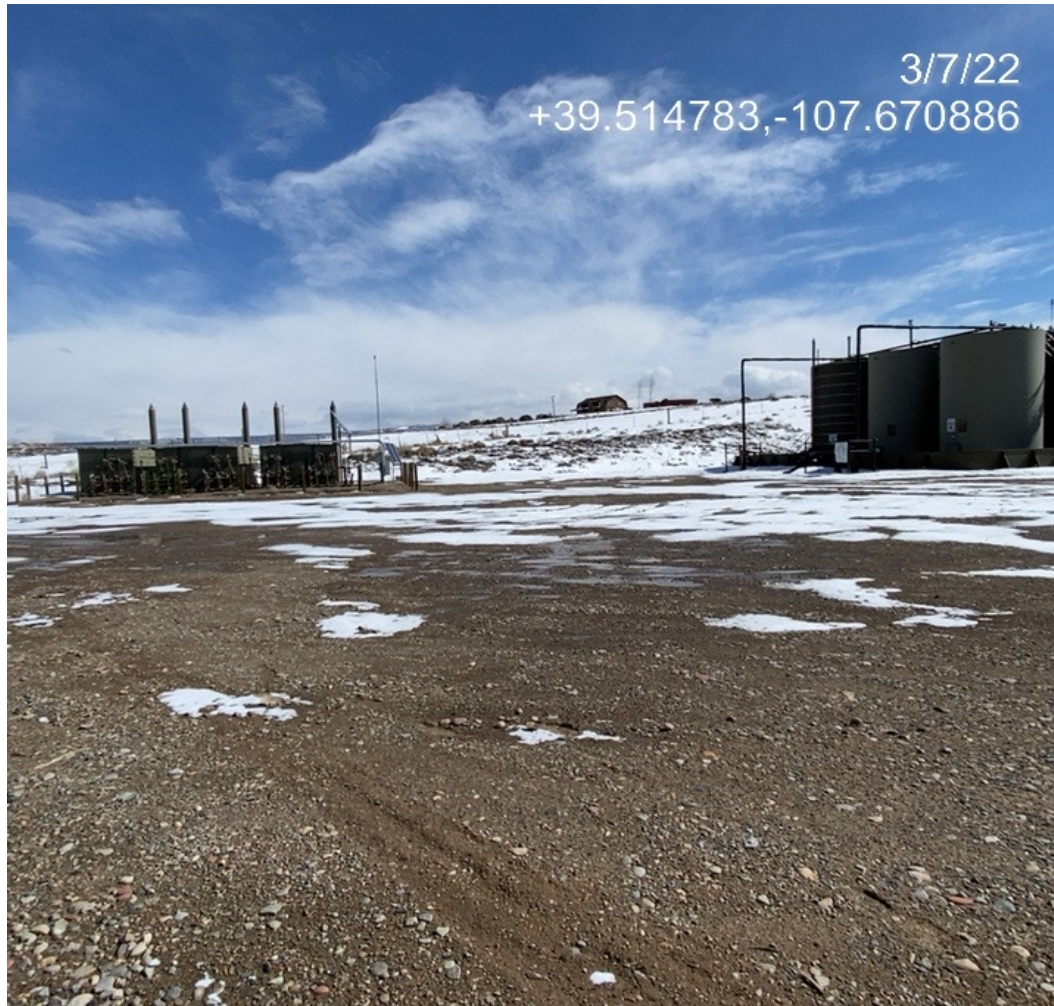
Photo 1. Photo taken from the northern production area facing southeast shows an overview of the eastern portion of the Location.

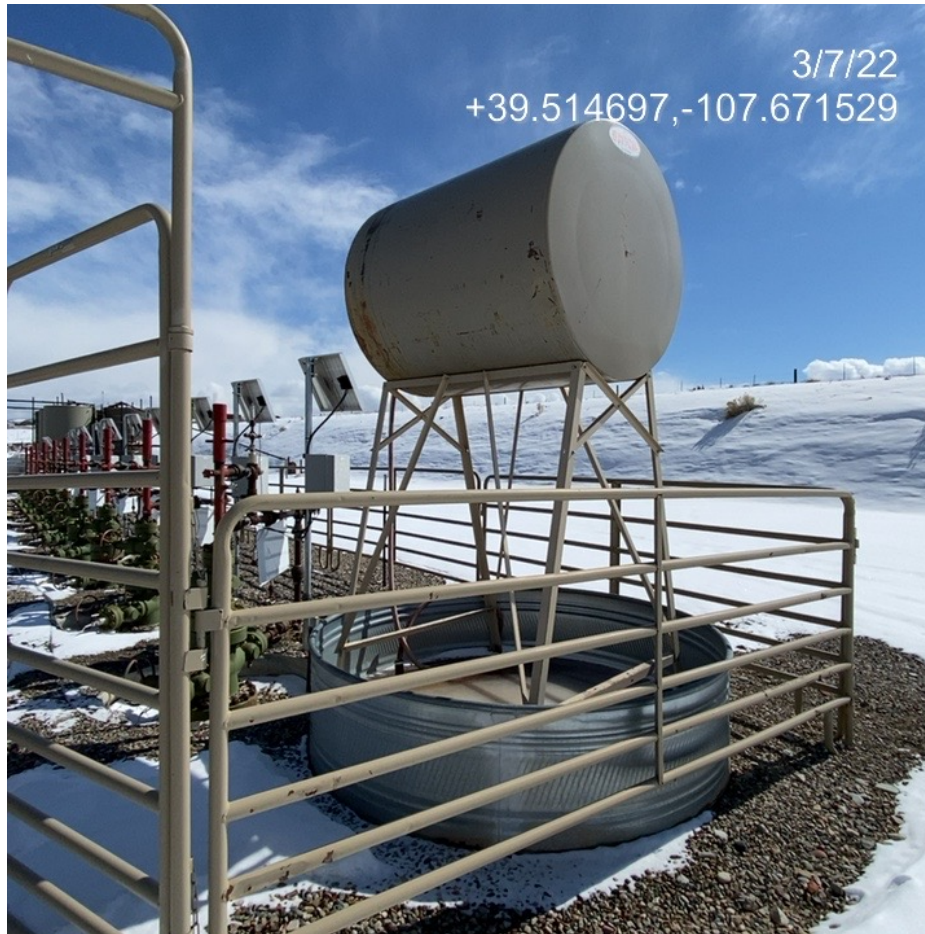
Photo 2. Photo taken from the southwestern production area facing south shows wildlife protection control measures are absent on the stock tank located within the well area.

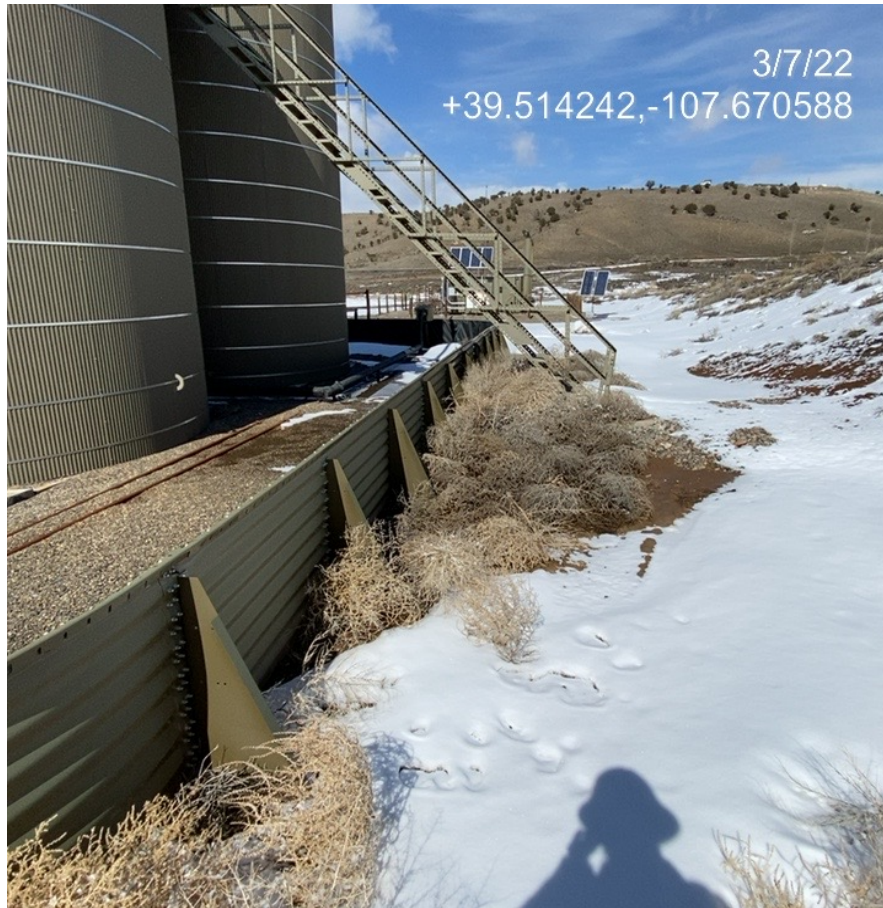
Photo 3. Photo taken from the southeastern production area adjacent to the tank battery facing north shows weed debris accumulating around equipment in the production area.

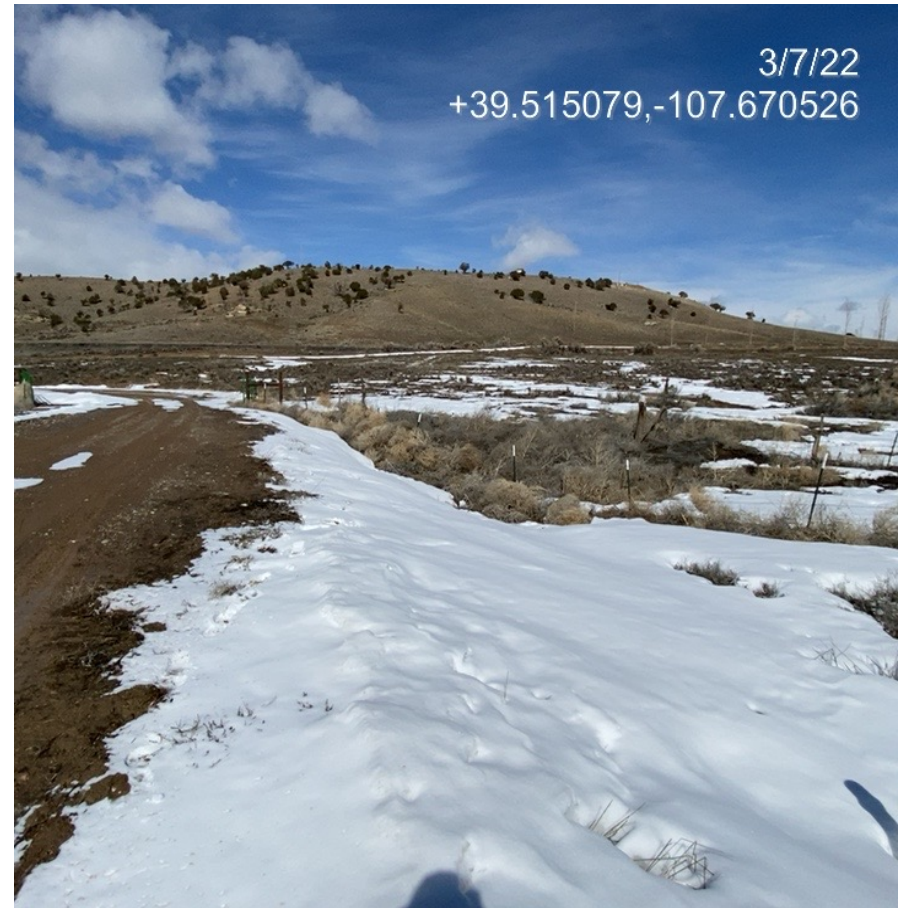
Photo 4. Photo taken from the northern entrance to the location facing north shows weed debris accumulating along fences in the interim areas.

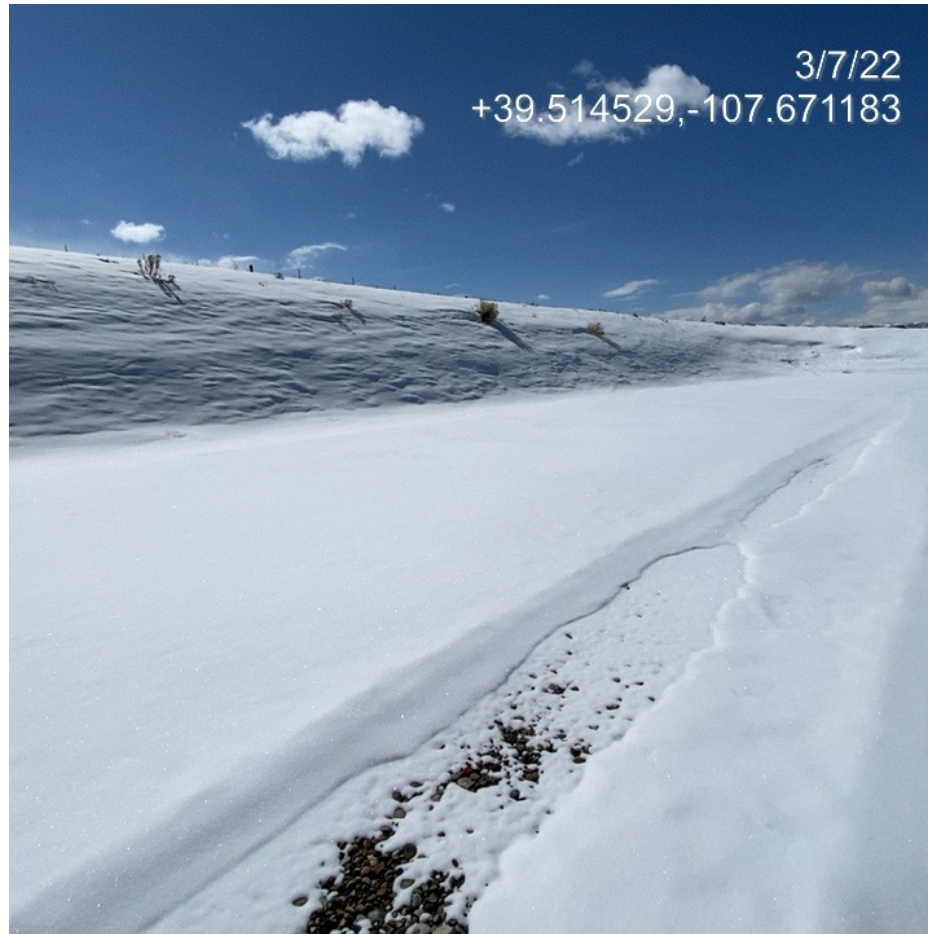
Photo 5. Photo taken from the south of the Location facing south shows slopes covered in snow. A follow up inspection is necessary to properly asses stormwater management and interim reclamation.

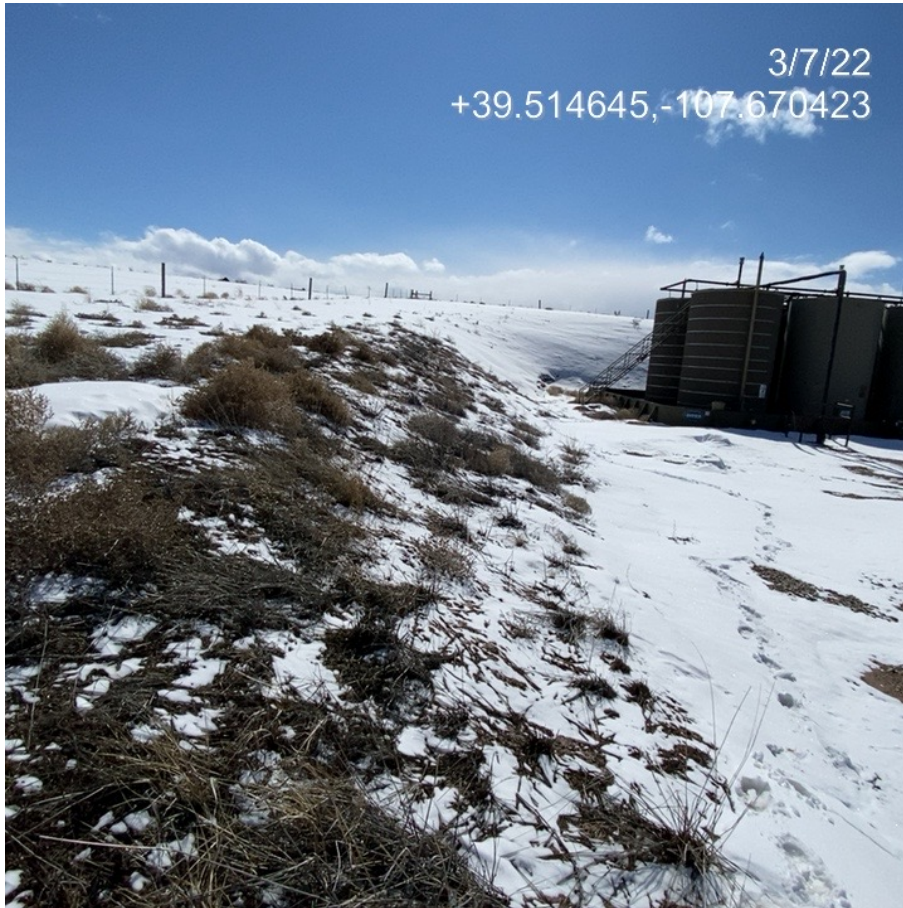
3/7/22
+39.514645,-107.670423

Photo 6. Photo taken from the east of the Location facing south shows slopes partially covered in snow. A follow up inspection is necessary to properly asses stormwater management and interim reclamation.

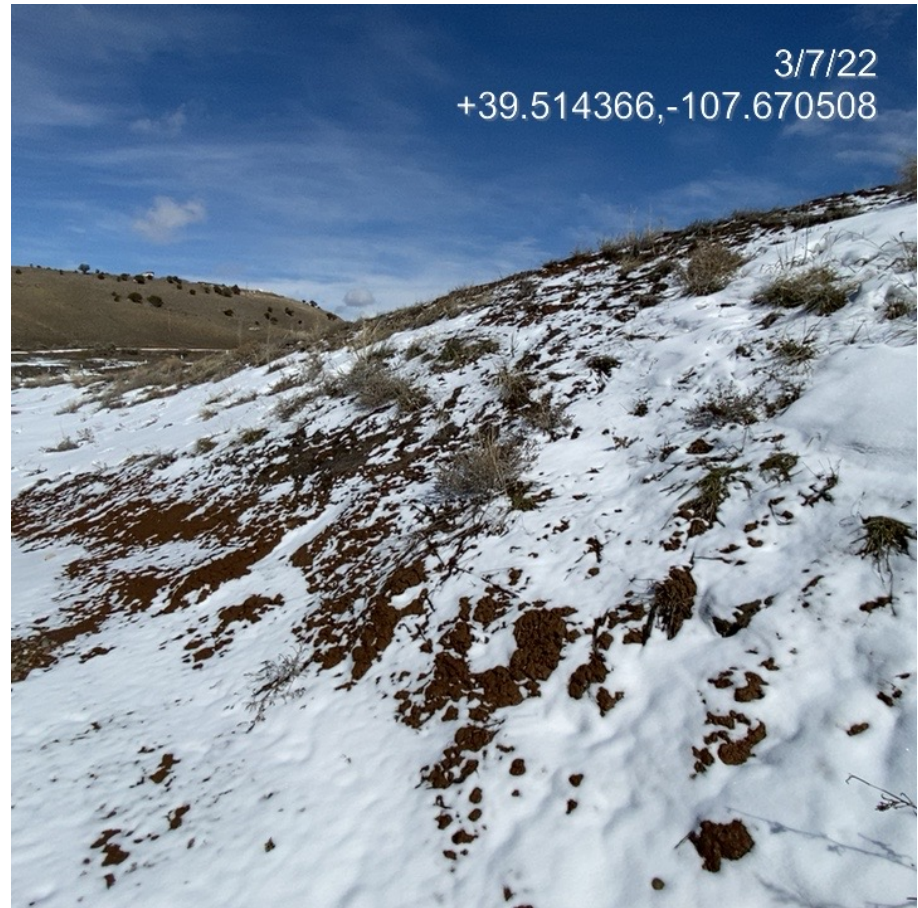
3/7/22
+39.514366,-107.670508

Photo 7. Photo taken from the east of the Location facing north. Refer to photo 6 for additional comments.
