Inspection Photos
Location Name: Abbott 10-43
Location ID: 320523

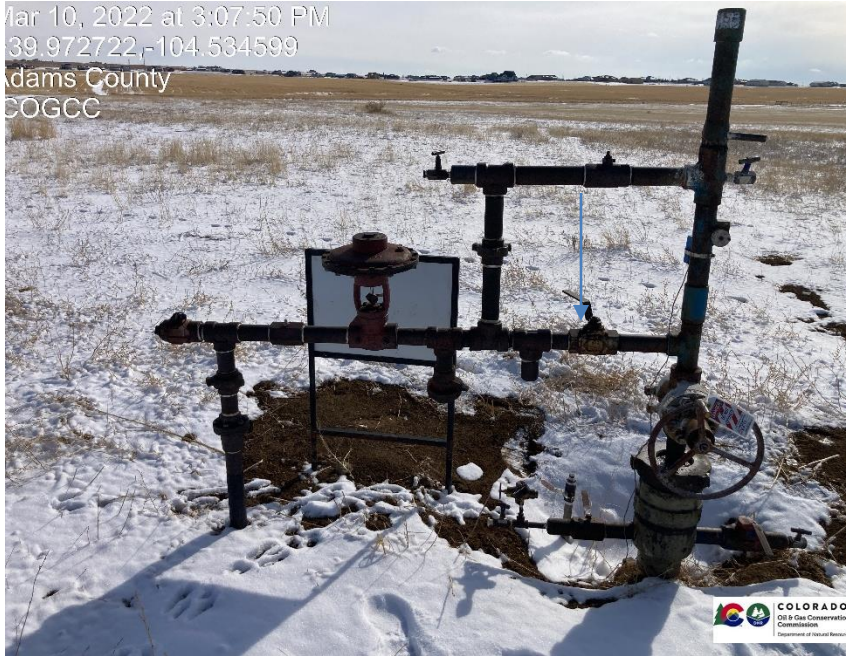
Pic 1 wellhead, At time of inspection all valves were in close position except one valve that is seized slightly open valves downstream of seized valve are in close position.
