Inspection Photos

Operator: TEP ROCKY MOUNTAIN LLC - 96850

Location ID: 334947

Garfield County, CO

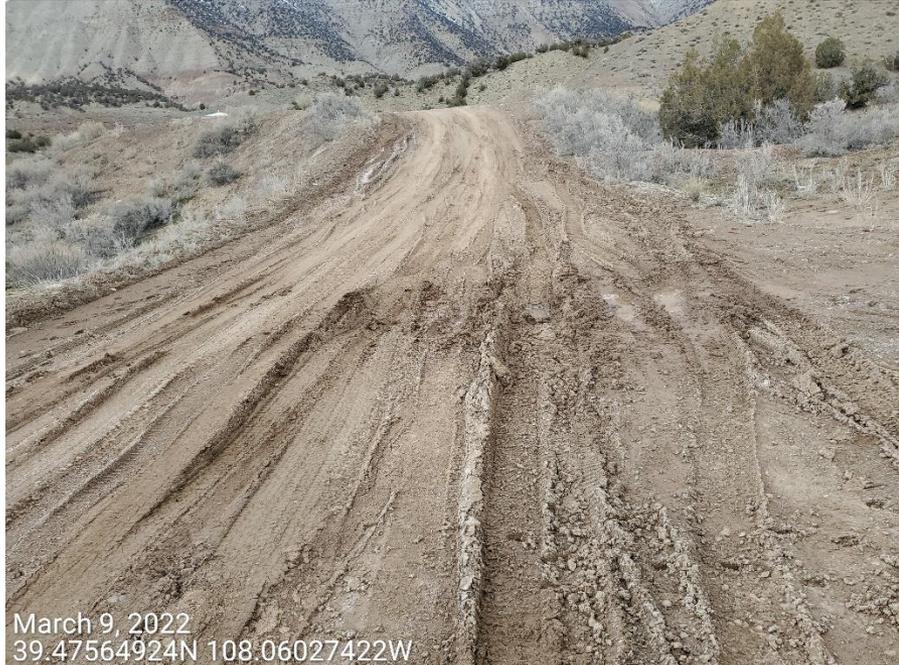
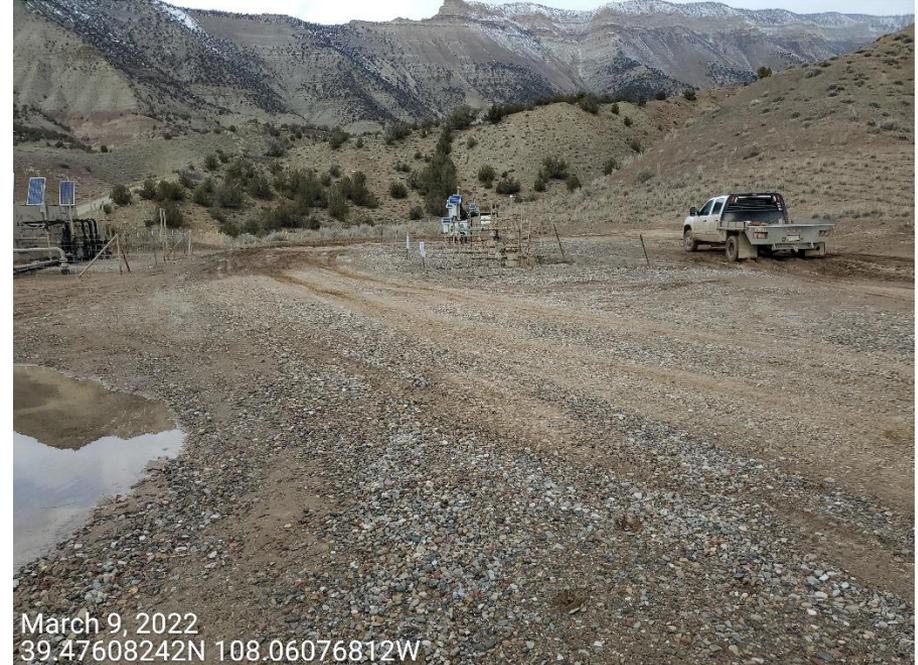
Photo 1: Photo left taken from the access road leading to the Location. Photo right taken from Location entrance. Photos facing North. Photos show control measures / BMPs to stabilize and minimize tracking/sediment transport from the road and Location remains missing or insufficient.

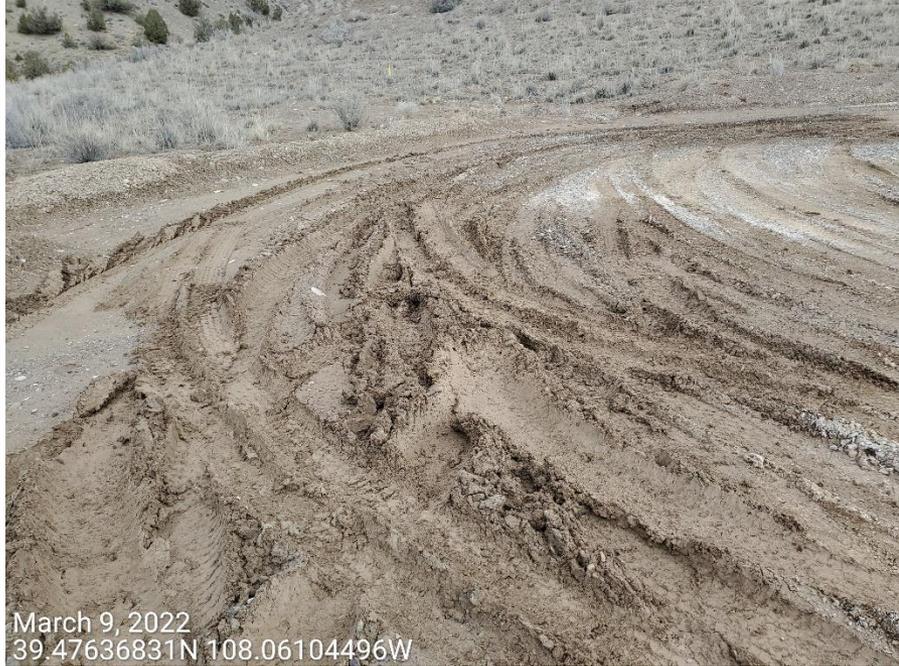
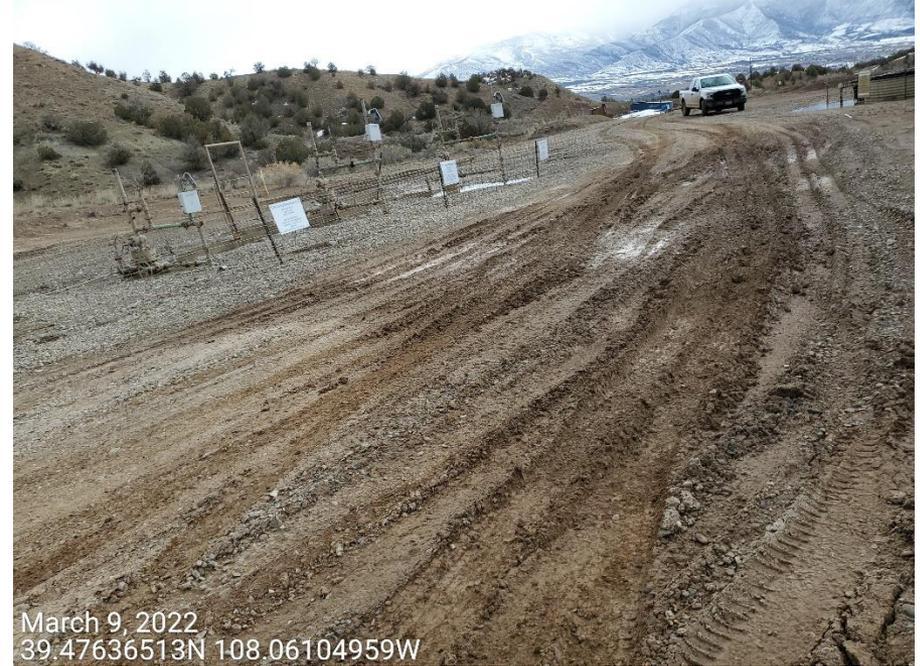
March 9, 2022
39.47636831N 108.06104496W

Photo 2: Photos taken from the Location. Photos examples showing control measures / BMPs to stabilize and minimize tracking/sediment transport from the road and Location remains missing or insufficient.

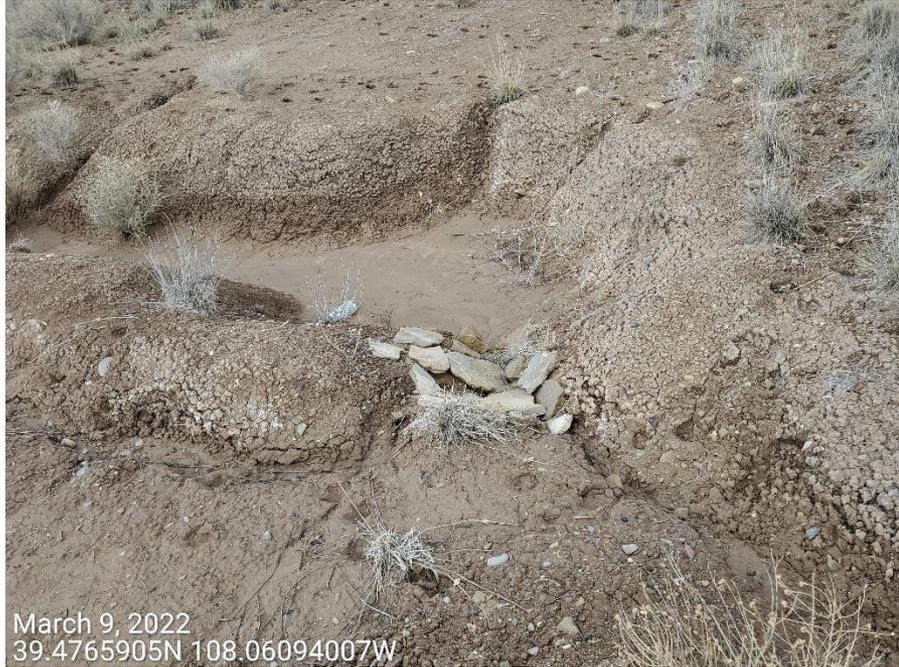
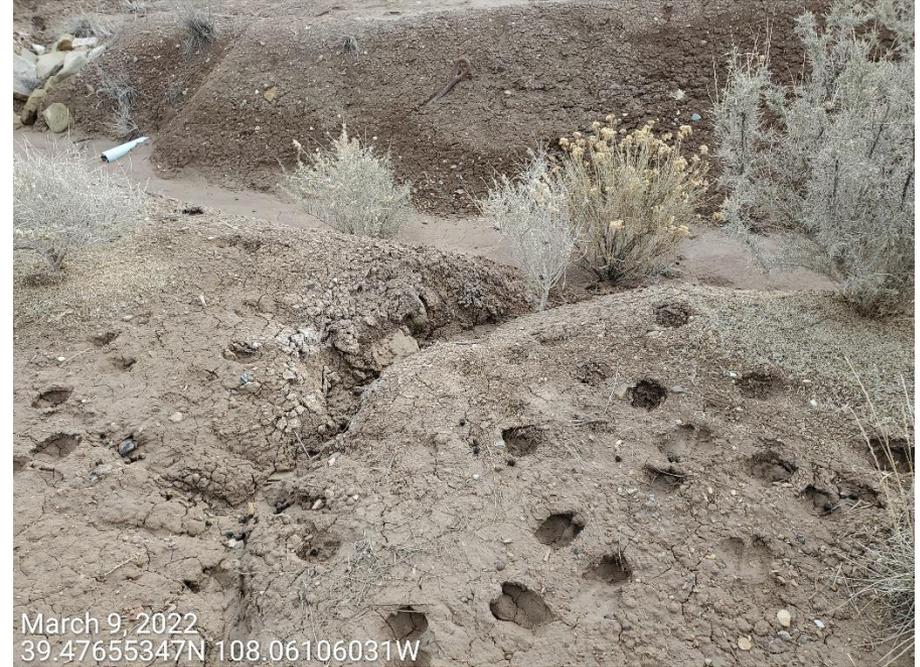
Photo 3: Photos taken from the sediment trap and stormwater outlet on the north end of the Location. Photos show BMP has not been installed in accordance with good engineering practices, or maintained in proper functioning condition.

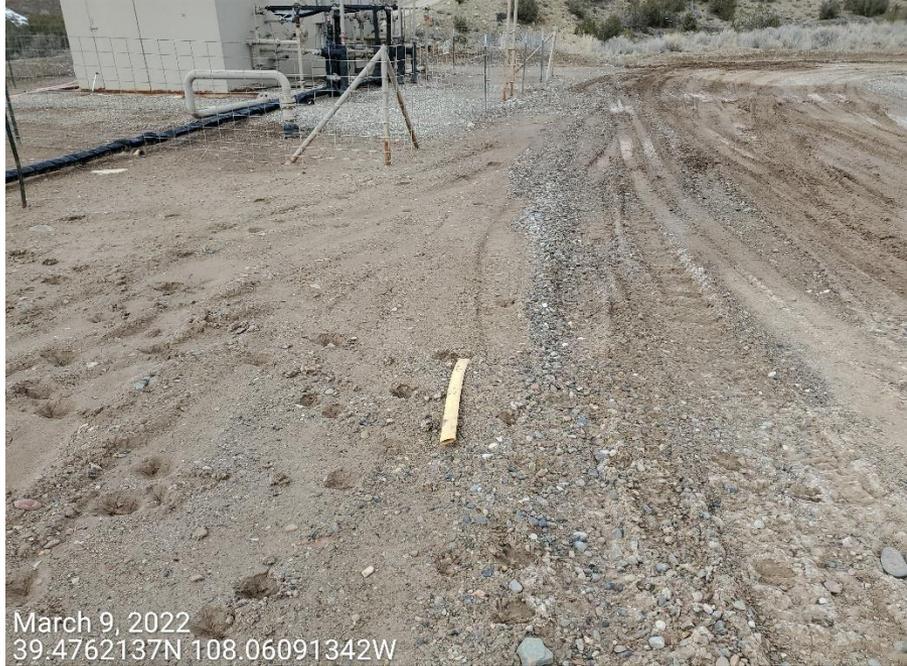
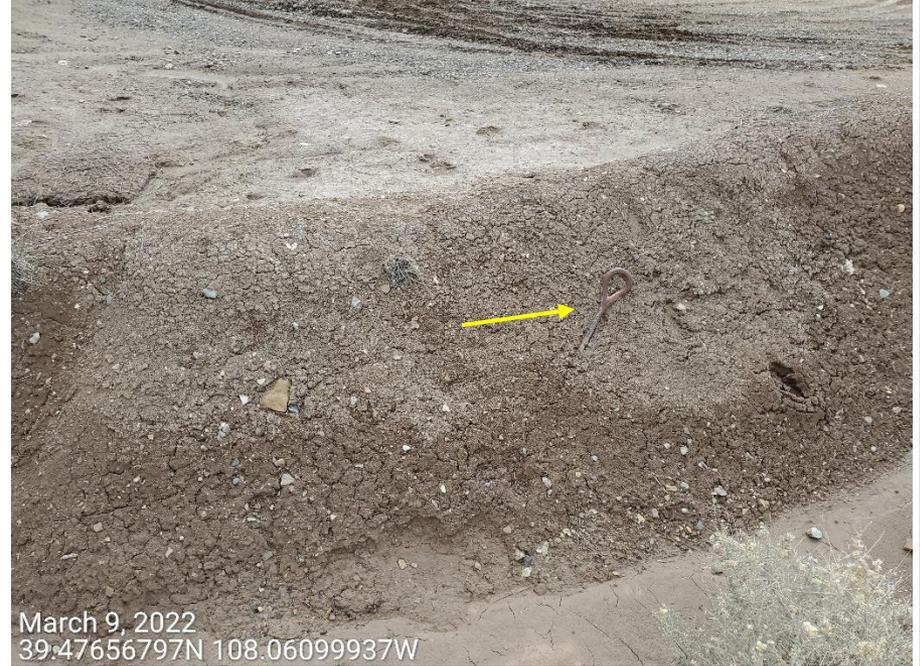
March 9, 2022
39.4762137N 108.06091342W

Photo 4: Photos examples showing markers at anchors on Location are missing, or in disrepair.

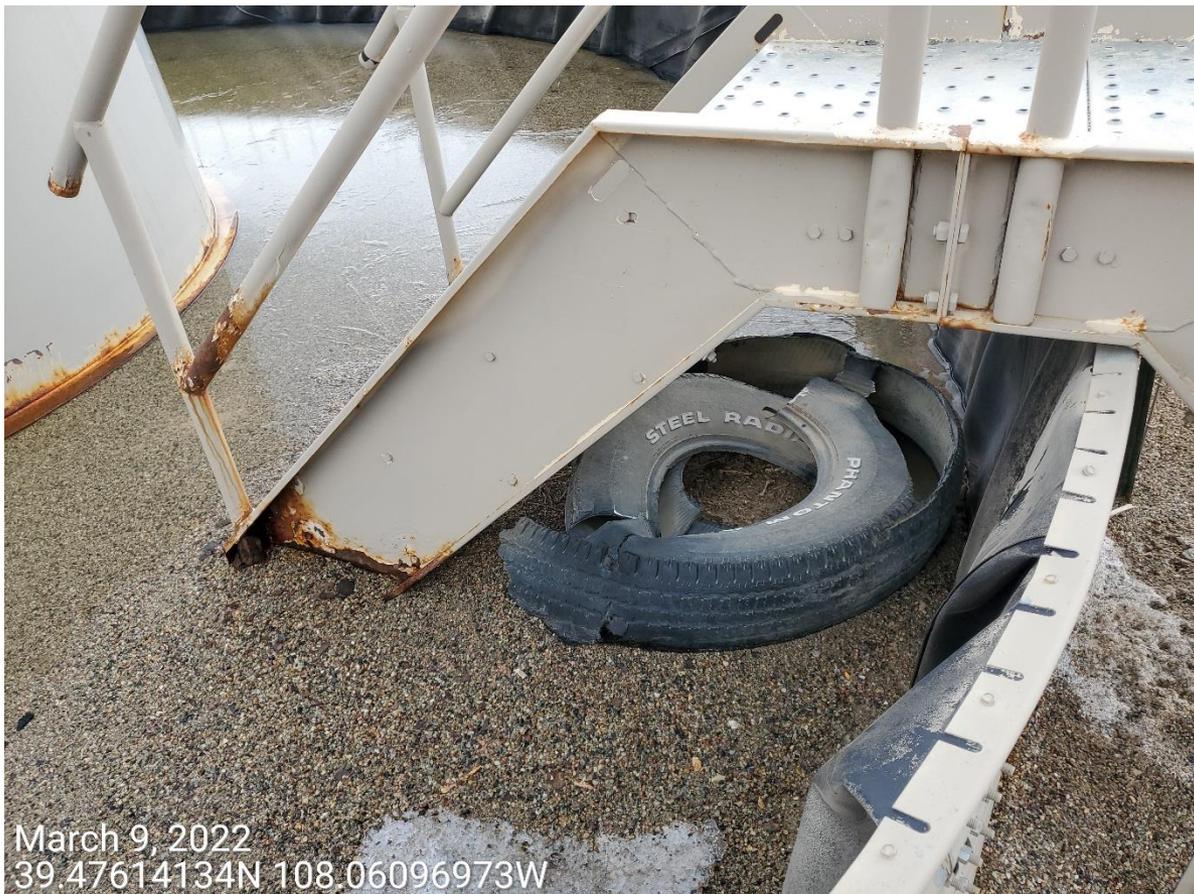
Photo 5: Photo shows trash debris improperly stored within the secondary containment of the tank battery.
