Inspection Photos

Operator: TEP ROCKY MOUNTAIN LLC - 96850

Location ID: 334716

Garfield County, CO

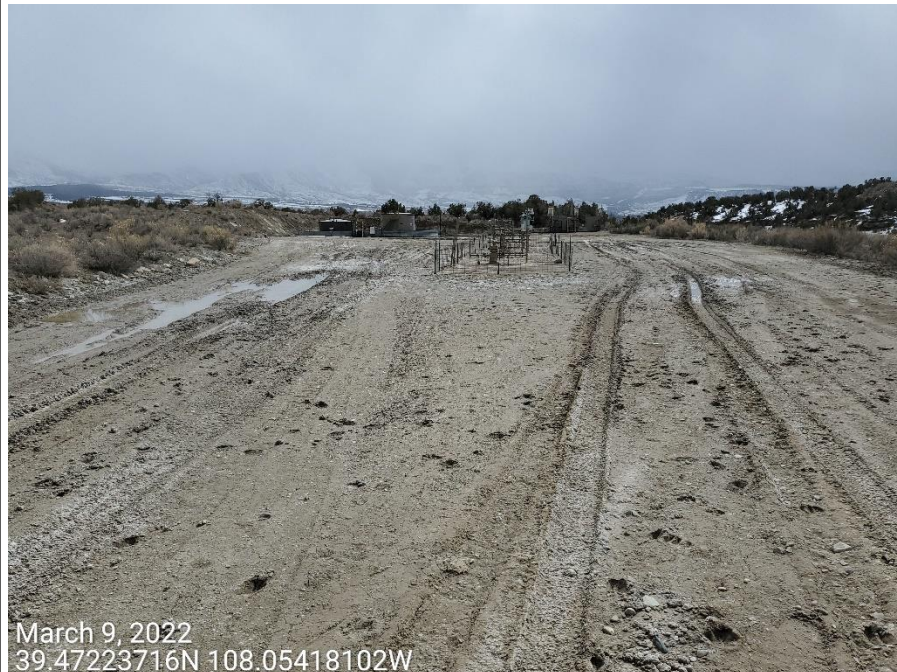
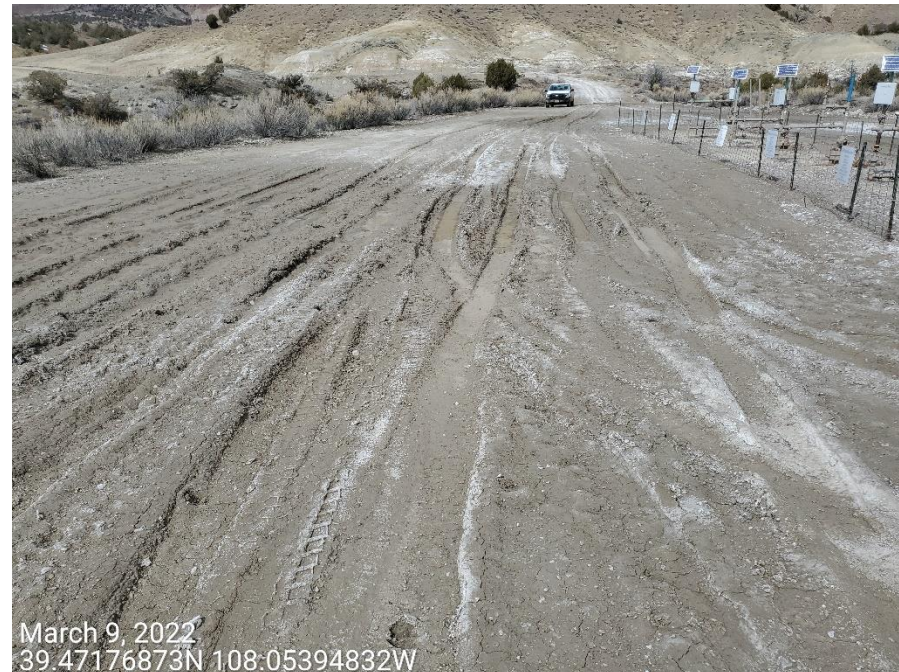
Photo 1: Photos taken from the Location and provide examples showing control measures / BMPs to stabilize the Location and address tracking issues remains missing or insufficient.

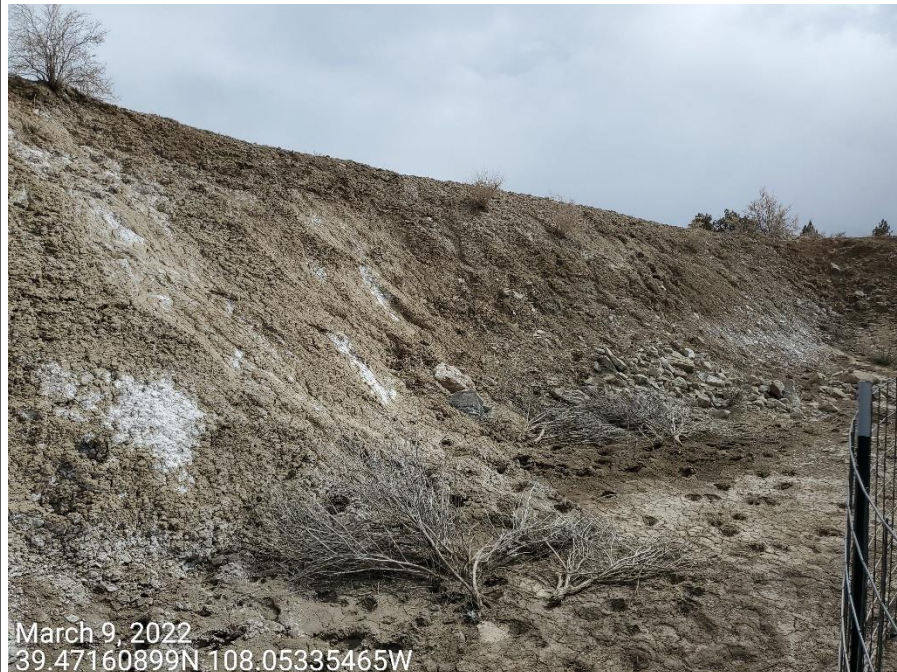
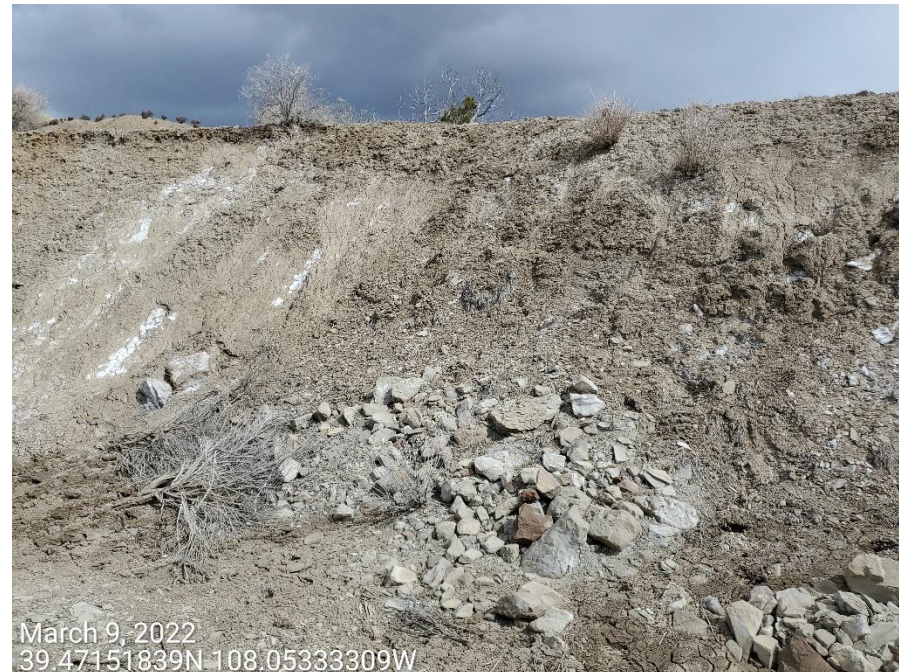
Photo 2: Photos 2-3 taken from the cut slopes on the east and southern ends of the Location. Photos show control measures are missing or insufficient to protect/stabilize the cut slopes.

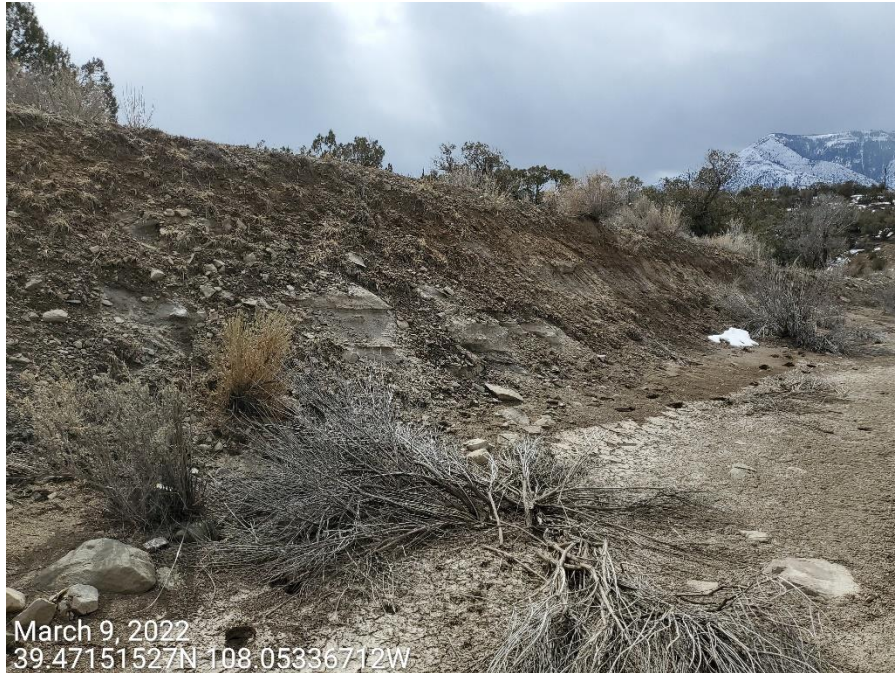
March 9, 2022
39.47151527N 108.05336712W

Photo 3: See comments under photo 2.

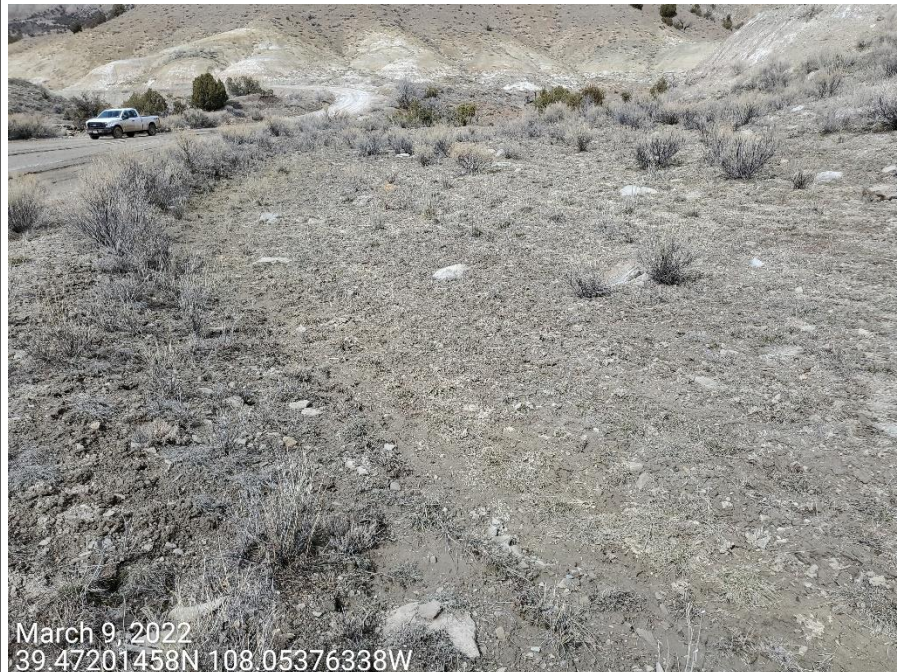
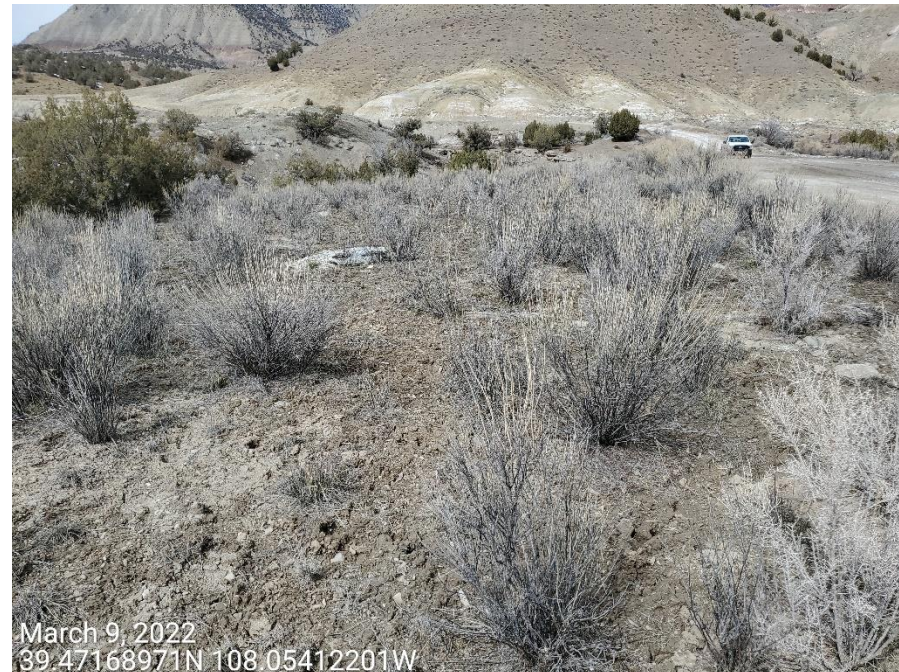
Photo 4: Photos provide examples of the interim areas of the Location; areas appear to be progressing towards 1003 standards.
