# Inspection Photos

Operator: TEP Rocky Mountain LLC - #96850

Location Name: Valley Farms B

Inspection Document #: 702800025

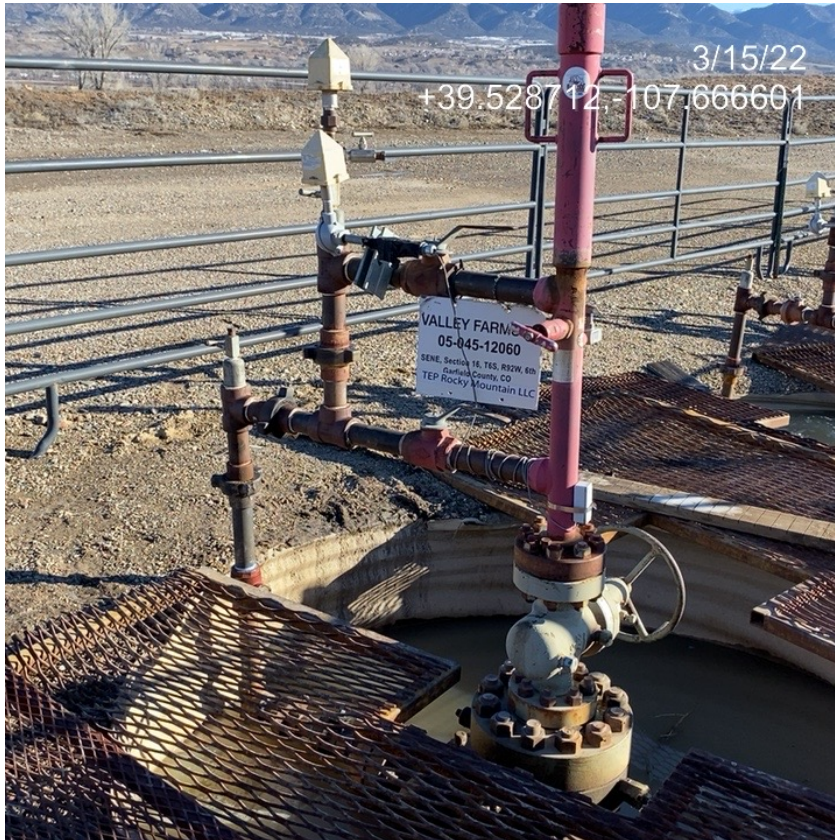
**Photo 1.** Photo taken from well API # 05-045-12060 facing north shows the well where a potential gas leak was observed in a previous inspection. Photo shows that water has been partially pumped from the cellar.

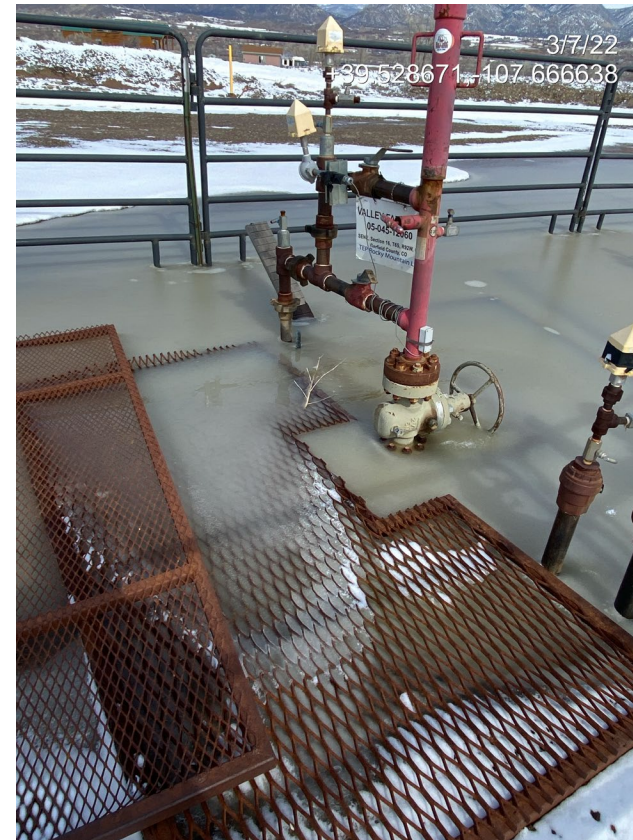
**Photo 2.** Photo taken from well API # 05-045-12060 during the previous inspection shows the cellar inundated with stormwater and bubbles in the water indicating a potential gas leak.

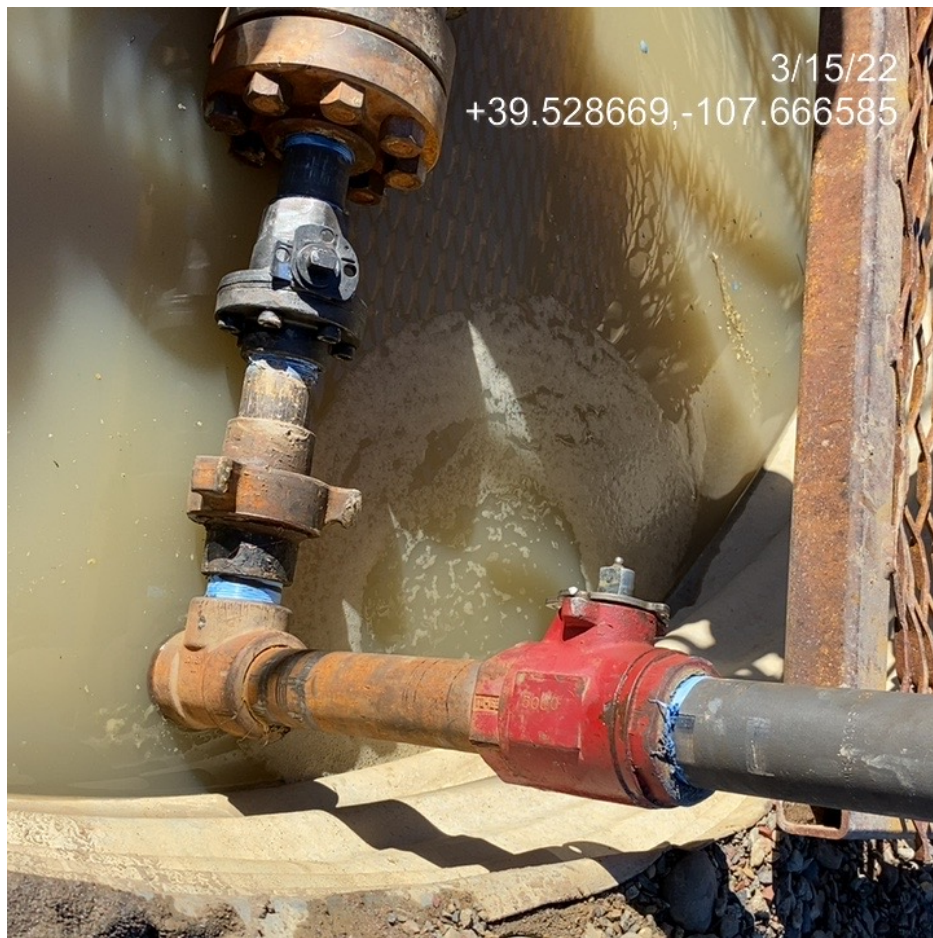
**Photo 3.** Photo taken from well API # 05-045-12060 shows the location of the bubbles from the previous inspection. Bubbles are no longer present. Photo shows new sealant tape on pipes indicating recent maintenance.

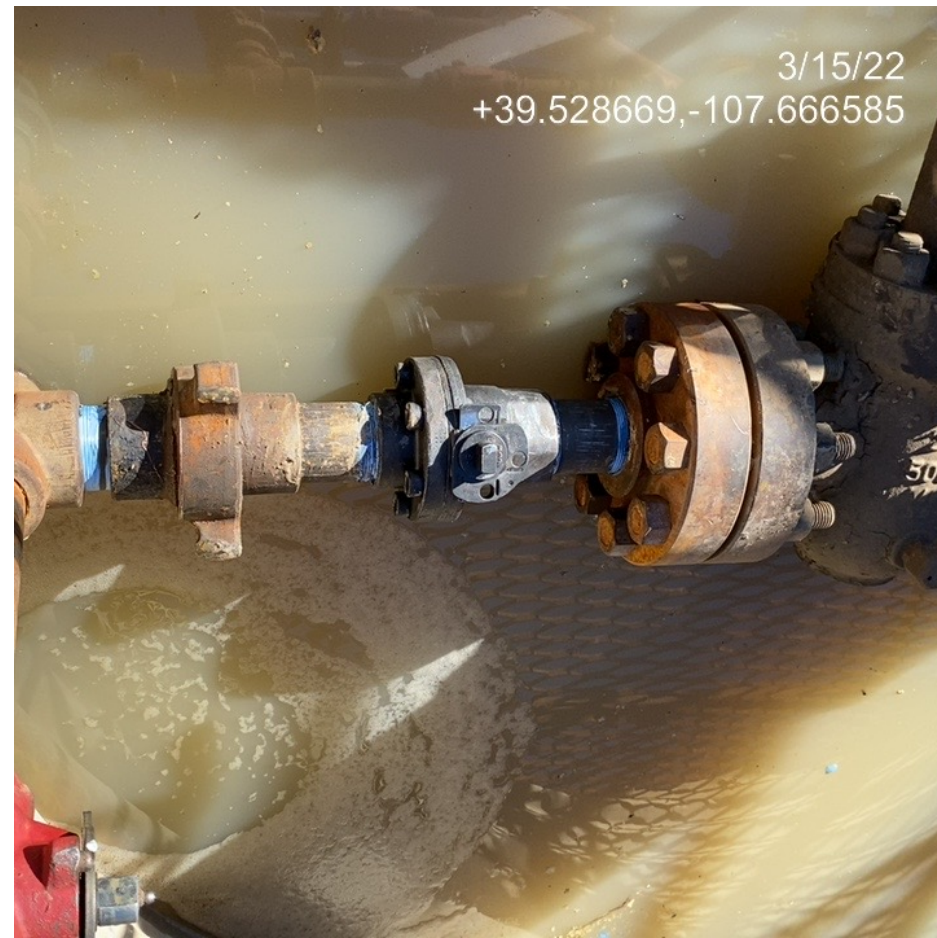
**Photo 4.** Refer to Photo 3 comments.
