Inspection Photos

Location Name: Egan State 23-36

Location ID: 320584

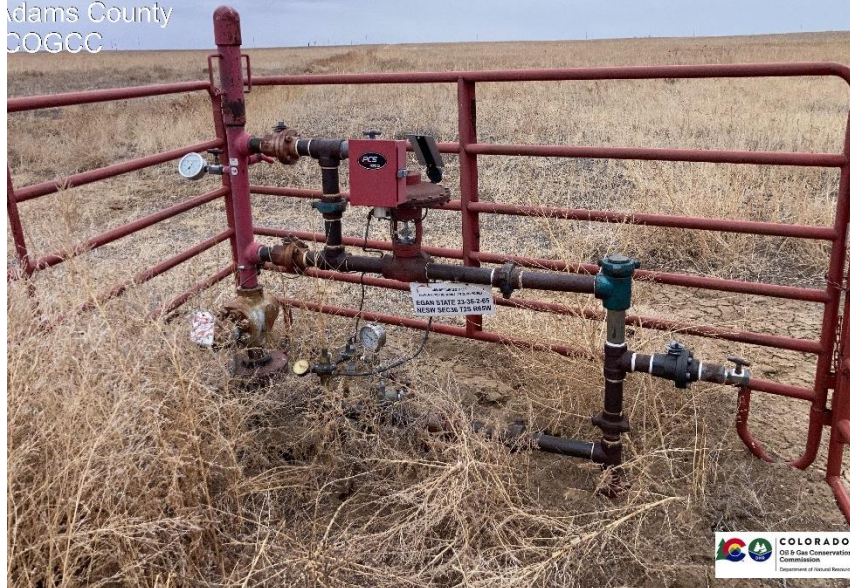
Mar 21, 2022 at 2:49:27 PM
39.832211,-104.614454
Adams County
COGCC

Pic 1 wellhead, at time of inspection one casing valve was slightly open and was put in the close position. Master valve is seized in position, unable to determine if valve was in open or close position. Ball valves on flowline are in close position.

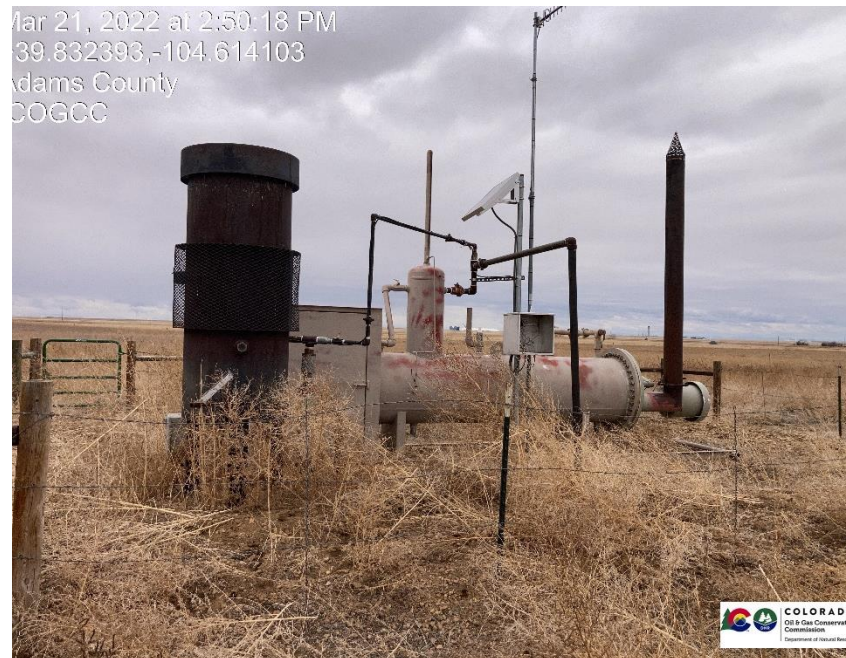
Mar 21, 2022 at 2:50:18 PM
39.832393,-104.614103
Adams County
COGCC

Pic 2 Separator, and ECD. Weeds are unmanaged on location.

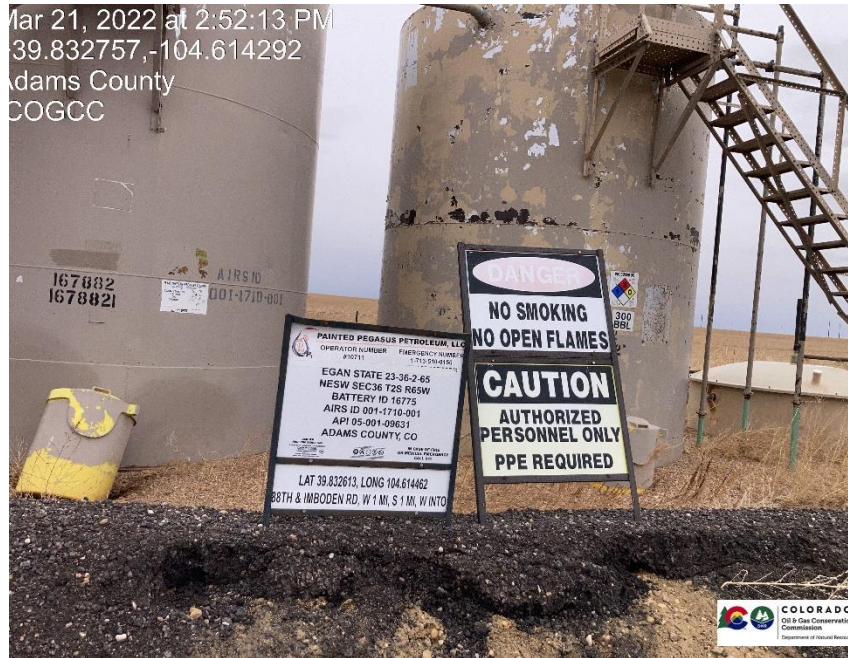
Pic 3 tanks. Tanks appear to be empty.
