# Inspection Photos

Operator: CHEVRON USA INC # 16700

Location ID: 314631

Rio Blanco County, CO

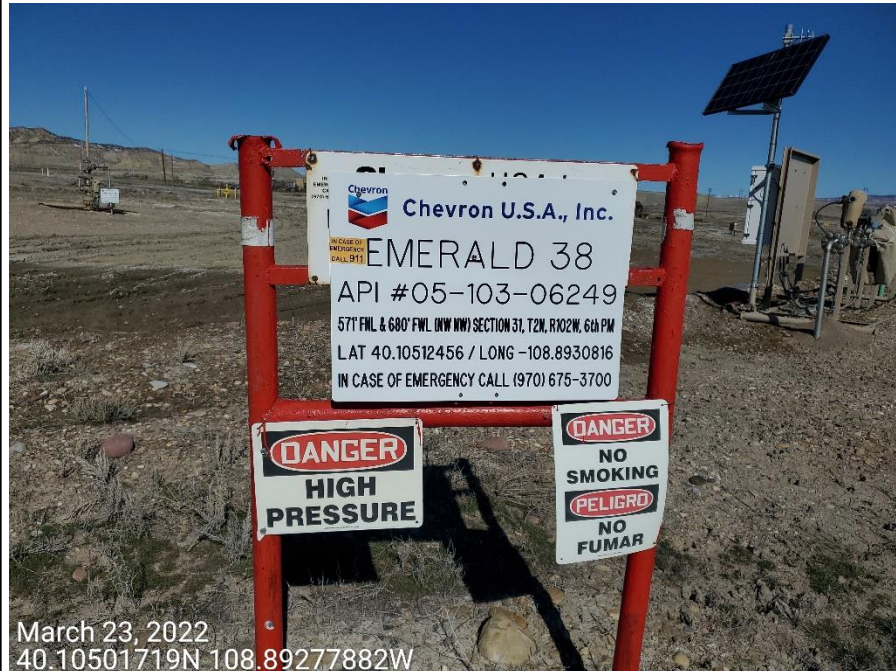
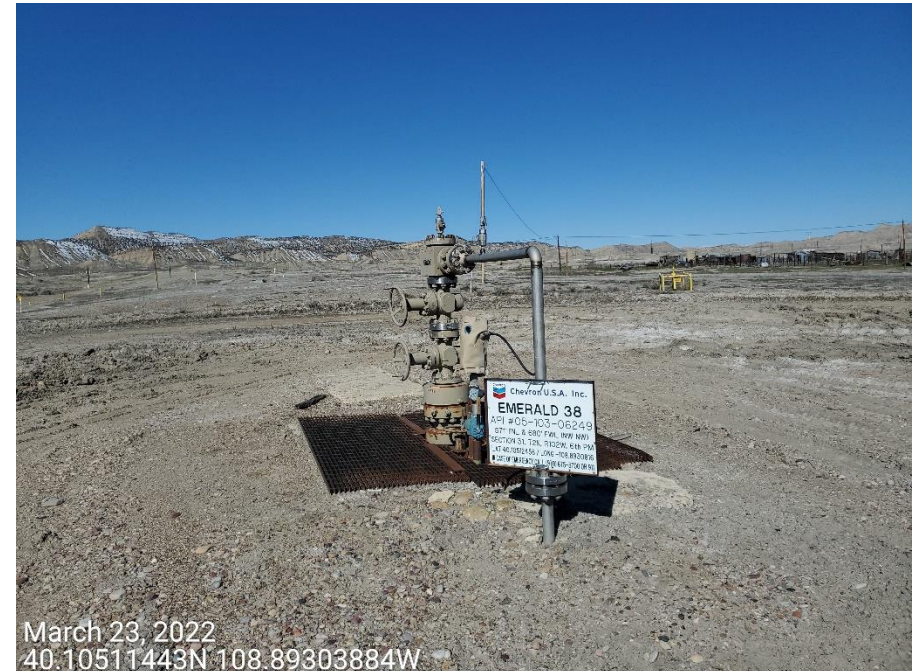
**Photo 1:** Signage at Location entrance and well.

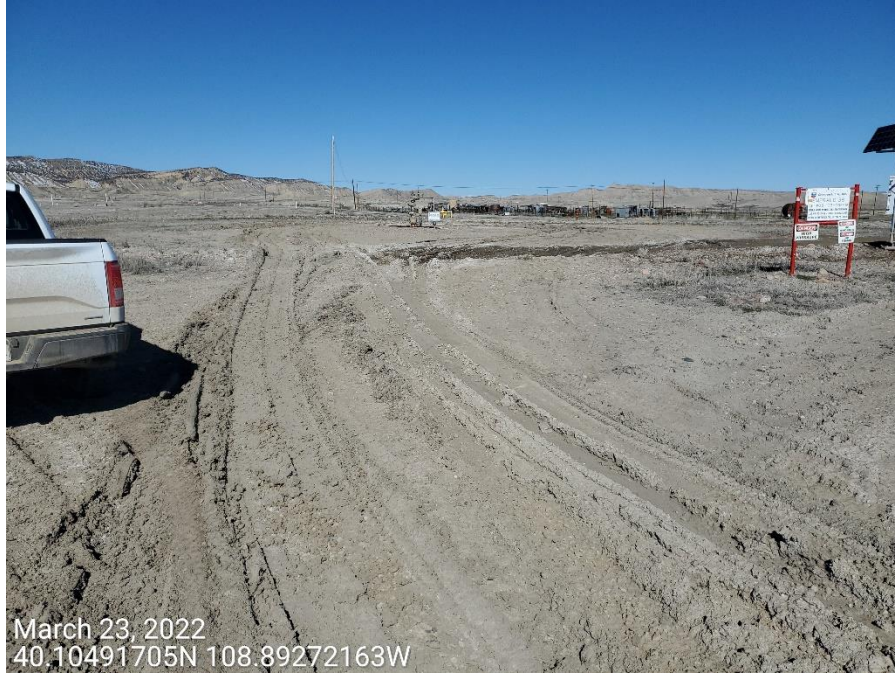
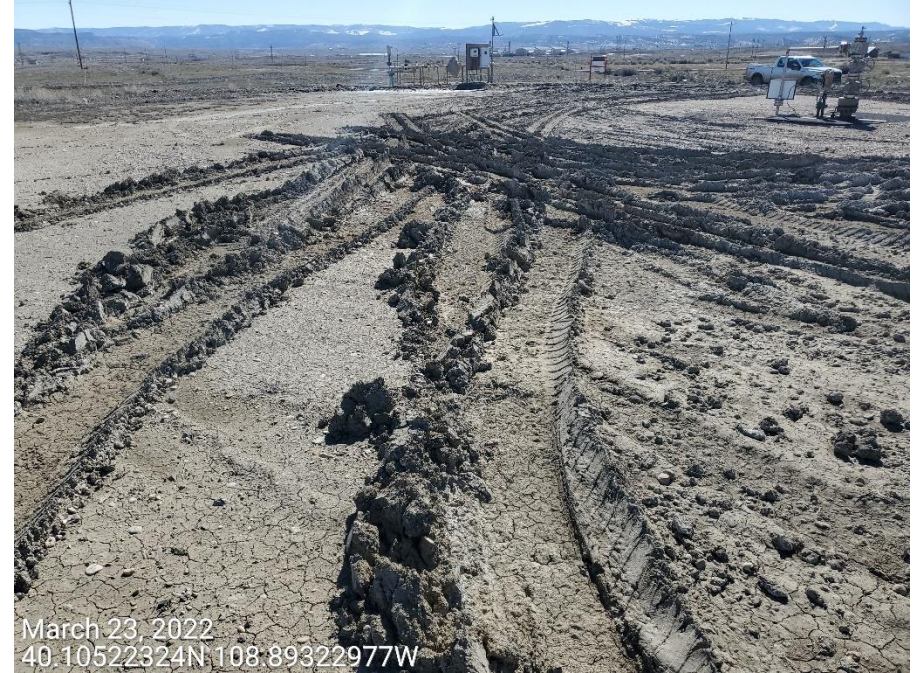
**Photo 2:** Photo left taken from Location entrance on the southeast end of the Location, facing northwest. Photo right taken from the northwest end of the Location, facing southeast. Photos provide examples showing lack of stabilization on the Location; BMPs to stabilize the location, minimize erosion, degradation and sediment transport are missing or insufficient; tracking / rutting and sediment transport evident.

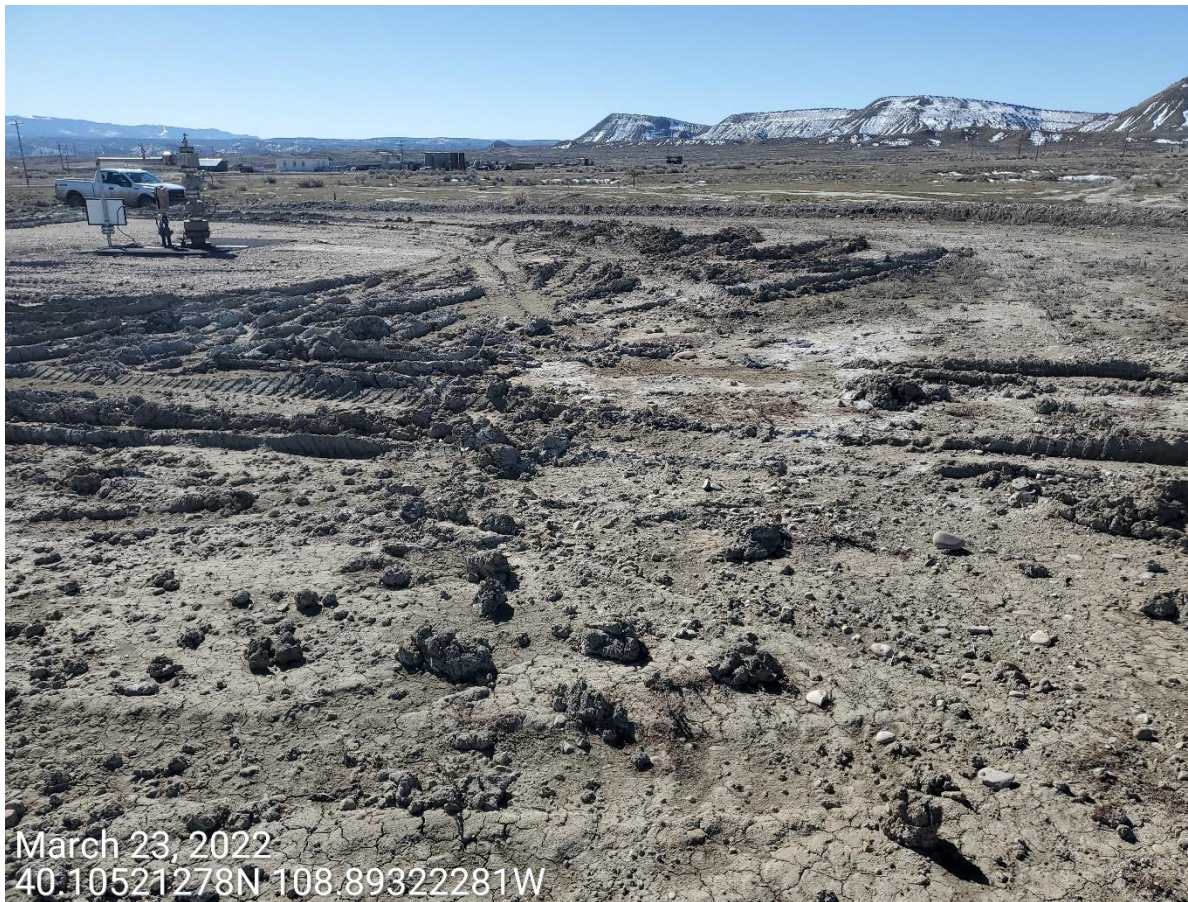
**Photo 3:** Photo taken from the northwest end of the Location, facing south. See comments under photo 2. .

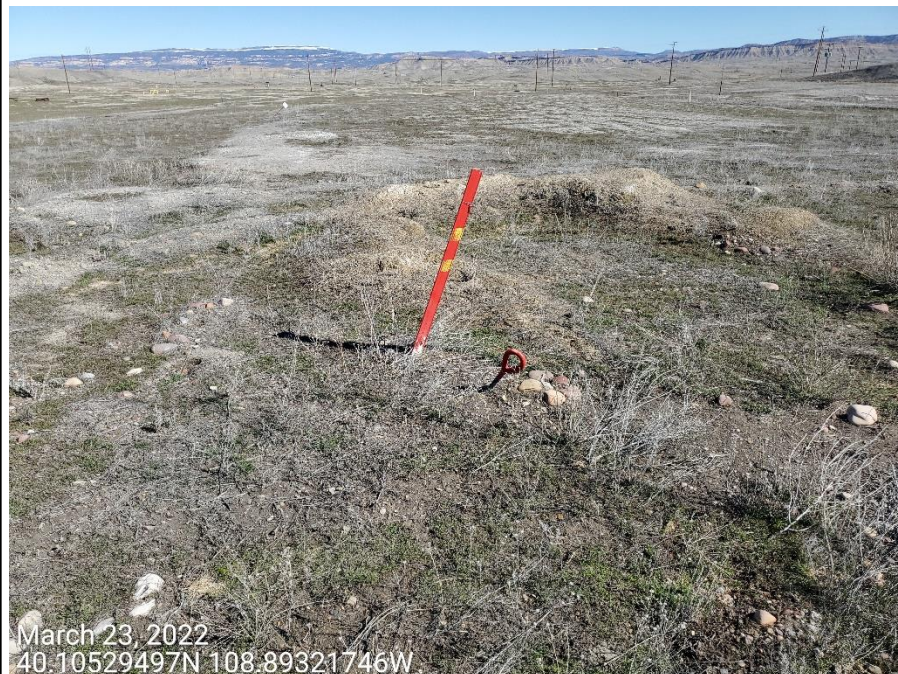
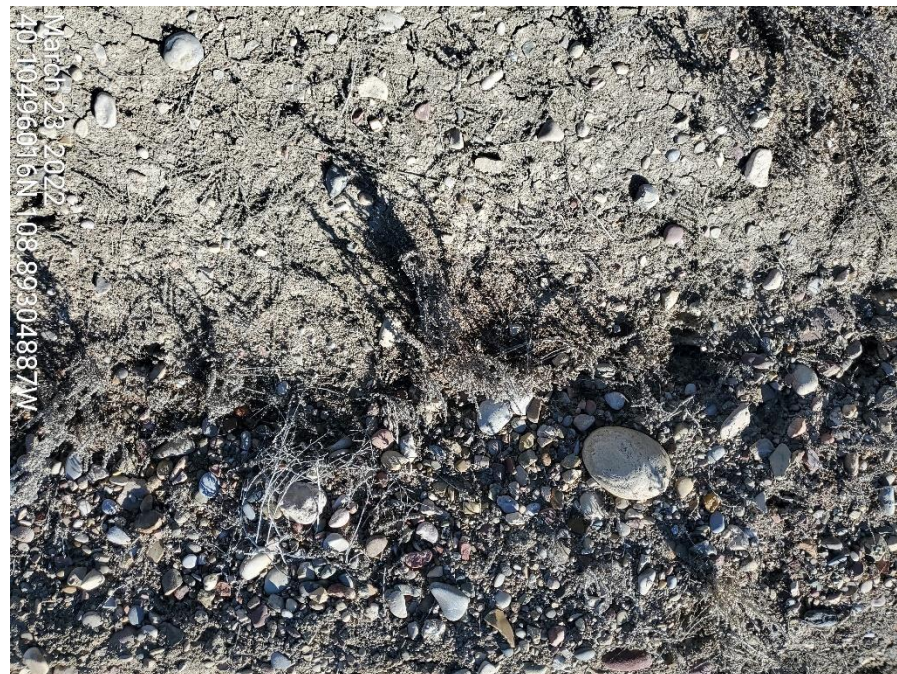
**Photo 4:** Photo left example of marked anchors on Location. Photo right example of Noxious weed remnants (Halogeton) from the 2021 growing season that was observed on the Location.
