Inspection Photos

API: 073-06774

Operator: KODA EXPLORATION LLC

Inspection Date: 3/24/2022

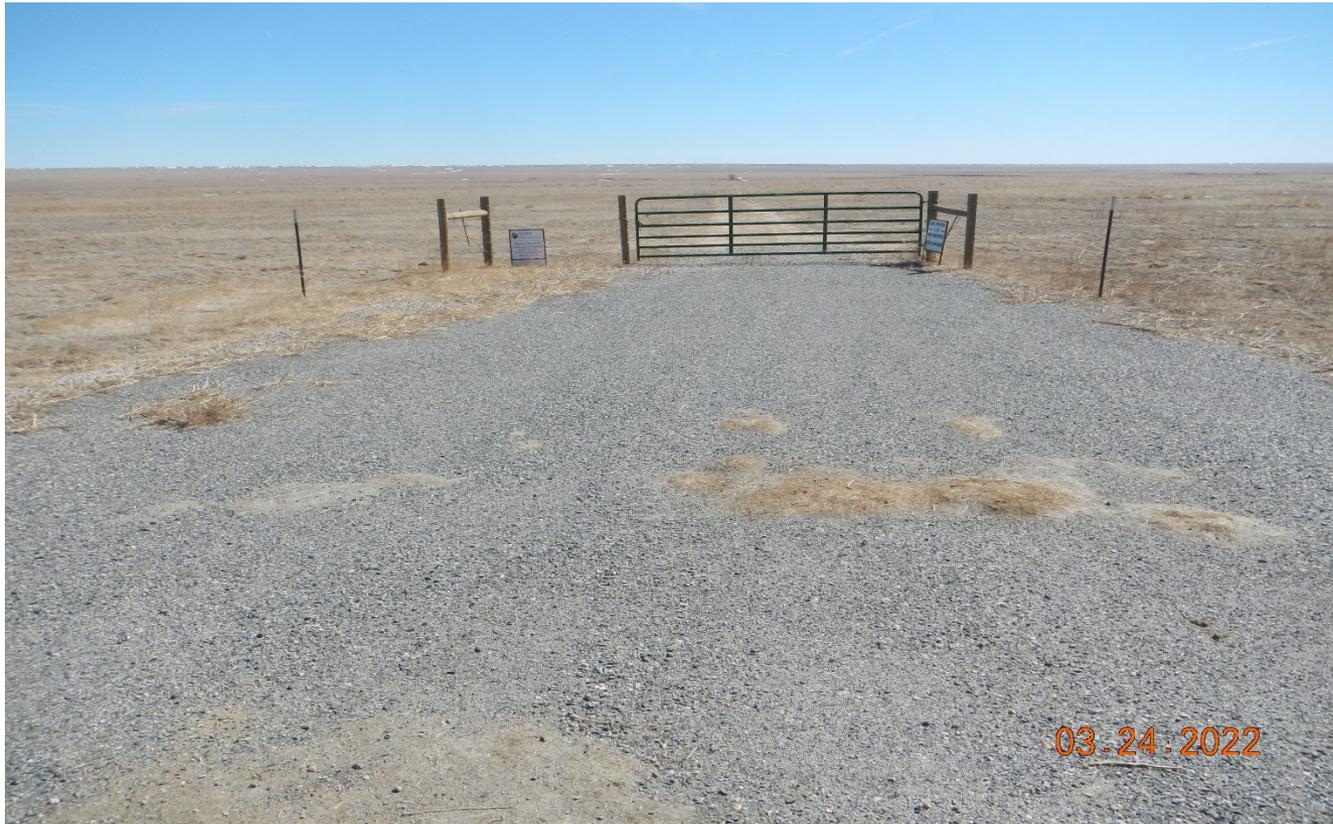
Photo 1. Facing east at the beginning of the access road. If well is plugged and abandoned the gravel will need to be removed and road will need to be reclaimed.

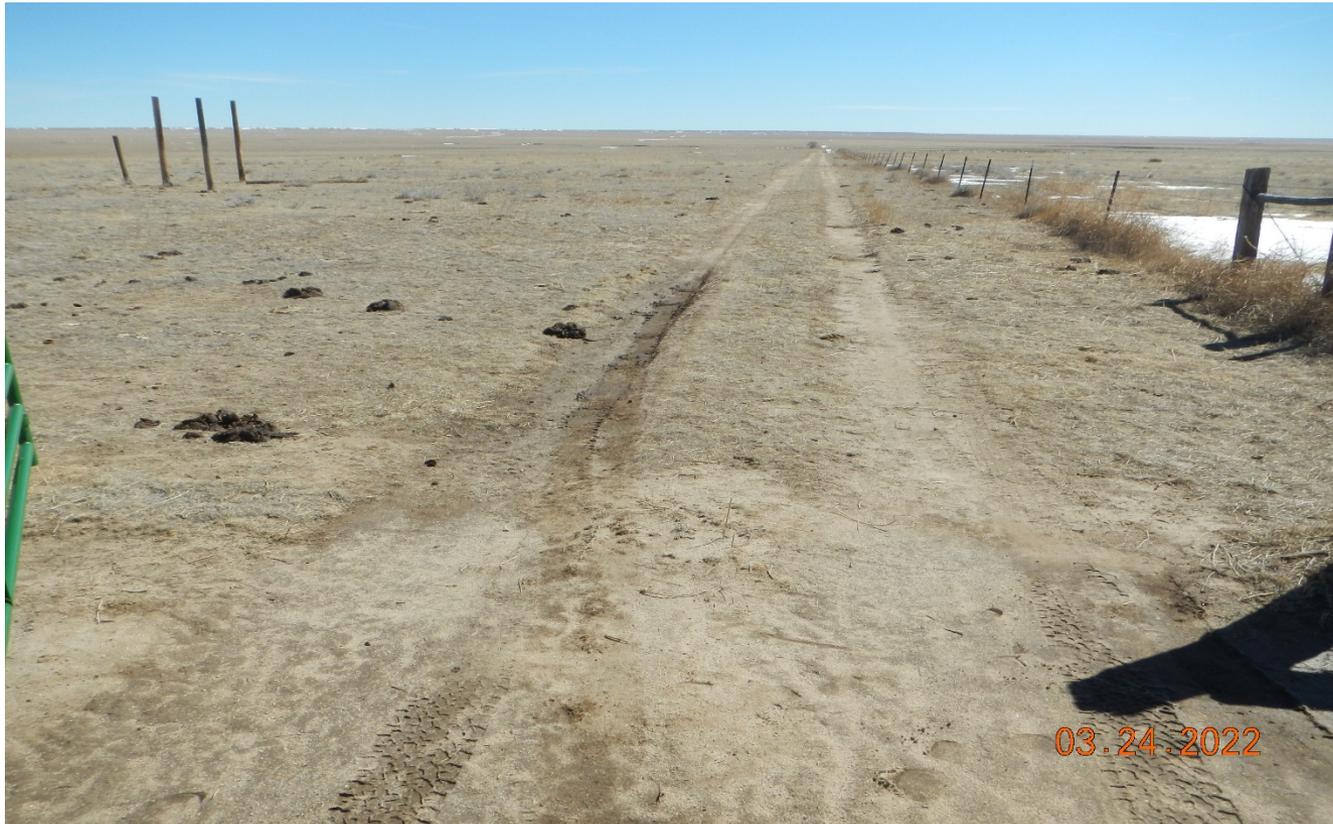
Photo 2. Facing east along the two track road.

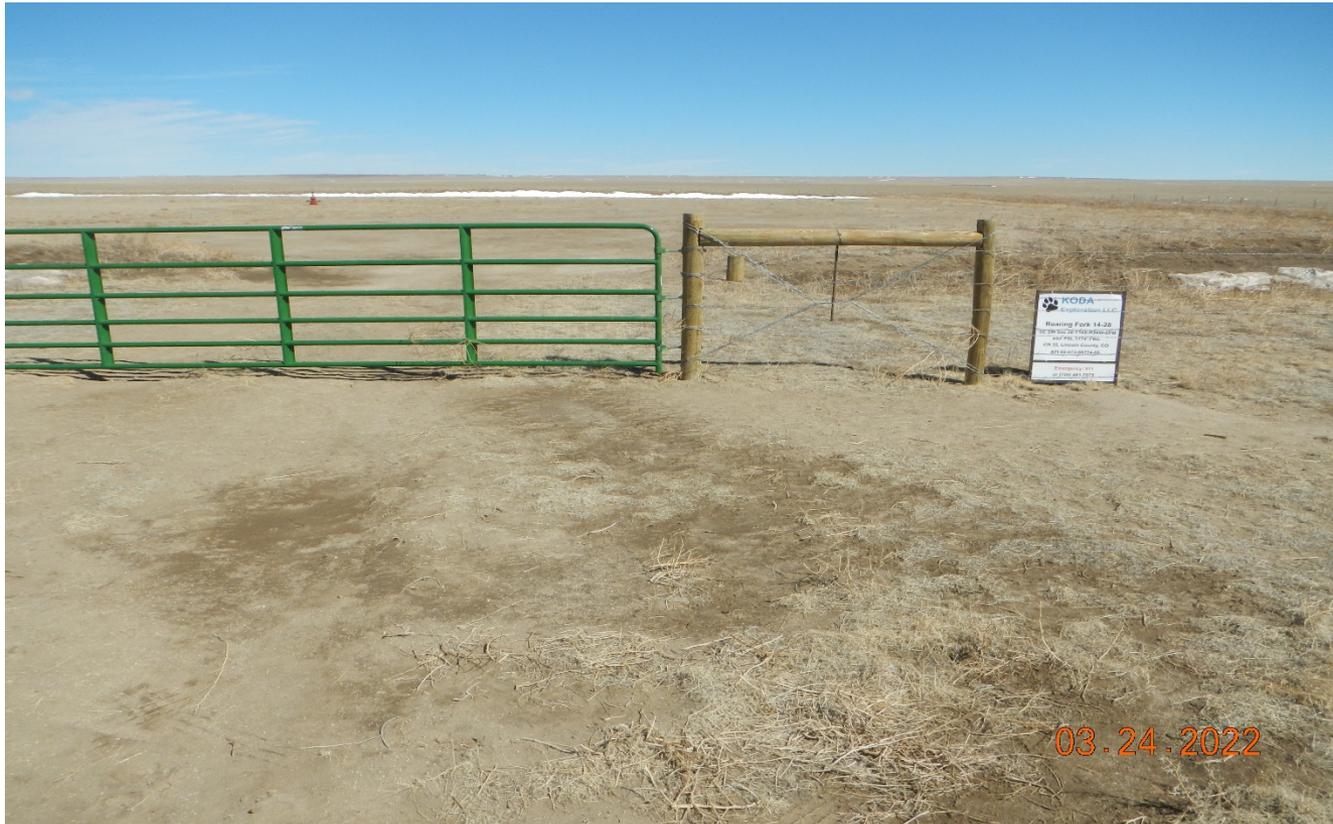
Photo 3. Facing north toward the fenced location.

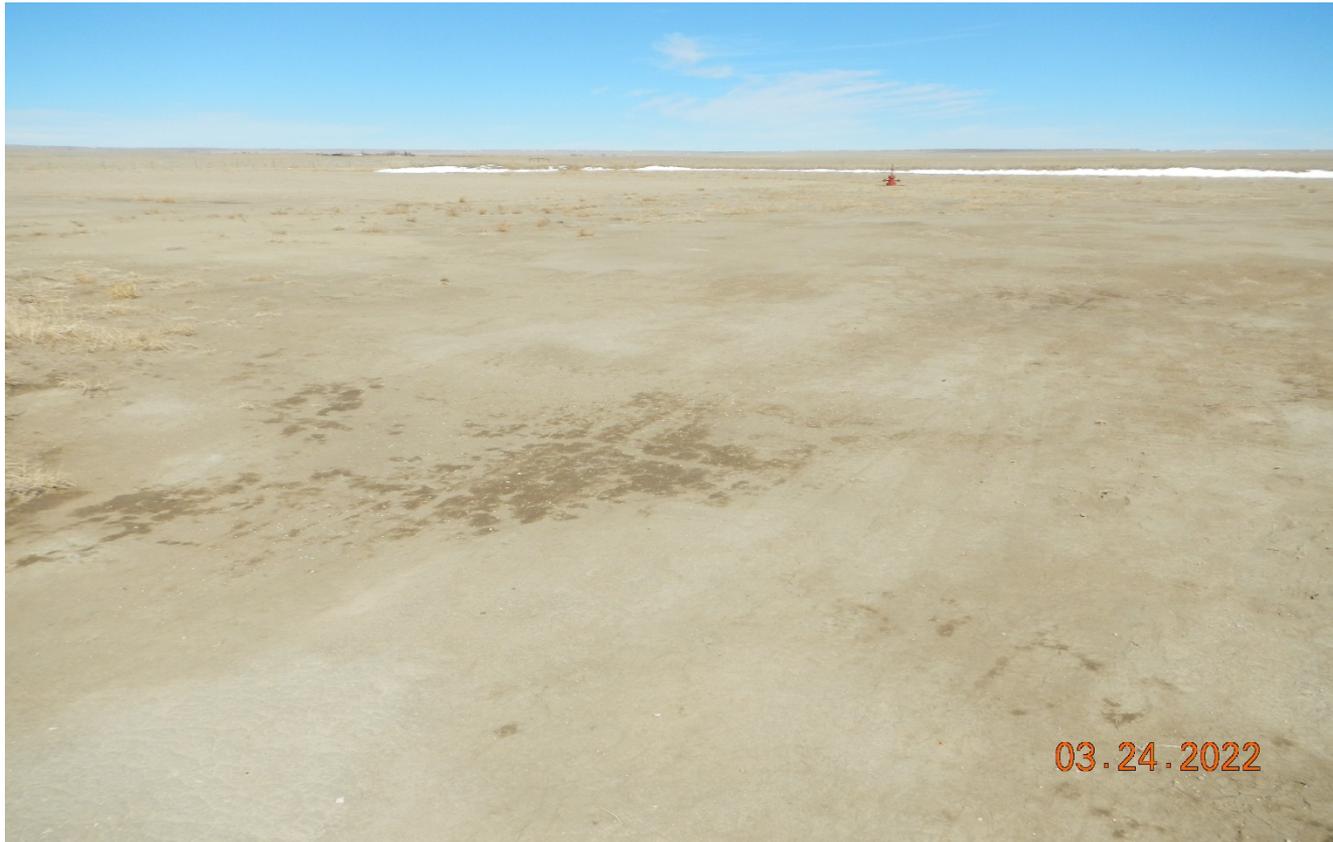
Photo 4. Facing northwest at the location. The location has not been reclaimed per the 1003 Rules. Soils are not protected from erosion and degradation.

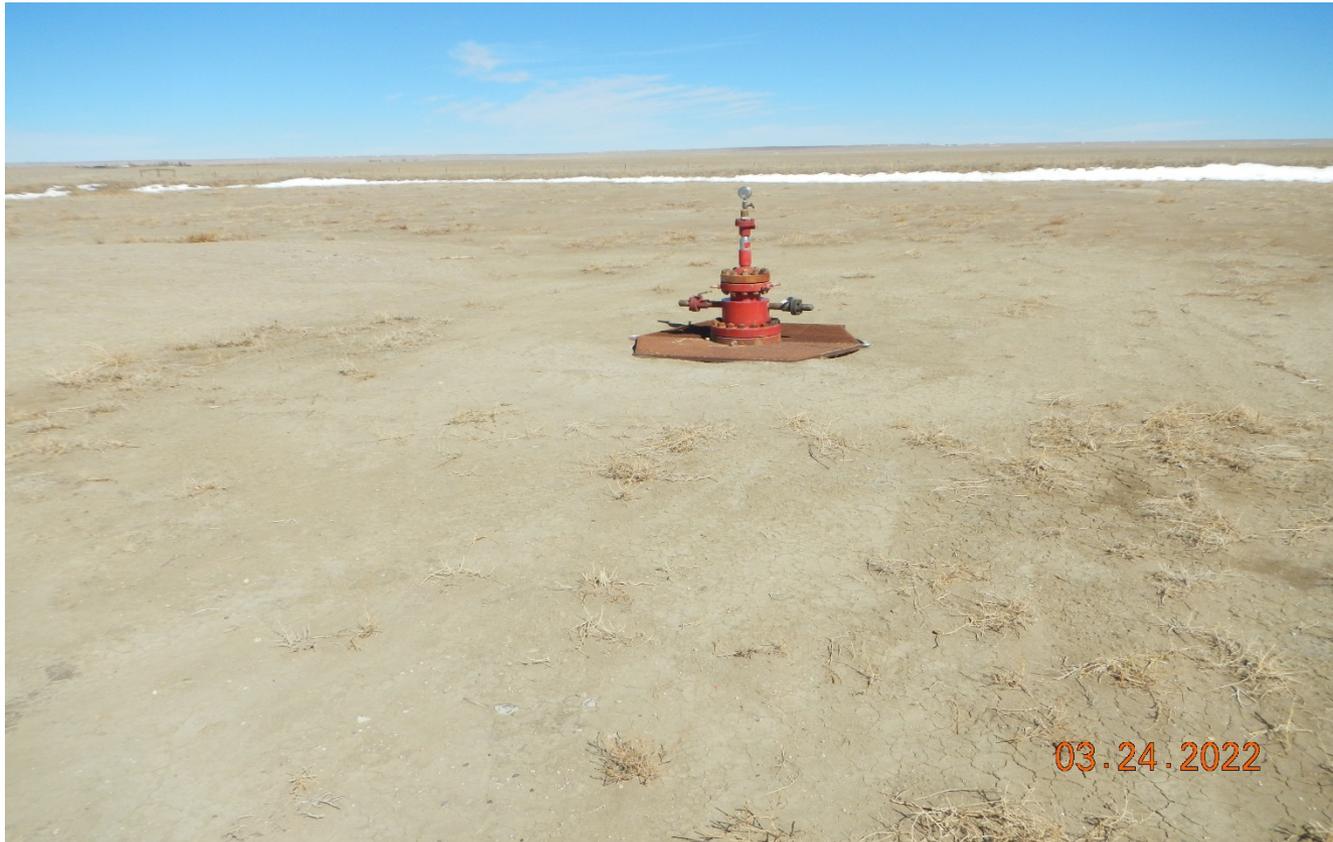
Photo 5. The well remains at center of location.

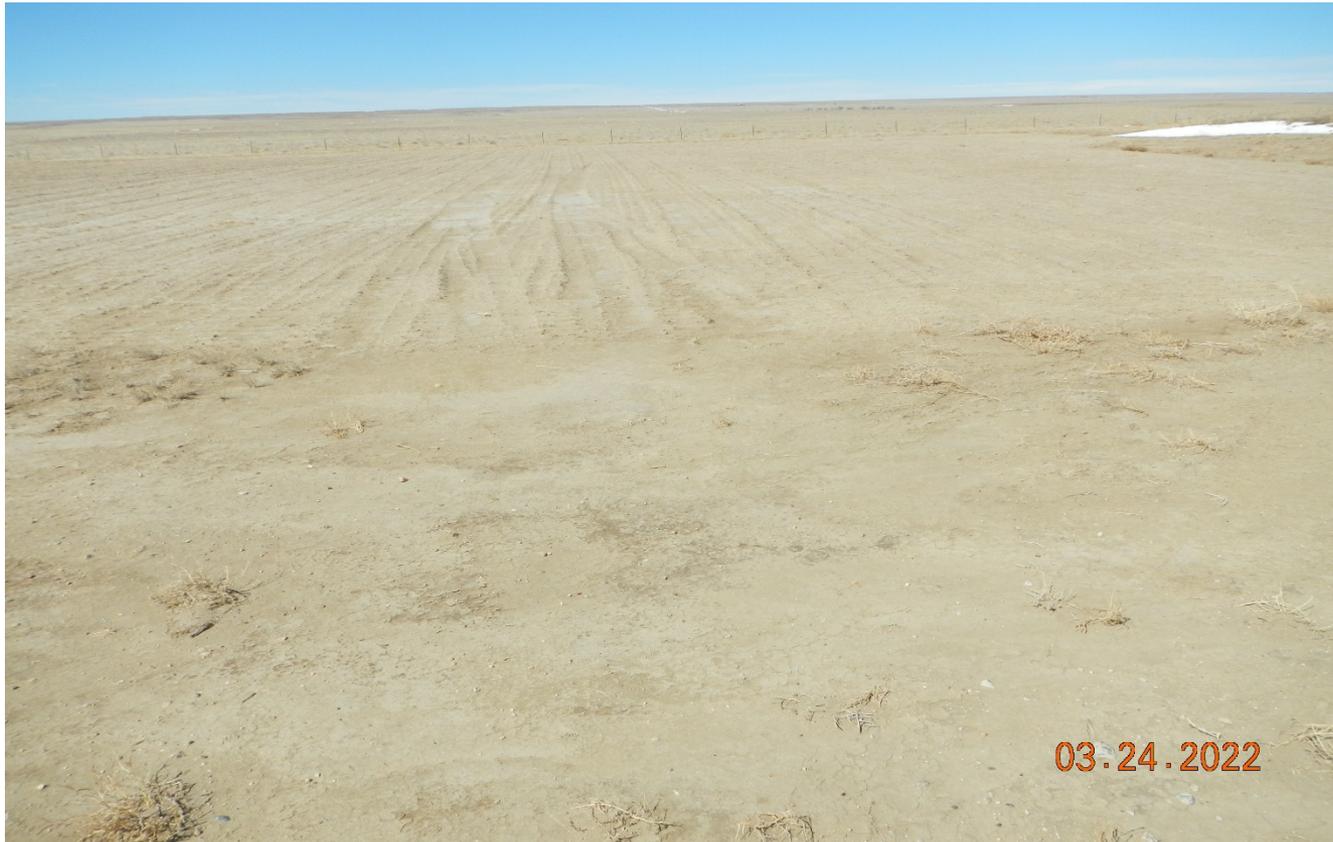
Photo 6. Facing toward the area of the pit which was backfilled. Bare soils are susceptible to erosion. Unused areas of the location have not been reclaimed.

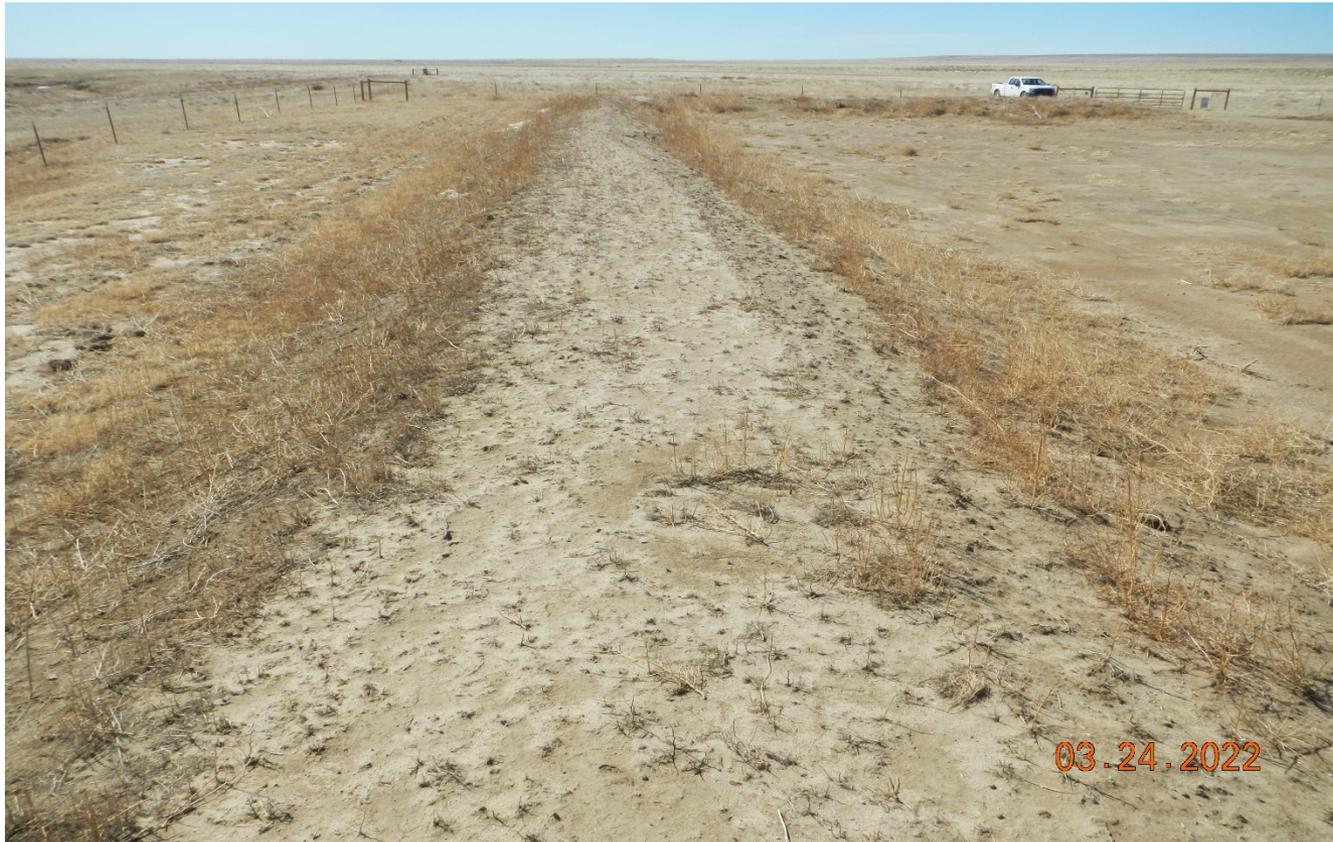
Photo 7. The topsoil pile stored along the perimeter are not protected from erosion and weed infestation. There are undesirable weeds throughout the topsoil piles.

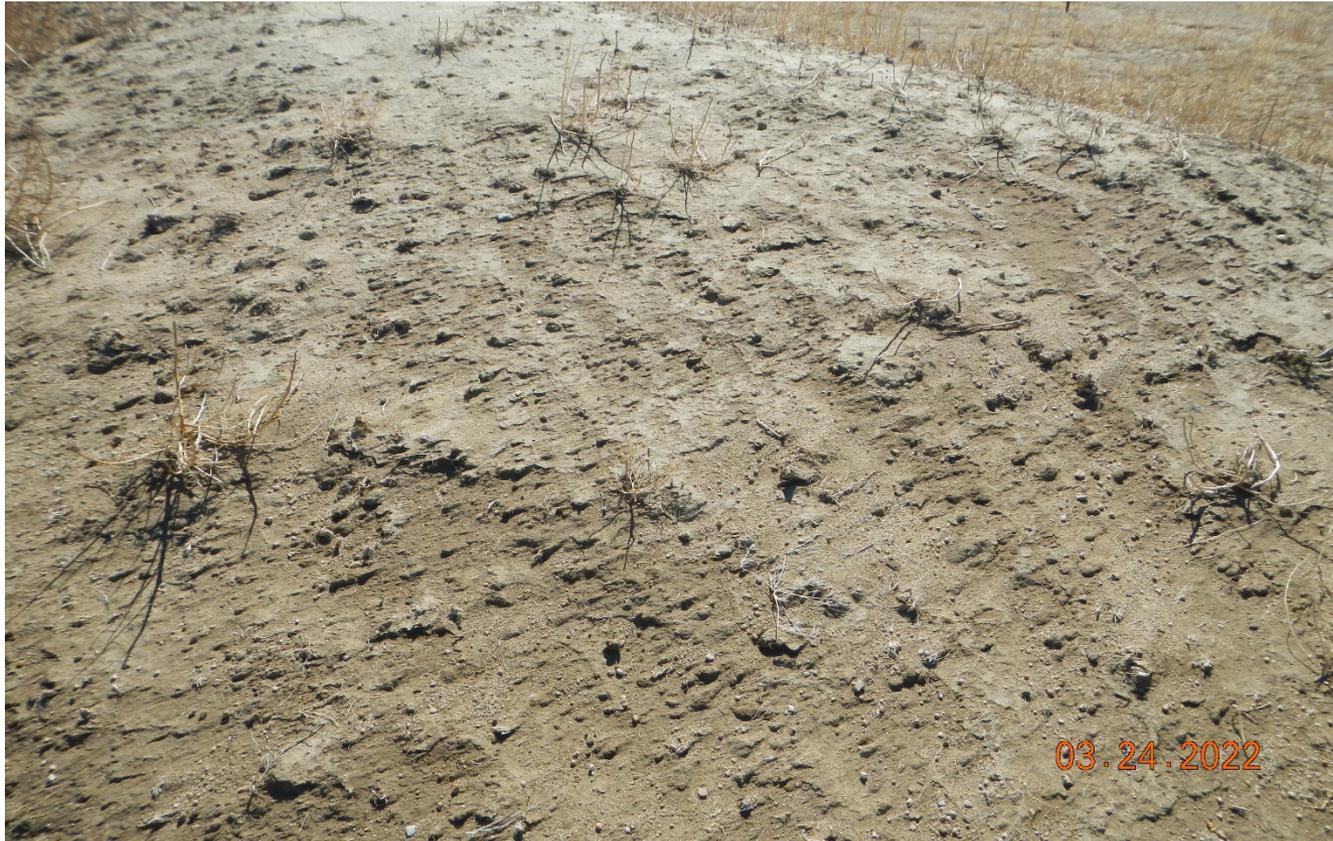
Photo 8. There is signs of wind erosion along the topsoil piles which are not stabilized.
