Inspection Photos

Operator: TEP Rocky Mountain- #96850

Location Name: Gentry B Pad

Inspection Document #: 702800065

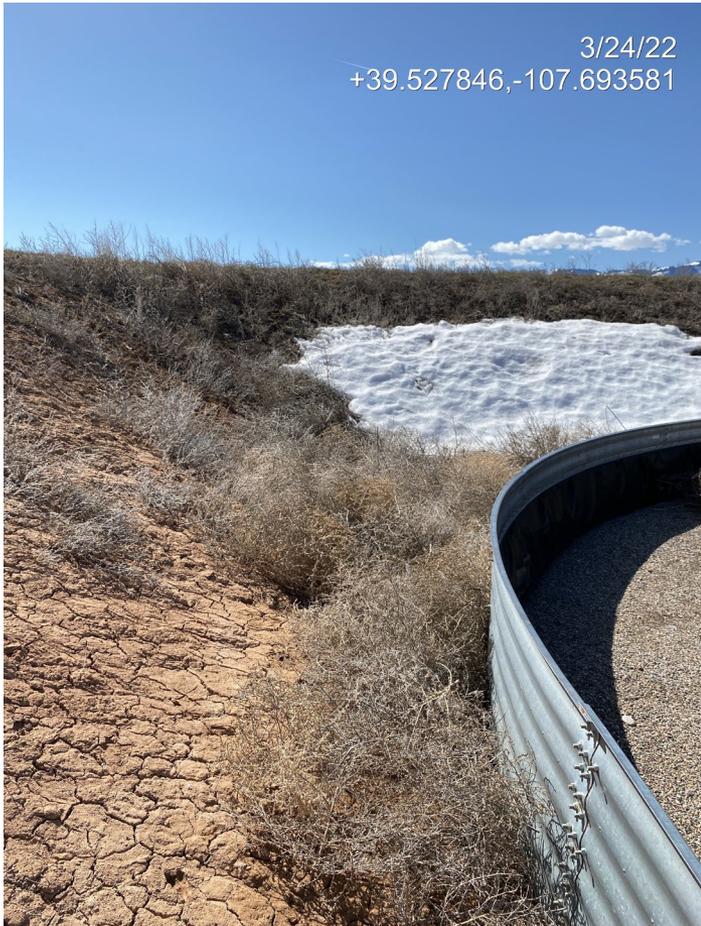
Photo 1. Photo taken from the southeast of the Location shows undesirable plant species/weed debris accumulating in interim areas and production areas adjacent to the tank battery.

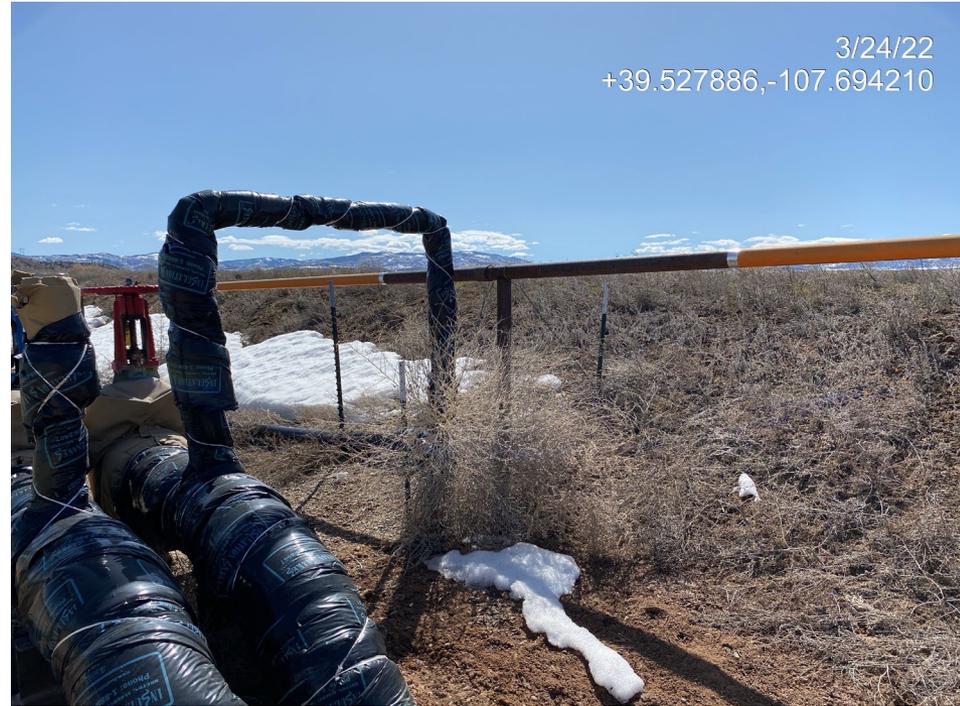
Photo 2. Photo taken from the south of the Location shows undesirable plant species/weed debris accumulating in production areas.

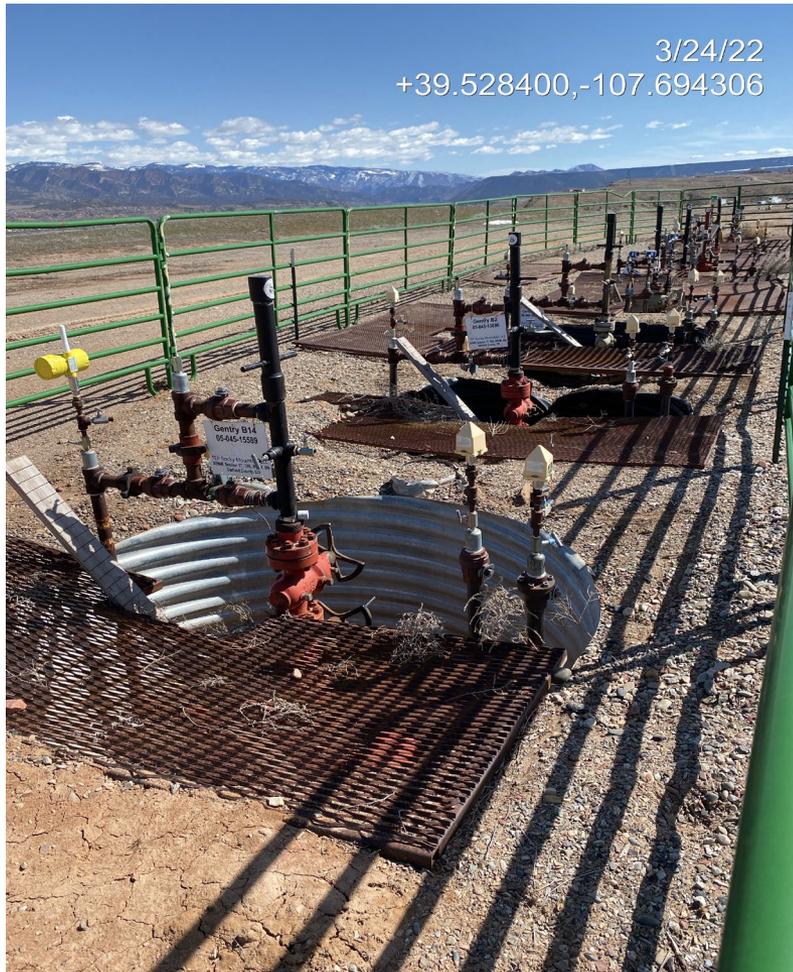
Photo 3. Photo shows BMPs to prevent wildlife access to the well cellars were missing or insufficient

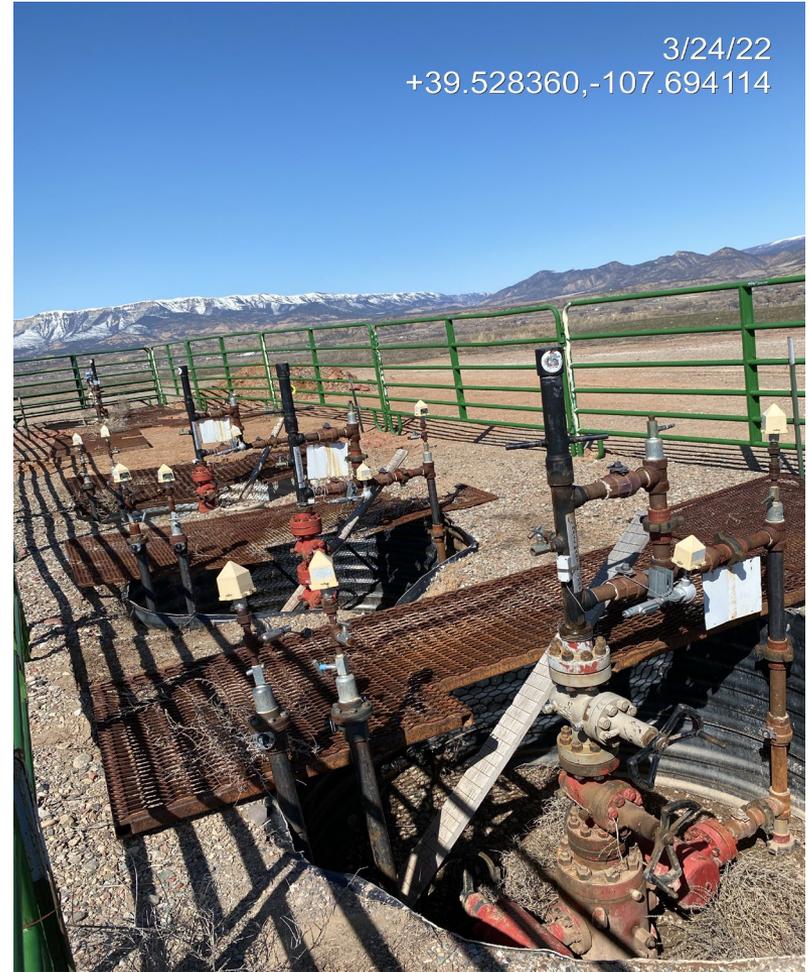
Photo 4. Refer to Photo 3 comment.

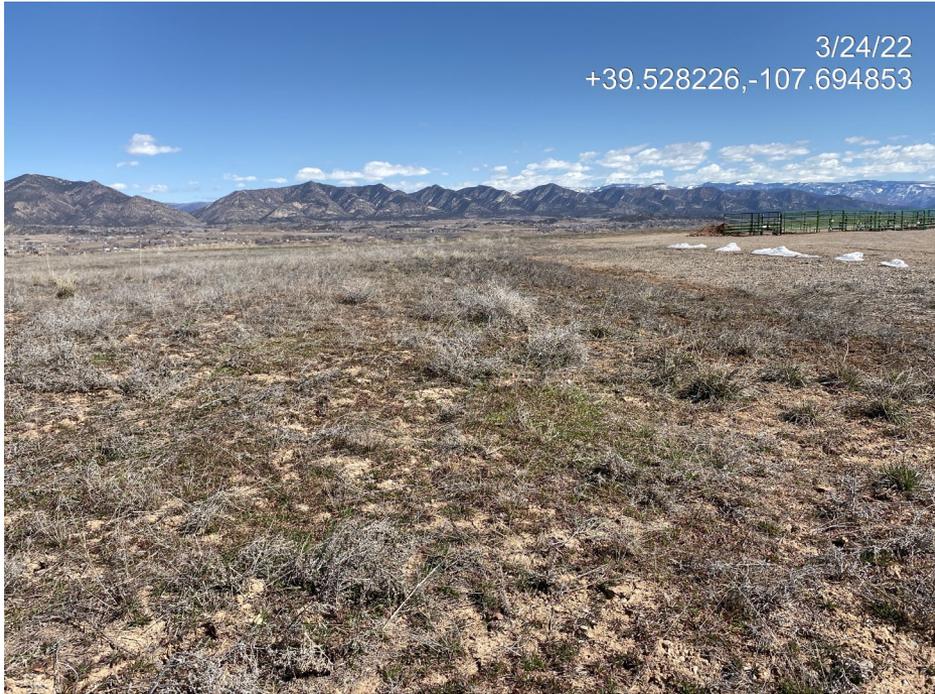
Photo 5. Photo taken from the western interim areas of the Location facing northeast shows interim areas dominated by annual, non-native and undesirable plant species/weeds including kochia, cheatgrass, mustard sp. and annual wheatgrass.

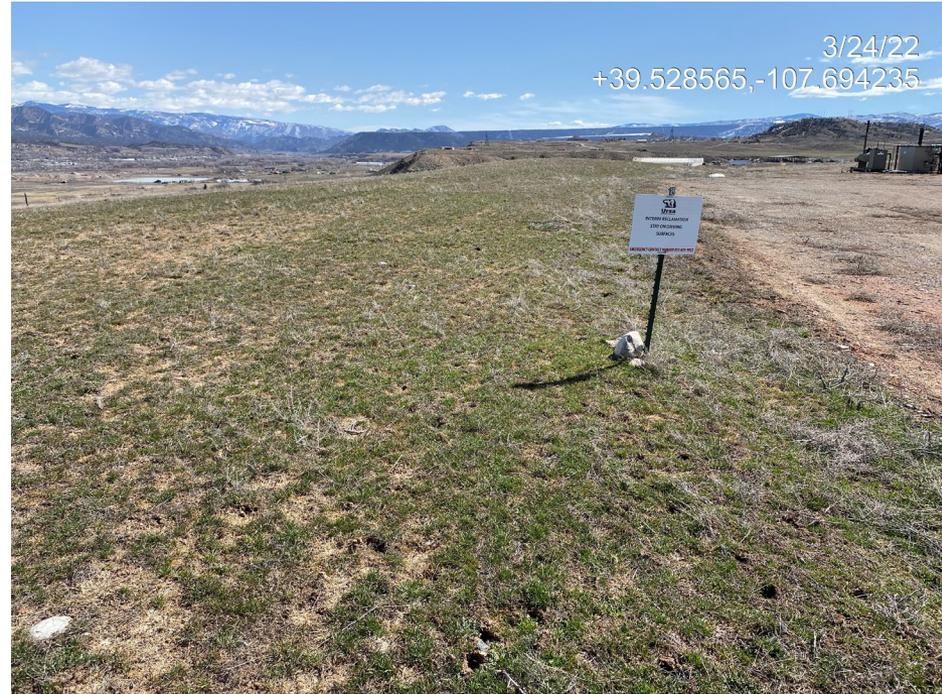
Photo 6. Photo taken from the northern interim areas of the Location facing east. Refer to additional comments under Photo 5.

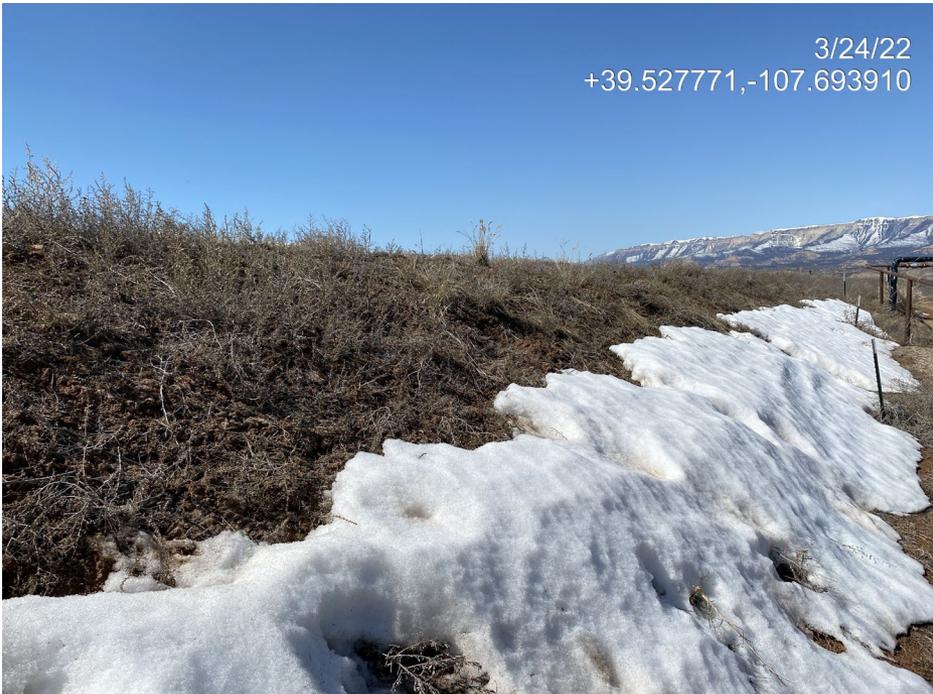
Photo 7. Photo taken from the south of the Location facing west shows cut slopes dominated by the undesirable plant species/weed, kochia. The perennial grass, crested wheatgrass is also present, but uncommon.

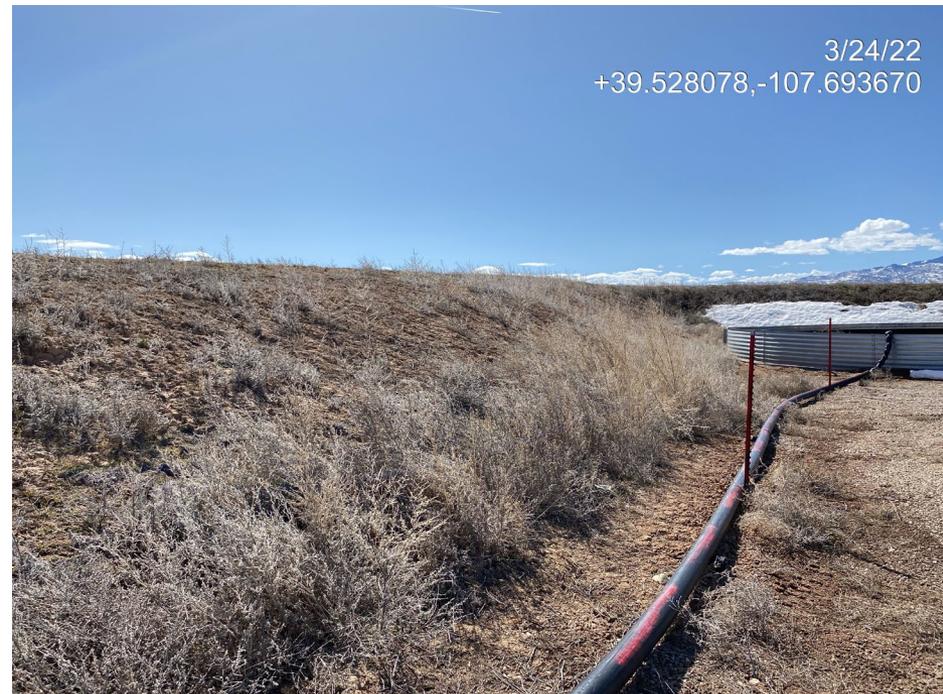
Photo 8. Photo taken from the east of the Location facing southeast shows cut slopes dominated by the undesirable plant species/weed, kochia.
