Inspection Photos

Location Name: Benzel P26NWB Pad & Dumpline Release

Location ID: #335365 & Spill/Release ID: #481823

Inspection Date: March 28, 2022

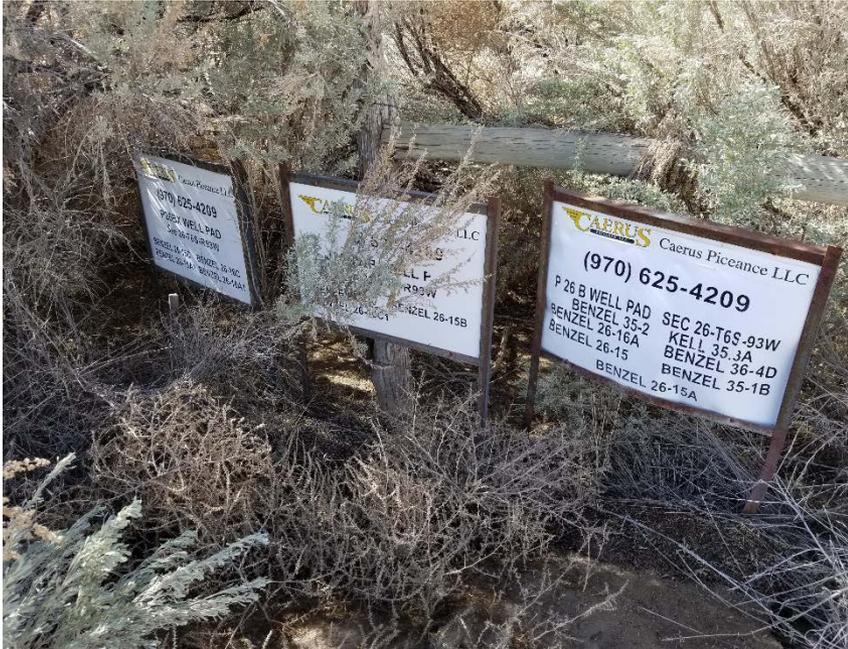
Photo #1 – Signs at entrance to pad.

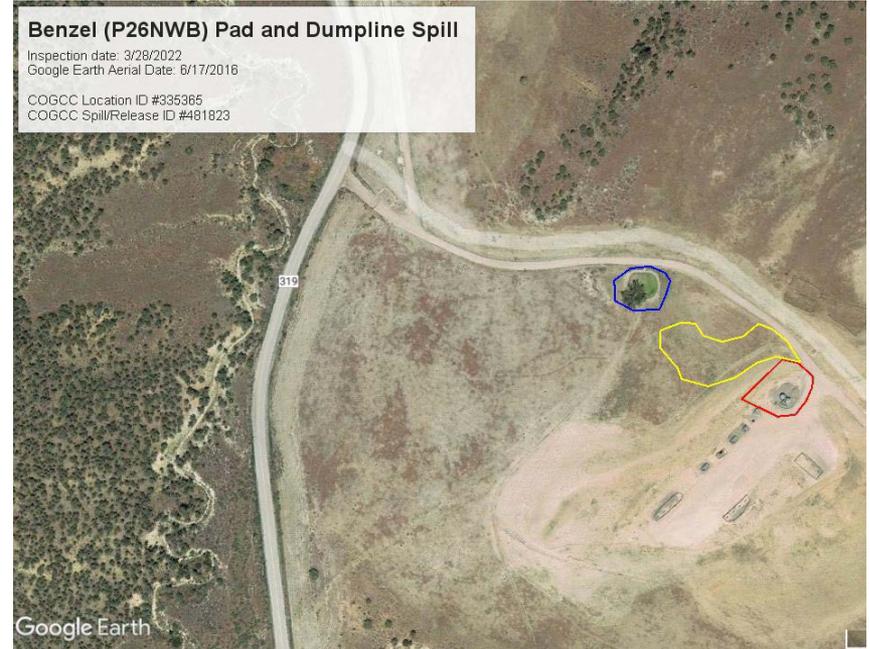
Photo #2 – Overview of the inspection area. Color-coded polygons refer to the following:

Blue – impacted stock pond

Yellow – observed flow path

Red – observed excavation area

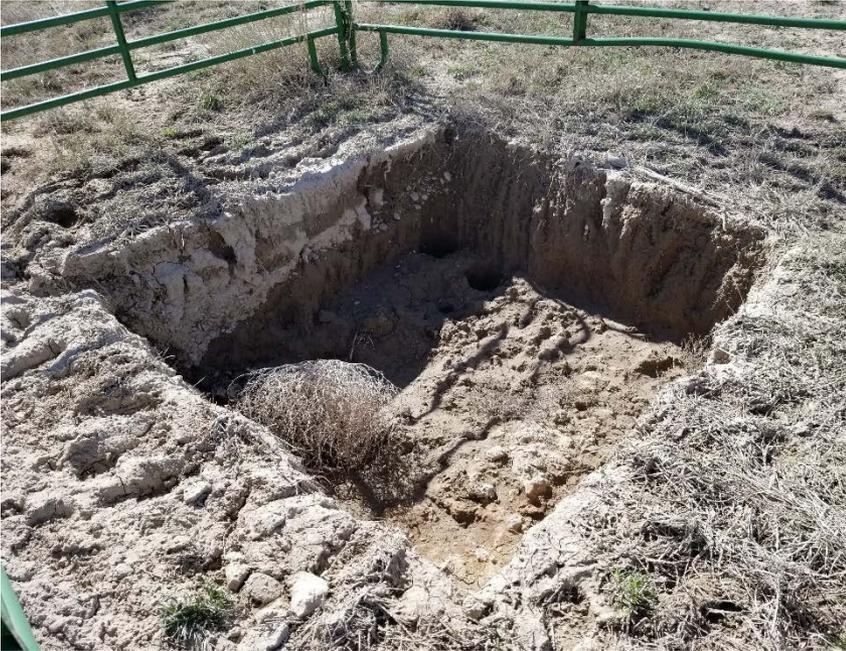
Photo #3 – Fenced pothole located at entrance to facility. It is unclear whether this relates to Spill/Release ID #481823. Pothole measured approximately 5'x5'x4' on inspection date.

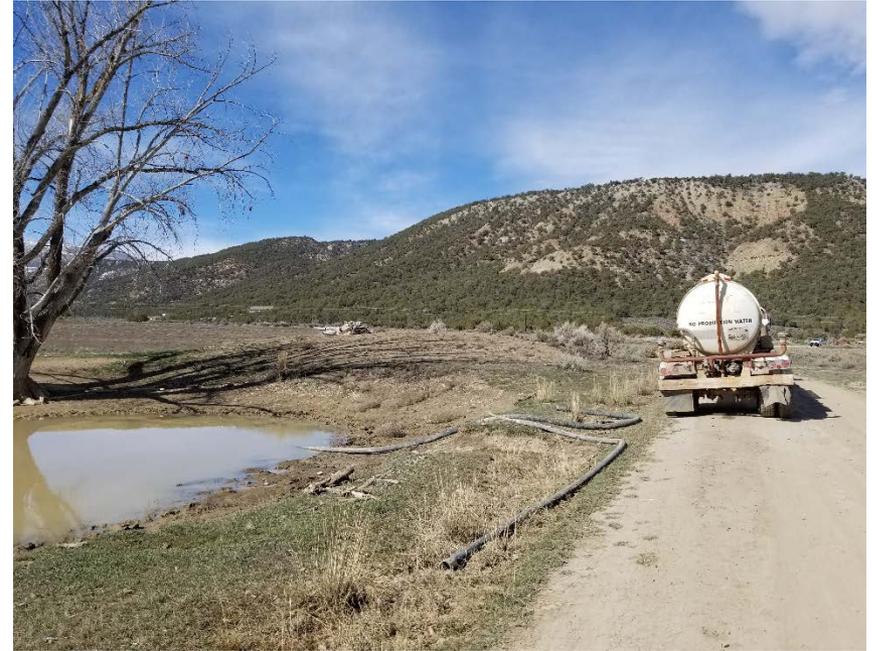
Photo #4 – Overview of stock pond, looking southwest. Note presence of water truck onsite during inspection and hoses leading into stock pond.

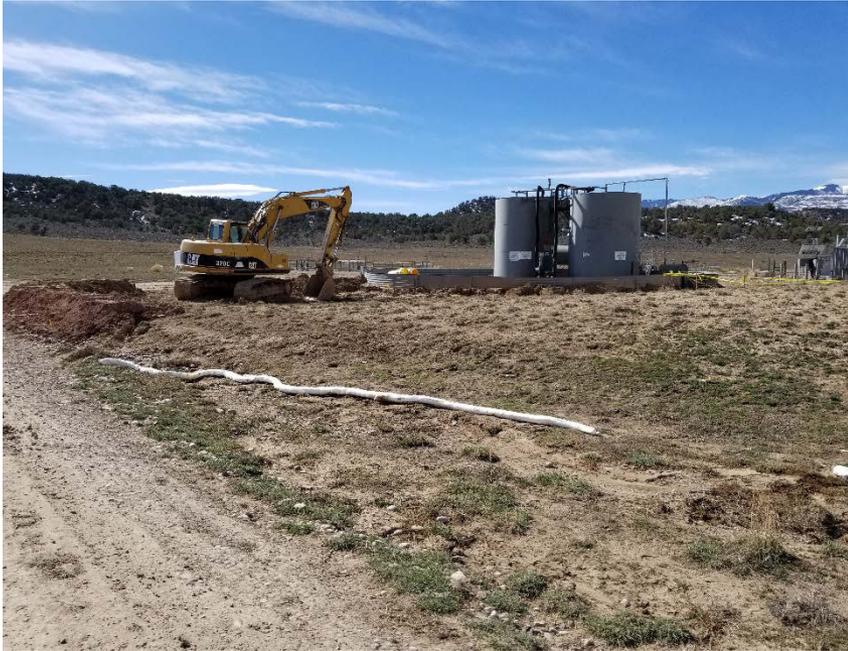
Photo #5 – Overview of tank battery from north. Note excavator remaining in excavation area and installation of absorbent boom downhill from excavation.

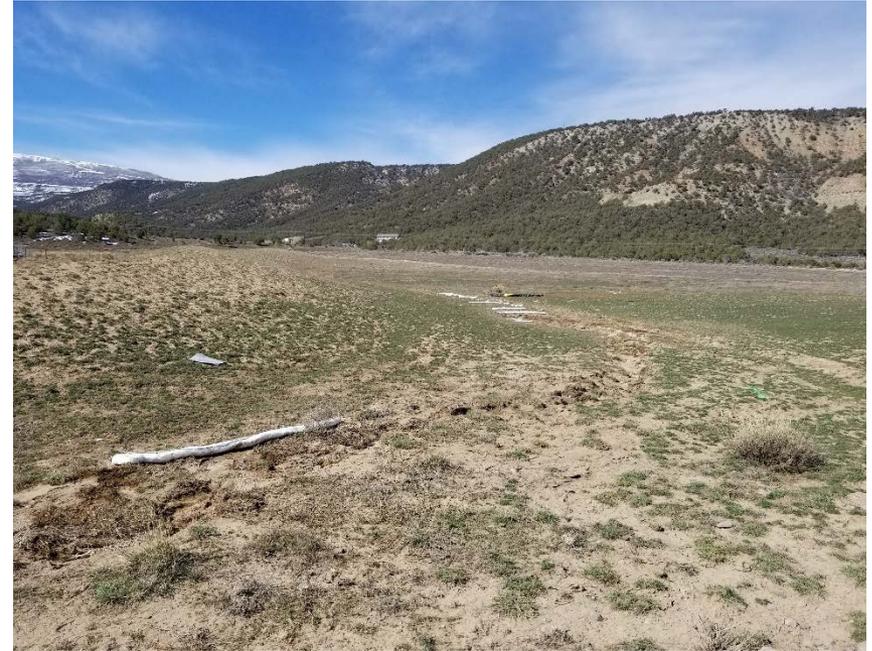
Photo #6 – Observed flow path leading west and south from the tank battery.

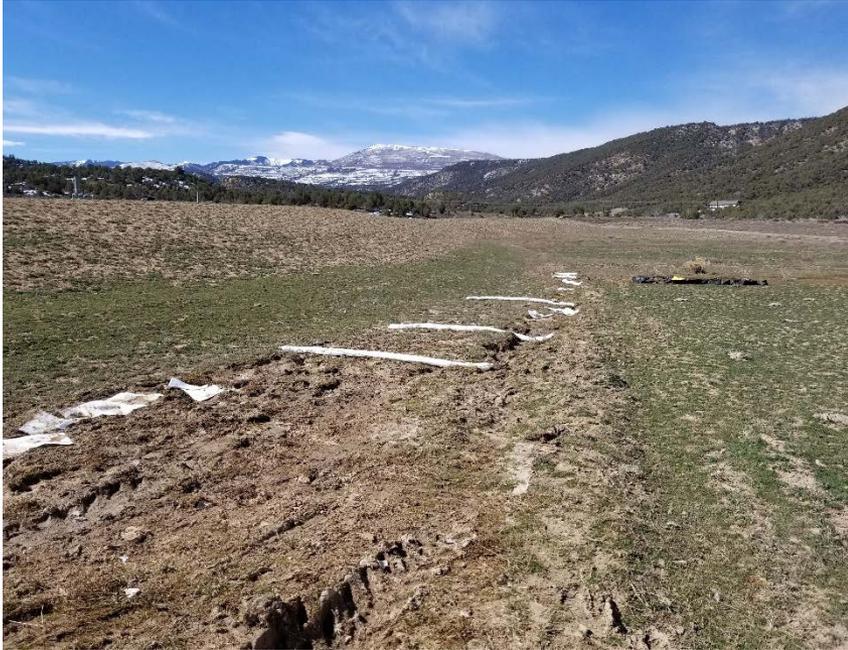
Photo #7 – Absorbent pads and booms installed by operator along flow path.

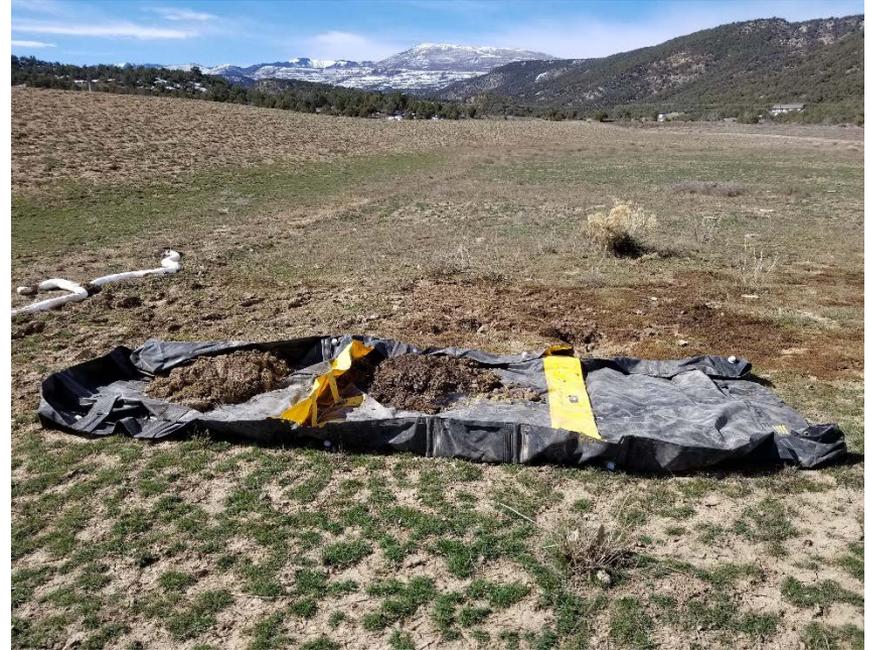
Photo #8 – Impacted soil stockpiled on liner in flow path area.

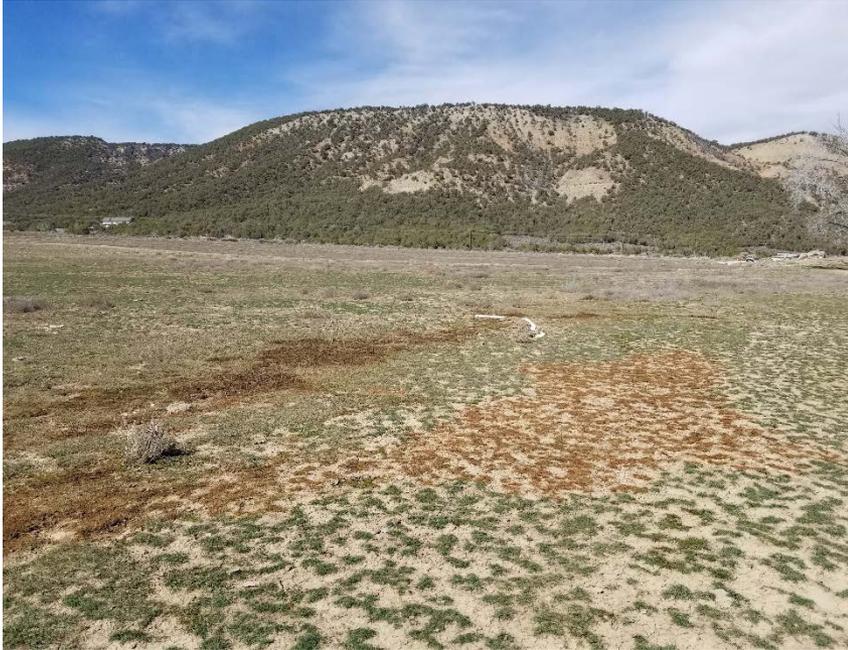
Photo #9 – View along flow path, looking west. Note hydrocarbon staining on vegetation. Hydrocarbon odors associated with stained vegetation were observed on inspection date.

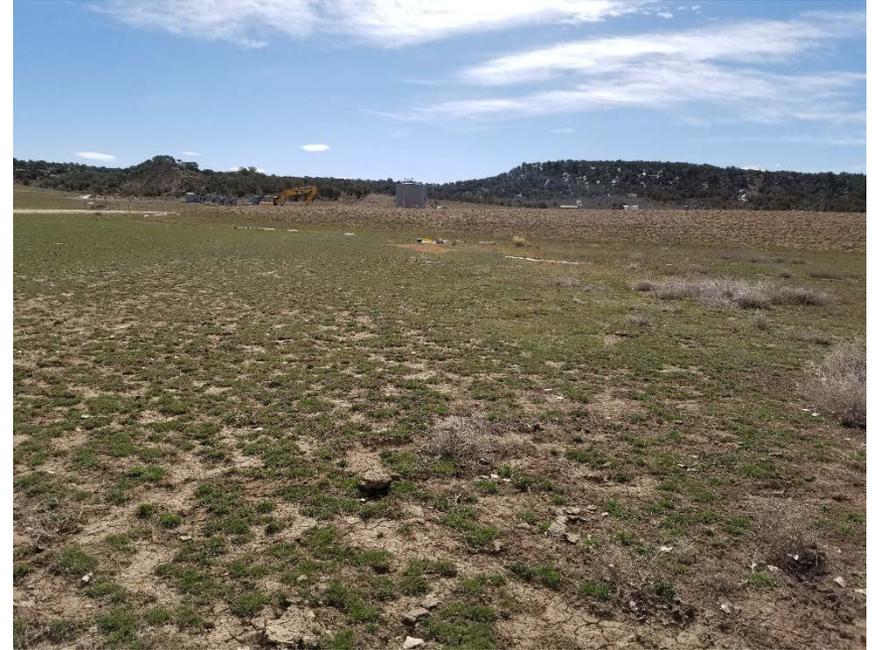
Photo #10 – View from terminus of flow path, looking east.

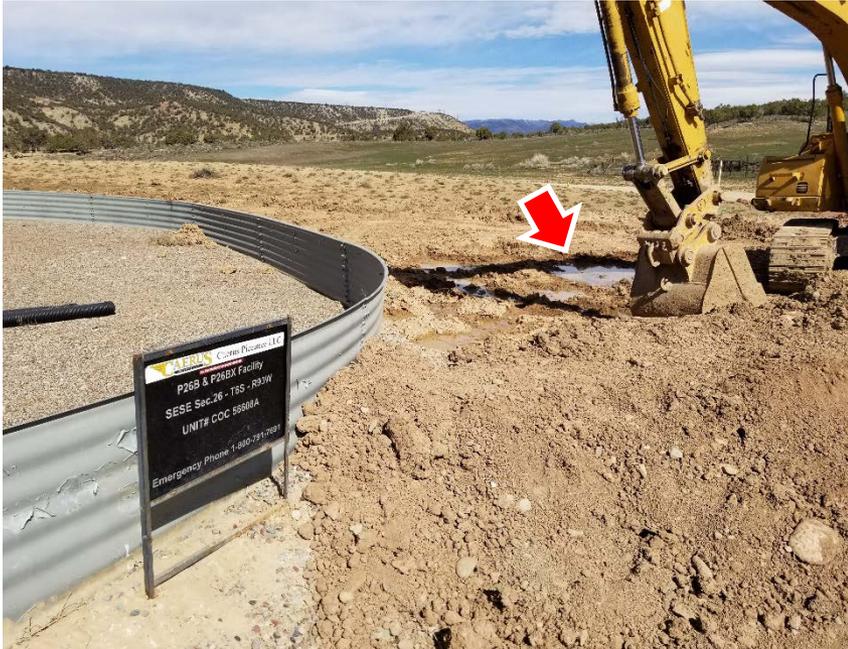
Photo #11 –View of excavation area north of tank battery. Note unidentified fluids were observed in this location on inspection date (red arrow).

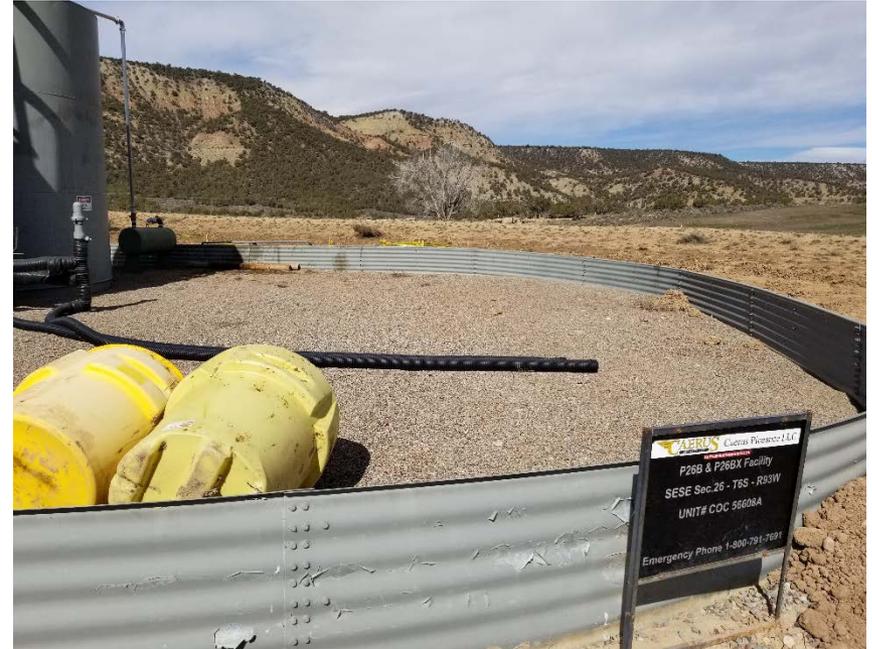
Photo #12 – North end of tank battery, looking west. Note no tank battery liner was observed on inspection date.

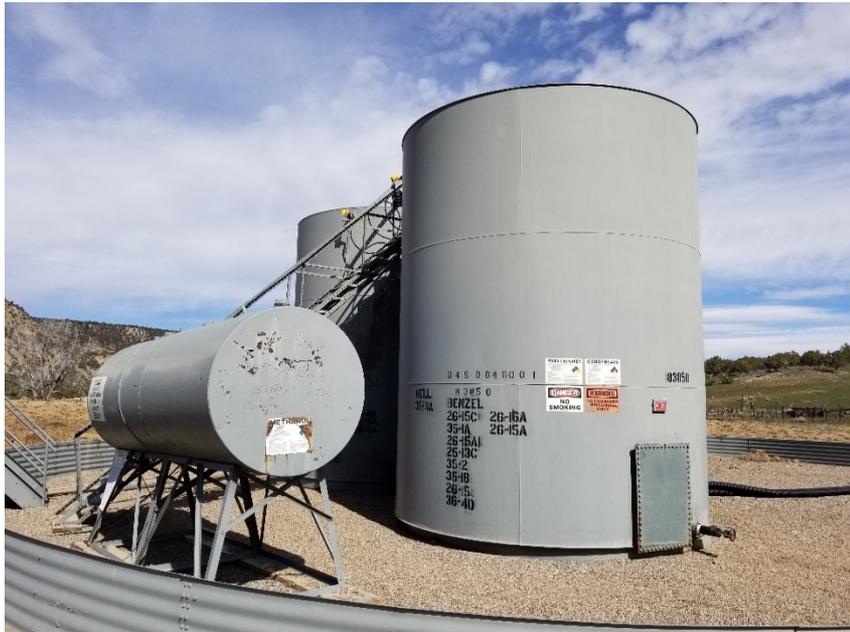
Photo #13 – Tank battery secondary containment ring contained two 300 bbl steel ASTs labeled to contain produced water and condensate and one 1000 gallon methanol tank on inspection date.

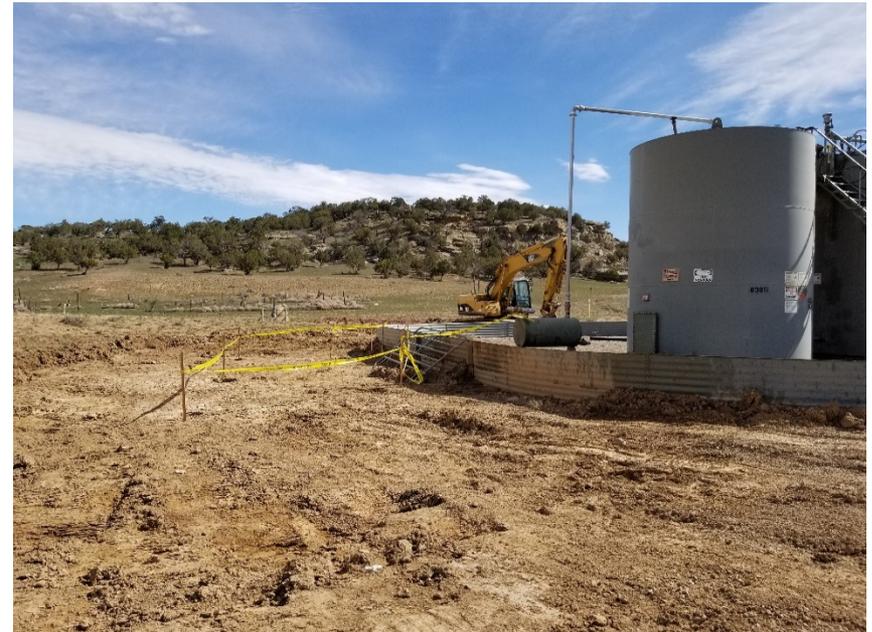
Photo #14 – Overview of excavation area west of tank battery.

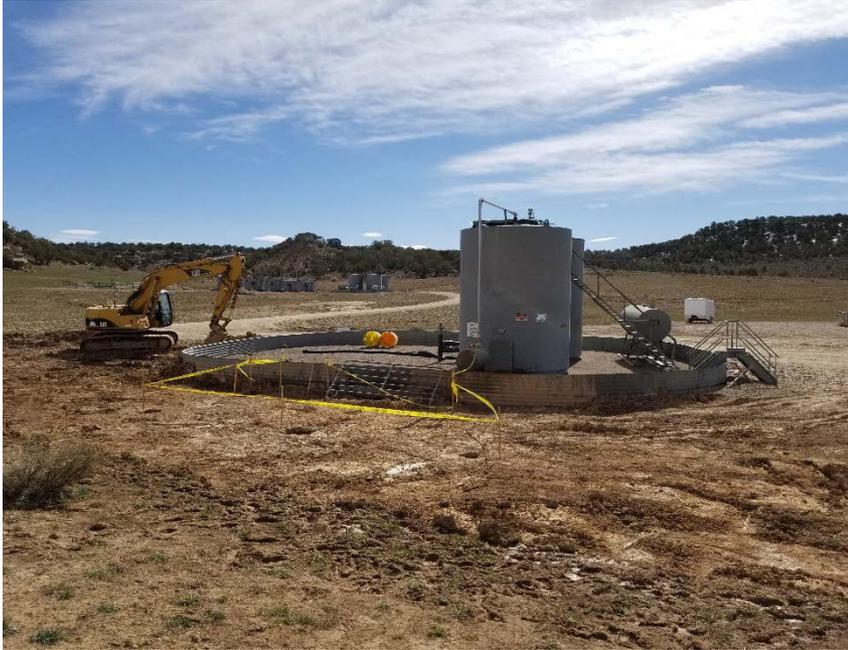
Photo #15 – Overview of tank battery and excavation area from west.

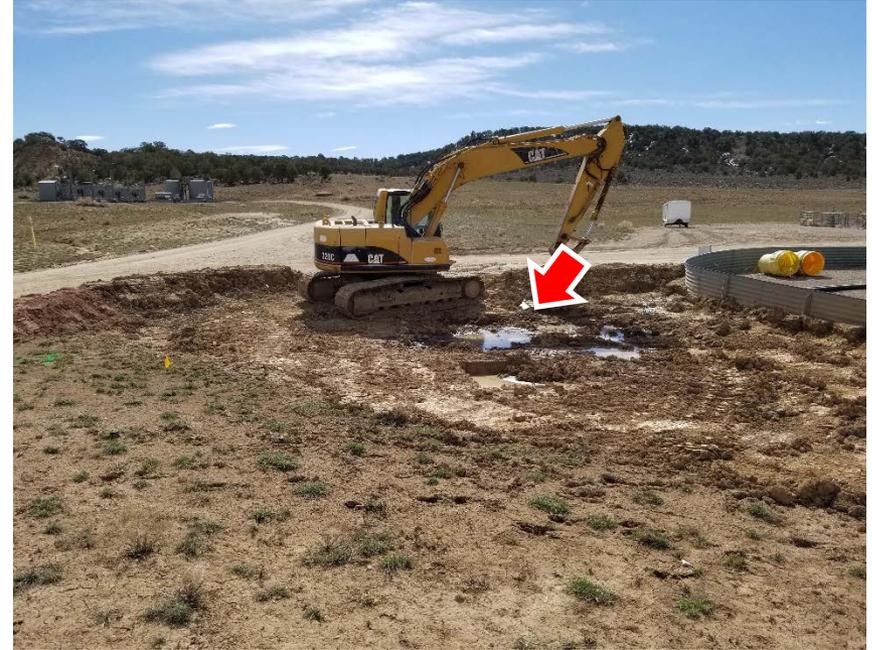
Photo #16 – View of north end of excavation. Note unidentified fluids remaining in tank battery (red arrow).

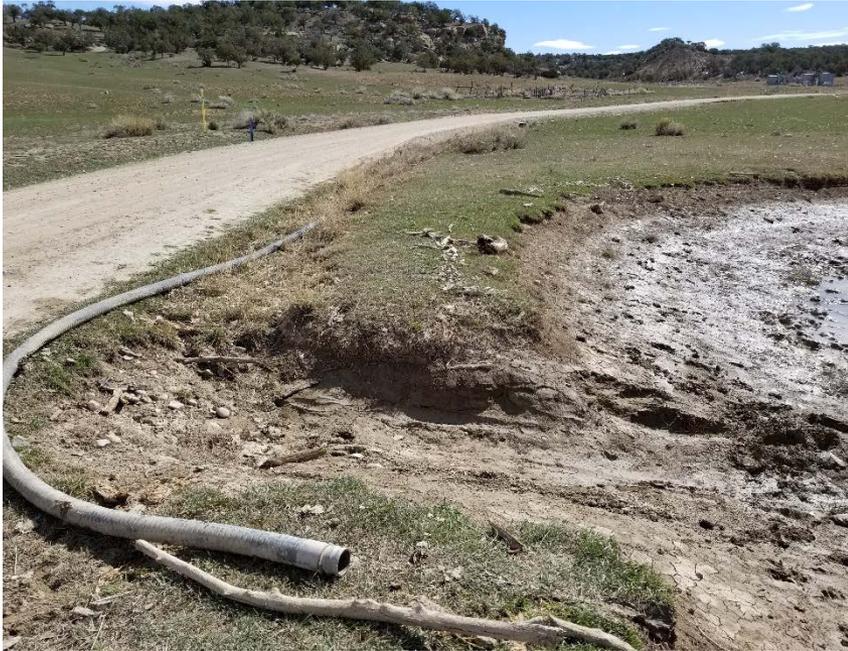
Photo #17 – Inlet from roadside ditch to stock pond is located on north side of pond. No hydrocarbon staining or odors were observed in this area on inspection date.

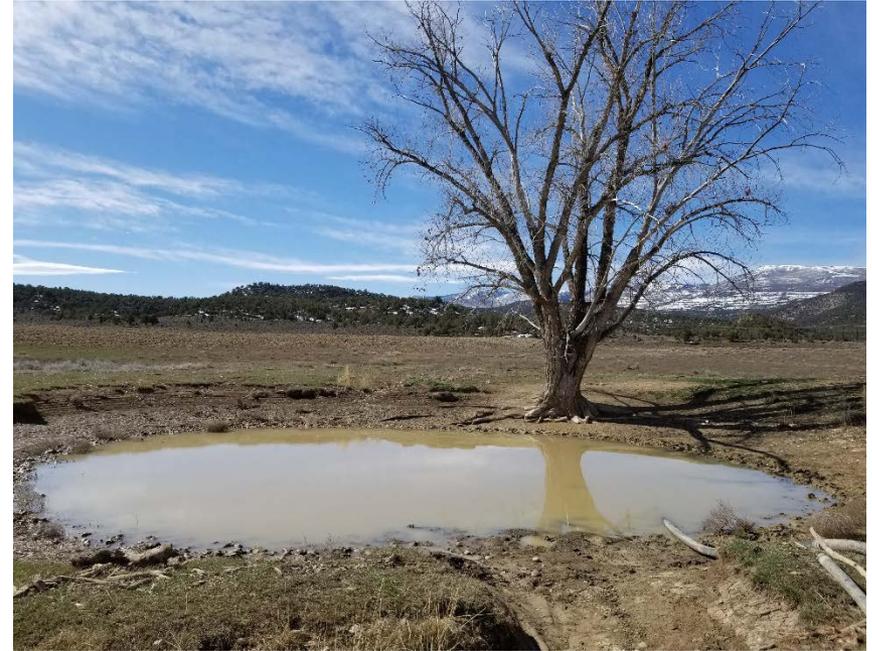
Photo #18 – View of stock pond from north. No obvious hydrocarbon stains, sheens, or odors were observed during inspection. Soil and surface water sampling is required to demonstrate remediation and Table 915-1 compliance of documented impacts to soils and stock pond.
