# Inspection Photos

Operator: BERRY PETROLEUM COMPANY LLC

Location ID: 335716

Garfield County, CO

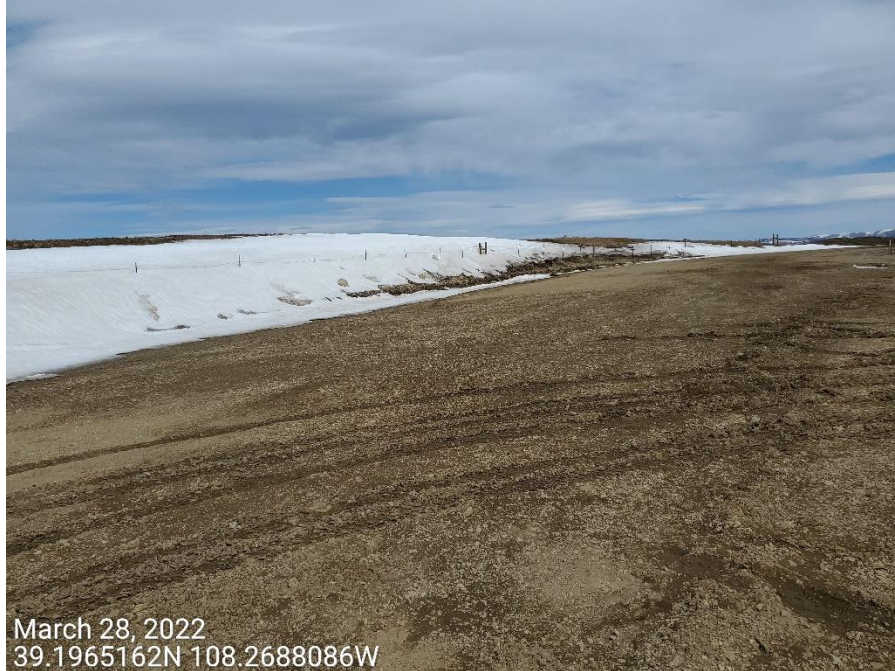
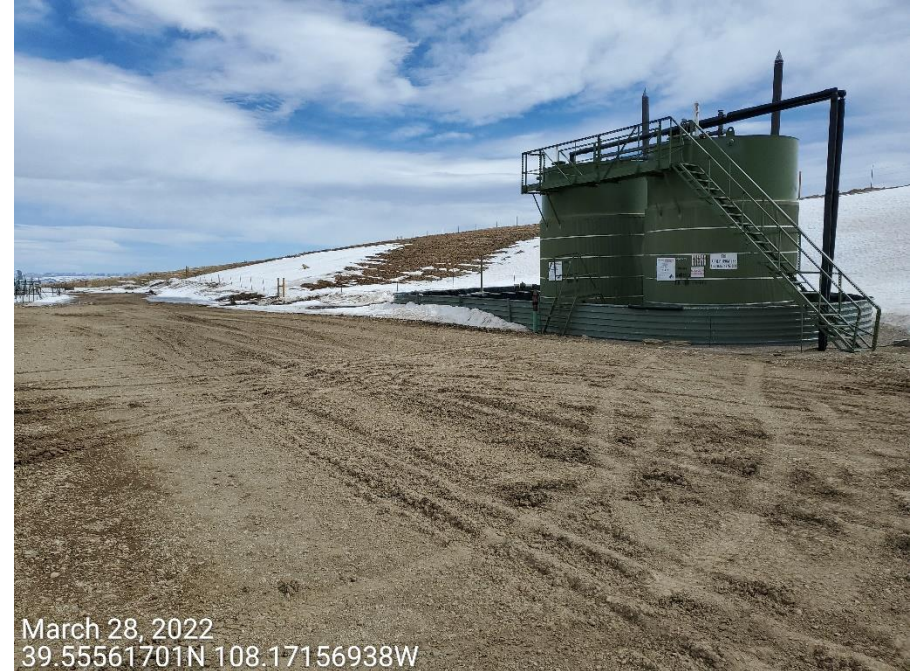
**Photo 1:** Photos taken from the south end of the Location, facing north. Photos provide overview working pad areas; areas of Location used for soil remediation have been included within the areas interim reclaimed.

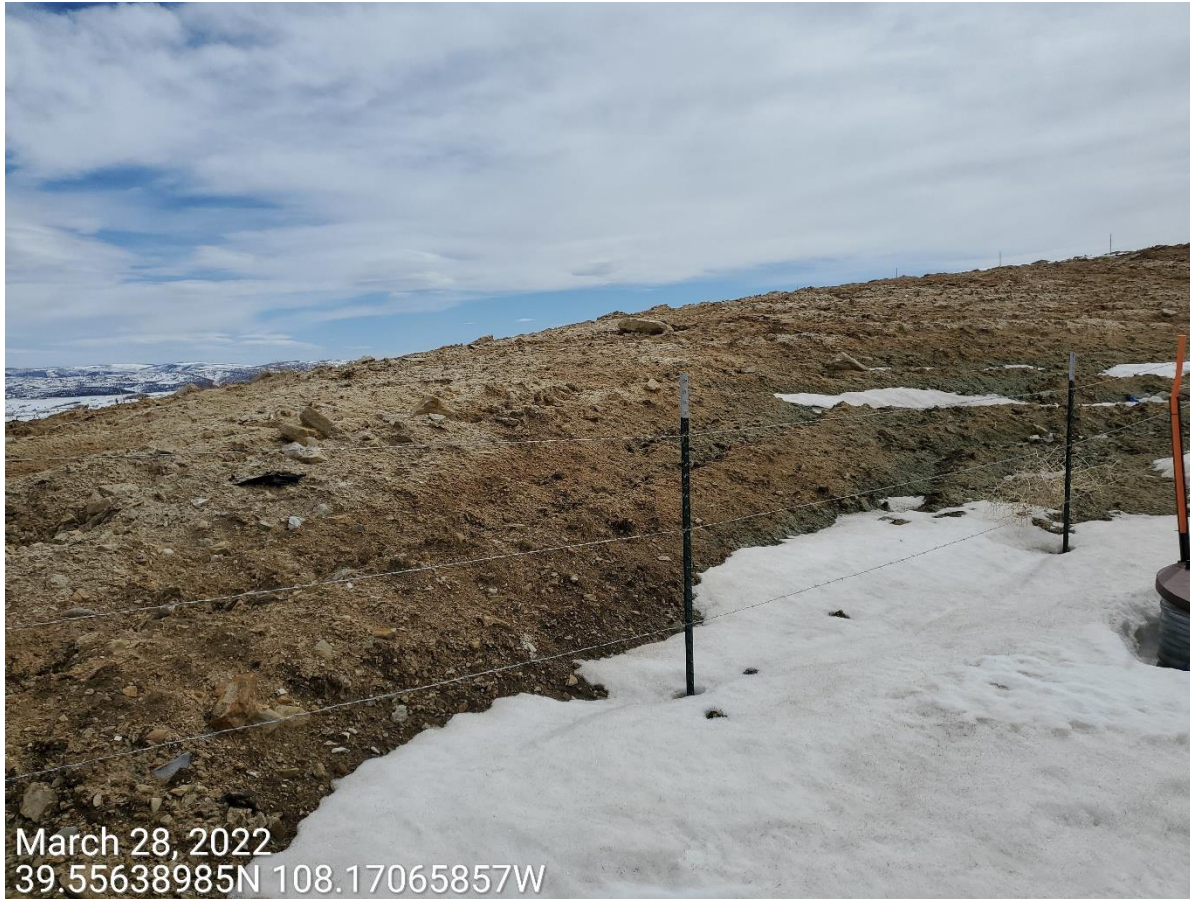
**Photo 2:** Interim areas of the Location; Areas appear to be hydroseeded and a soil binder implemented to stabilize the seeded soils

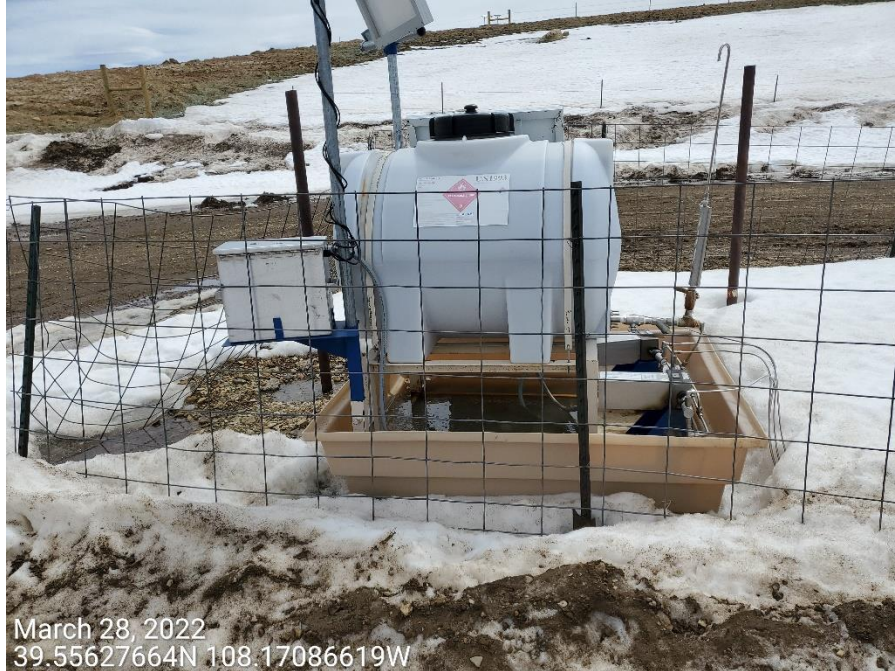
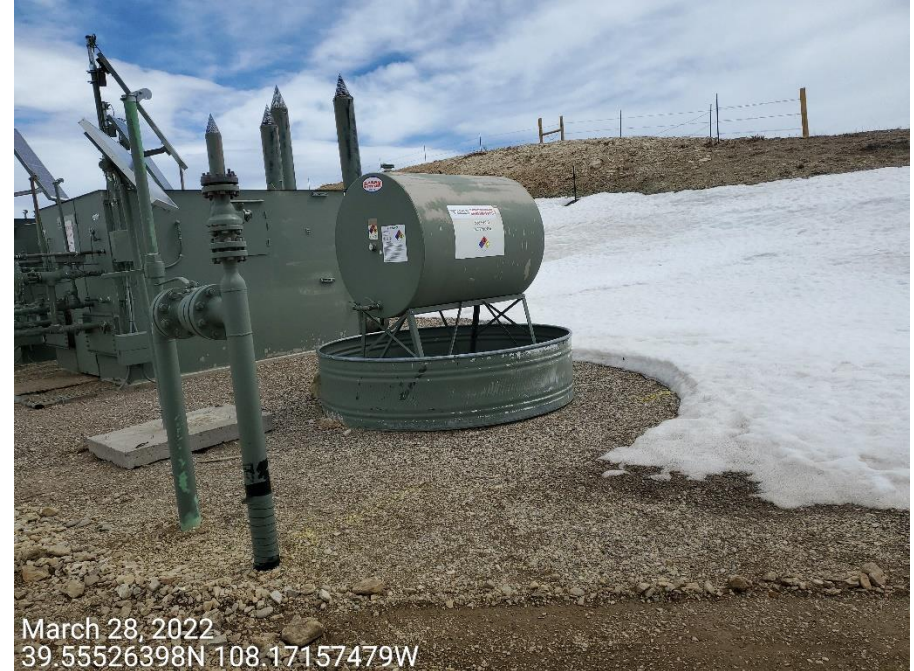
**Photo 3:** Photos show methanol tanks on the Location. BMPs to prevent wildlife access is missing from the secondary containment.

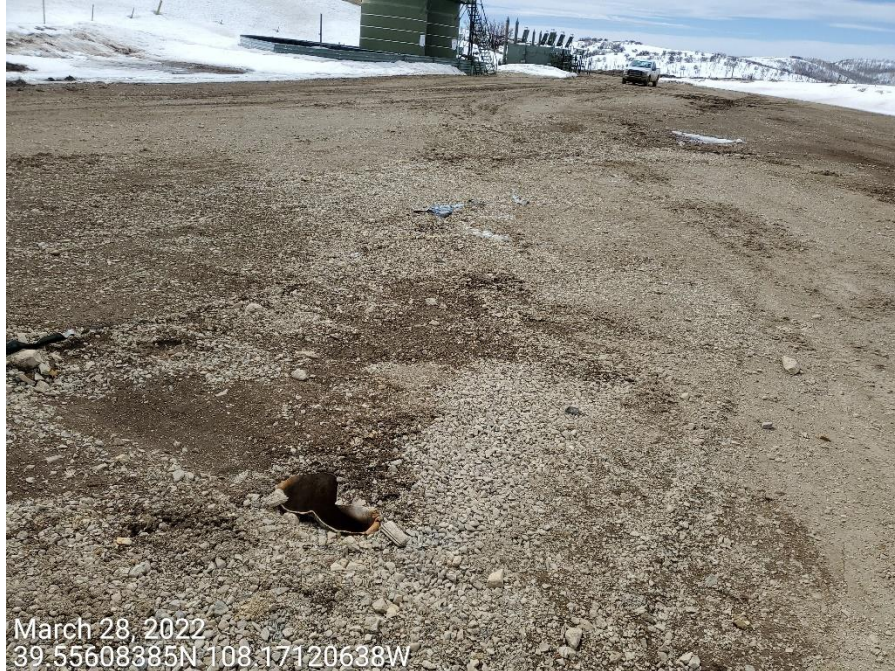
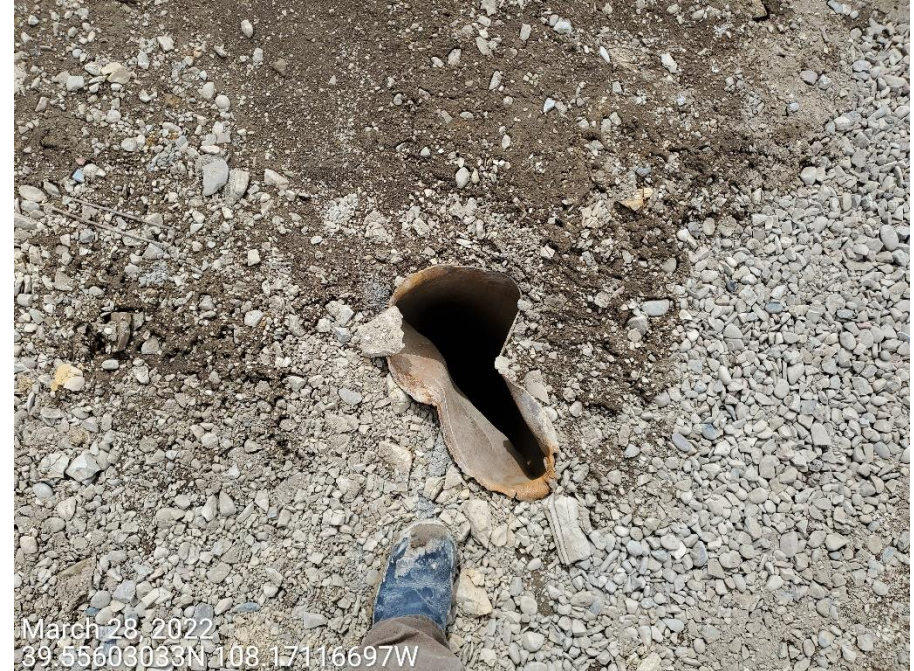
**Photo 4:** Photos taken from the south end of the producing wells. Photos show conductors/cellars associated with the AL wells on the Location appear to have been exposed during winter work; pipe observed open at surface; conductors/cellars do not appear to have been adequately cut/plugged/reclaimed.

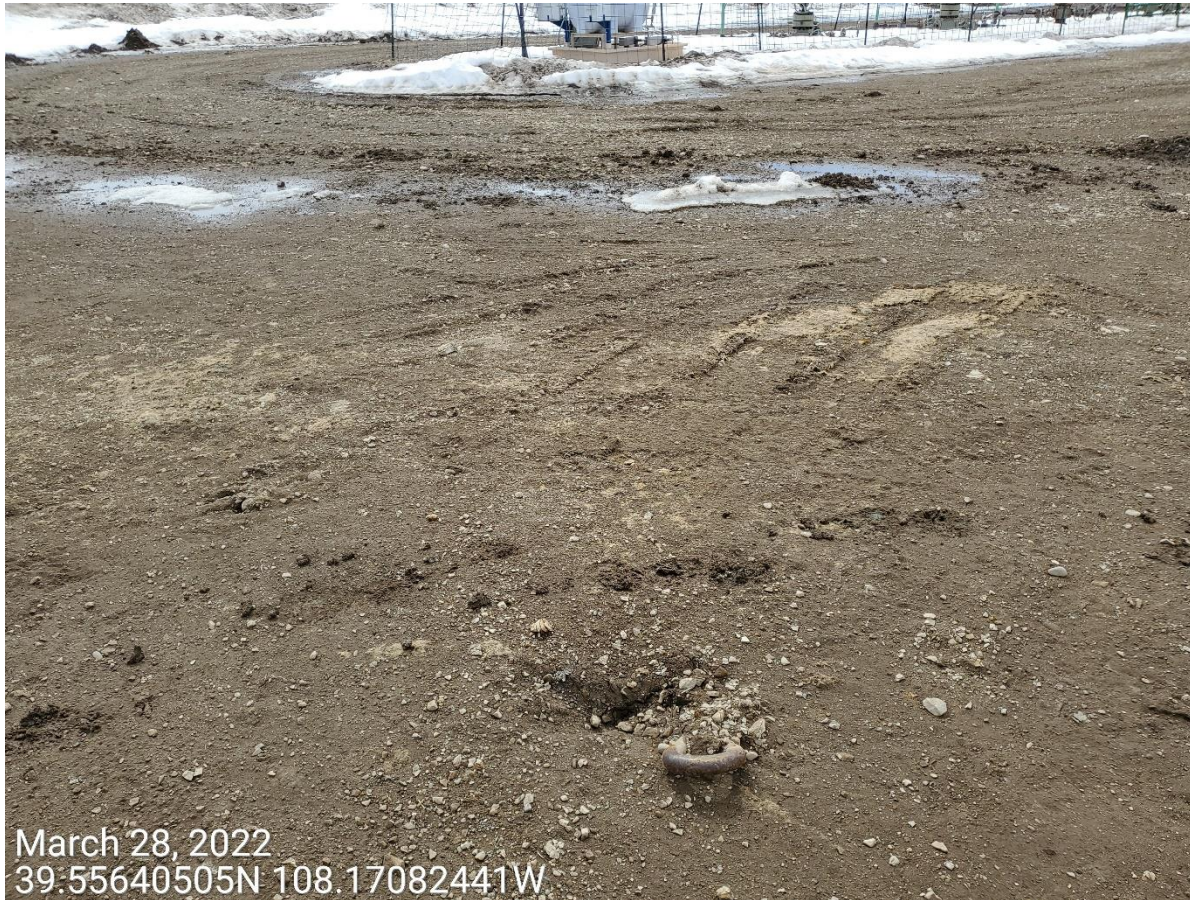
**Photo 5:** Photo shows unmarked anchor on Location.
