Inspection Photos

Operator: CAERUS PICEANCE LLC - 10456

Location ID: 335880

Garfield County, CO

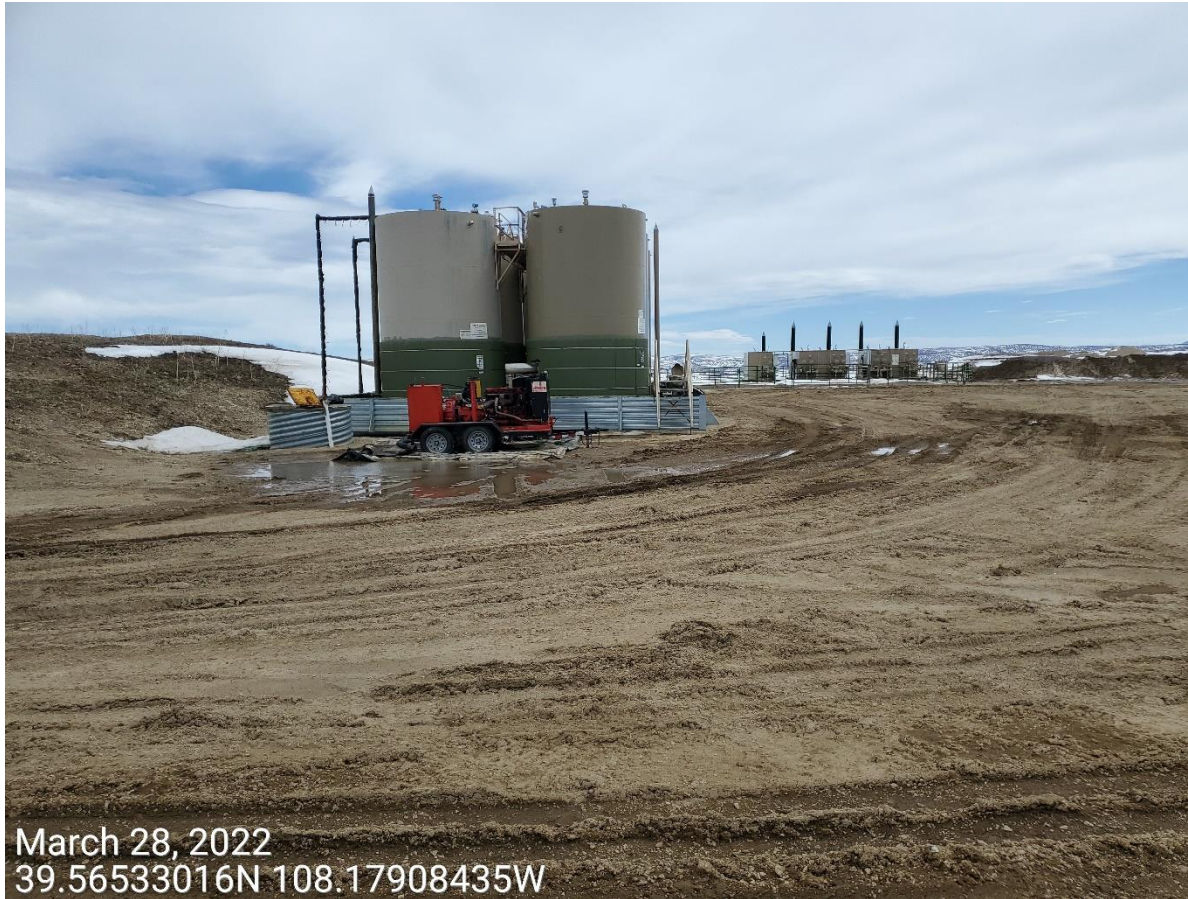
March 28, 2022
39.56533016N 108.17908435W

Photo 1: Photo shows pump trailer stored on the west end of the battery facility. Photo also shows stormwater ponding around equipment.

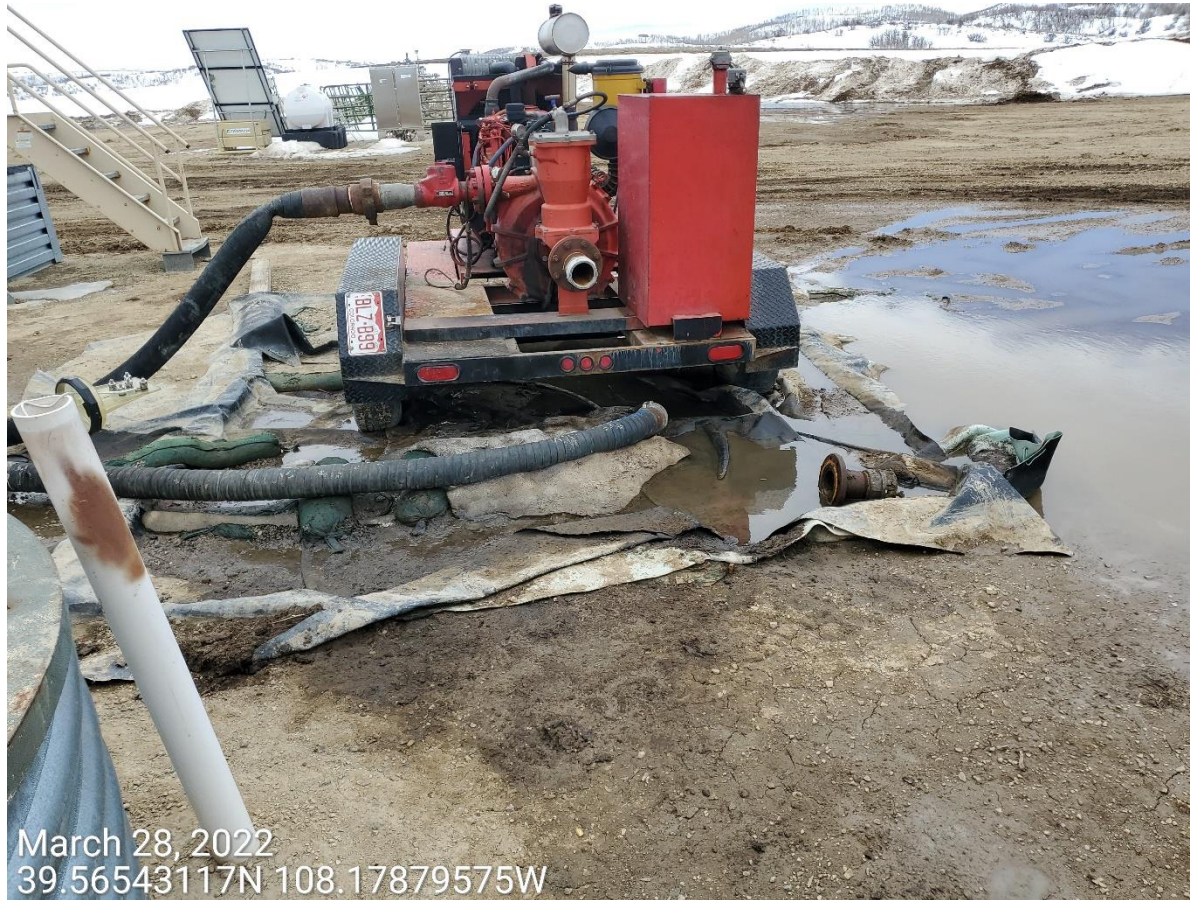
Photo 2: Photo of pump trailer and stormwater; liner/secondary containment BMP at pump inadequate to prevent spills and contamination of stormwater. Stained soils around pump equipment/liner evident.

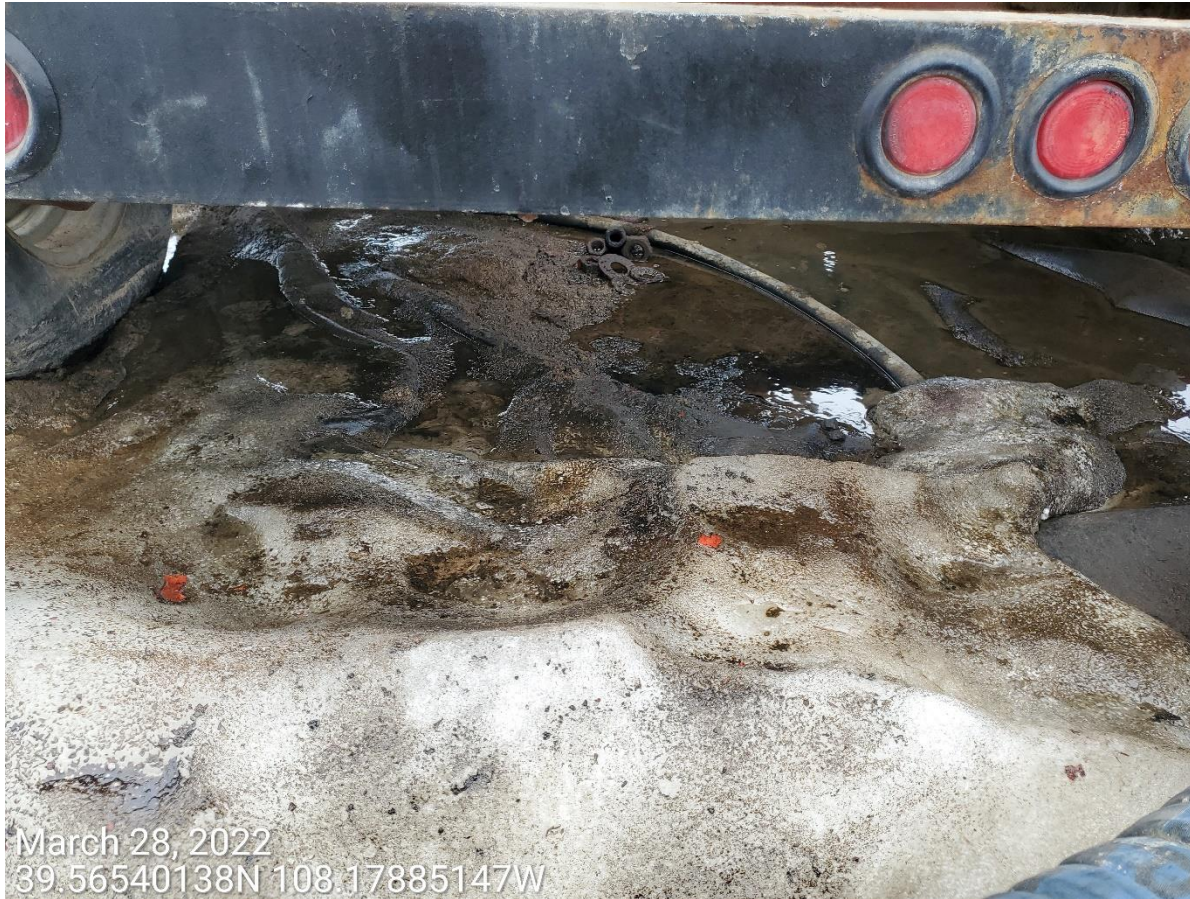
Photo 3: Photo taken from beneath pump trailer. Photo shows leaks/drips and impacting stormwater
