Inspection Photos
Operator: Simcoe
API: 067-06043
Date: 3/28/2022

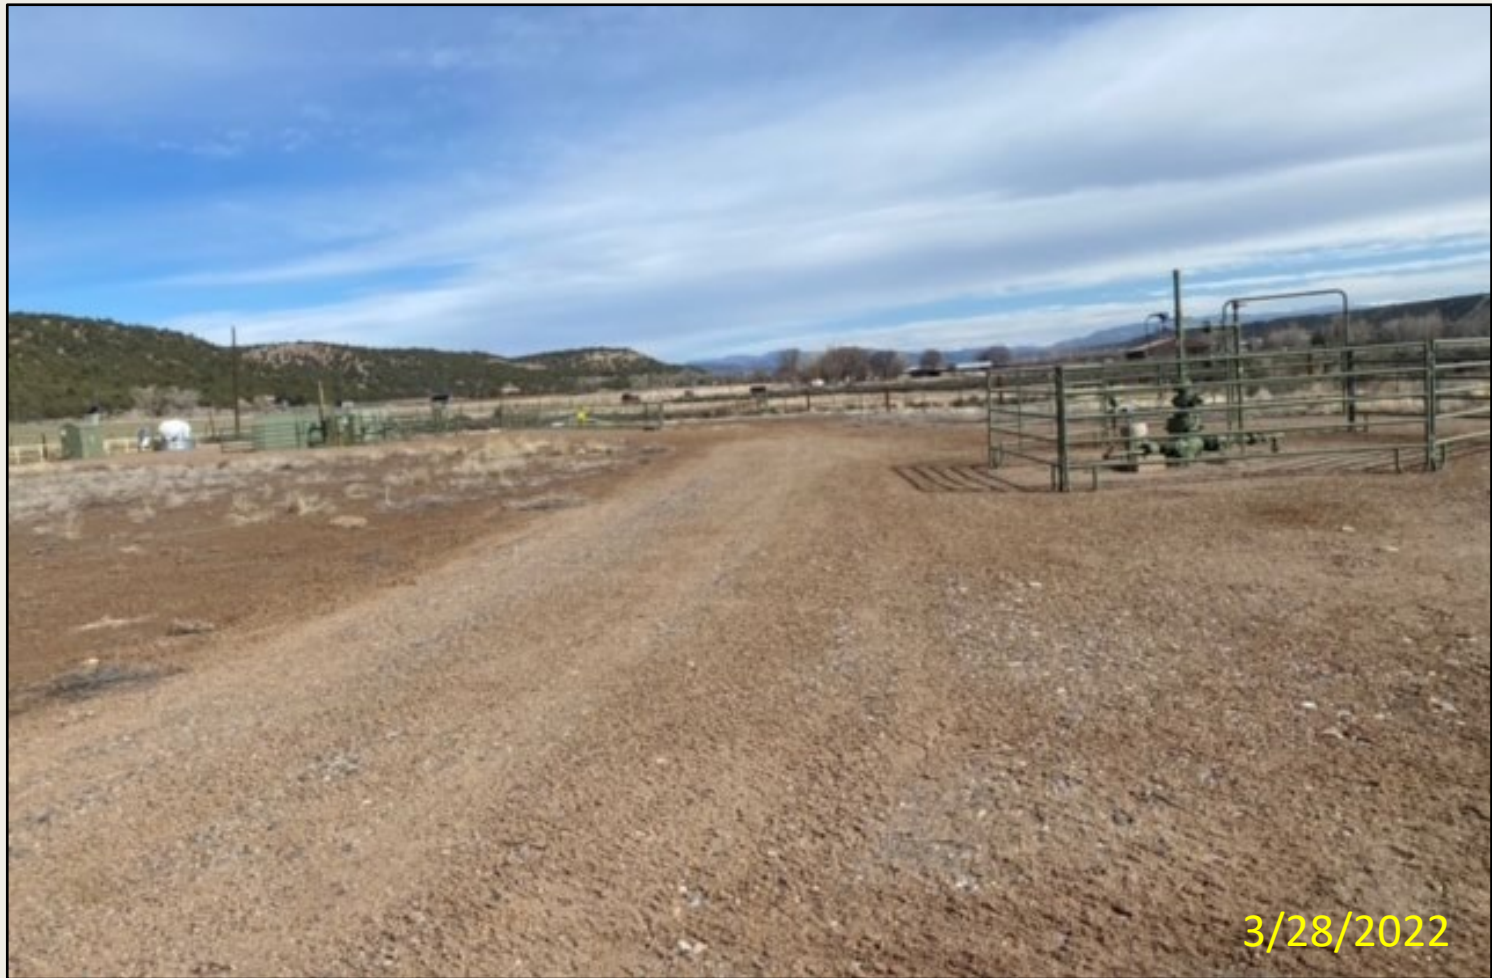
Photo 1. View of the project area from the well pad entrance facing center.

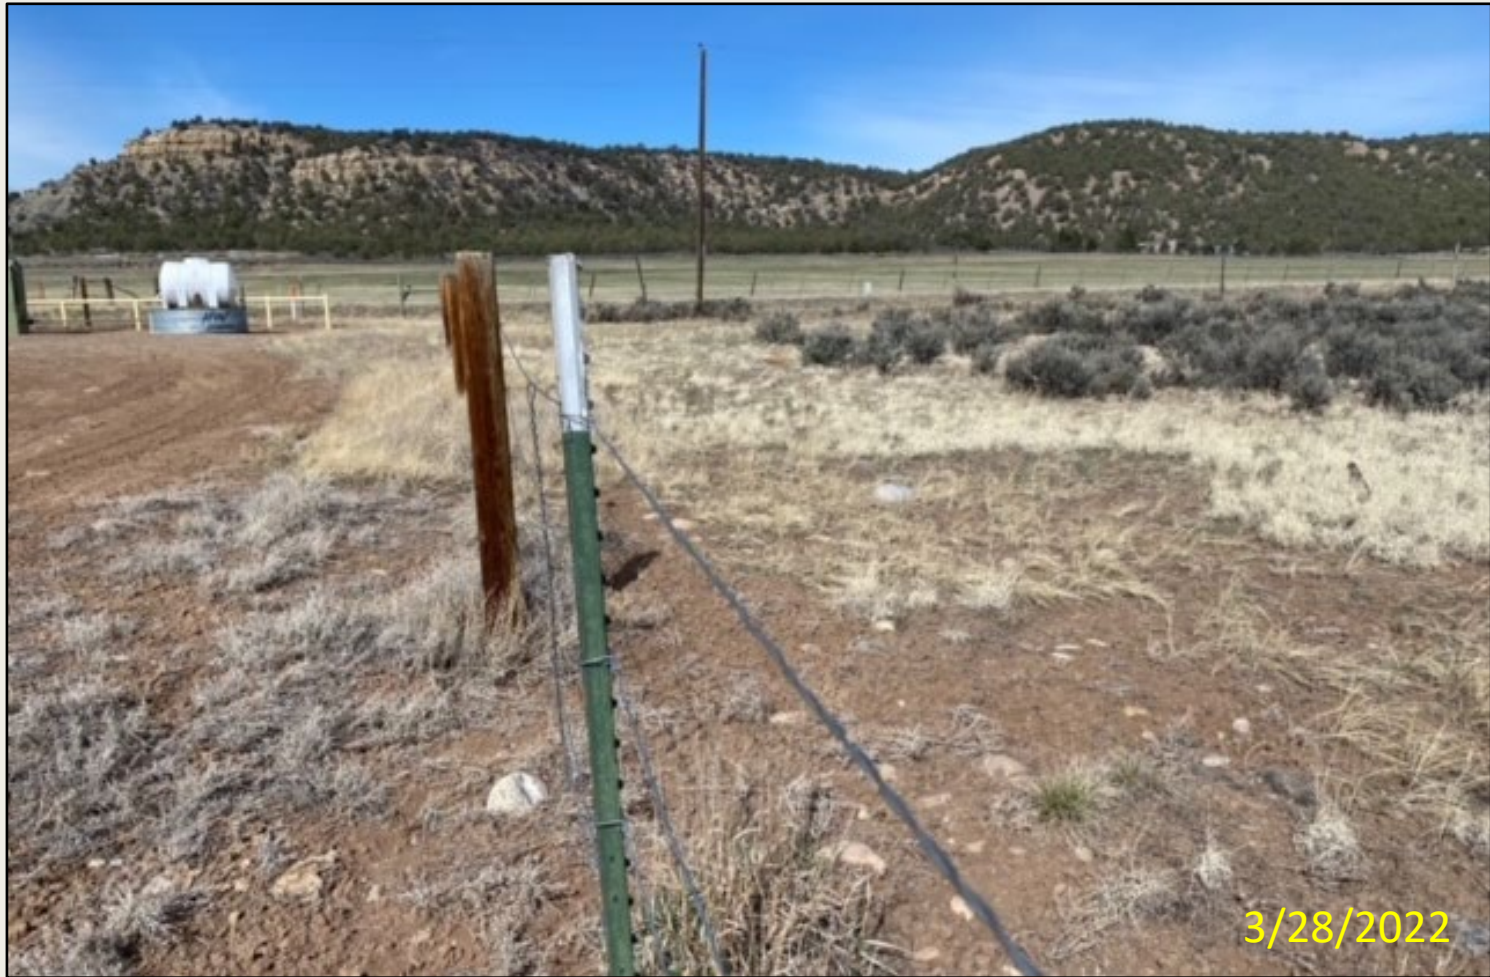
Photo 2. View of the northern project area from the northeastern corner facing westward. Revegetation is progressing here with grasses such as western wheatgrass, crested wheatgrass, and sand dropseed.

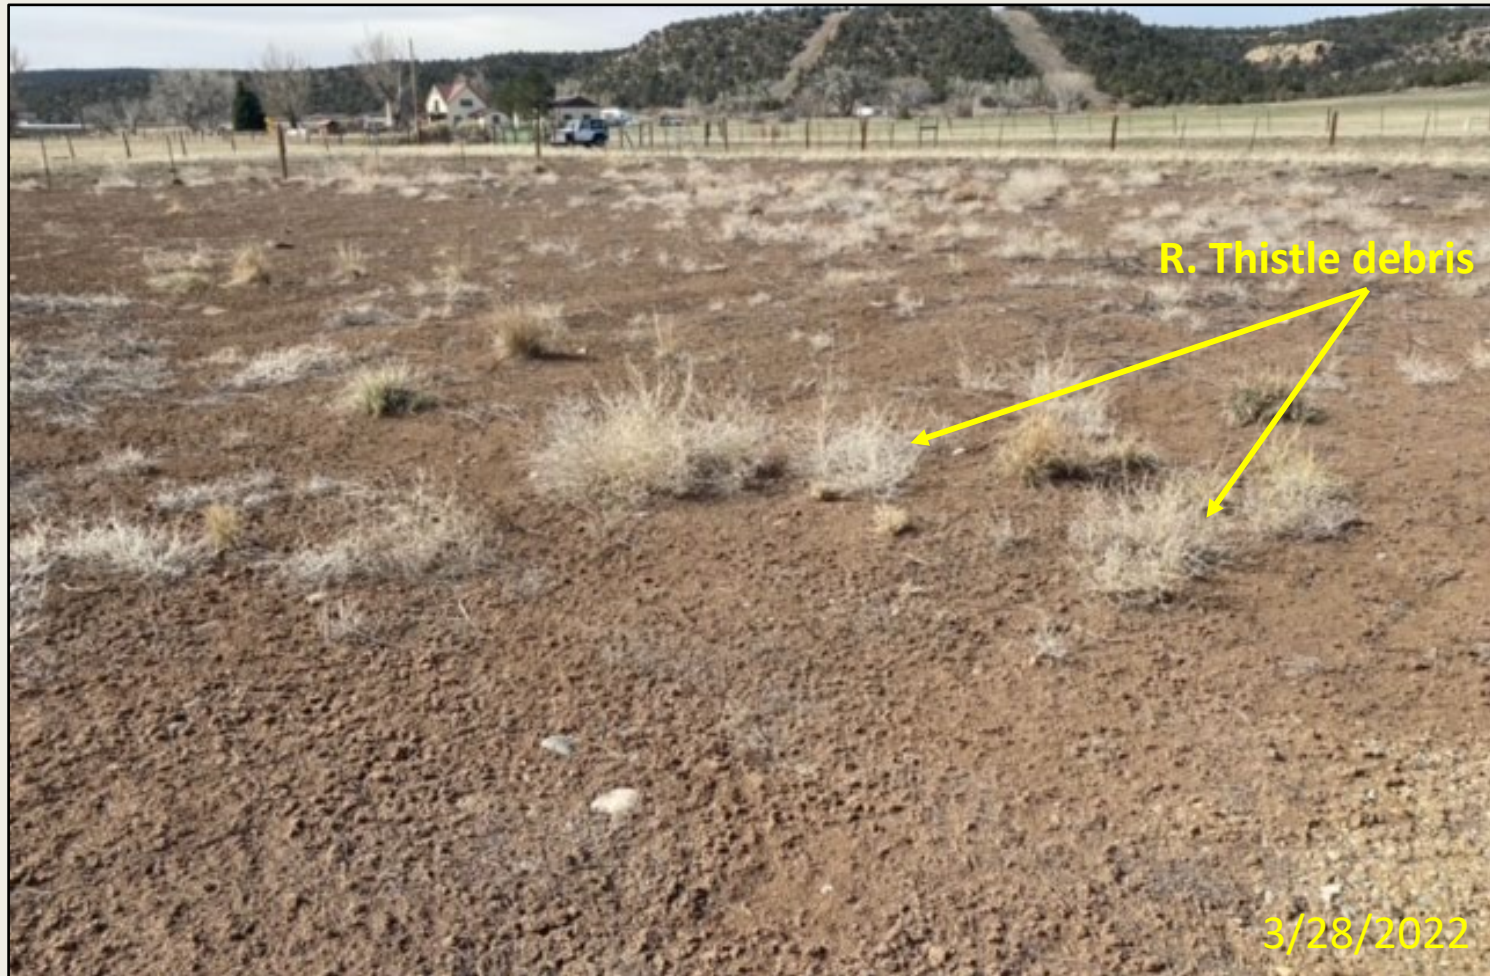
Photo 3. View of area in the southwestern project area where bare/sparse soils need revegetation. Only scattered grasses observed here, vegetation is mostly Russian thistle.

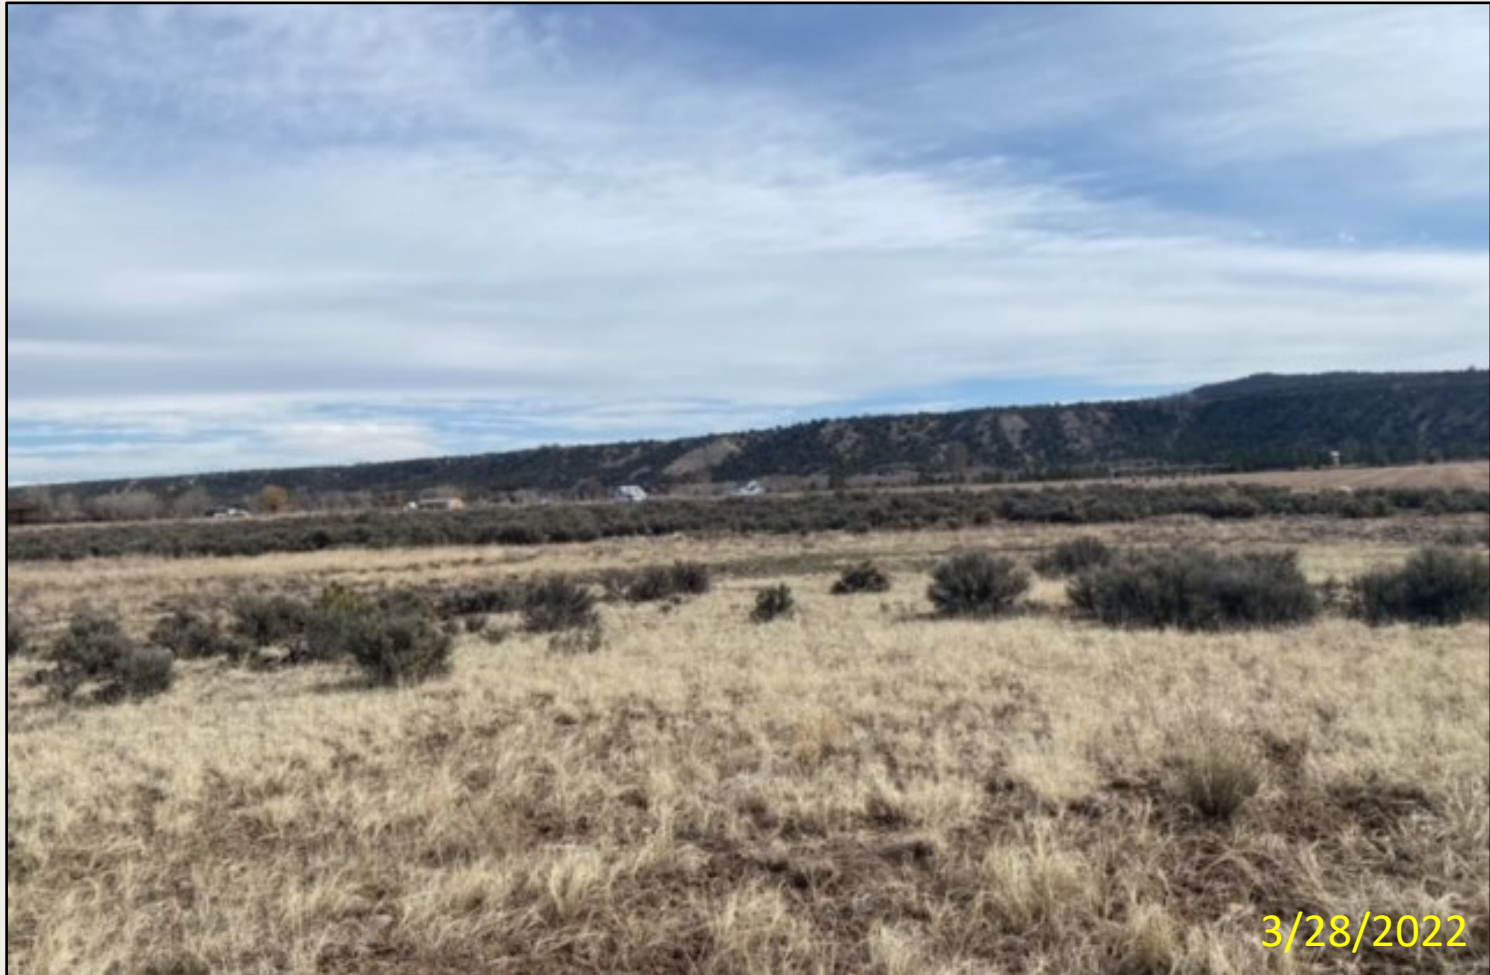
Photo 4. View of reference area comprised of sagebrush shrubland with understory of grasses such as sand dropseed, western wheatgrass, and blue grama.
