Inspection Photos

4/04/2022

Operator: GUNNISON ENERGY LLC - 10515

Location ID: 324459

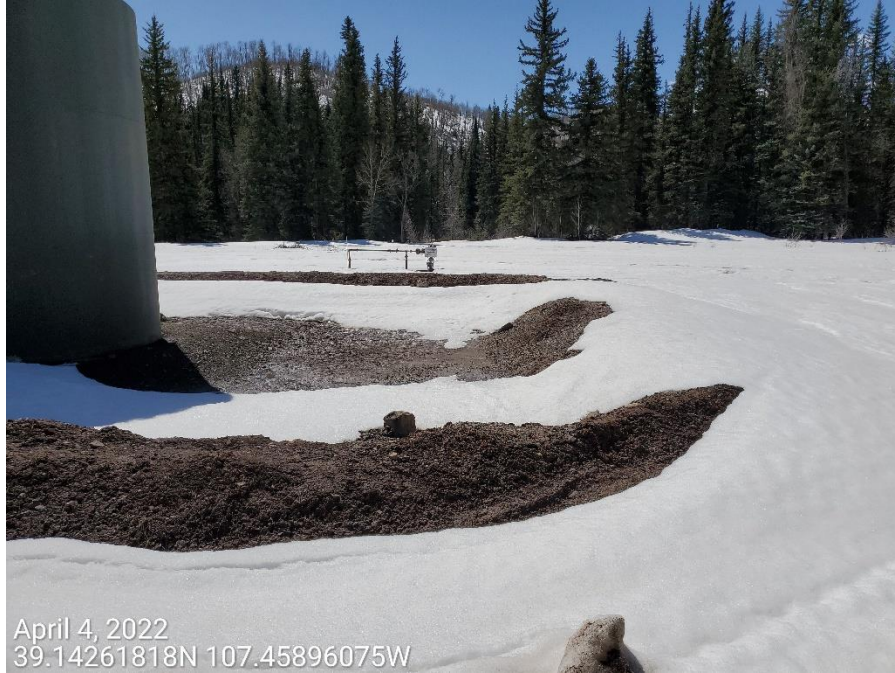
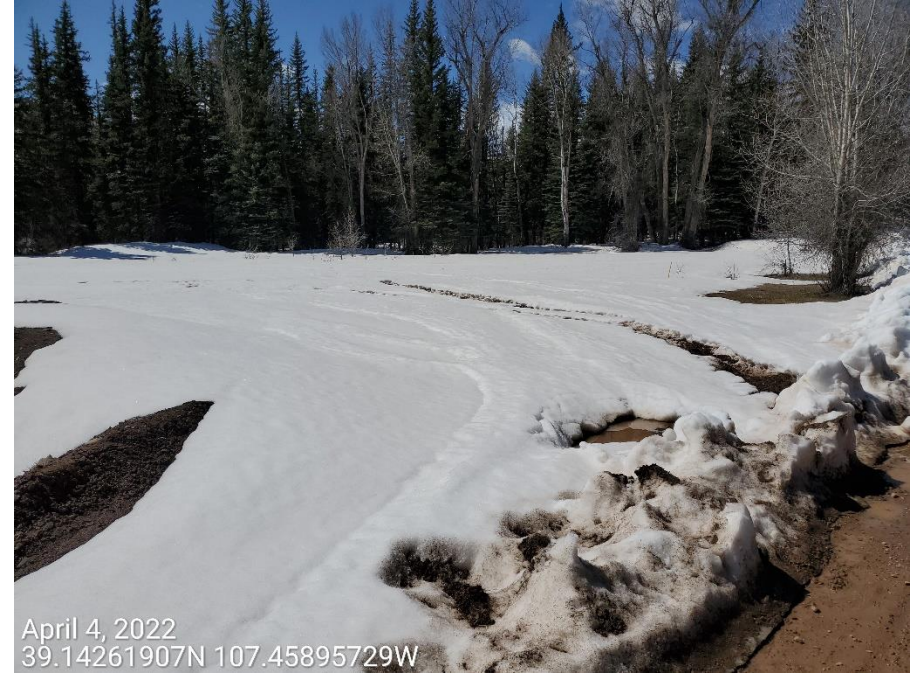
Photo 1: Limited visibility due to snow cover prevented Reclamation specialist from conducting an accurate assessment of compliance with Rule 1003, 1002.f and 912. A followup inspection will be conducted. Photo shows vehicles not necessary for production have been removed from the Location.

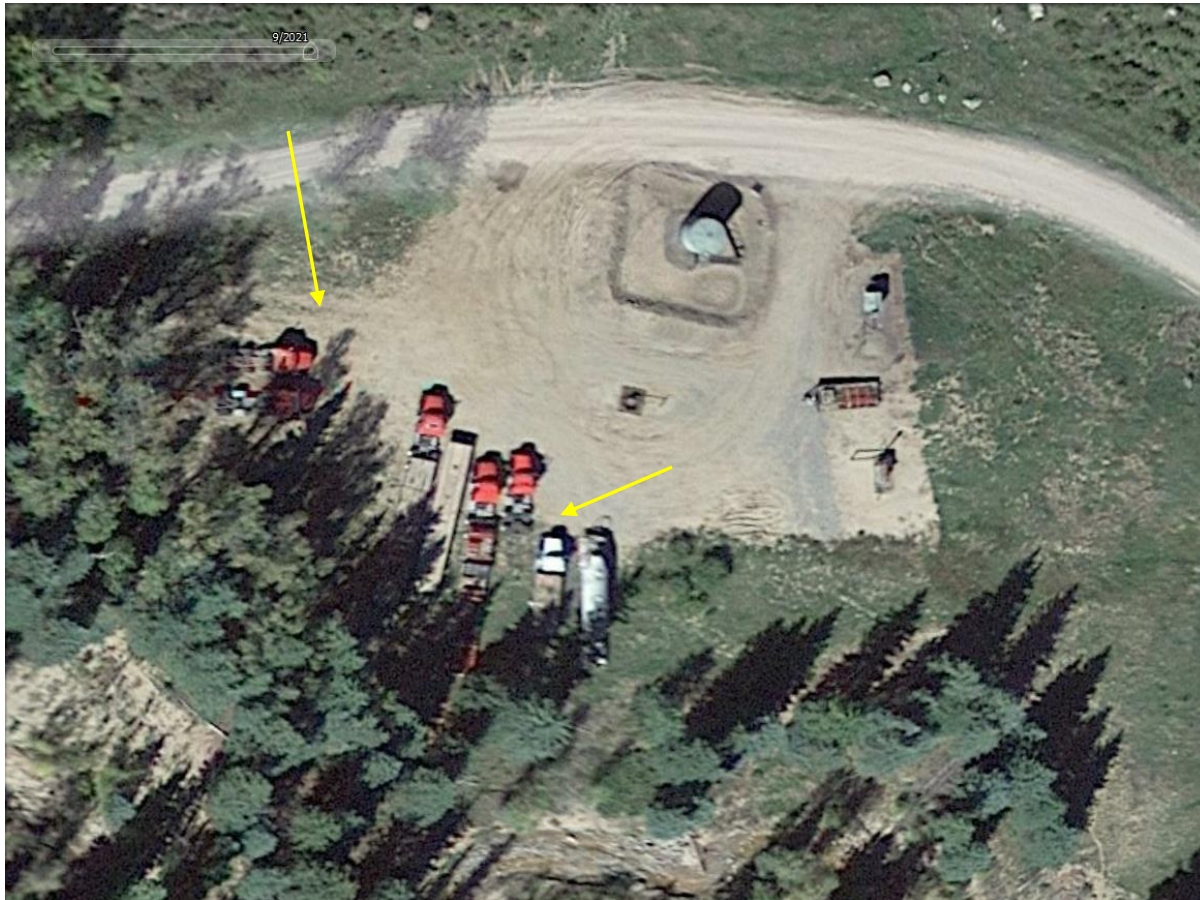
Photo 2: 9/2021 Google Earth aerial image. Photo shows overview of the Location, vehicles stored on the production and interim areas, which resulted in additional degradation and disturbance.
