Inspection Photos

4/04/2022

Operator: GUNNISON ENERGY LLC - 10515

Location ID: 412922

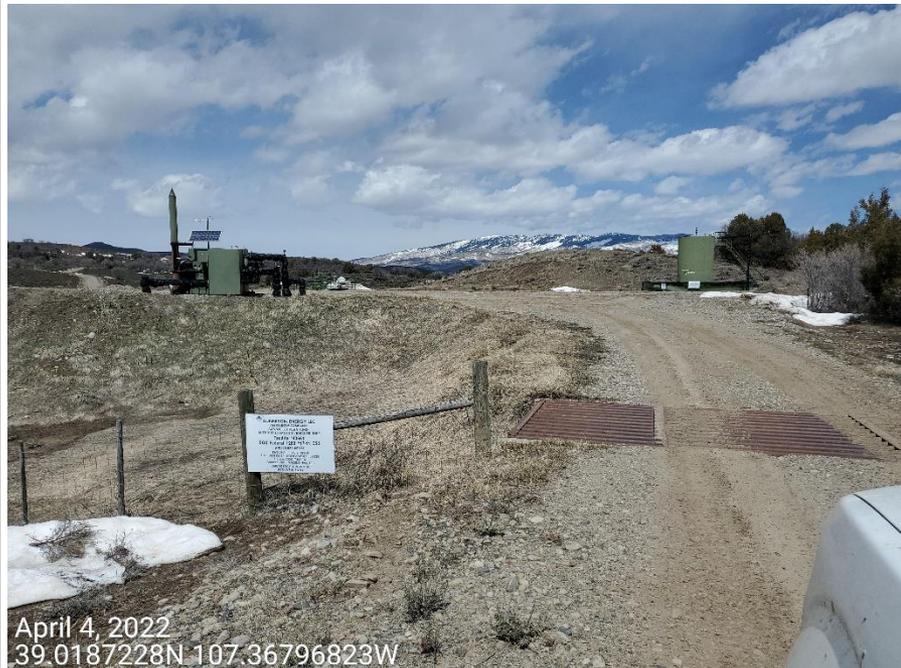
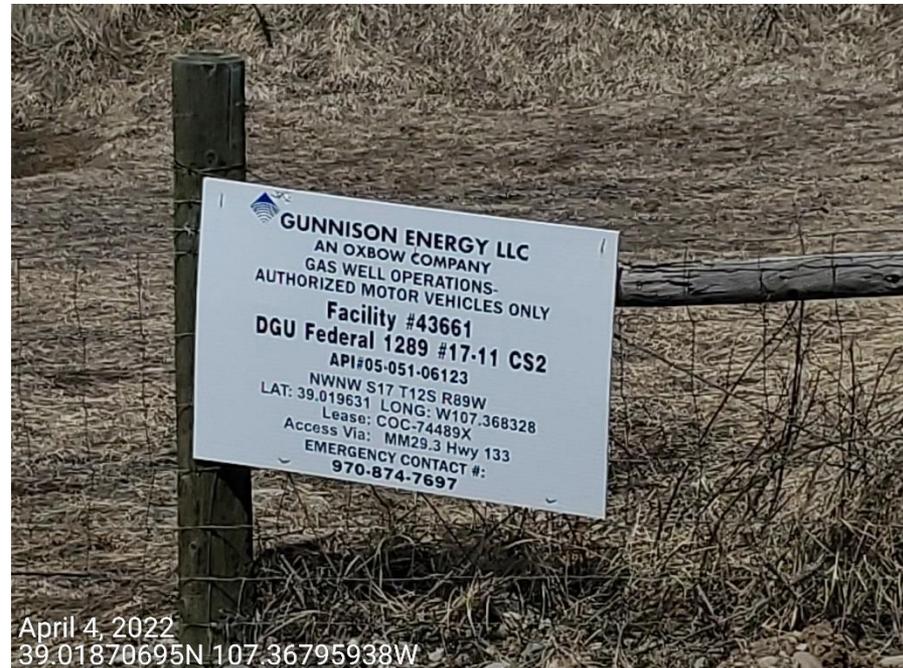
Photo 1: Photos show signage at Location entrance. Location received a variance to delay IR with COAs requiring a sign at the Location entrance stating the following: ""A COGCC variance has been approved to delay the commencement of interim reclamation to no later than December 9, 2022"". Photos show sign has not been posted.

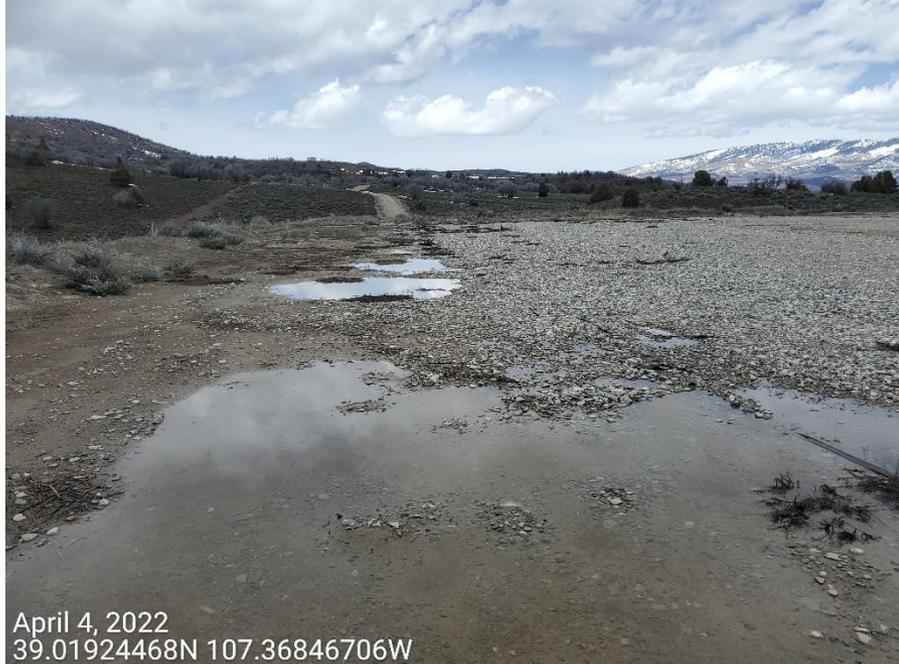
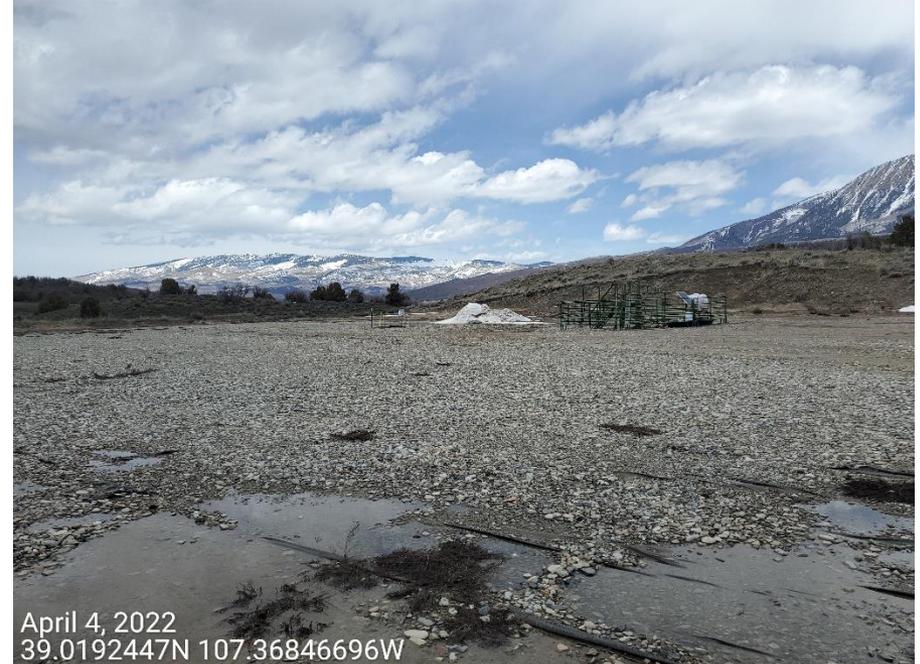
Photo 2: Photos 2-3 taken from the west end of the production area. Photos provide an overview of the Location from northwest, north, southeast to south.

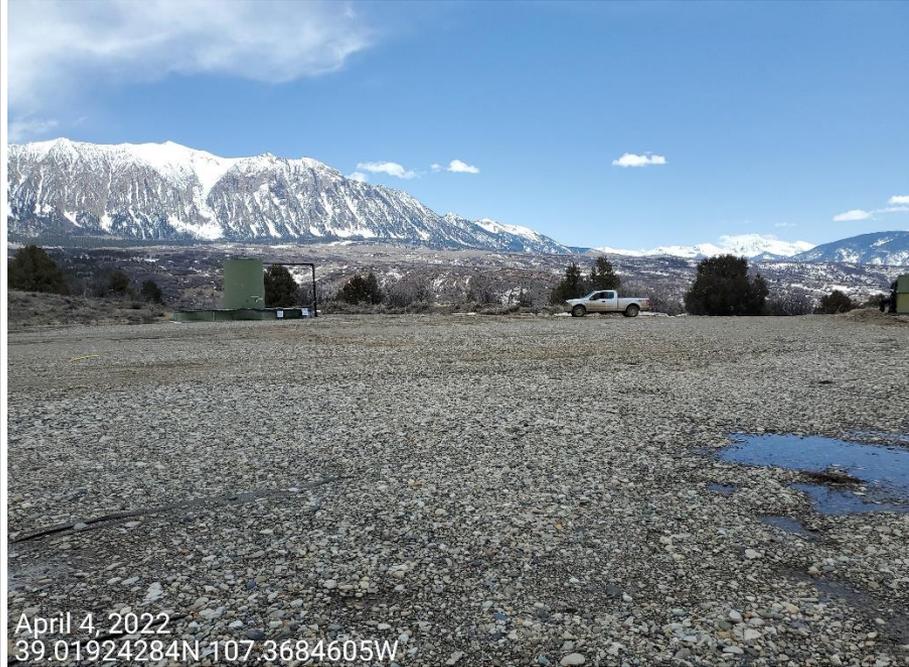
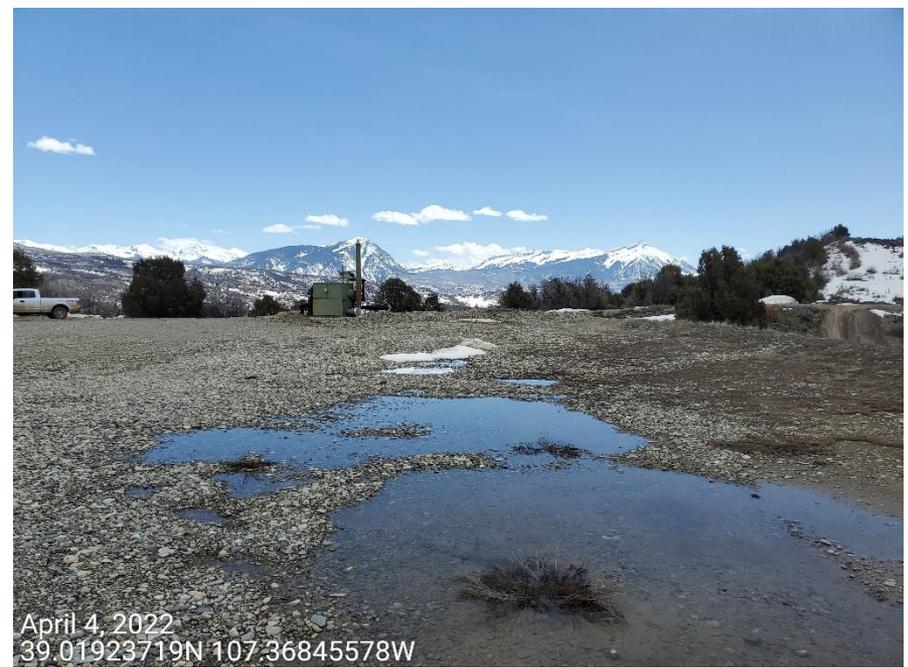
Photo 3: See comments under photo 2.

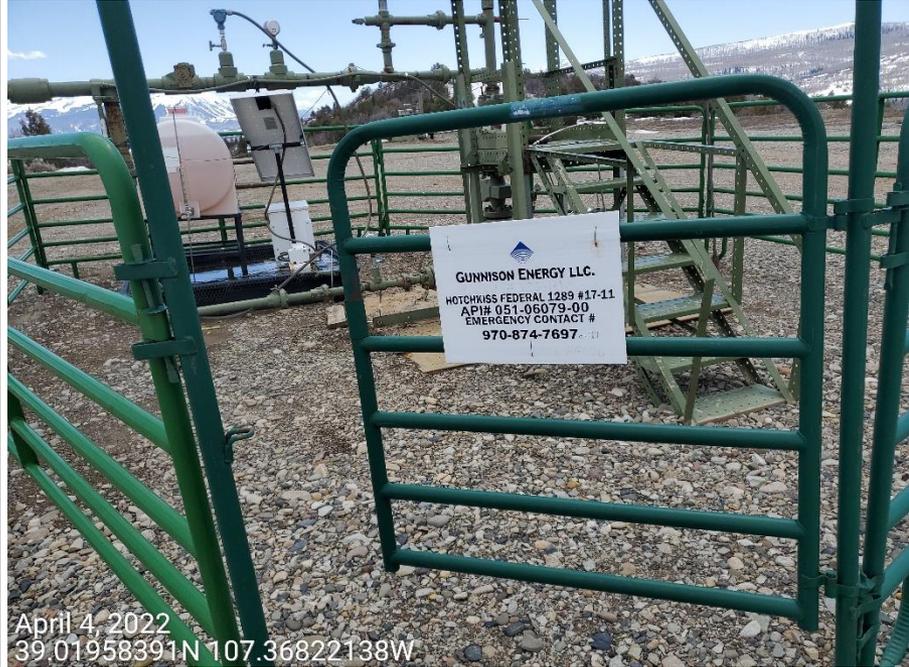
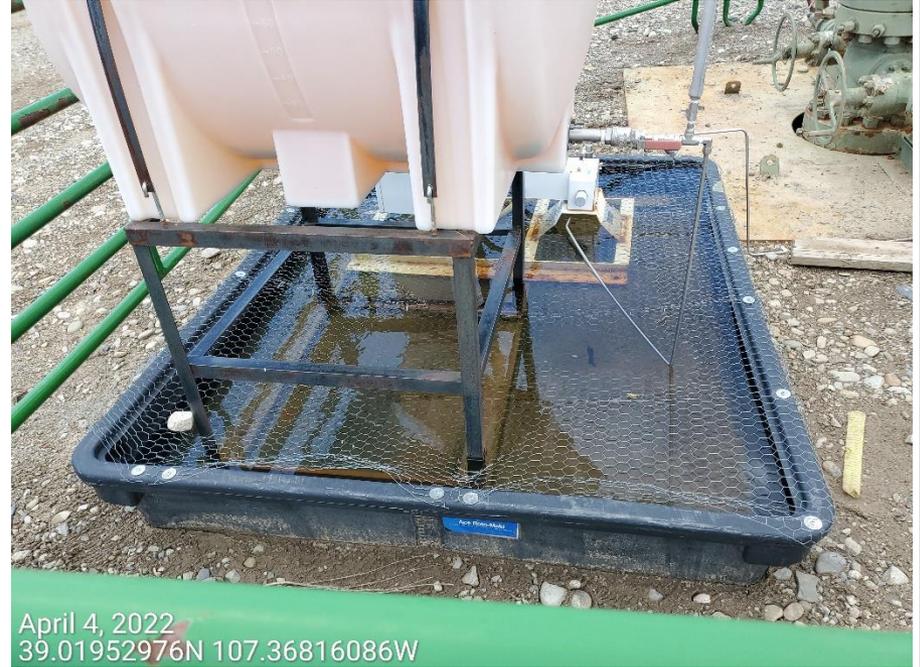
Photo 4: Photo left shows legal description on well sign remains illegible. Photo right shows containment BMP has filled with fluids and is no longer adequate to contain a spill.

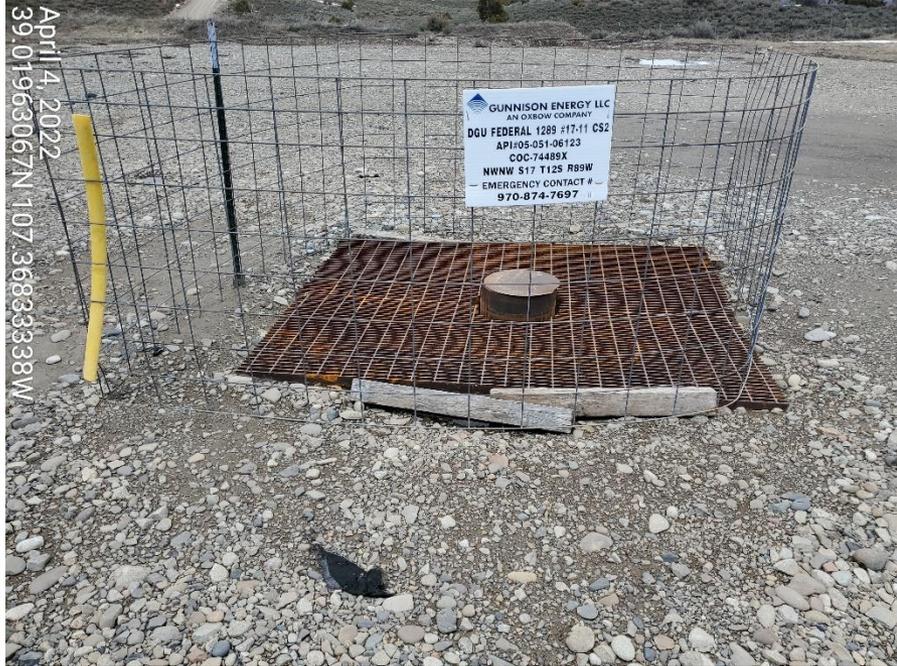
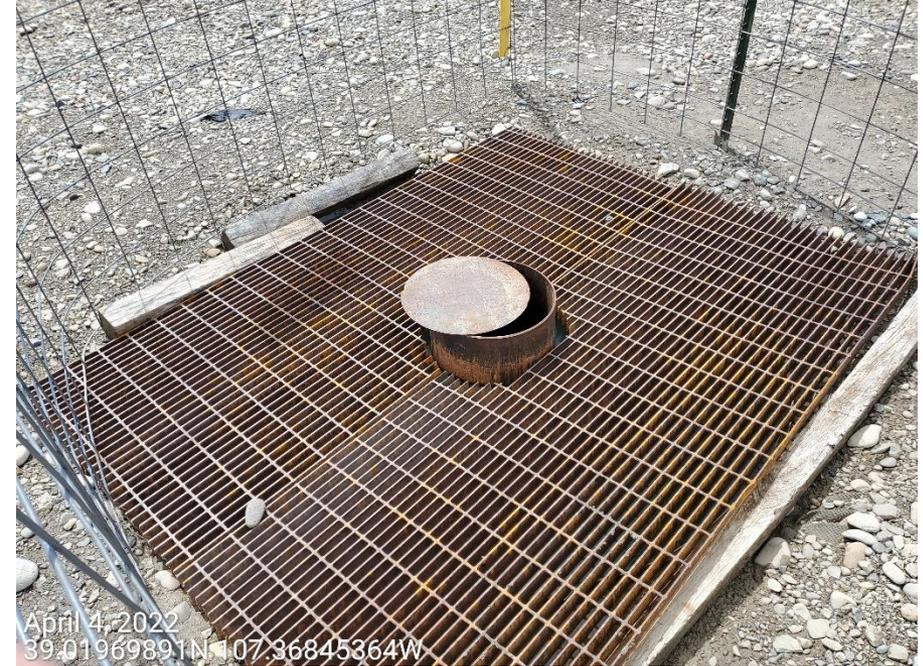
Photo 5: Photos show conductor and cellar for Well API #051-06213; records show well is abandoned; conductor and cellar for this well have not been plugged and reclaimed per Rule 406 requirements; conductor and cellar remaining; plate on top of the conductor pipe not welded per requirements. No Form 4 - "Report of work done" to report plugging of the conductor has been submitted. Well conductor requires plugging and reclamation.

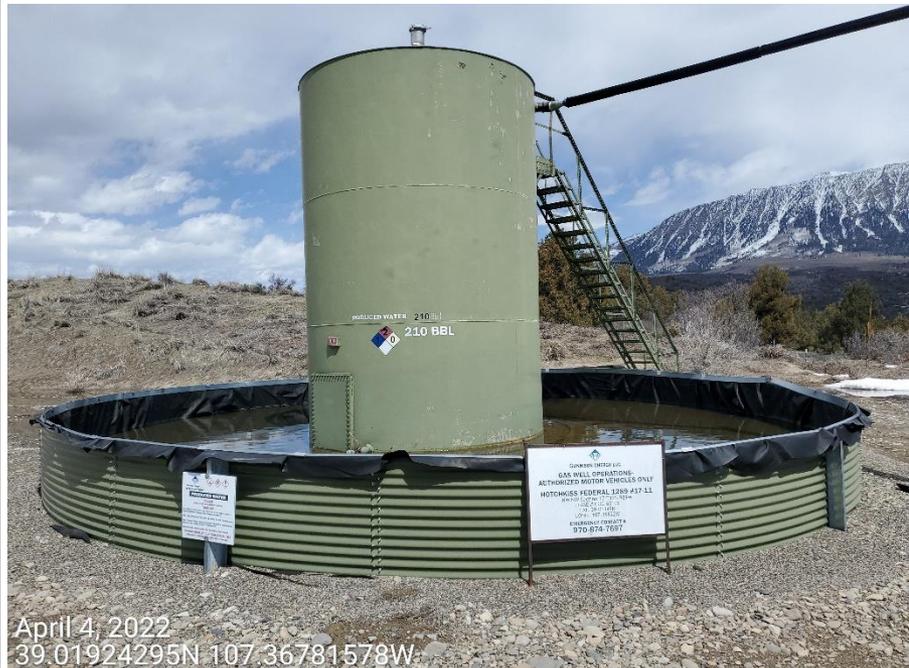
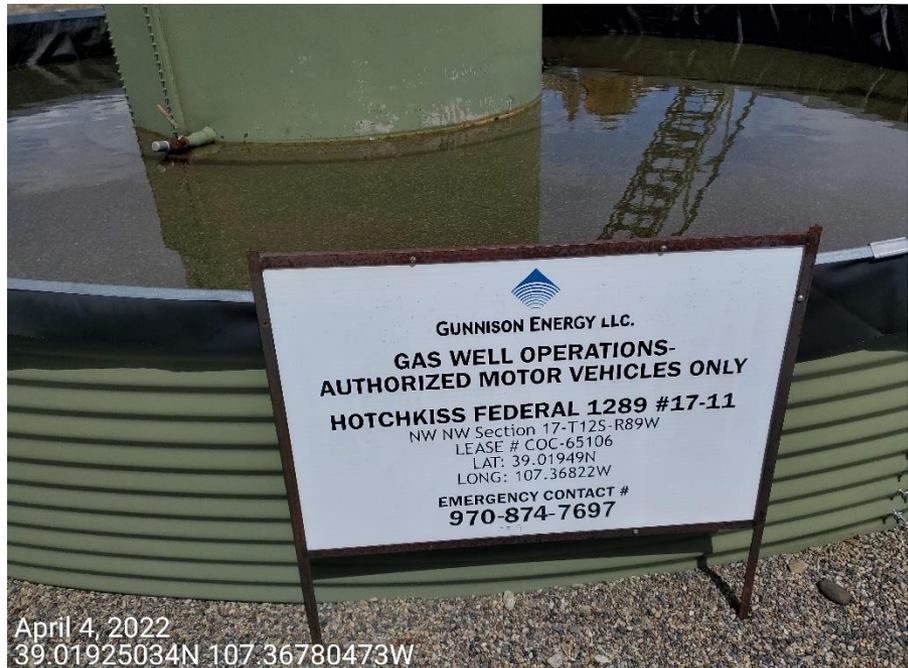
Photo 6: Signage at tank battery remains inadequate; sign missing information per Rule 605.e.. EMS# or 911, Nearest public road, and API. First letter of tank contents on side of the tank remains missing.

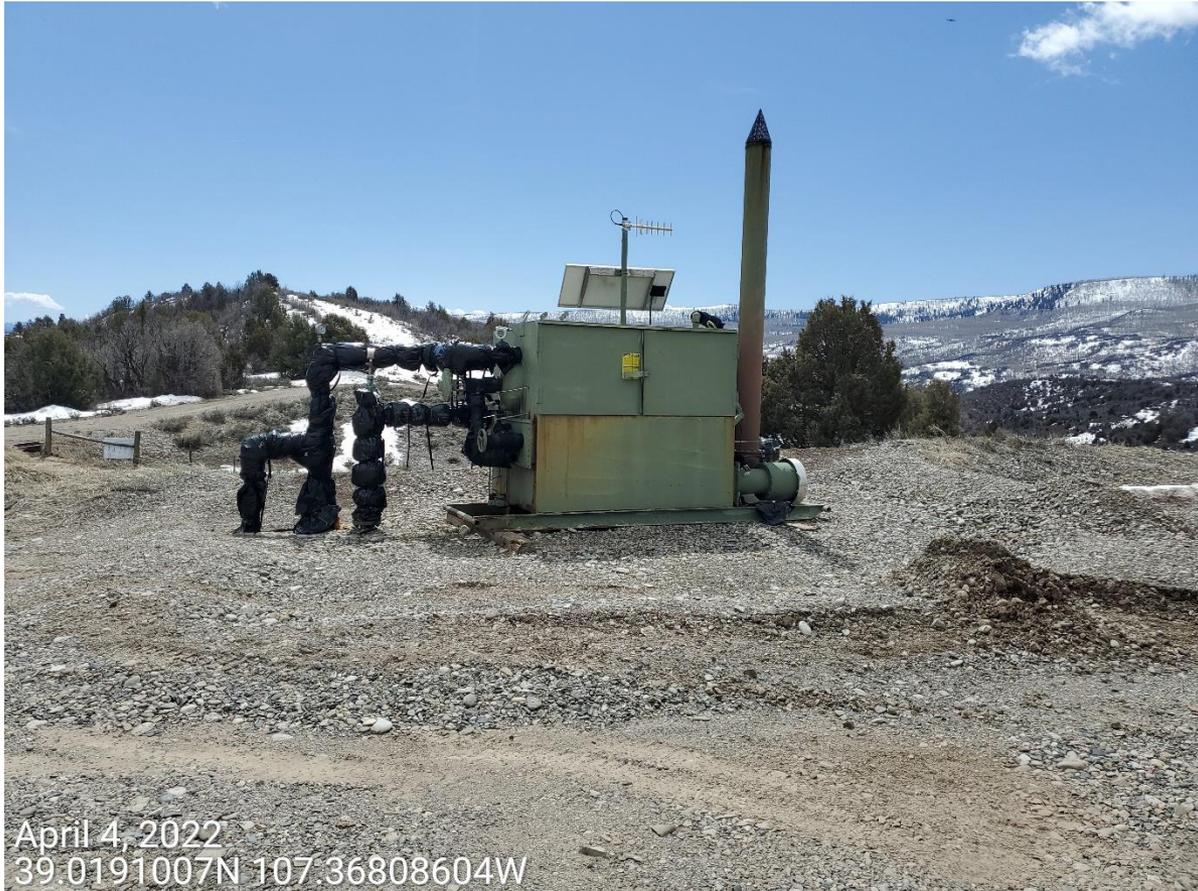
Photo 7: Required labeling at Heated separator with glycol storage tank not evident.
