Inspection Photos

Operator: GUNNISON ENERGY LLC - 10515

Location ID: 427218

Gunnison County, CO

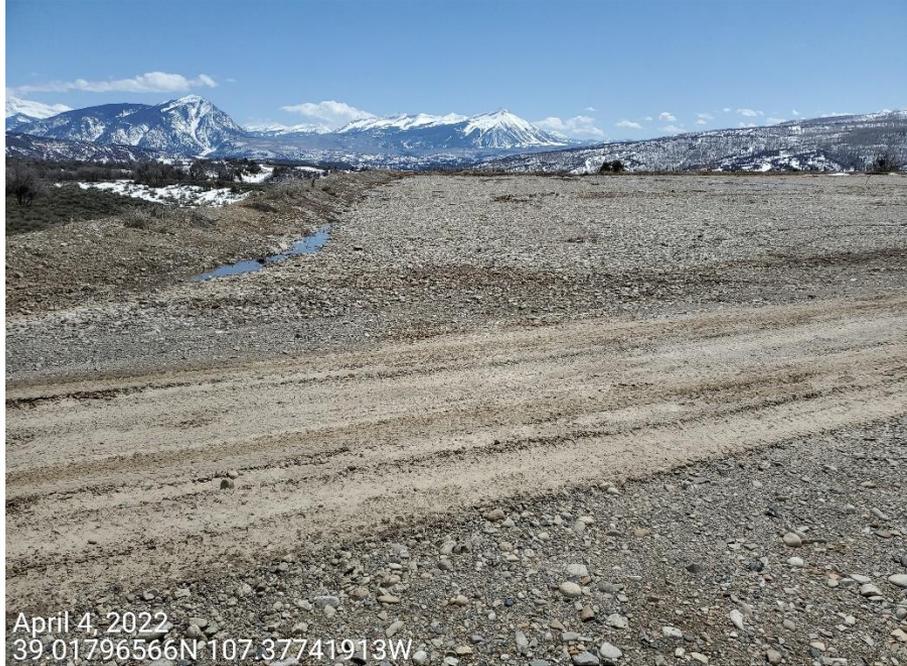
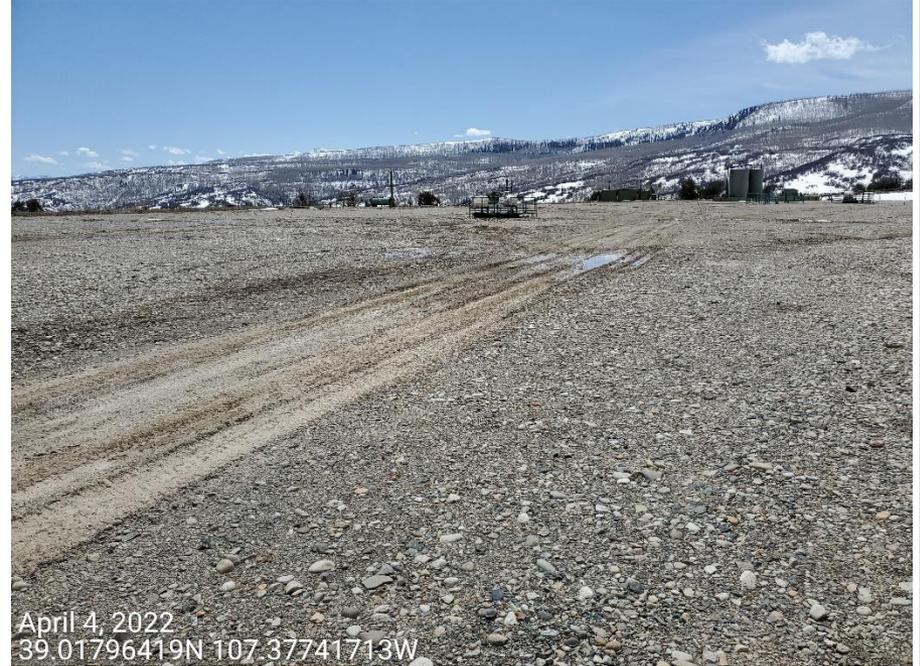
Photo 1: Photos 1-2 taken from the northeast end of the production area. Photos provide an overview of the Location from south, southwest to west.

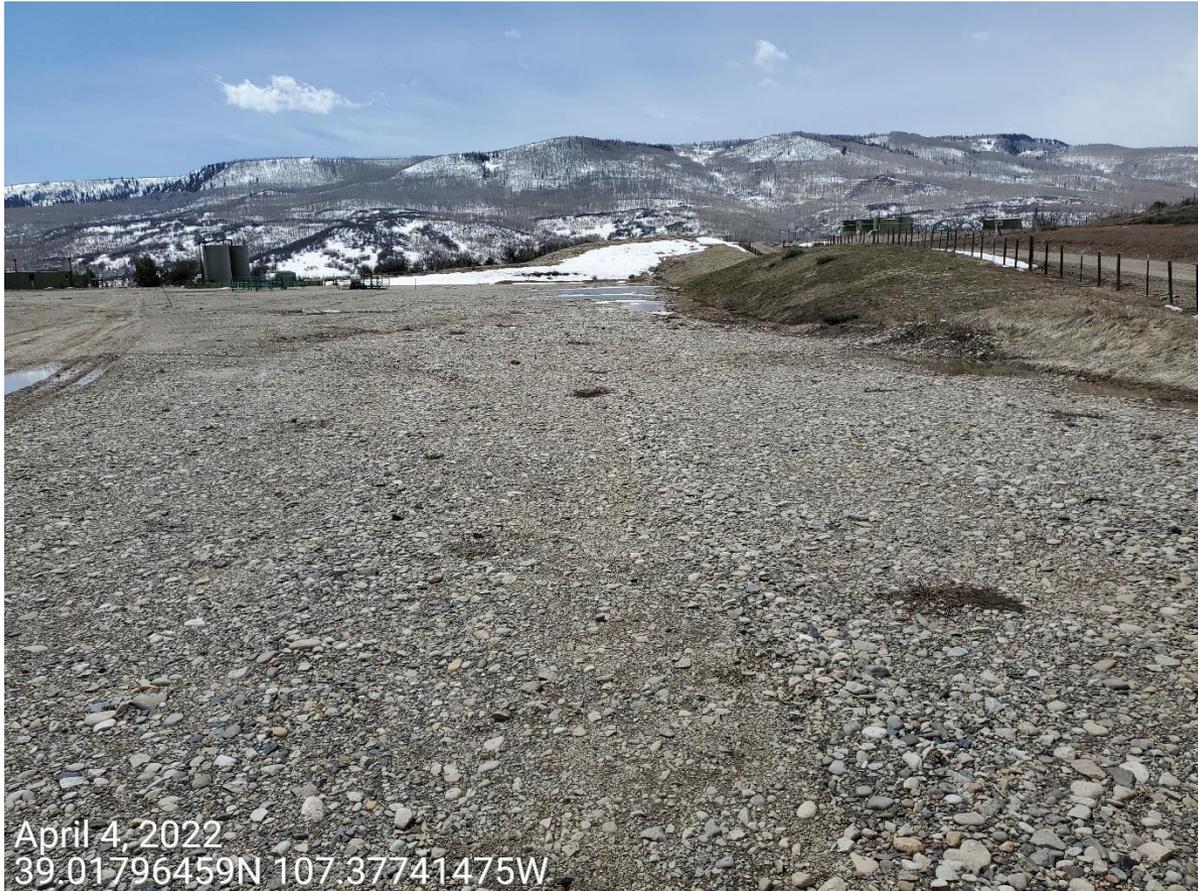
April 4, 2022
39.01796459N 107.37741475W

Photo 2.: See comments under photo 1.

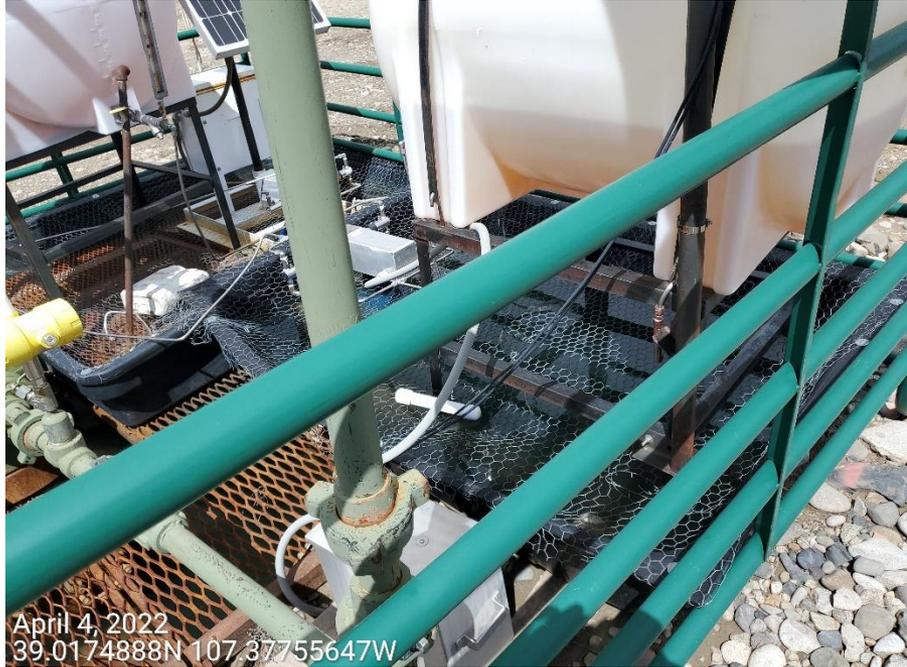
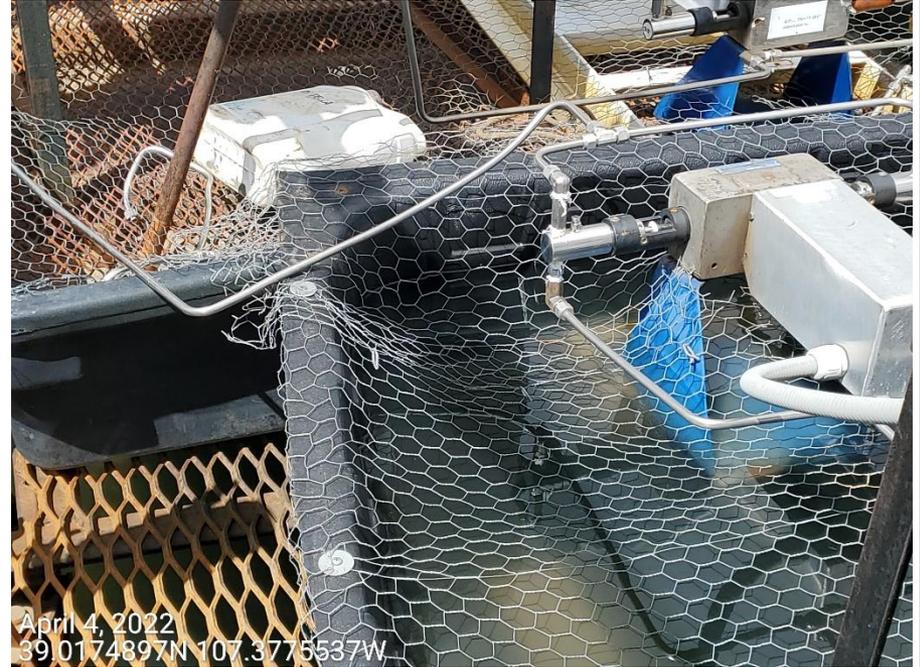
Photo 3: Photos example showing secondary containment for tanks adjacent to the wells have filled with fluids, and are no longer adequate to contain a spill.
