Attachment B

TANK BATTERY DECOMMISSIONING FORM

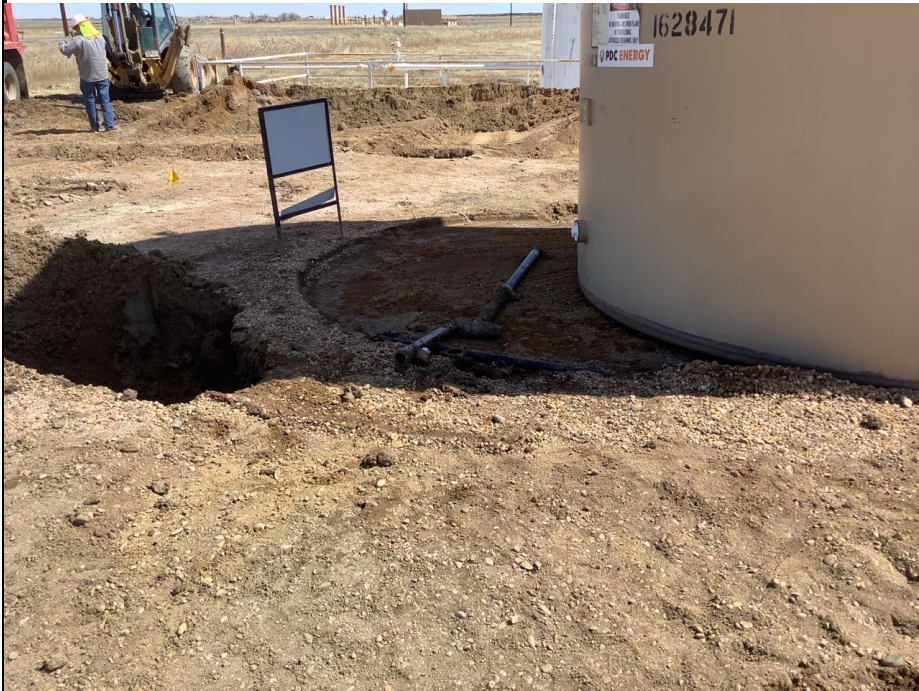
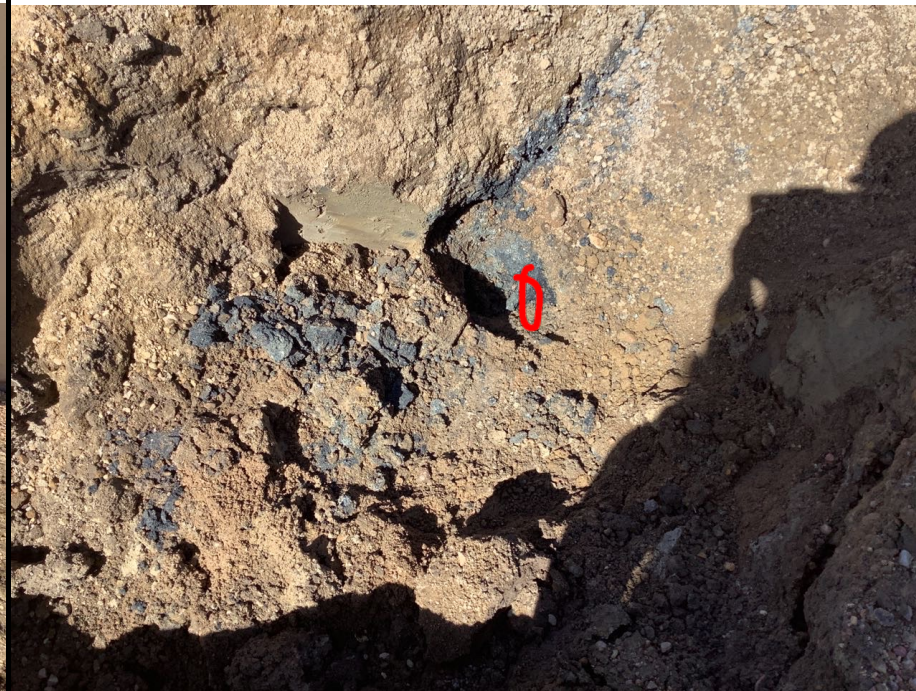
Equipment ID:		Equipment Type:		Equipment ID: AST01-DL @ 3'		Equipment Type:			
Material:		Volume:		Material:		Volume:		Contents:	
Notes/Conditions: AST Footprint					Notes/Conditions:

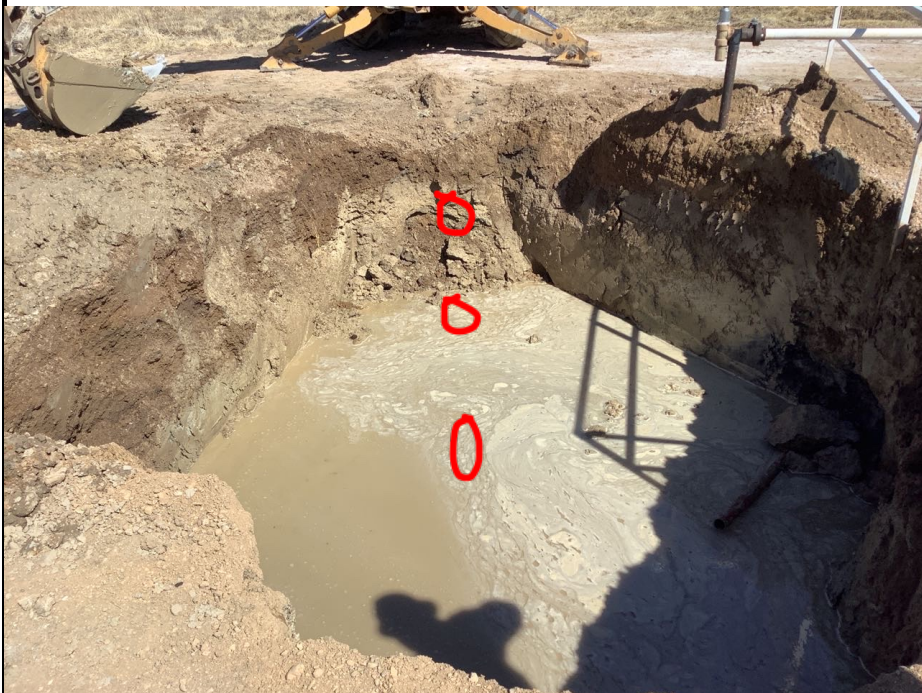
Equipment ID: GW02		Equipment Type:		Equipment ID: Tank Bottom		Equipment Type:	
Material:	Volume:	Contents:		Material:	Volume:	Contents:	
Notes/Conditions:				Notes/Conditions:

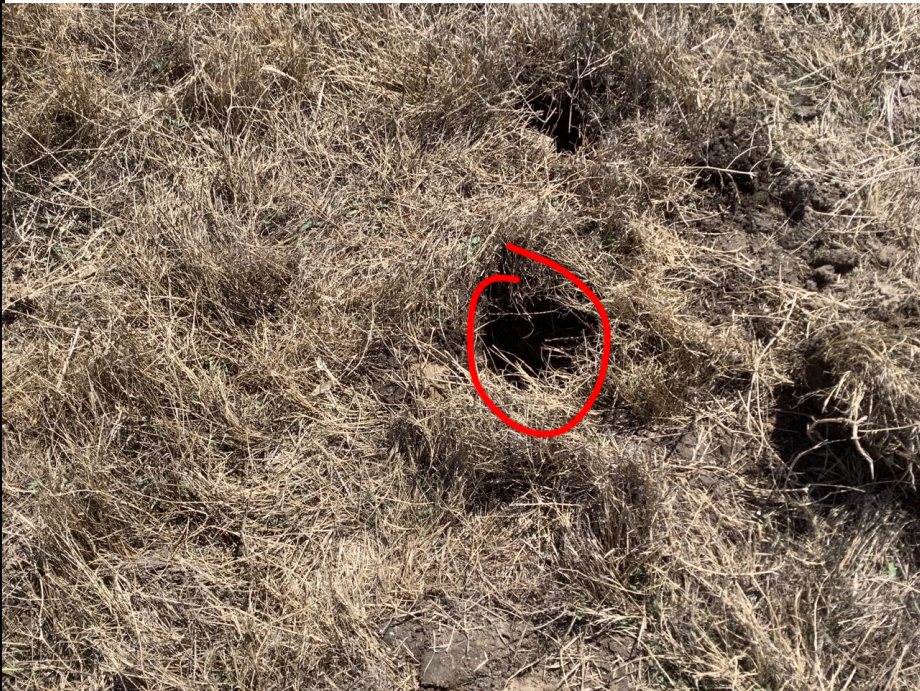
Equipment ID:		Equipment Type:		Equipment ID:		Equipment Type:					
Material:		Volume:		Contents:		Material:		Volume:		Contents:	
Notes/Conditions: BKG01 @ 2.5', 3', 4', 5', 6'						Notes/Conditions:
