Inspection Photos

Location Name: McLin A Pad

Inspection Document #: 702800110

**Oil & Gas Conservation
Commission**

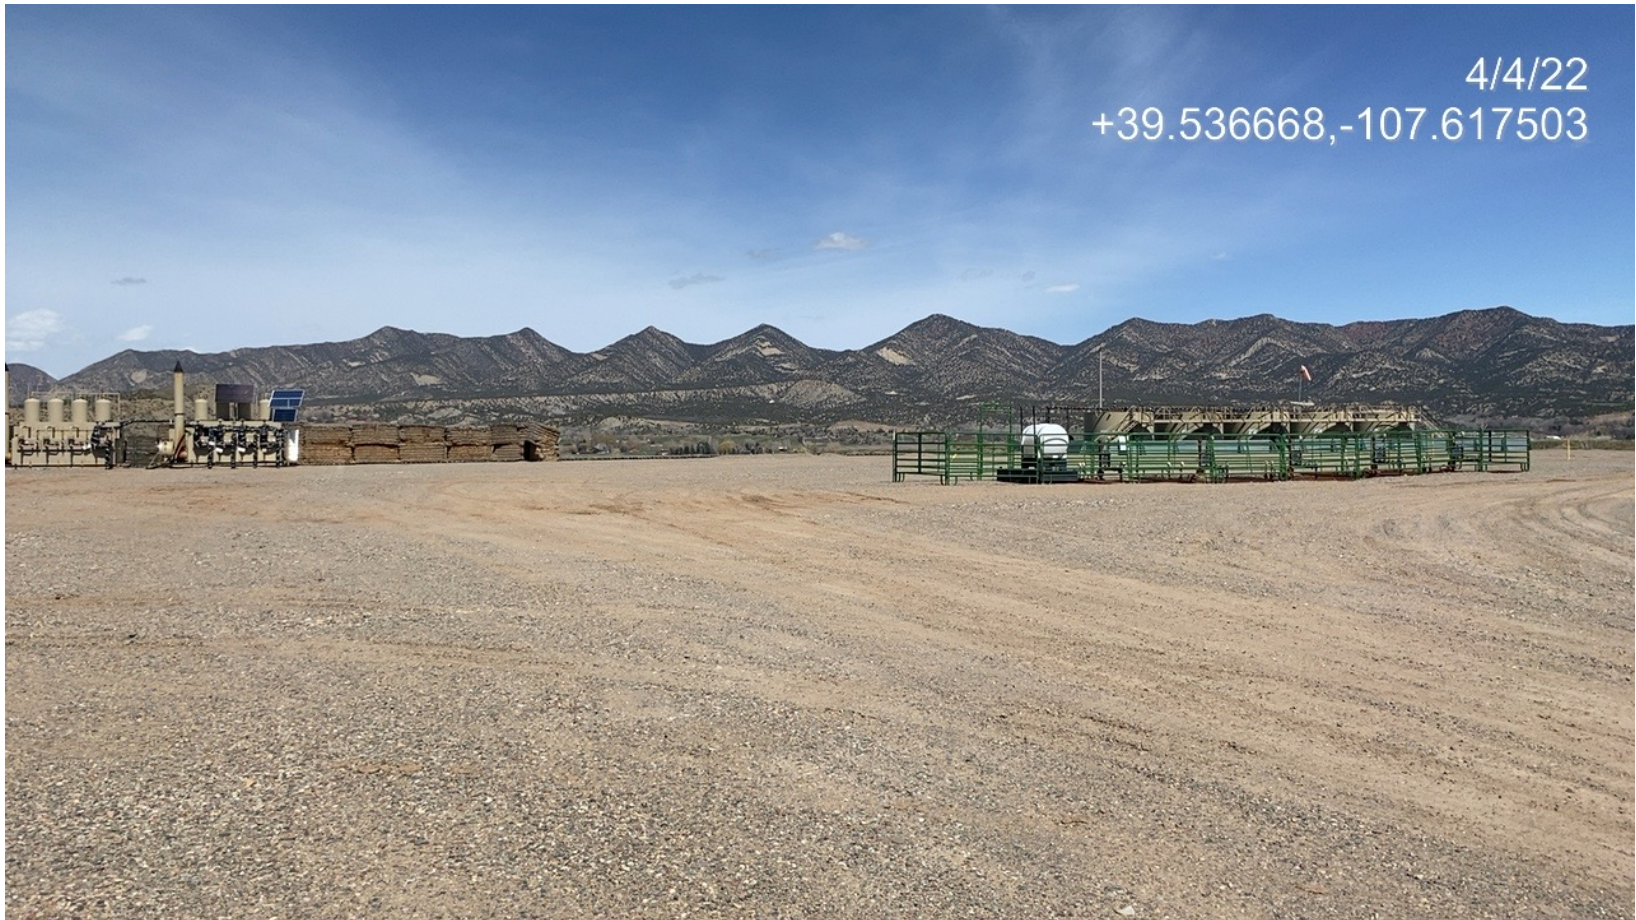
Photo 1. Photo taken from the Location entrance facing north shows an overview of the Location. Photo also shows areas no longer in use have not been reclaimed per 1003 Rules.

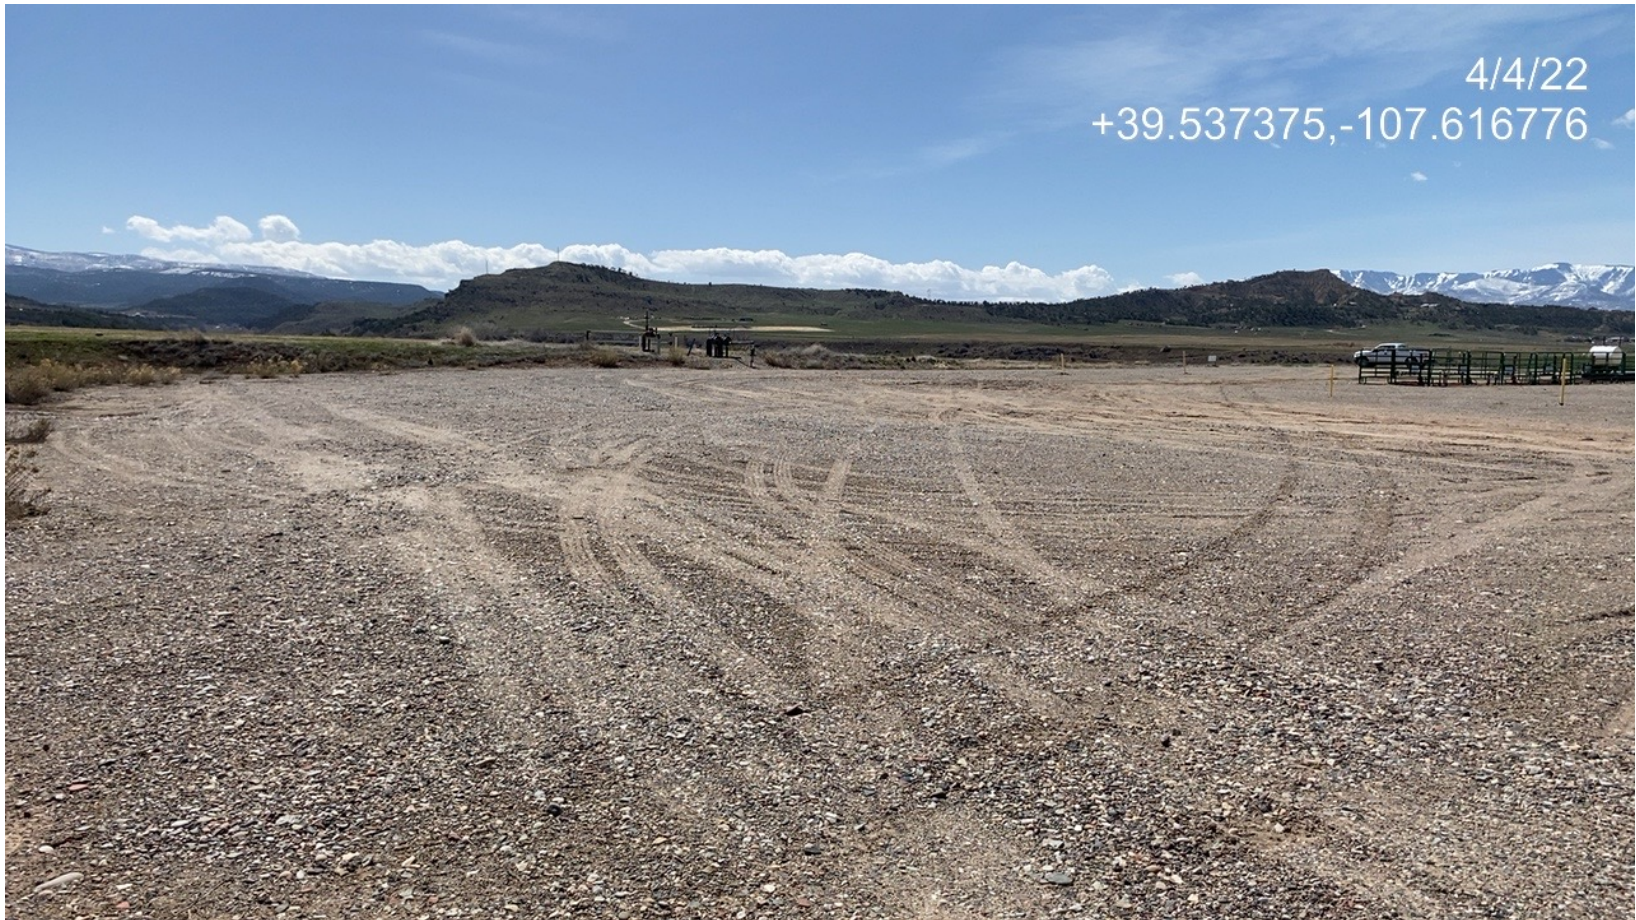
4/4/22
+39.537375,-107.616776

Photo 2. Photo taken from the northeast of the Location facing south shows areas no longer in use have not been reclaimed per 1003 Rules.

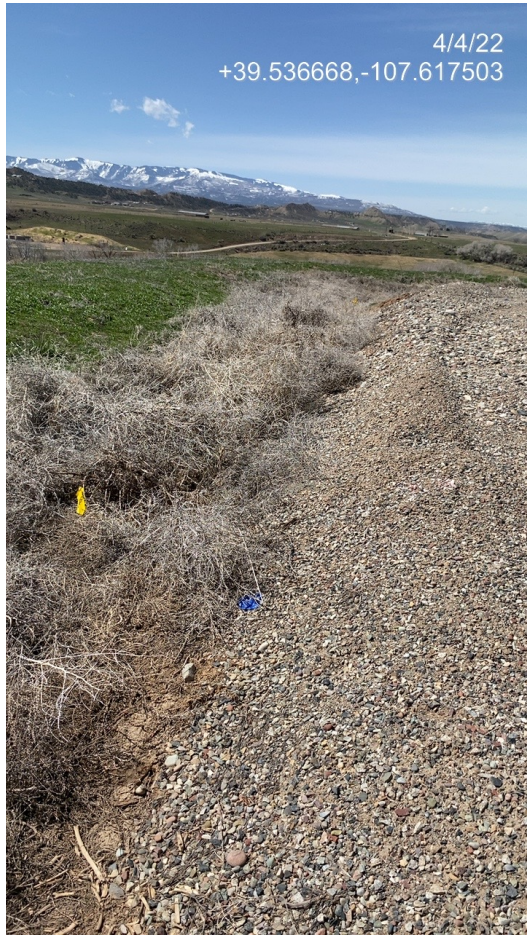
Photo 3. Photo taken from the west of the Location shows undesirable plant species/weed debris accumulating on Location.

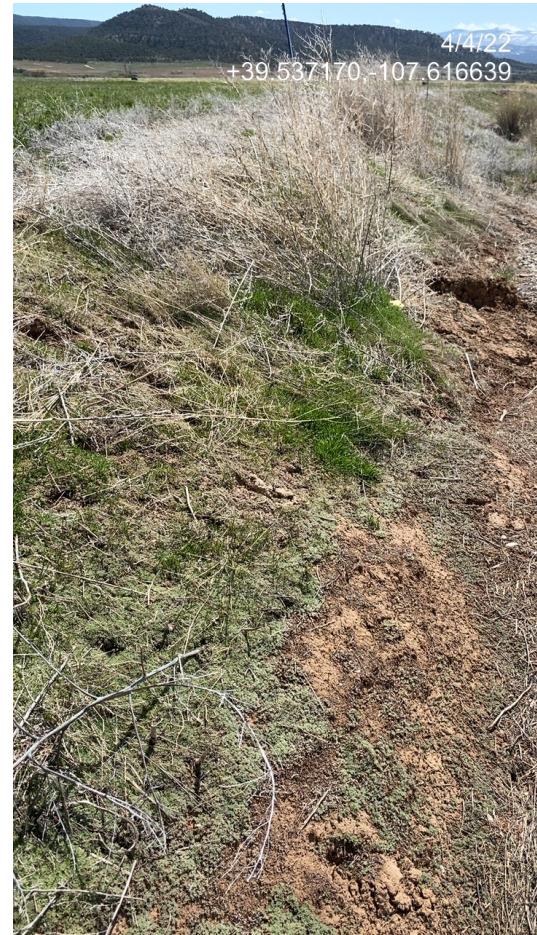
Photo 4. Photo taken from the east of the Location shows skeletons from the undesirable plant species/weed, kochia in the middleground and seedlings in the foreground.

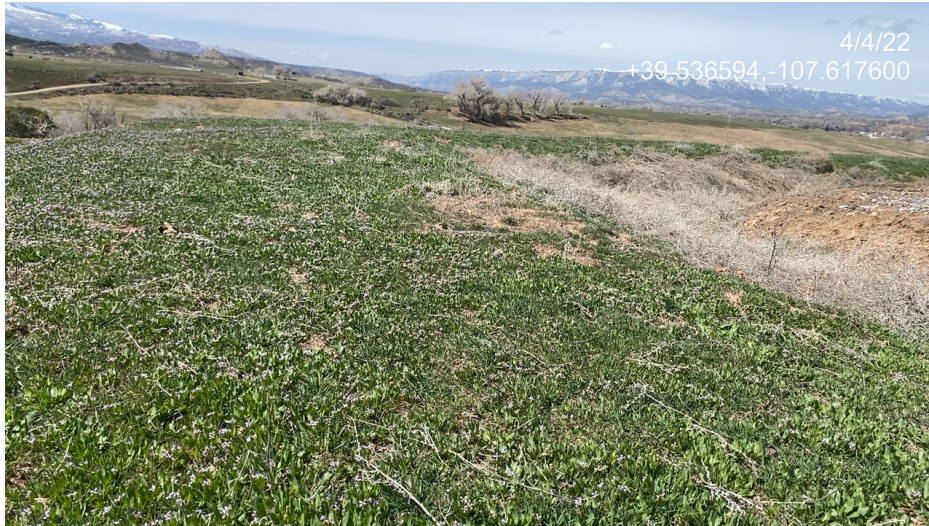
Photo 5. Photo taken from the west of the Location facing south shows the slopes of the Location are colonized by annual, invasive, undesirable plant species/weeds including purple mustard, cheatgrass and kochia.

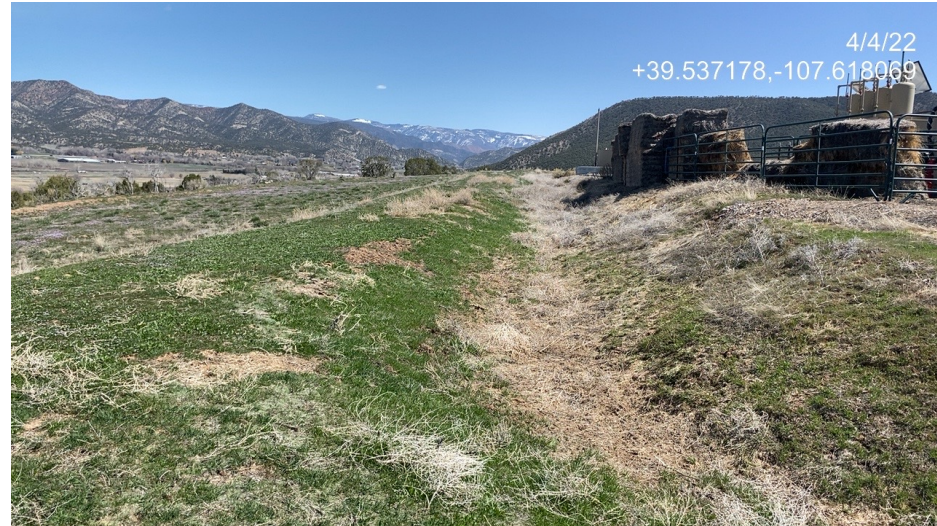
Photo 6. Photo taken from the northwest of the Location facing northeast. Refer to additional comments under Photo 5.

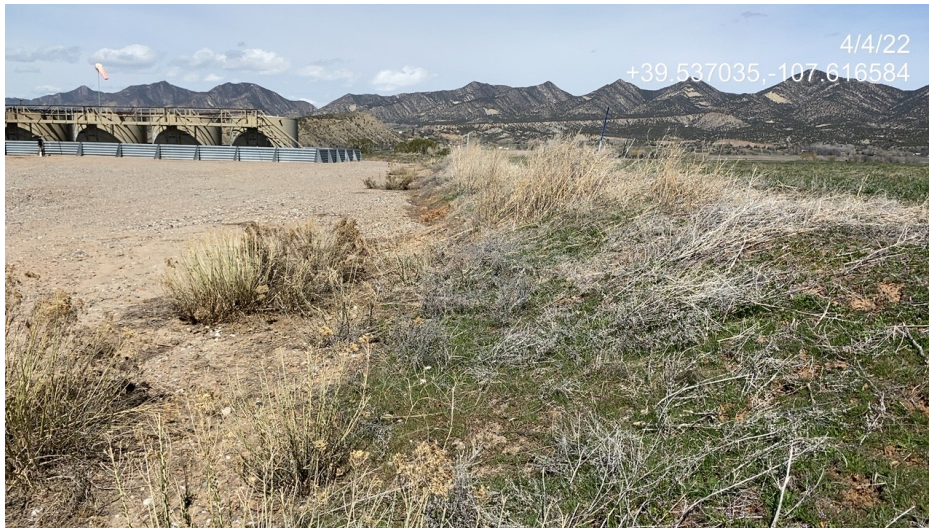
Photo 7. Photo taken from the east of the Location facing north shows the slopes of the Location are colonized by annual, invasive, undesirable plant species/weeds including purple mustard, cheatgrass and kochia.

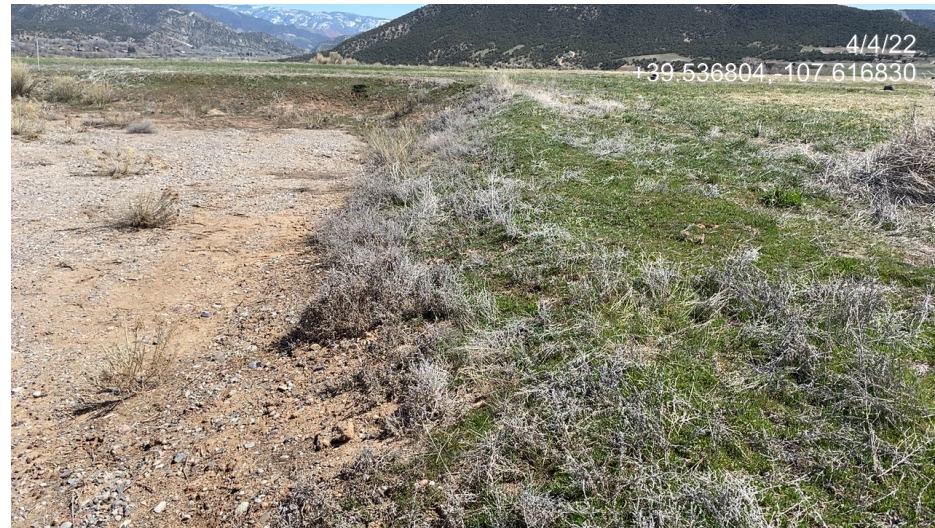
Photo 8. Photo taken from the southeast of the Location facing east. Refer to additional comments under Photo 7.
