# Inspection Photos

Location Name: Jolley /KP 13-17

Inspection Document #: 702800120

**Oil & Gas Conservation  
Commission**

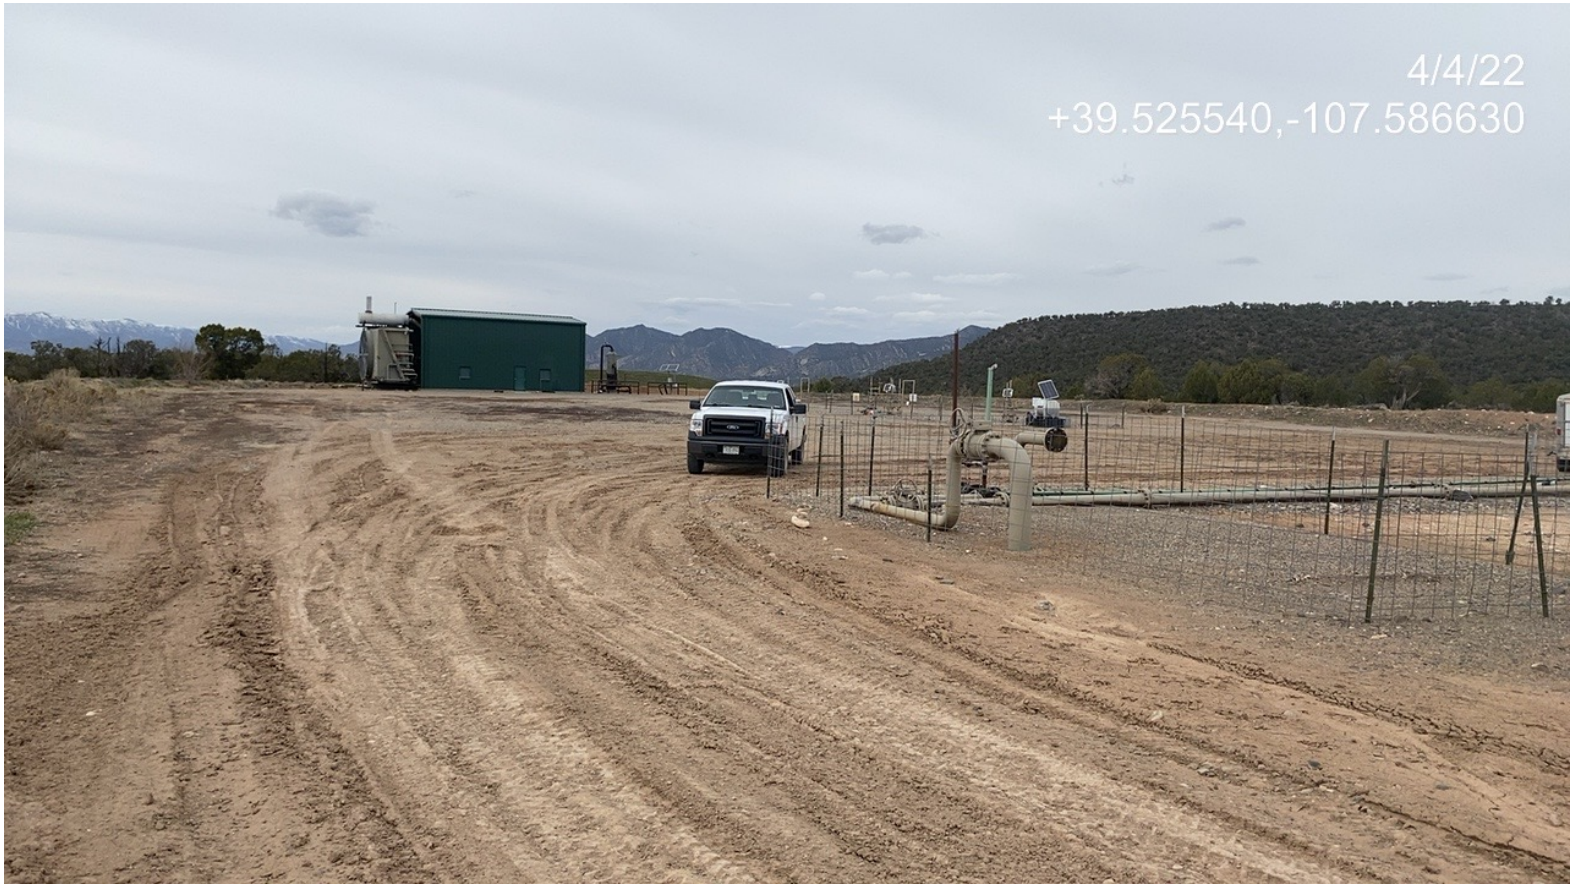
**Photo 1.** Photo taken from the Location entrance facing northwest shows an overview of the Location and the lack of signage at the Location entrance.

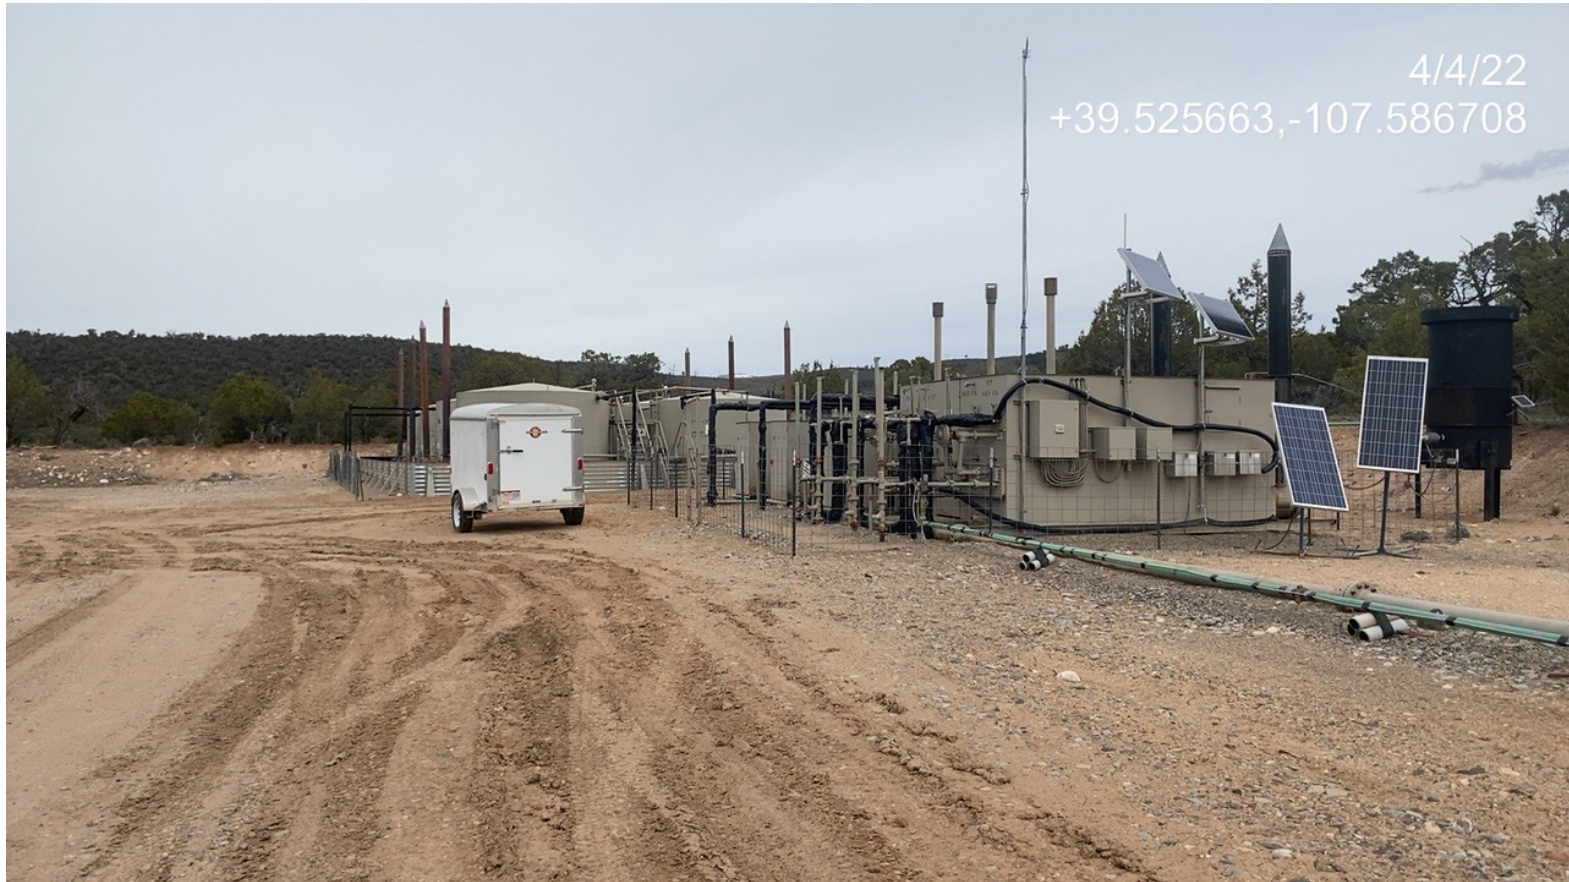
**Photo 2.** Photo taken from the southeast of the Location facing northeast shows storage of a trailer on Location. Photo also shows a lack of stabilization BMPs as is evidence by the presence of ruts.

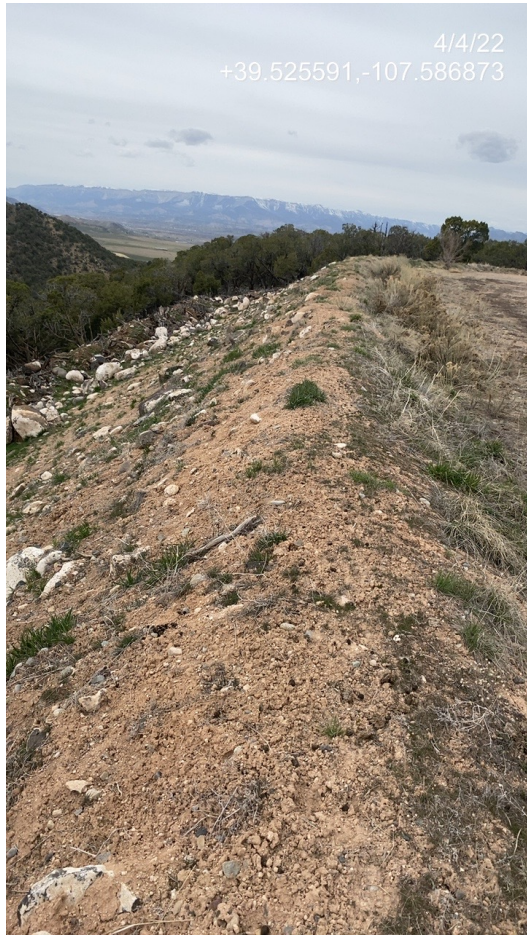
**Photo 3.** Photo taken from the south of the Location facing west shows slopes colonized by perennial grasses and annual undesirable plant species/weeds.

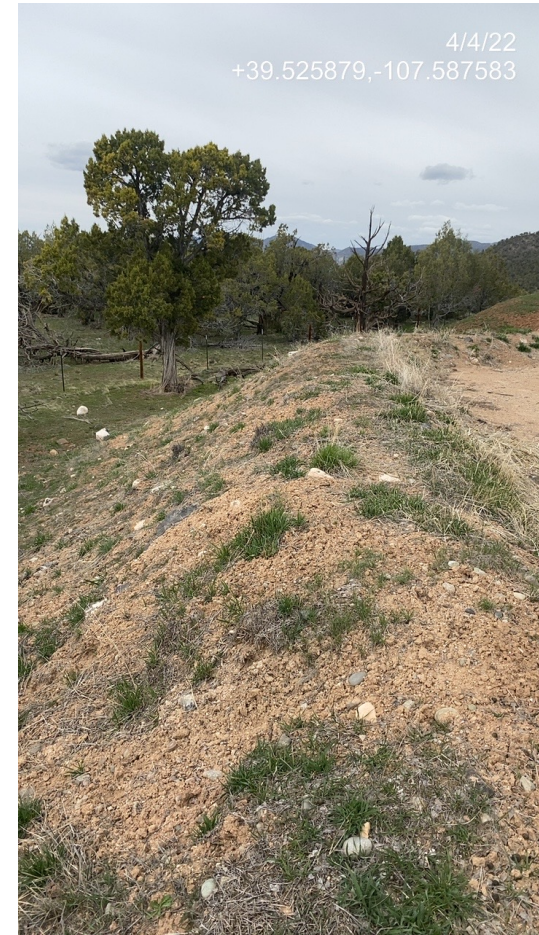
**Photo 4.** Photo taken from the southwest of the Location facing northwest. Refer to additional Photo 3 comments.

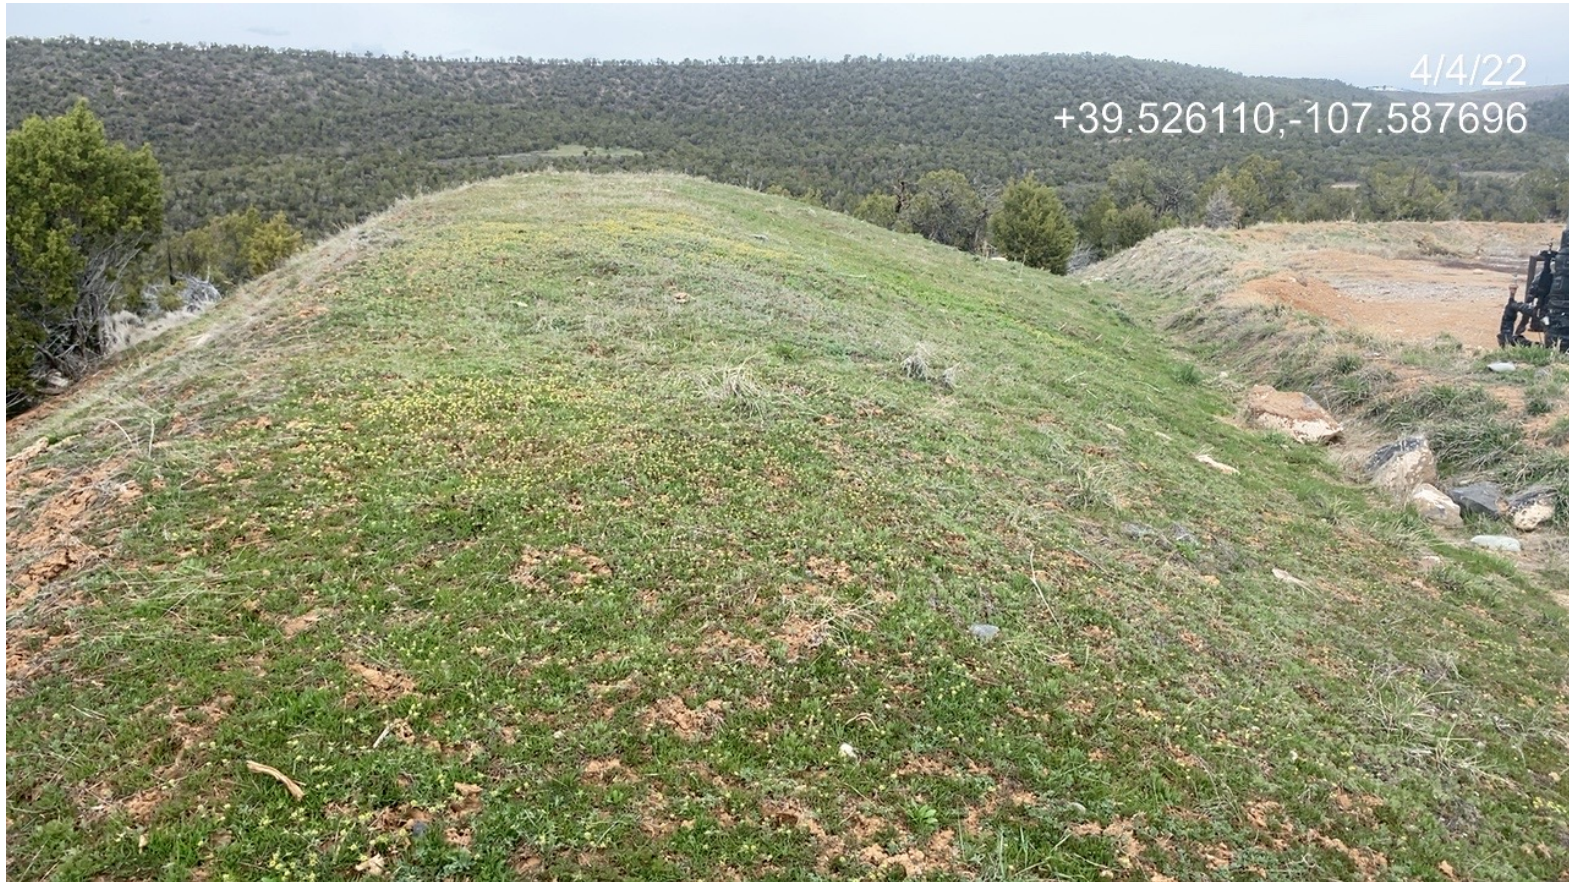
**Photo 5.** Photo taken from the west of the Location facing north shows a soil stockpile dominated by annual undesirable plant species/weeds and sparse perennial grasses.

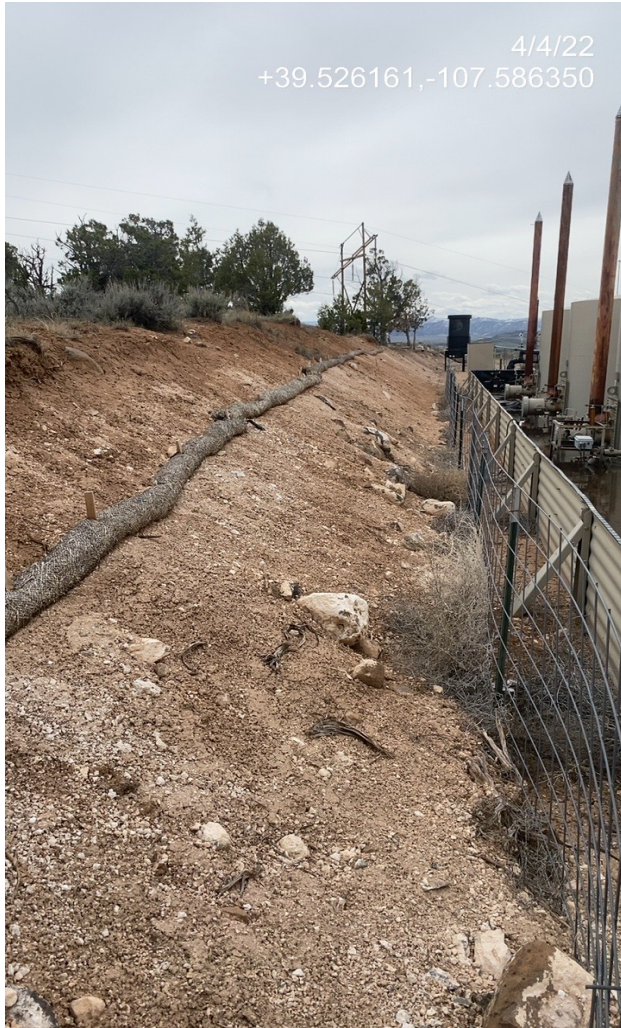
**Photo 6.** Photo taken from the east of the Location facing south shows an overview of the eroding cut slope.

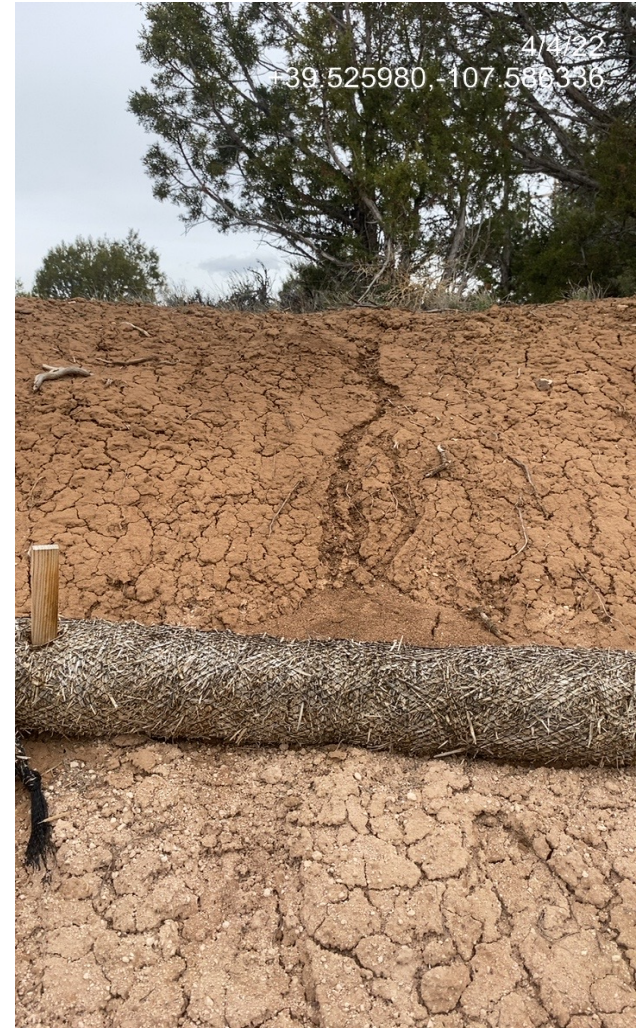
**Photo 7.** Photo taken from the east of the Location shows rill erosion occurring on the cut slope.

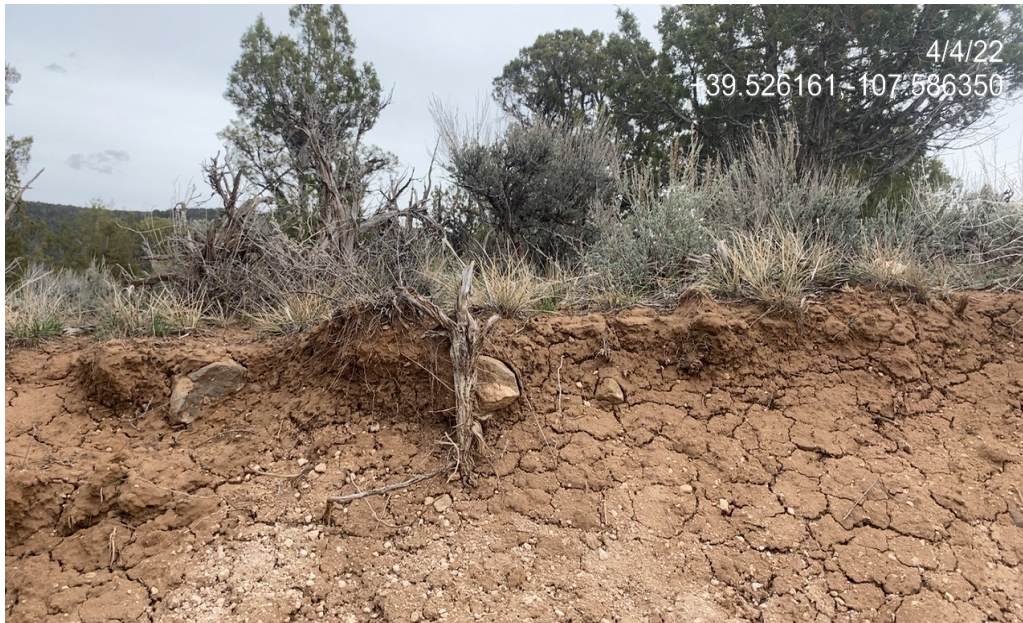
**Photo 8.** Photo taken from the east of the Location facing east shows undercutting and lateral erosion of cut slopes resulting in exposed roots and vegetation and soil loss from native plants communities off-Location.

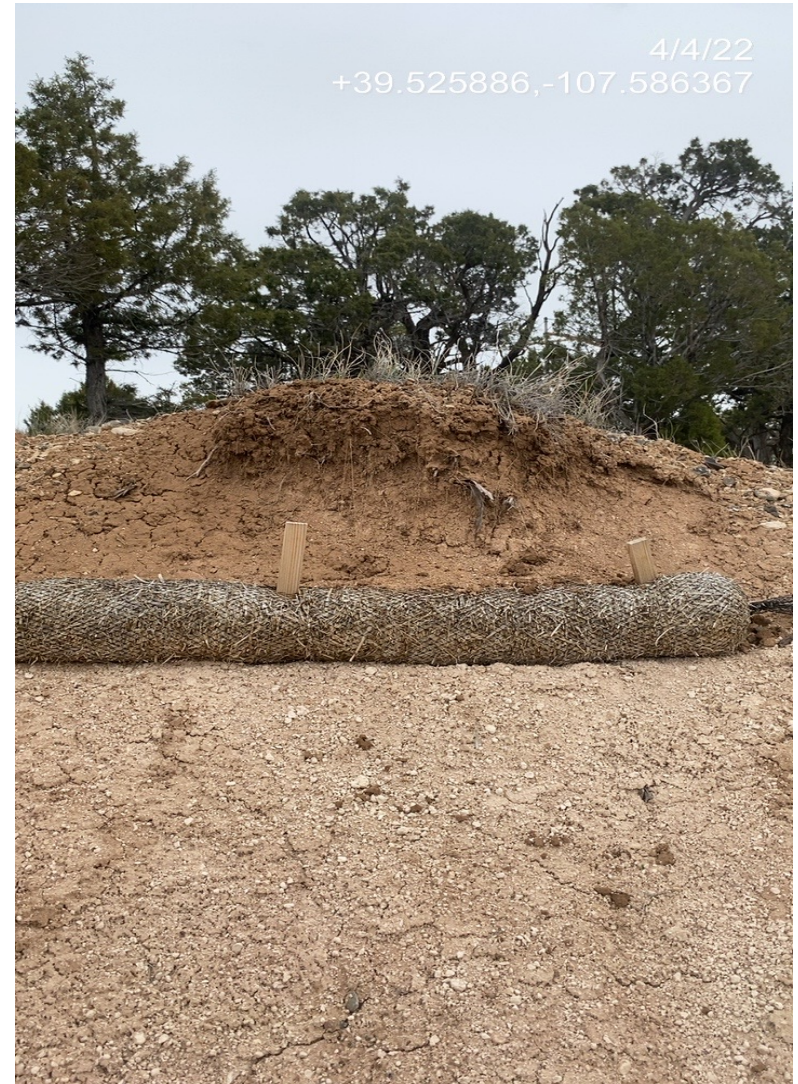
**Photo 9.** Refer to Photo 8 comment. A straw wattle does not appear to sufficiently prevent erosion.
