# Inspection Photos

API: 055-06306

Operator: MANZANO LLC

Inspection Date: 4/6/2022

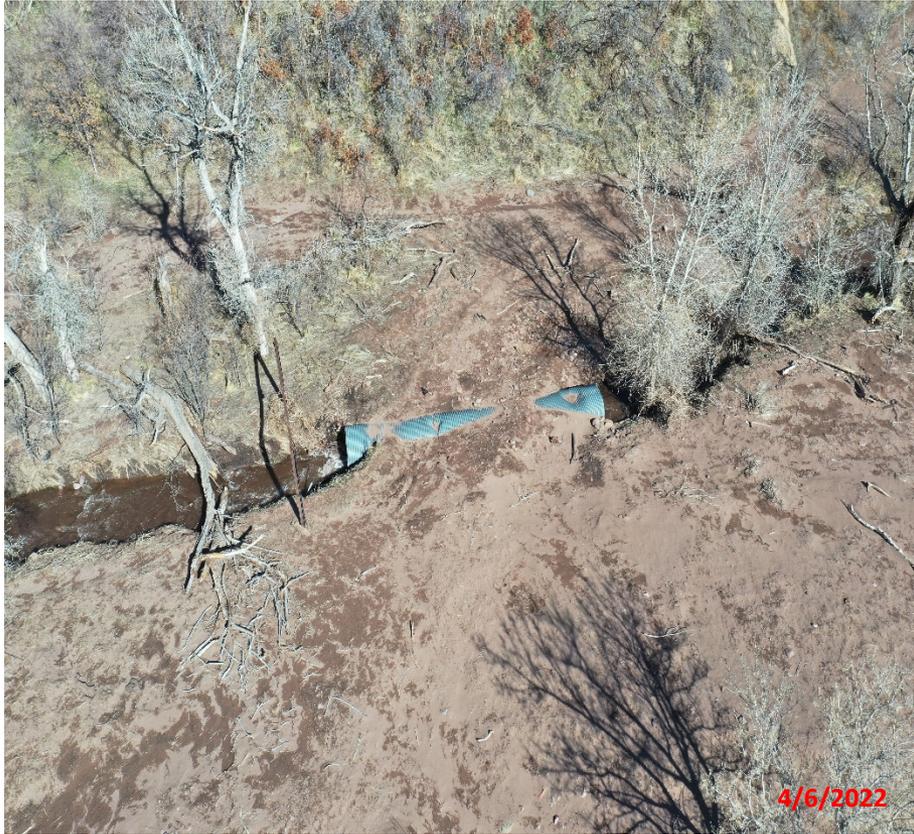
**Photo 2.** Drone aerial photo facing toward the access road which crossing the perennial stream. The culvert has become exposed due to erosion and is susceptible to further erosion.

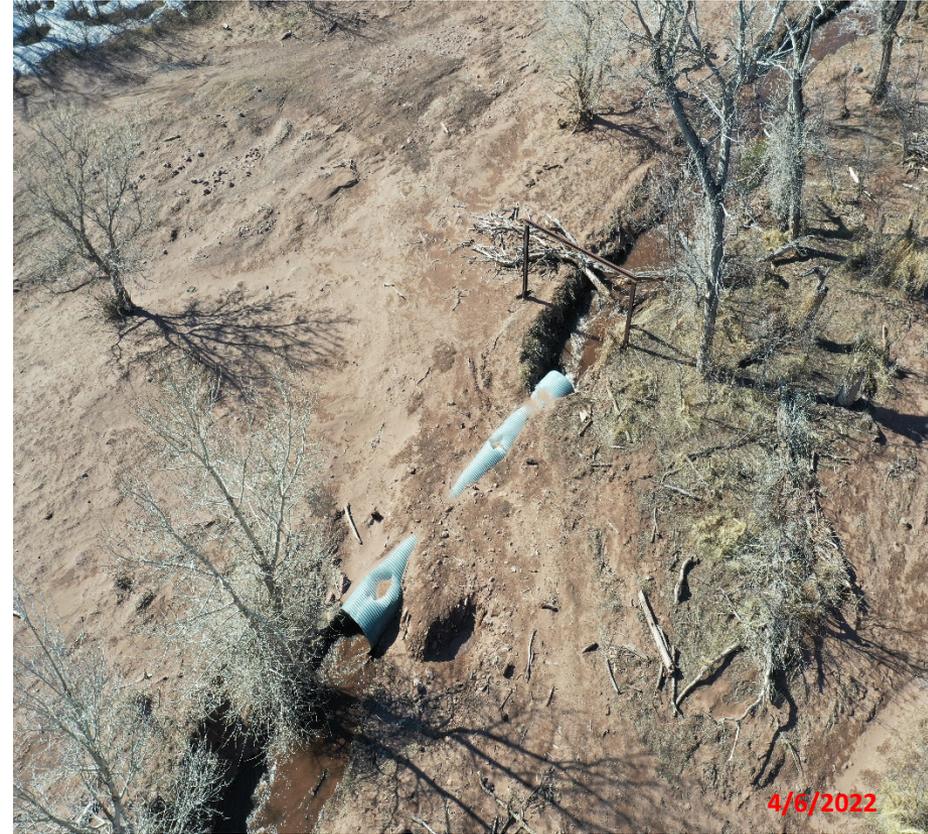
**Photo 3.** The culvert has become exposed due to erosion and is susceptible to further erosion and potential washout.

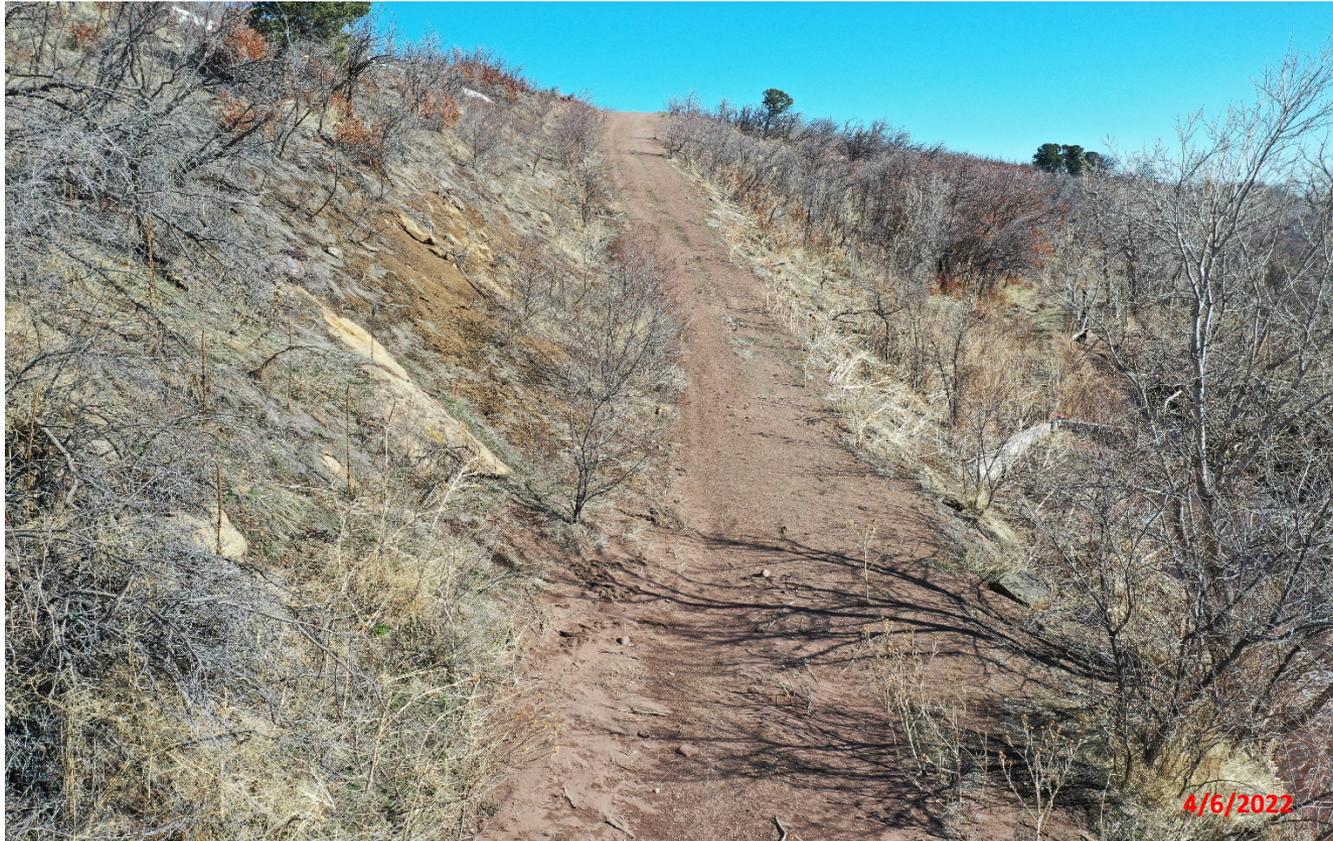
**Photo 4.** Facing toward the access road which has not been recontoured and reclaimed.

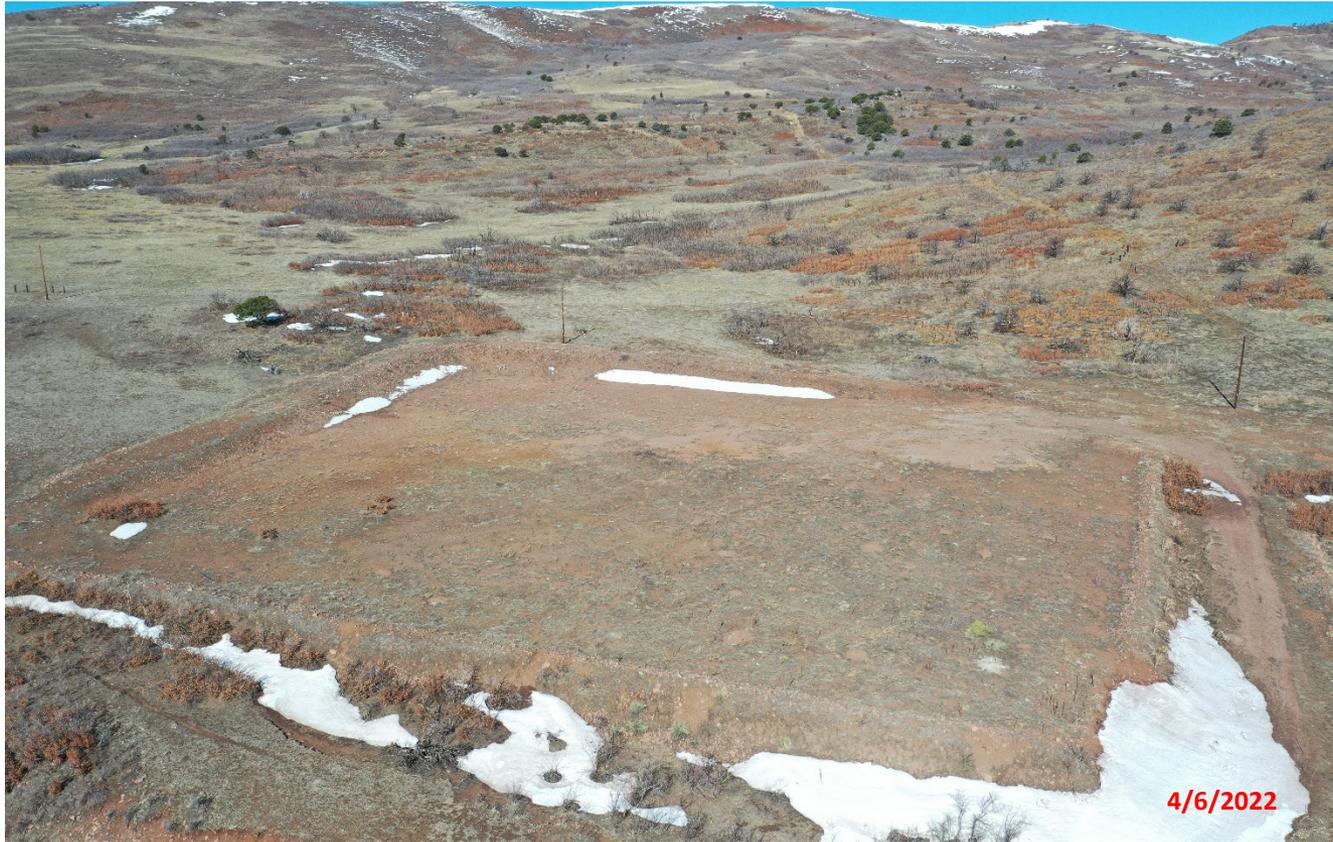
**Photo 5.** Facing northwest overlooking the location disturbance which is approximately 2.3 acres in size. Aerial image of the location shows the location has not been recontoured and reclaimed.

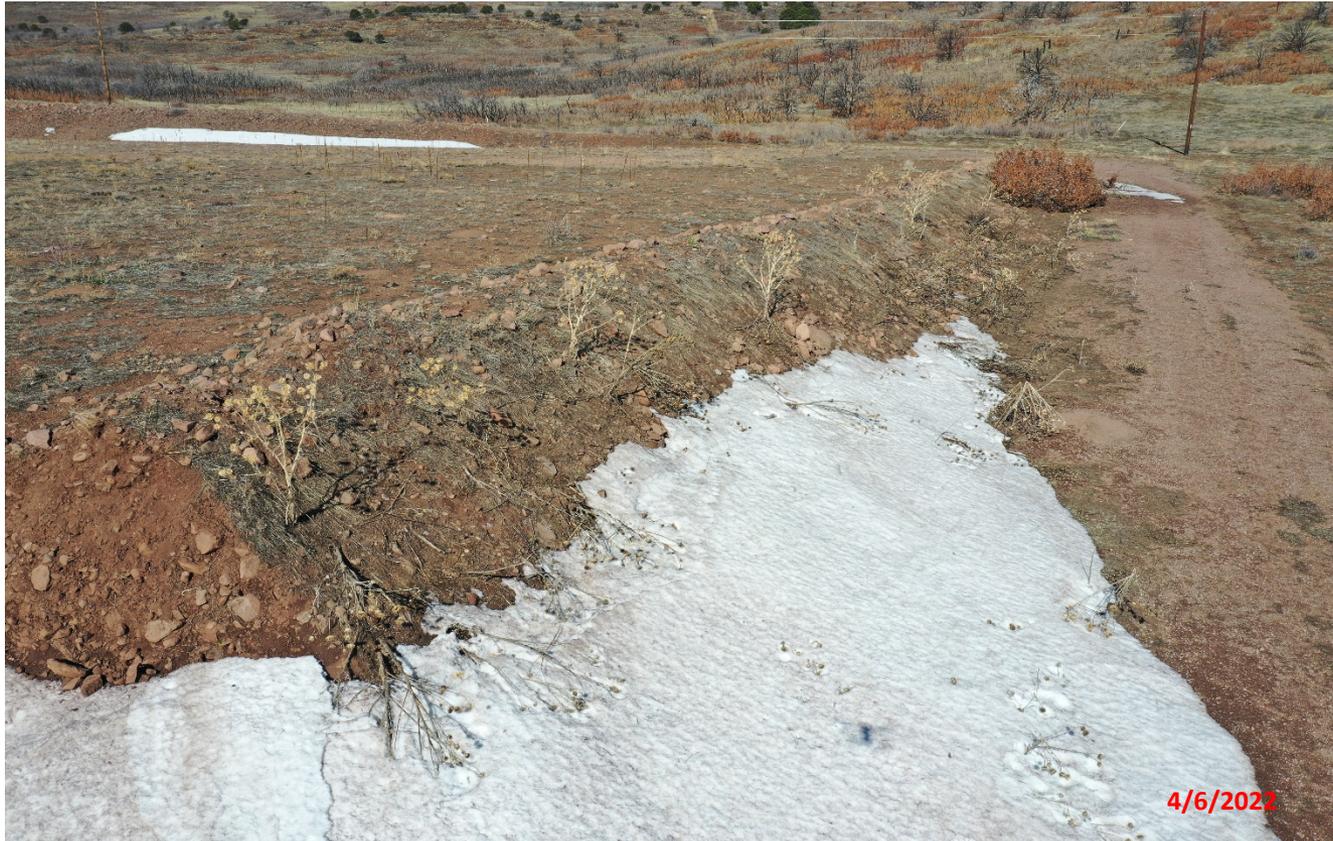
**Photo 6.** Facing northwest along the fill slope. There are numerous noxious weeds still remain along the fill slope. Noxious weeds observed include: Common mullien, Musk thistle, Plumeless thistle, and Scotch thistle.
