Inspection Photos

Operator: Caerus Piceance LLC- #10456

Location Name: Boulton-66S92W 33SWNE

Inspection Document #: 702800128

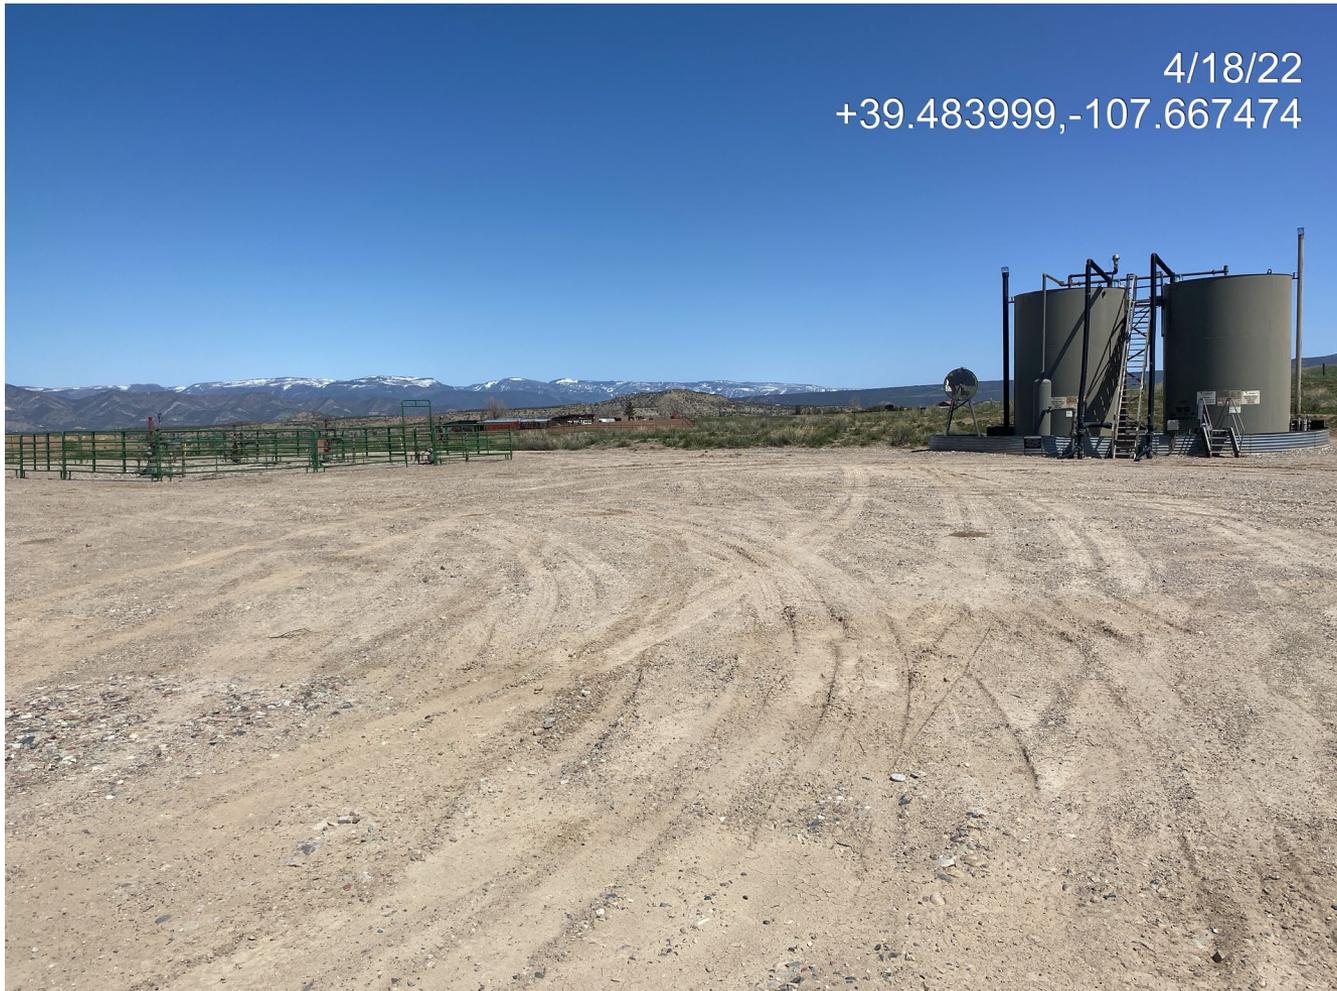
Photo 1. Photo taken from the southwest of the Location facing northeast shows an overview of the Location.

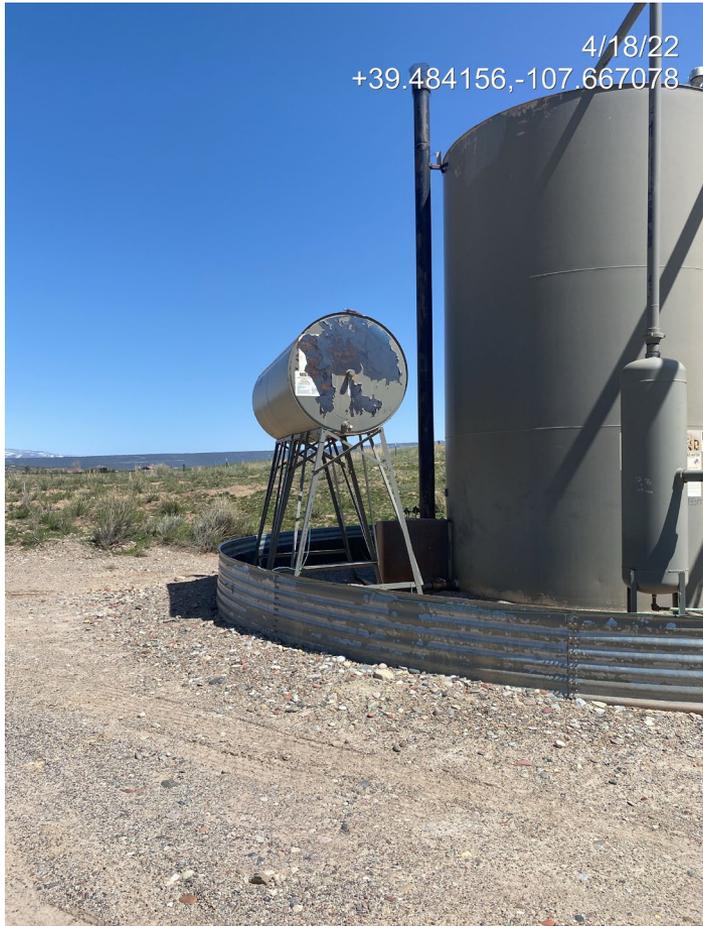
Photo 2. Photo taken from the tank battery shows the label on a methanol tank in disrepair.

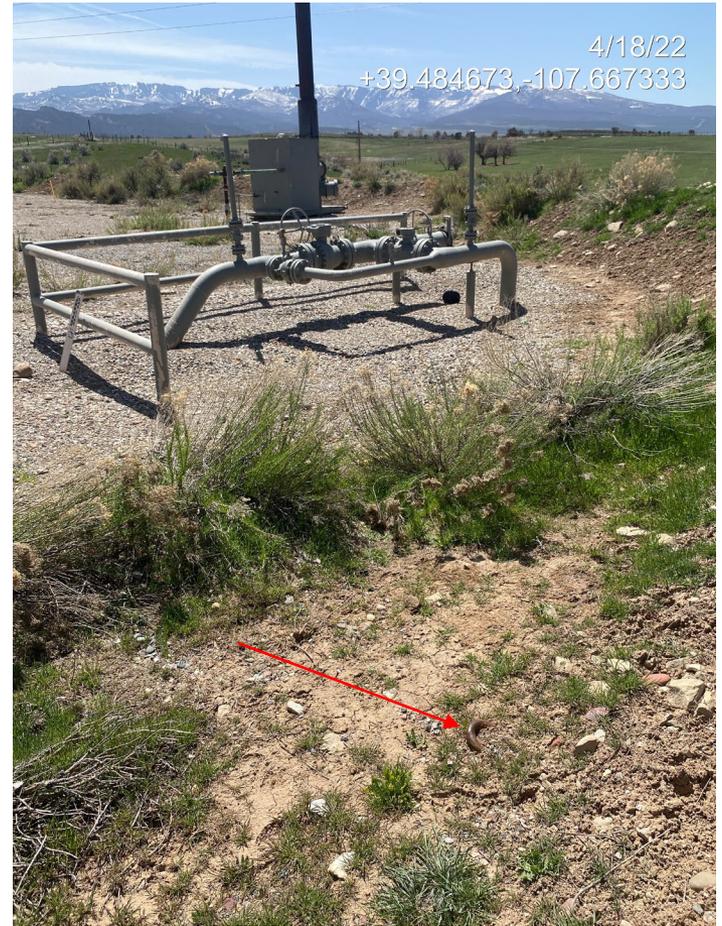
Photo 3. Photo taken from the north of the Location facing southwest shows an unmarked anchor.

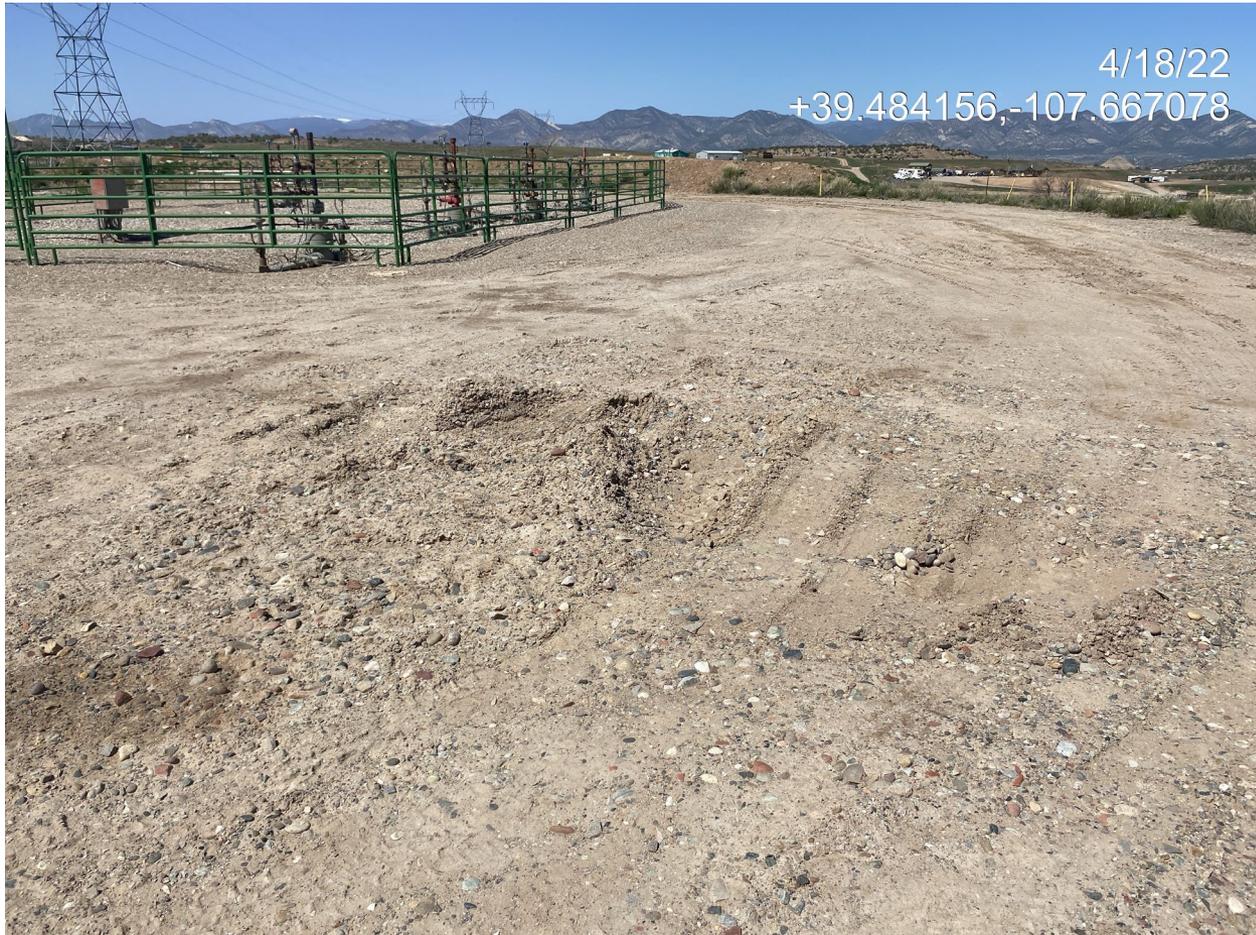
Photo 4. Photo taken from the southeast of the wells facing north shows where previously unmarked anchors appear to have been removed.

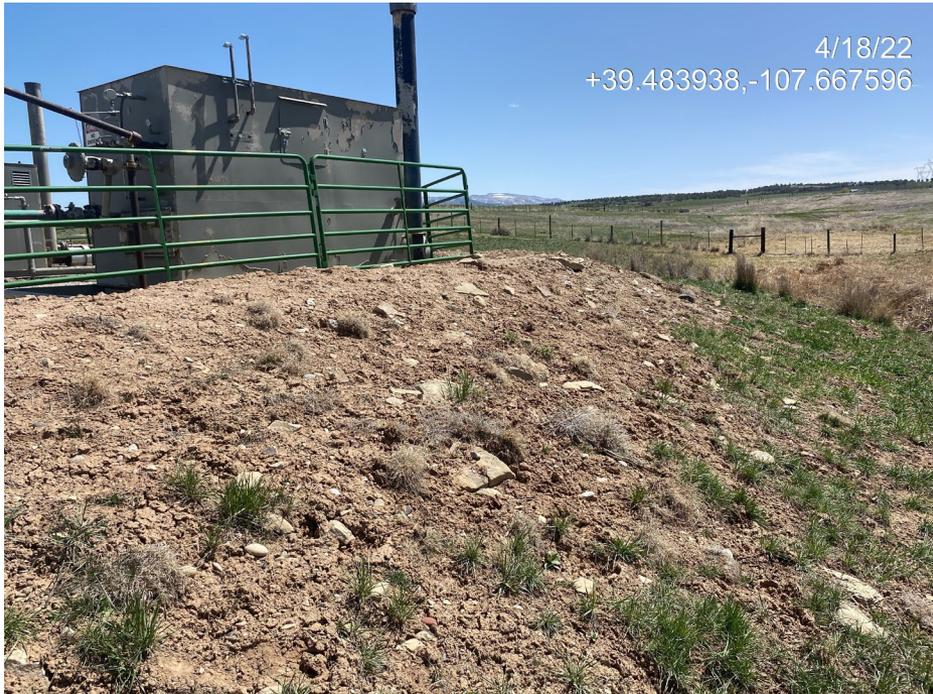
Photo 5. Photo taken from the southwest of the Location facing south shows slopes colonized by perennial grasses.

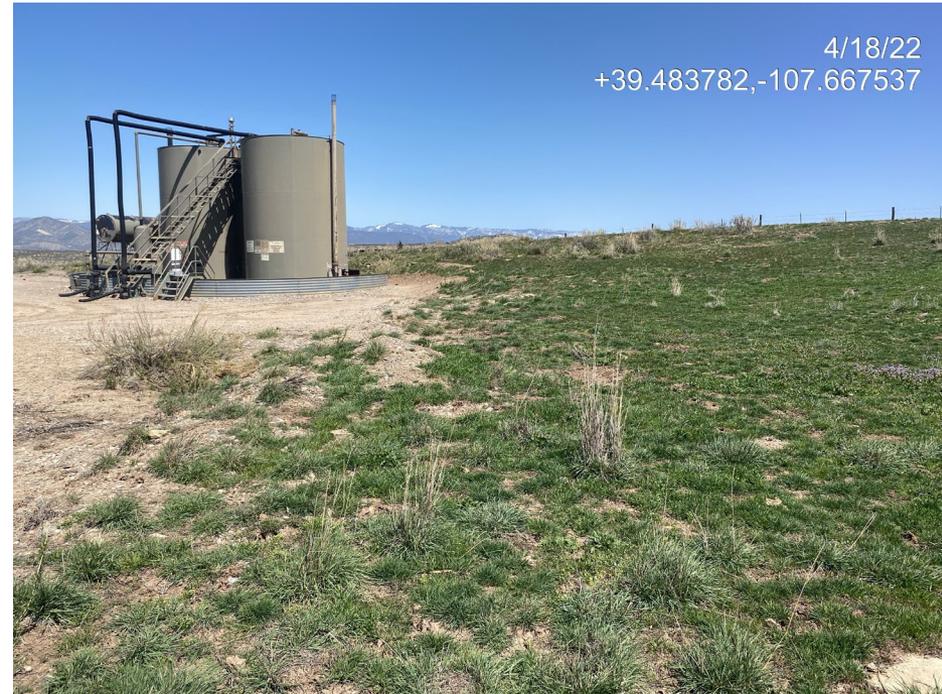
Photo 6. Photo taken from the south of the Location facing northeast shows interim areas colonized by perennial grasses.

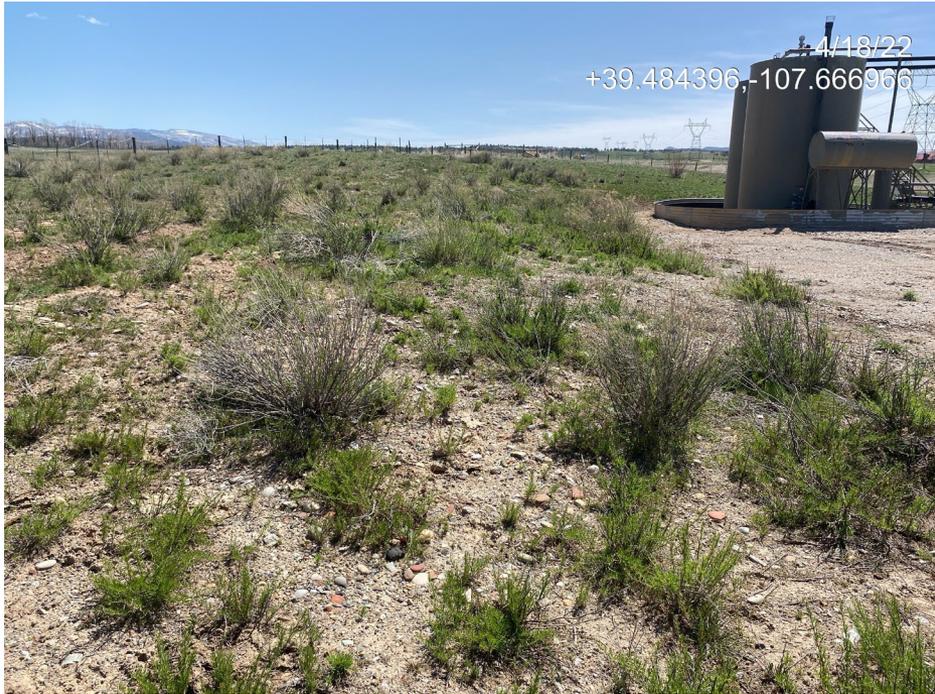
Photo 7. Photo taken from the east of the Location facing south shows interim areas colonized by rubber rabbitbrush. Photo also shows gravel remaining in the interim area.

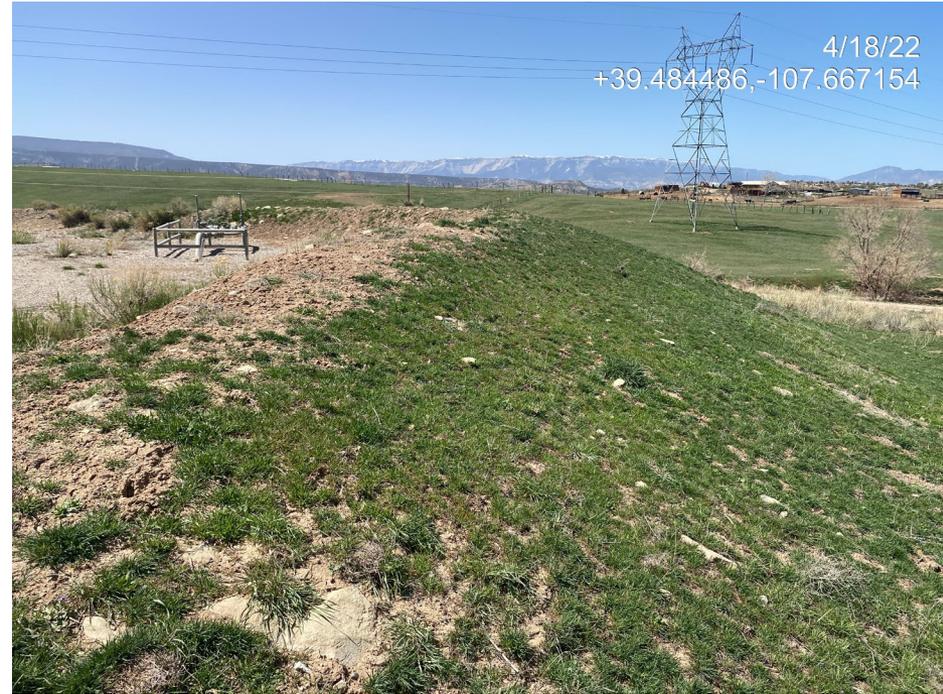
Photo 8. Photo taken from the north of the Location facing west shows a slope colonized by perennial grasses and CO List B noxious weeds cheatgrass and bulbous bluegrass.
